4.8 S10 – SECONDARY HIGHWAY 762 MISCELLANEOUS SITES

4.8.3 Site B

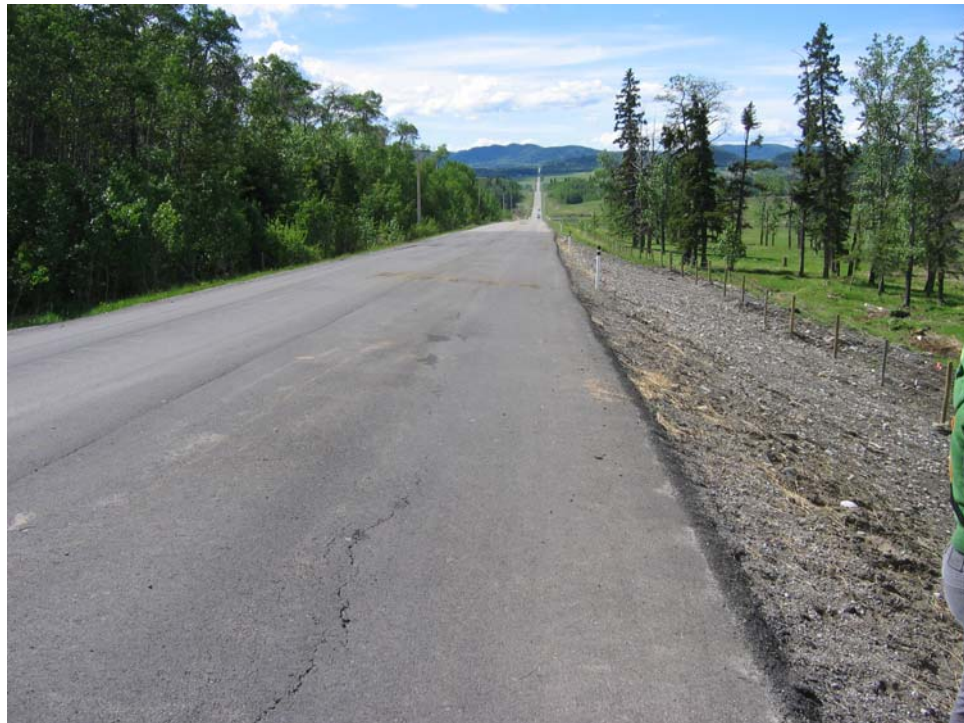
- Some longitudinal cracking has developed along the center of the repaved southbound lane (Photo S10(B)-1). Otherwise, the repaved road surface was in good condition (Photos S10(B)-2 and S10(B)-3).
- Three of the drainage pipe outlets that were installed during repairs to the road in 2005 were visible at the south end of the previously slumped area. Two of these drainage pipes were discharging a trickle of water at the time of the inspection.
- The natural area downslope/west of the fenceline slopes down to the west at approximately 10°. There were boggy areas and possible groundwater springs visible in this area along with several trees tilted in various directions. These conditions were consistent with previous inspections and shows that groundwater discharge is a long-term condition in this area.

Photo S10(B)-1 (upper left) – May 2006 – facing south along the road. The area was repaved since the 2005 inspection. Minor longitudinal cracking visible in the repaved surface.

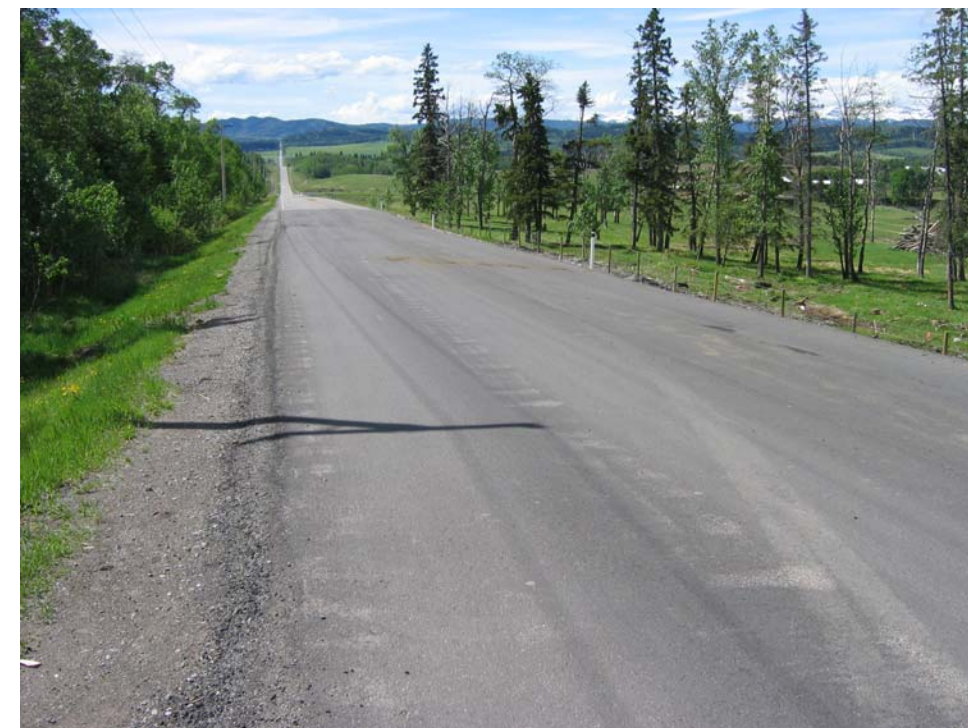
Photo S10(B)-2 (upper right) – May 2006 – facing south along the road. The area was repaved since the 2005 inspection. Compare with Photo S10(B)-3 (lower left) which shows the same area in June 2005.

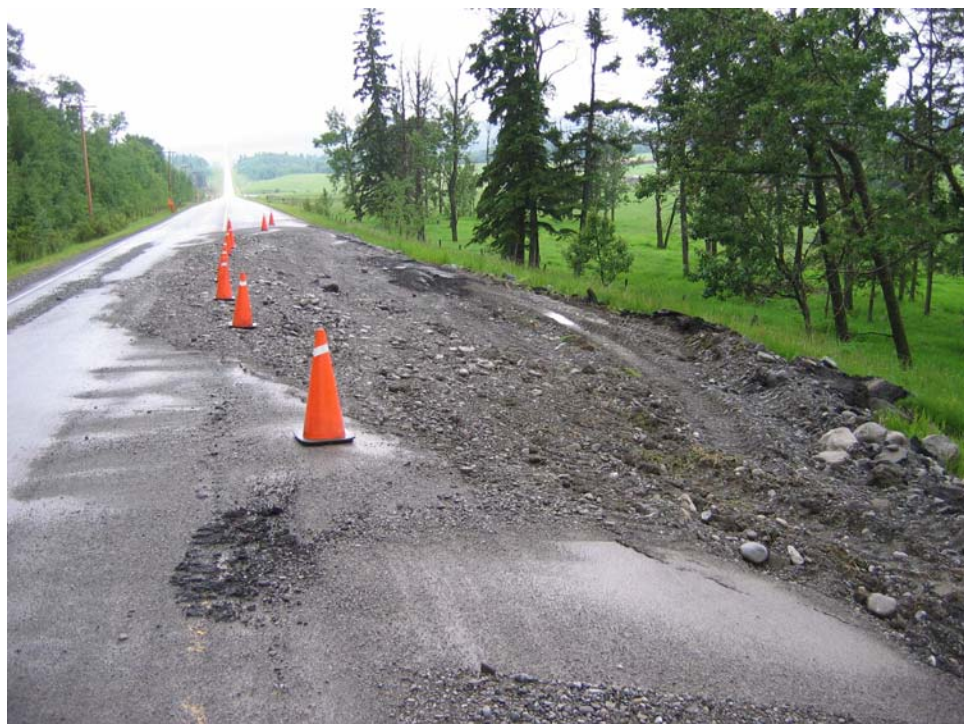
In the summer of 2005, major instability occurred at this site during/following the significant rainfall on June 18 and June 19, 2005. Photos S10(B)-3 and S10(B)-5 show the damage to the road as it appeared at the time. AMEC attended a call-out request to this site by AIT on June 21, 2005 and the description of the instability is summarized as follows:

- The instability consisted of slumping of the west slope of the road embankment that extended through the southbound lane and into the northbound lane.

- As a result of the slumping, the road surface experienced settlements in excess of 1 m on several occasions. Maintenance contractor personnel reconstructed the road surface using granular material several times in order to buttress the northbound lane and maintain alternating one-lane traffic using the northbound lane only (i.e. the regraded southbound lane was only lightly compacted and not intended to carry traffic). Some perforated drainage pipes were placed perpendicular to the road centerline, with the inlet end across the northbound lane trenched into the otherwise intact northbound lane and the outlet ends across the southbound lane at the base of the fill used to reconstruct the southbound lane

Photo S10(B)-3 (lower left) – June 2005 – shows same area as Photo S10(B)-2, as it appeared in June 2005.

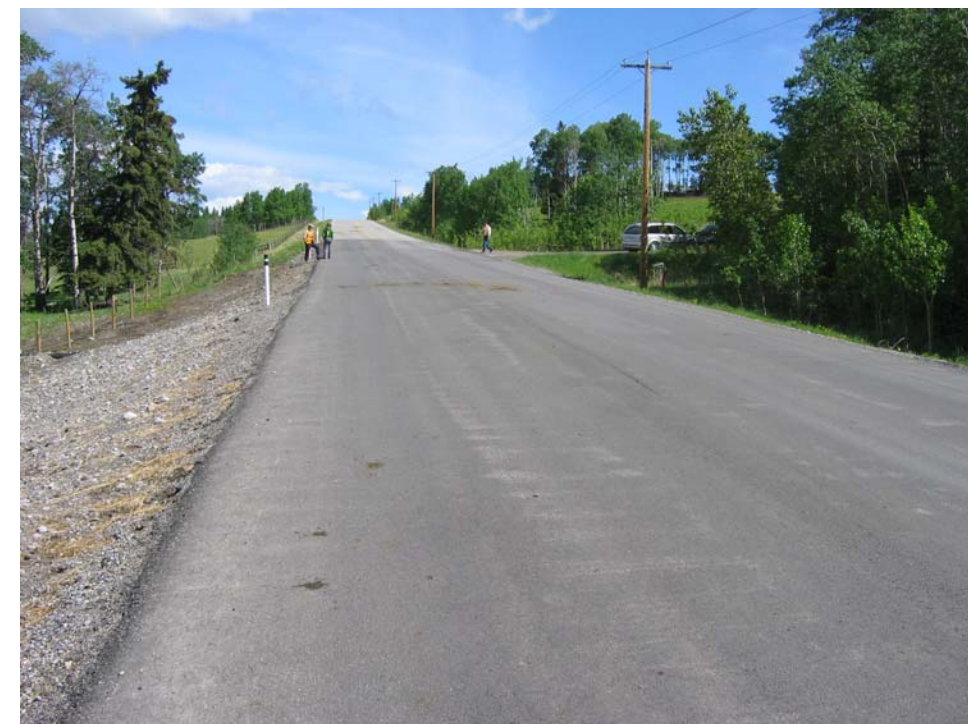
Photo S10 (B)-4 (lower right) – May 2006 – facing north along the road. The area was repaved since the 2005 inspection. Compare with Photo S10 (B)-5 (next page) which shows the same area in June 2005.

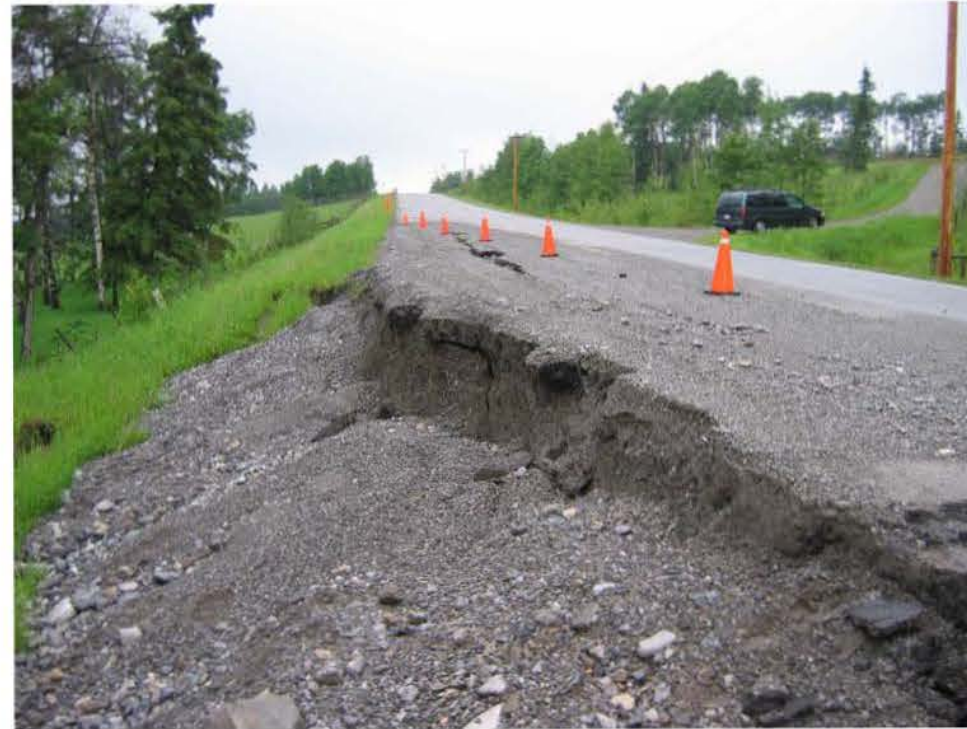
Photo S10(B)-5 (upper left) – June 2005 – shows the same area as Photo S10(B)-4, as it appeared in June 2005.
