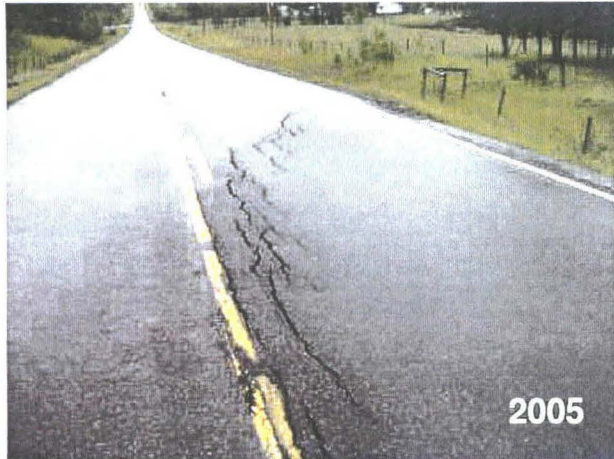
Photo S10(C)-1 – June 2005 (upper left)
Cracking and settlement of the road surface as observed during the 2005 site inspection.

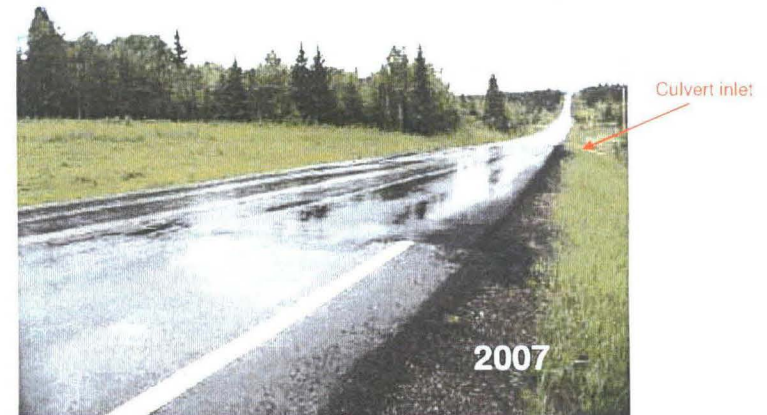
Photo S10(C)-2 – June 2007 (upper right)
Typical view facing north across the recent overlay at the site, as seen during the June 2007 site inspection. The approximate location of the culvert to the south of the overlay is shown.

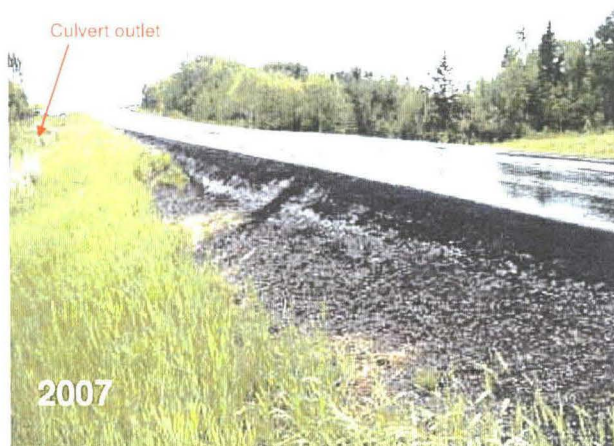
Photo S10(C)-3 – June 2007 (lower left)
Closer view of the edge of the recent overlay, along the east shoulder of the road. The approximate location of the culvert to the south of the overlay is shown.

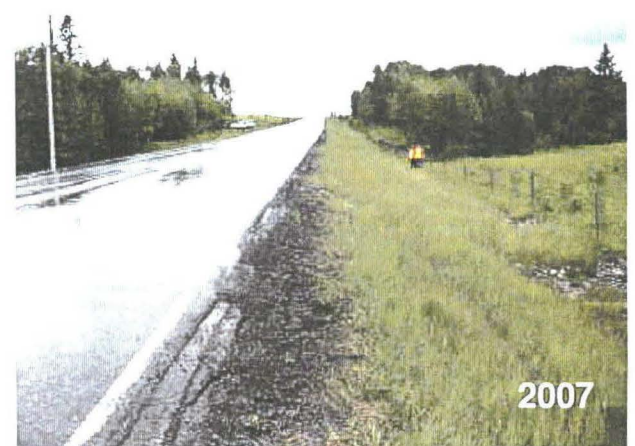
Photo S10(C)-4 – June 2007 (lower right)
Facing south along the west shoulder of the road. The culvert shown in Photos S10(C)-5 and 6 is just behind the two people standing in the ditch to the right of the road.
