AMEC Earth and Environmental (AMEC), a division of AMEC Americas Limited, performed a call-out site inspection at a site exhibiting cracks in the road surface along Highway 762:02 on March 5, 2010. The site is referred to as the "Hwy 762:02 Km 9.5 Surface Cracks Site". The call-out request was made by Mr. Ross Dickson of Alberta Transportation (AT). The site inspection was performed by Mr. Bryan Bale, P.Eng. of AMEC.

Client	Alberta Transportation		Figure 1	
Project	Hwy 762:02 - KM 9.5 Surface Cracks Site		Date:	Revision:
Site Plan and Cross-Sections			Mar-10	
			Job No.	CG25309.D
			File No.:

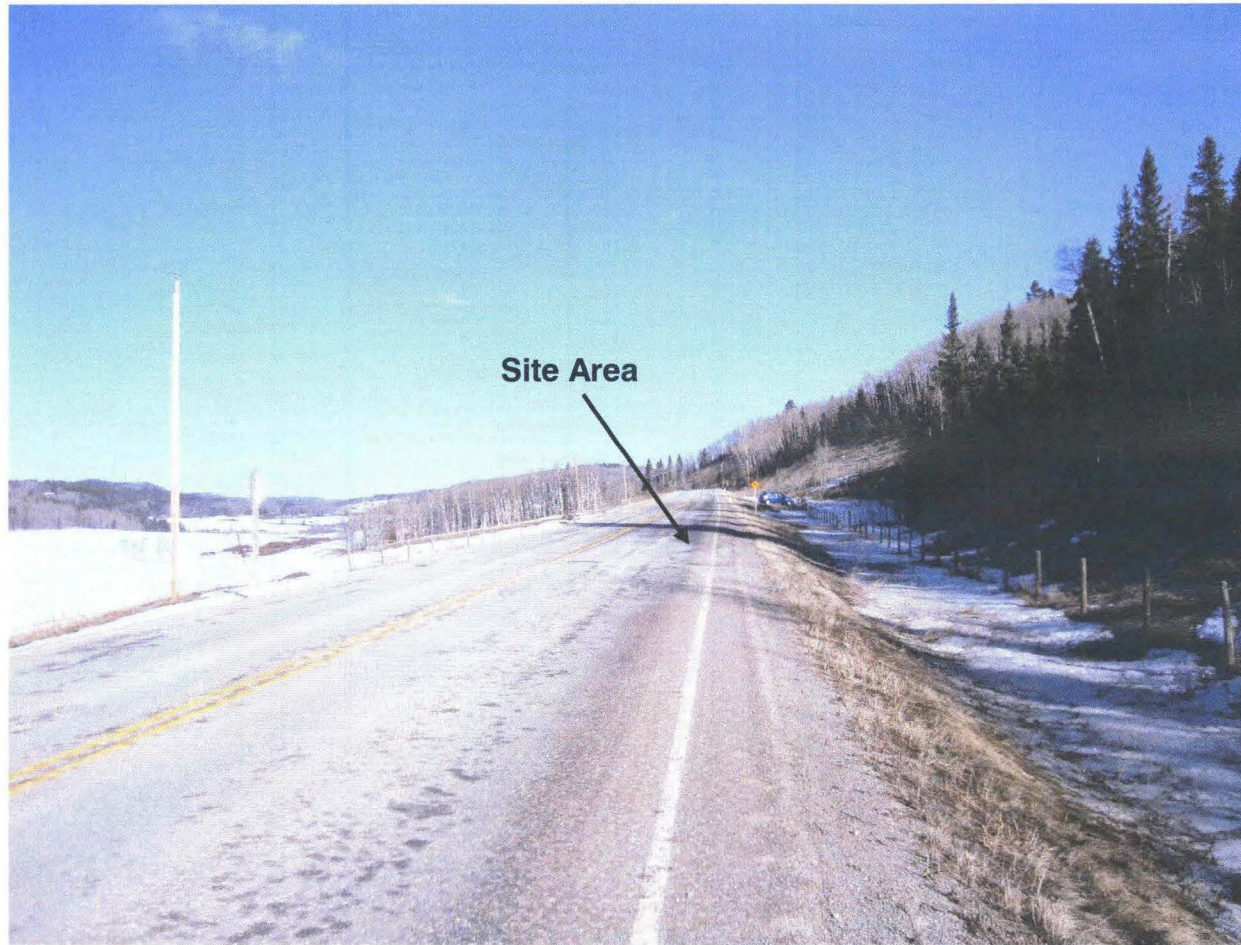
Photograph 1 – Looking northbound towards the site area. The power pole and sign post are indicated on Figure 1 for reference.

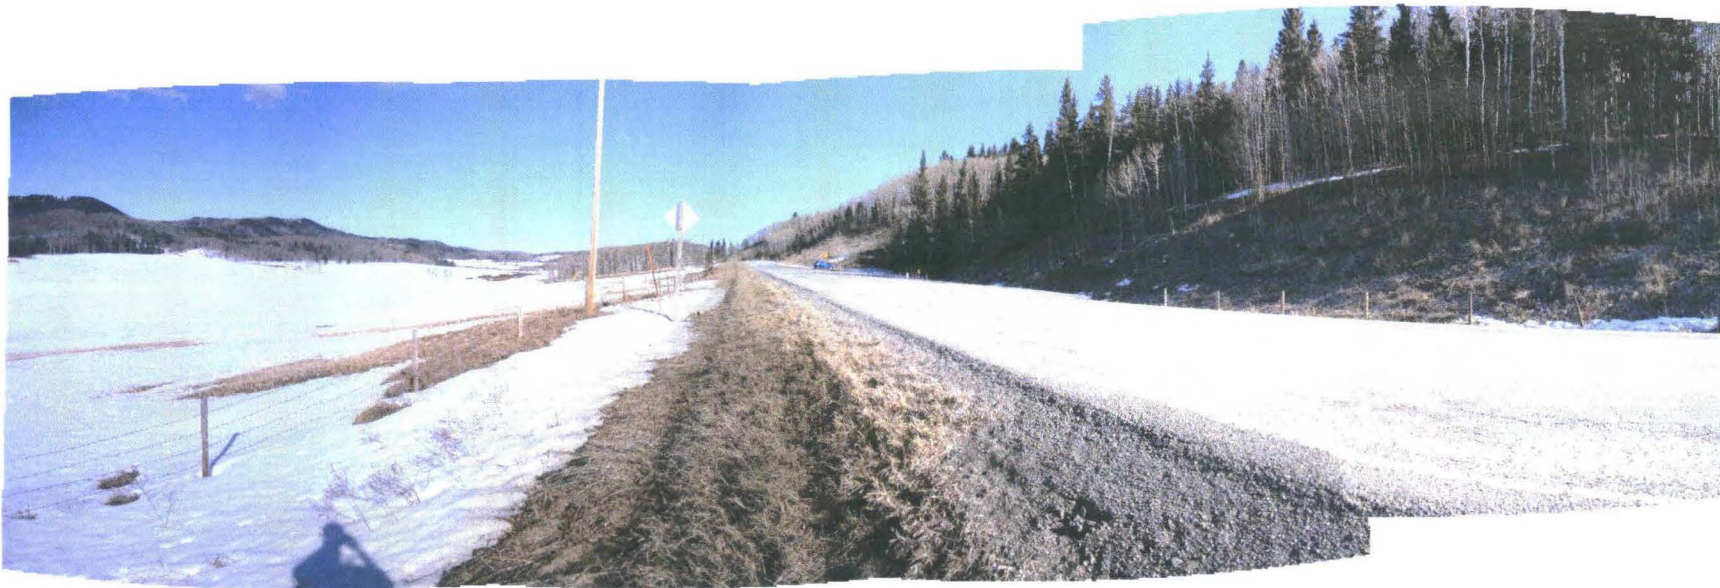
2. The road is built in a cut and fill location where it traverses across the lower portion of the west slope of the north/south oriented ridge adjacent to the highway (see inset map on Figure 1). The cut slope above the road is at an angle of 28° and has sandstone cobbles/boulders protruding from the soil that may be indicative of bedrock near the ground surface. The slope is sparsely vegetated with small poplars, and shows no visible signs of shallow or deep instability. The natural slope above the cut slope is at an angle of 12°, is well vegetated with mature poplars, and also appears stable. The slope below the road is at 10°, is used for pasture, and appears stable. The road embankment is 1.3 to 1.5 m high above the adjacent ditches. Refer to the cross-section on Figure 1.

Photograph 2 – Stitched photographs of the site area, facing northbound and taken from the west edge of the road, showing the natural slope downslope of the road, and the cut slope in the ridge upslope of the road.

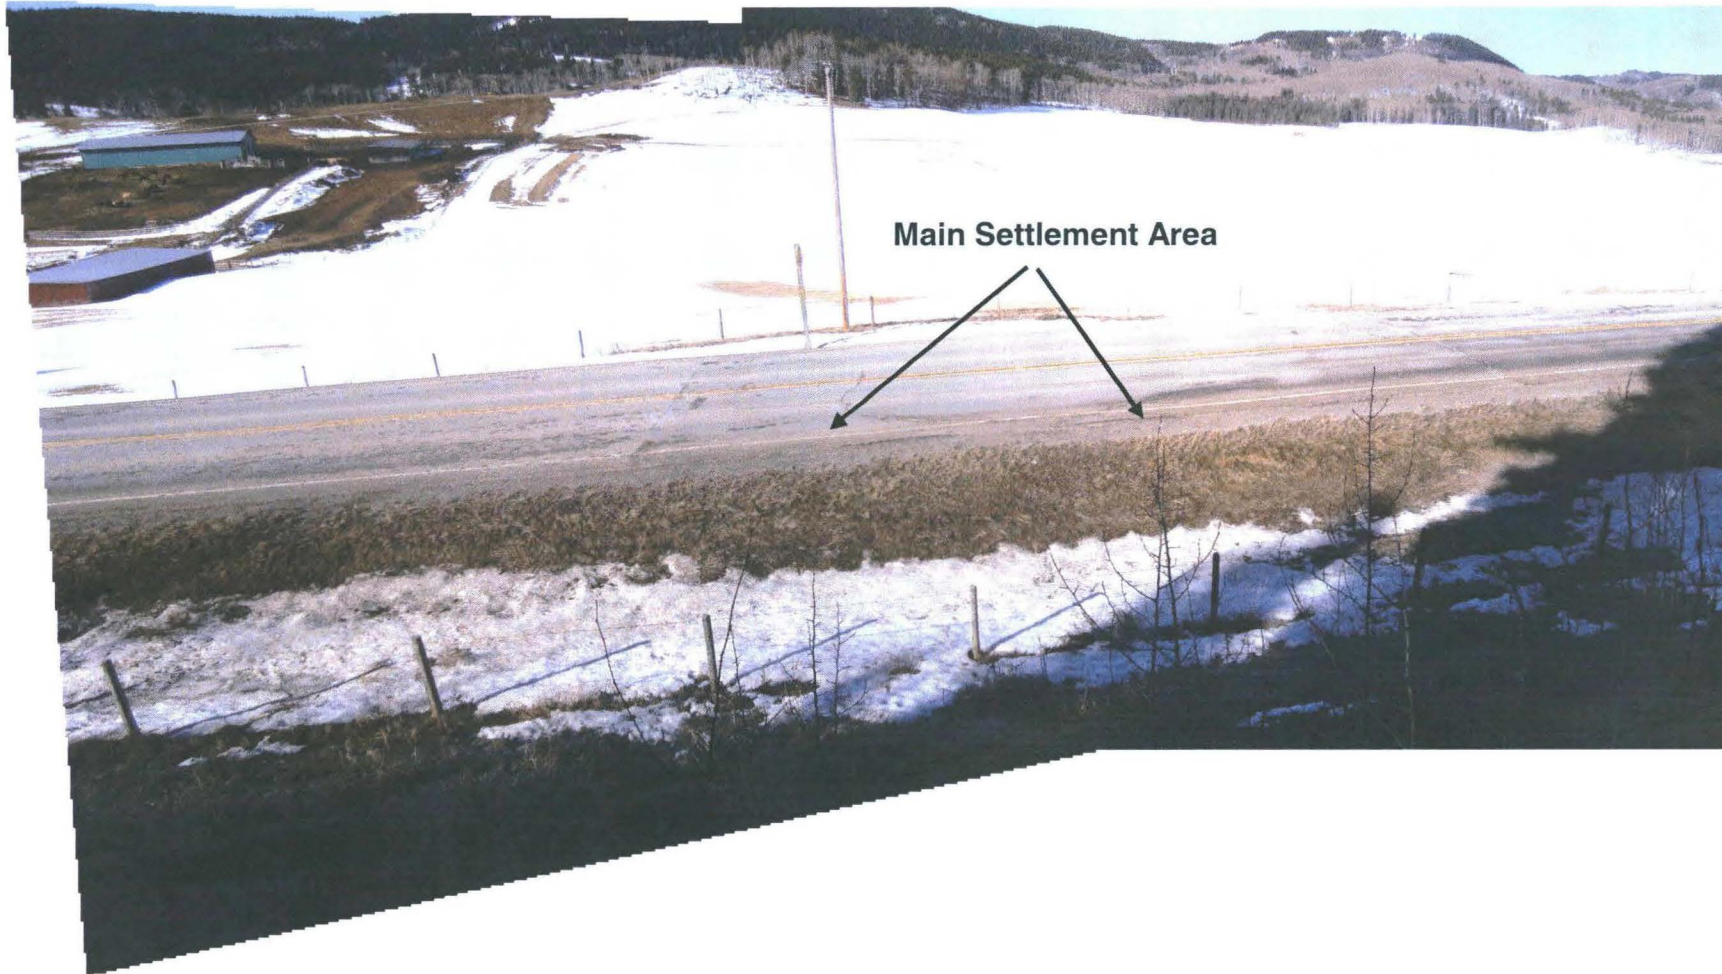
1. Cracks were observed in the asphalt road surface and gravel shoulder perpendicular to the direction of travel, and also forming arc patterns. The locations of the cracks are shown on the site plan on Figure 1. The cracks were up to 40 mm deep with an aperture of 20 to 30 mm and no vertical downdrop. Some of the cracks extended onto the gravel road shoulder, which also had open cracks. Minor settlement was noted on the upslope edge of the road near the arc shaped cracks, which was only visible when standing downslope of the road with the road surface at eye level. When driving over the site the settlement is noted as a gentle bump. An asphalt overlay that appears to be at least several years old was noted at the site, the boundaries of which roughly correspond to the area presently exhibiting cracks in the asphalt surface. Refer to Photograph 3 to Photograph 6 for illustration of the cracks in the road surface.

Based on the observed arc-shaped pattern of cracking and settlement in the northbound lane, it appears that two shallow slumps (1 to 2 m deep) in the road fill towards the upslope ditch have caused the majority of the road damage. These shallow slumps are likely due to weak and poor quality fill material used for construction of the road embankment and possibly an underlying organic layer that was not fully removed during construction (based on site investigations at the nearby S10A – Archery Range and S22 – S-Curve sites). The other cracks perpendicular to the direction of travel are likely due to contraction and expansion of the road fill and surface due to seasonal temperature and water content variations in the road base.

Photograph 3 – Stitched photographs of the site area from upslope showing the extent of cracking on the road surface, and the settlement areas.

2. Based on the visual monitoring up to June 2010, a maintenance or repair method can be selected from the following:
 - a. Slow Movement Not Threatening Loss of Road – Repair the road surface with asphalt overlays and treat as an ongoing maintenance item. However, AT should consider the ongoing maintenance commitment and costs versus the upcoming asphalt overlay of this segment of Highway 762.

- b. Rapid or Episodic Movement – Rebuild the northbound lane at the damaged area with competent fill. Approximately 250 m³ (500 tons) of competent fill would be required, with closure of the northbound lane during the repair. This option would also be suitable to mitigate slow and ongoing movement.

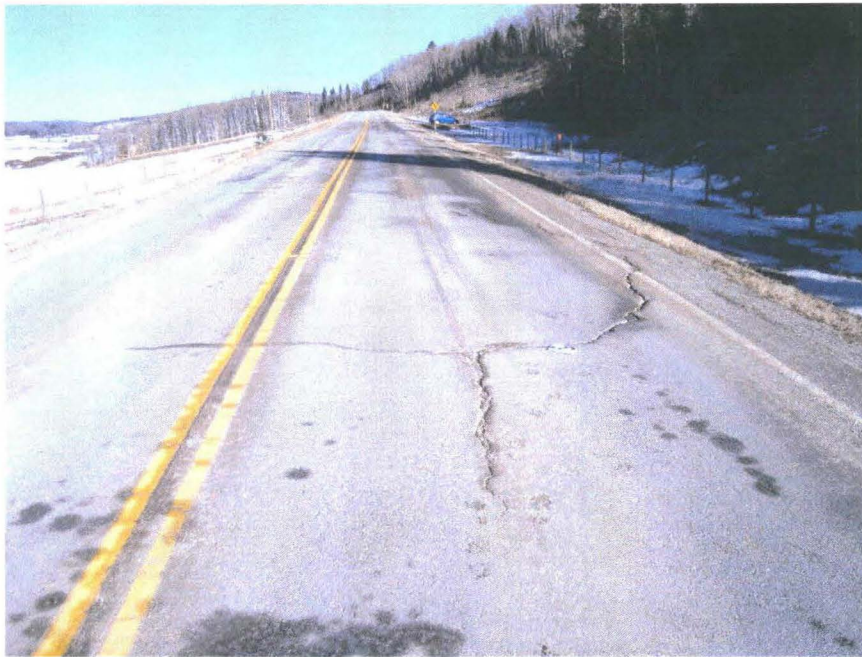
Photograph 4 - Looking north towards the arc shaped cracks in the road surface. Field notebook shown for scale.

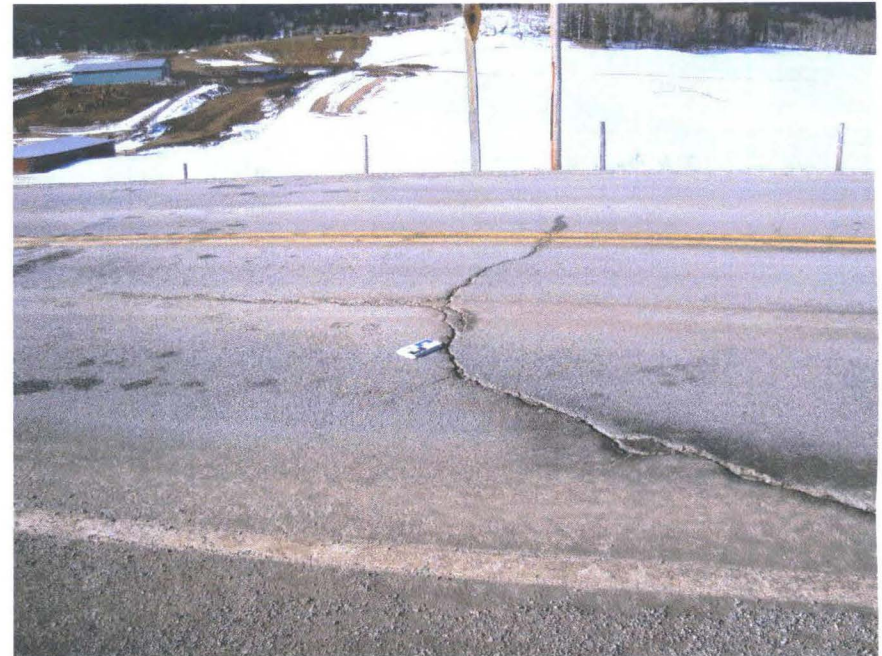
Photograph 5 – Looking west at the arc shaped cracks in the road surface.

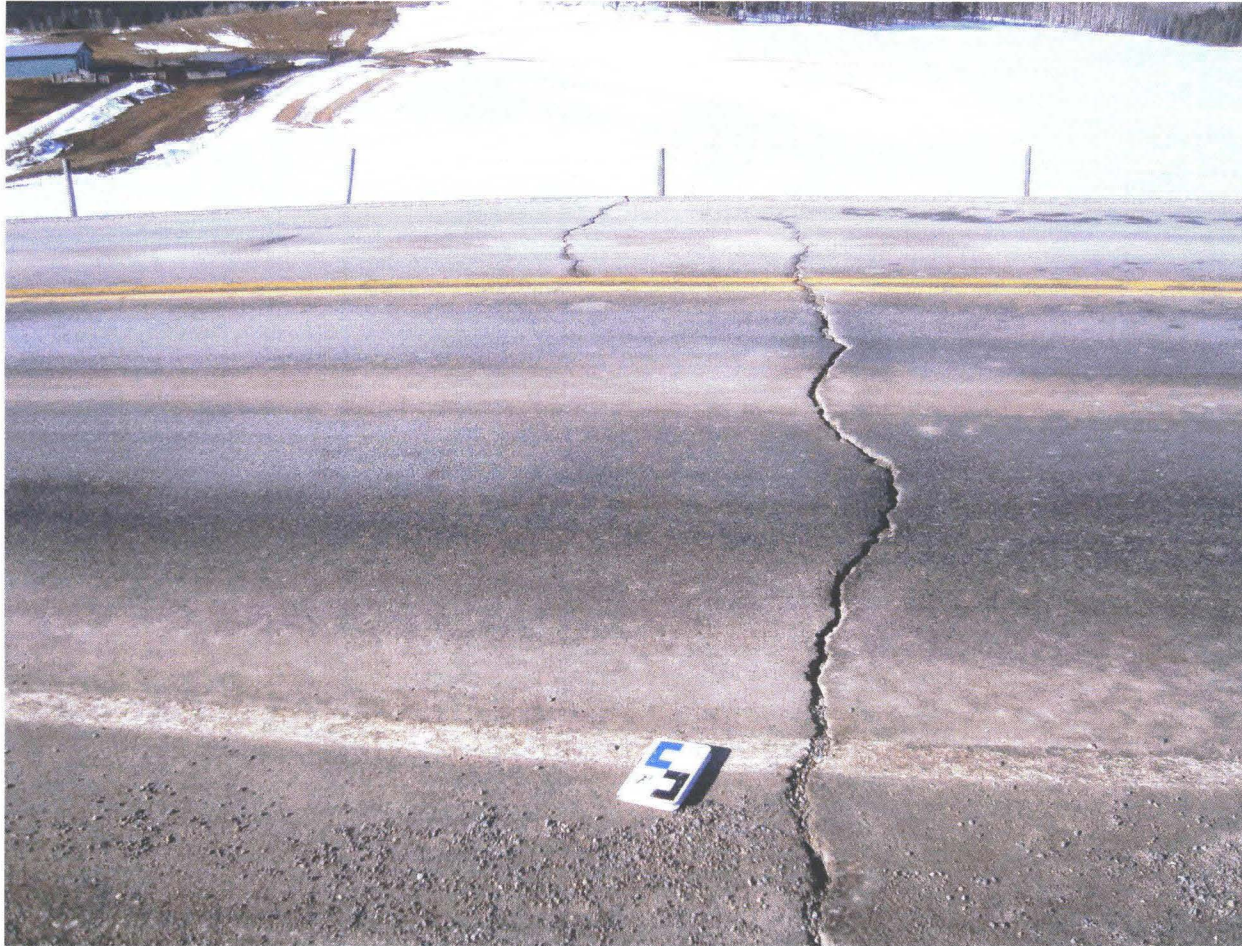
Photograph 6 – Looking west at the cracks perpendicular to the direction of travel.

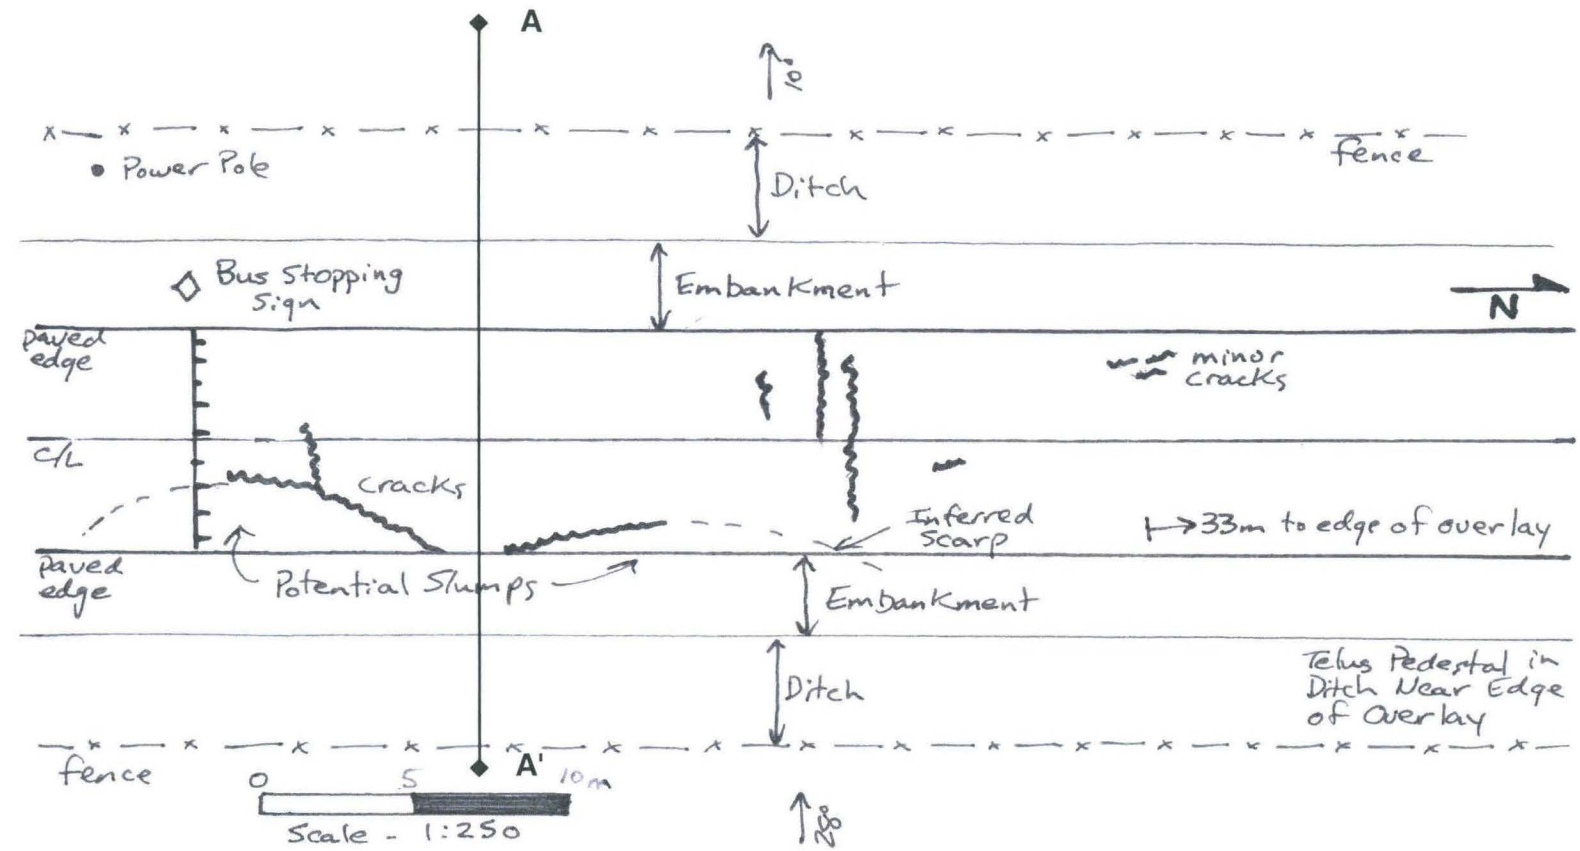
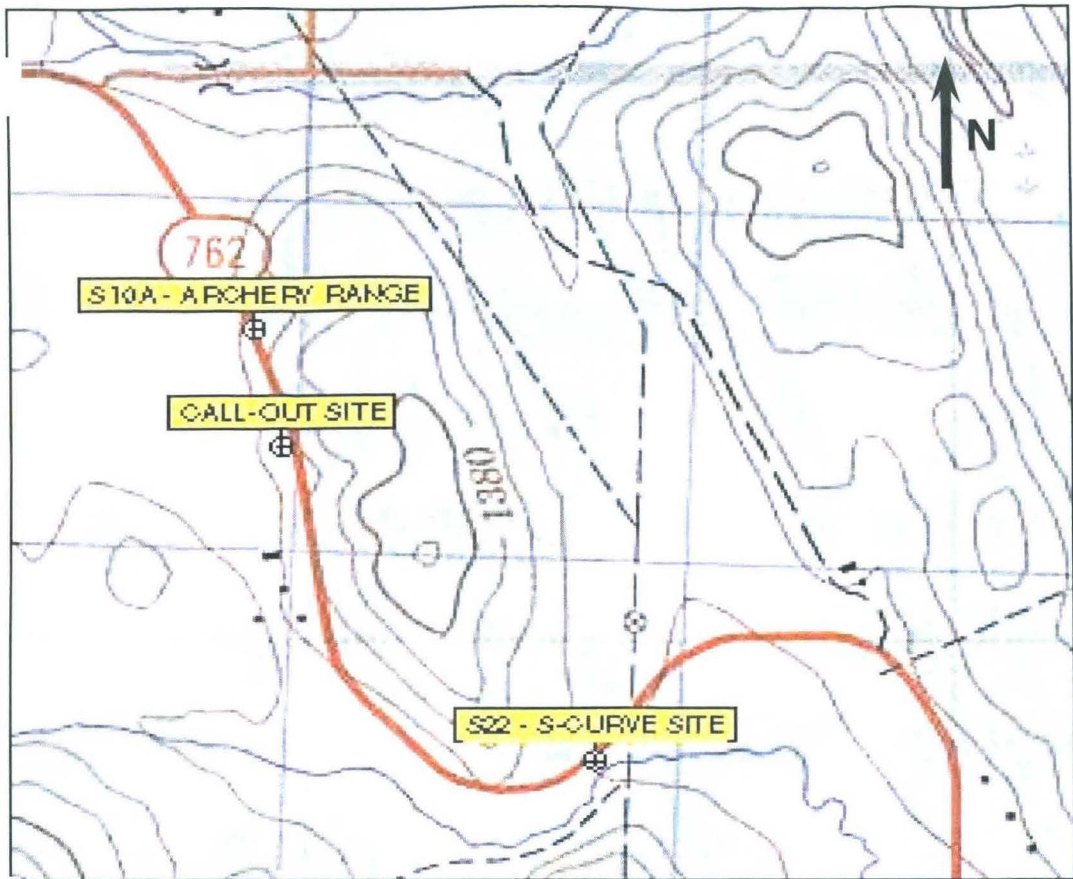
Approximate Site Plan

A site plan along with slope cross-sections through the landslide area is attached as Figure 1.
