CG25309.B

**Re: Southern Region Geohazard Assessment Program
Site S33 – Highway 774, Beaver Mines/“Limber Pine Creek” Site
2009 Annual Inspection Report**

This letter documents the 2009 annual inspection of the Beaver Mines/“Limber Pine Creek” site located approximately 4.2 km southbound along Highway 774 from Beaver Mines, AB.

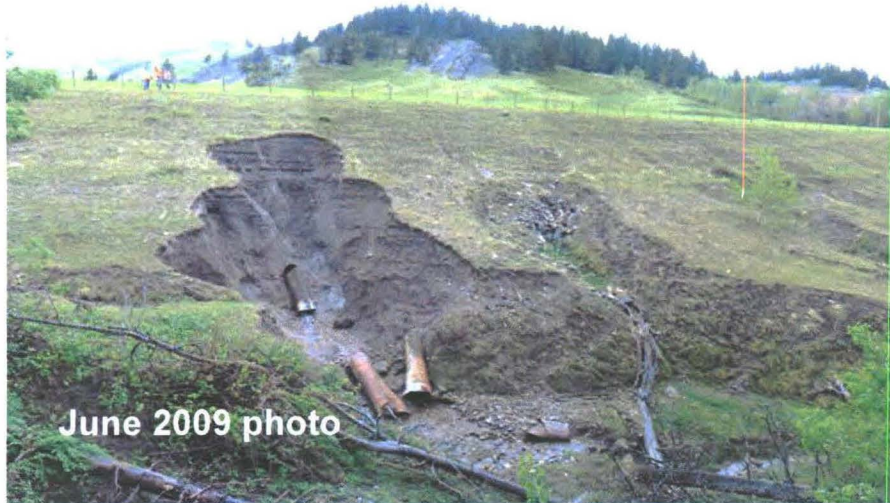
- No repair work has been performed at the site since the June 2008 inspection.
- The road embankment fill erosion around the culvert outlet has continued since the June 2008 inspection, however the size of the eroded area does not appear to have increased significantly since June 2008. Photos 1 and 2, attached, show comparative views of the erosion area from the June 2008 and June 2009 inspections. The offset distance between the upslope extent of the erosion area and the downslope edge of the highway was in the order of 10 m or more at the time for both inspections.

- The road surface continues to show no signs of damage due to the embankment fill erosion around the culvert outlet.
- As shown in Photos 1 and 3, since the June 2008 inspection an additional 2.8 m length of the culvert outlet has broken away.

- The failure of the culvert outlet and erosion of the embankment slope from around the culvert outlet appears to be due to the embankment backfill being eroded by groundwater seepage through the base of the embankment along with high exit gradients for the seepage around the culvert outlet. It is also possible that the seepage through the base of the embankment and around the culvert is causing piping erosion within the embankment. The groundwater seepage appears to be creek flow that bypasses the culvert due to the inlet being too high along with the broad, distributed nature of the creek flow in the area upstream of the highway (i.e. not a single, defined channel flowing directly into the culvert). There is also the possibility that there is leakage from the culvert into the base of the embankment that is contributing to the seepage around the culvert.

- The erosion area on the downstream embankment face has still not started to undermine the road surface. However, the oversteepened upper portion of the erosion area will not be stable over the longer term and it will eventually retrogress further upslope. This will eventually begin to destabilize the road surface.

Photo 1 – June 2009 (top)
Facing upstream towards the southeast embankment slope. Note the failure of the culvert outlet and the erosion around the outlet that has retrogressed up the embankment slope towards the highway. Compare the extent of erosion with Photo 2, taken in June 2008.

[It is recommended to] install a new, smaller diameter culvert/HDPE pipe through the existing culvert and grout the annular space between the two pipes. This option should be less expensive than a trenchless installation of a replacement culvert. However, it may not be possible to install a new culvert/pipe through the existing one due to the dent visible in the existing culvert and a smaller diameter culvert may not have sufficient flow capacity for this site. Also, this option would not mitigate the possible voids in the embankment around the original culvert aside from possibly at least partially filling some voids with grout that leaks outwards through any holes in the existing culvert.

1. *Trimming back the oversteepened headwall areas of the erosion area to a gentler slope.*
2. *Placing a layer of geotextile on the erosion area face, then backfilling the erosion area with granular material. The geotextile will prevent fine-grained material from the embankment fill from piping out into the granular backfill. The granular backfill material will need to be suitably graded to prevent groundwater flow through the lower portion of the embankment from eroding it away.*
3. *Spreading topsoil across the backfilled area and revegetating the slope.*

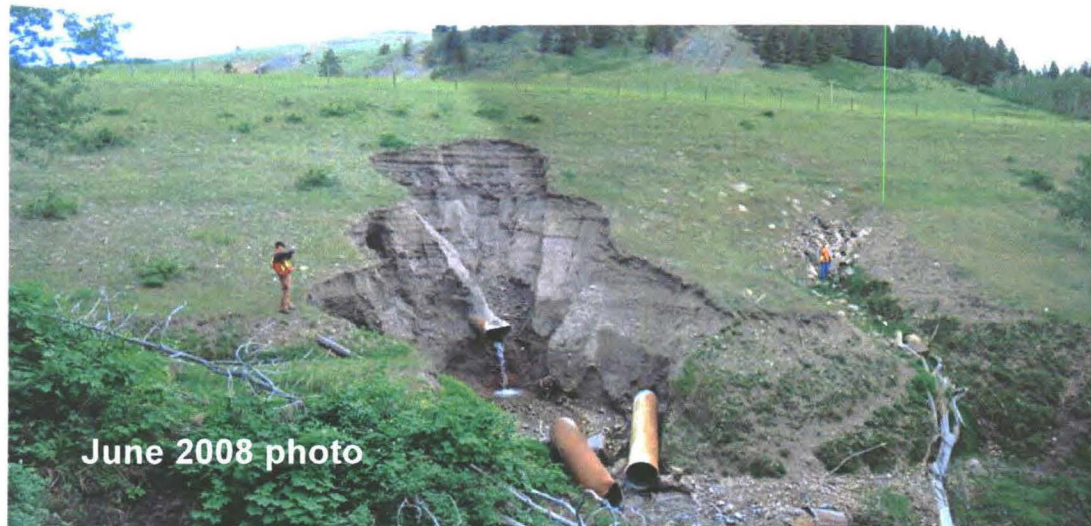
Photo 2 (bottom)
June 26, 2008 photo.

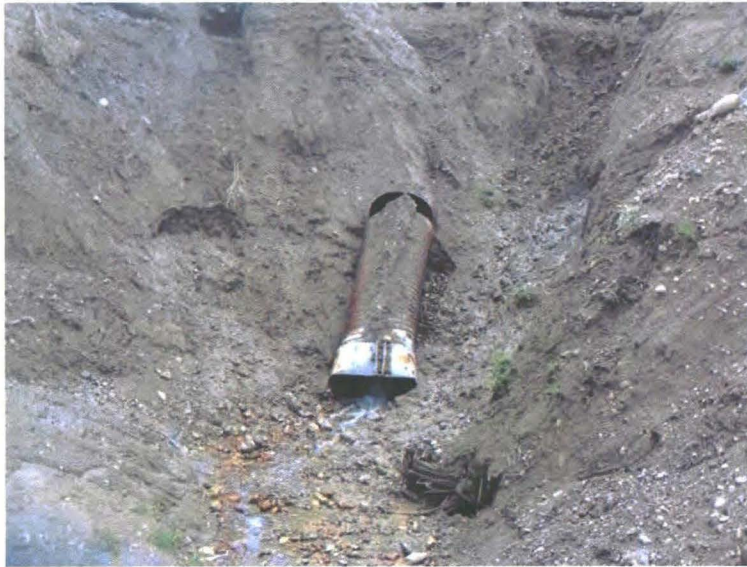
- Clear groundwater seepage was daylighting from several areas in the eroded embankment face within a few metres of either side of the culvert outlet. The seepage was daylighting at elevations around the crown of the culvert and below. Photo 3, attached, shows the distribution of seepage discharge around the culvert outlet. The seepage discharge was widespread and it was not possible to get even an approximate measurement of the seepage rate. Subjectively, the seepage rate appeared to be less than noted during the June 2008 inspection, however the rate of creek flow in June 2009 also appeared to be proportionally less than during the June 2008 inspection.

Photo 3 – June 2009 (top)
Culvert outlet within the erosion area on the downstream face of the embankment. Note the 2.8 m long segment of culvert that has become detached since the June 2008 inspection. Note also the sloughed areas in the erosion slope around the outlet – these areas delineate the groundwater seepage discharge around the culvert outlet.

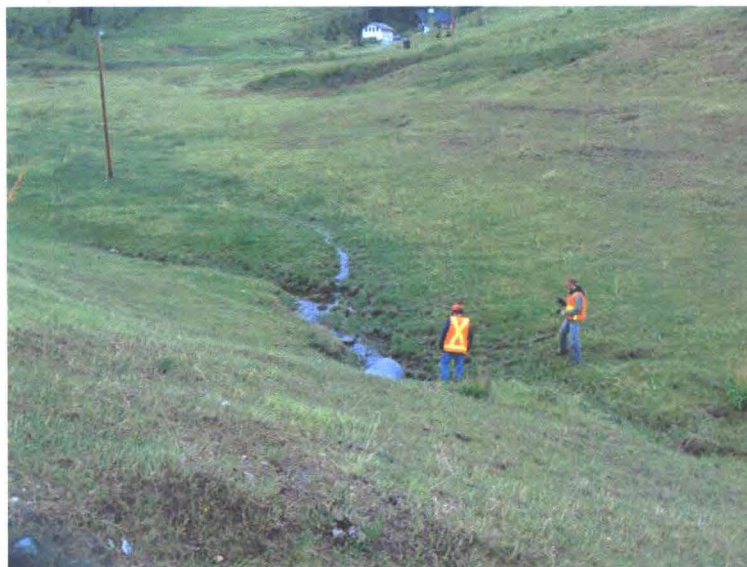
- Photos 4 and 5 show the area around and upstream of the culvert inlet as they appeared at the time of the June 2009 inspection. There were no significant changes in this area since the June 2008 inspection. The culvert inlet elevation remains slightly higher than it should be relative to the channel elevation (Photo 5).

Photo 4 – June 2009 (bottom)
Facing upstream from the highway, with the culvert inlet visible in the middle foreground.

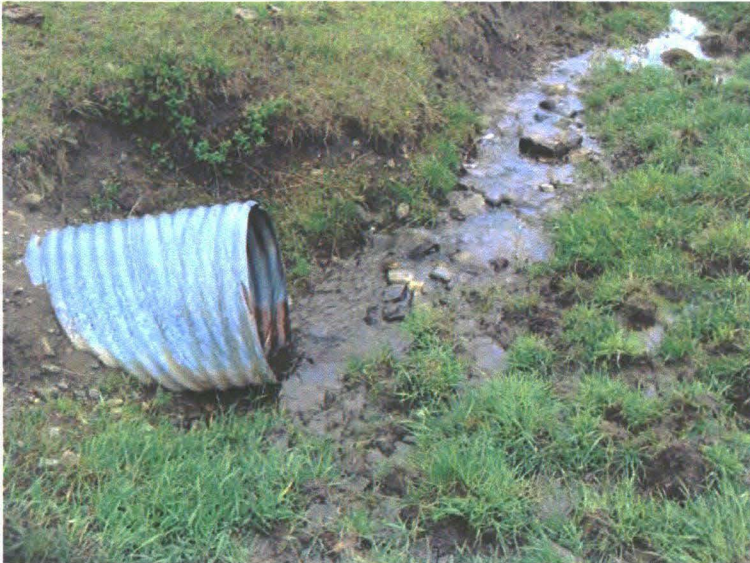
Photo 5 – June 2009 (bottom)
Close-up view of the culvert inlet.
Note how the inlet is slightly higher
than the base of the creek channel.
