October 14, 2010

CG25332.200

**Re: Southern Region Geohazard Assessment Program  
Site S33 – Highway 774, Beaver Mines/“Limber Pine Creek” Site  
2010 Annual Inspection Report**

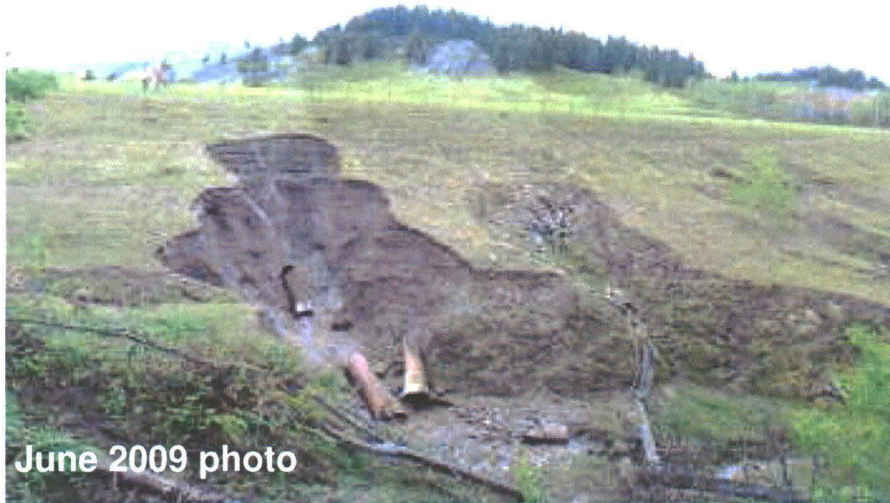
- The site has been repaired since the June 2009 inspection. A new segment of culvert outlet has been attached and the slope has been rebuilt. Rip-rap has been placed at the culvert outlet, and in one of the erosion gullies. The repair appears effective, and the slope was in good condition. Photos S33-1 and S33-2 show comparative pictures of the site before and after repair.

**Photo S33-1 – June 2009 (top)**  
Facing upstream towards the southeast embankment slope prior to the repair work. Note the failure of the culvert outlet and the erosion around the outlet that has retrogressed up the embankment slope towards the highway. Compare with Photo S33-2.

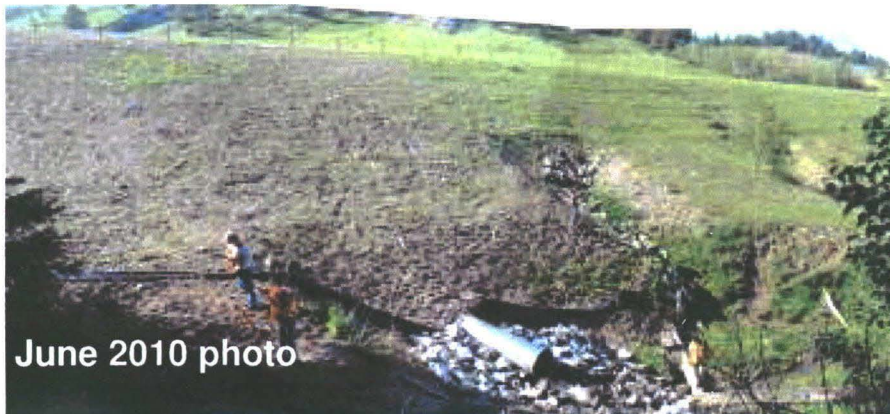
The repair work appears to have effectively repaired the erosion damage around the culvert outlet. The other erosion gullies upslope and northeast of the culvert outlet remains in the same condition as in past inspections, and currently poses little risk to the road.

**Photo S33-2 – June 2010 (bottom)**  
Taken from the same angle as Photo S33-1, showing the repaired culvert outlet and regraded slope. The erosion gullies to the northeast were either lined with rip-rap or left unrepaired.

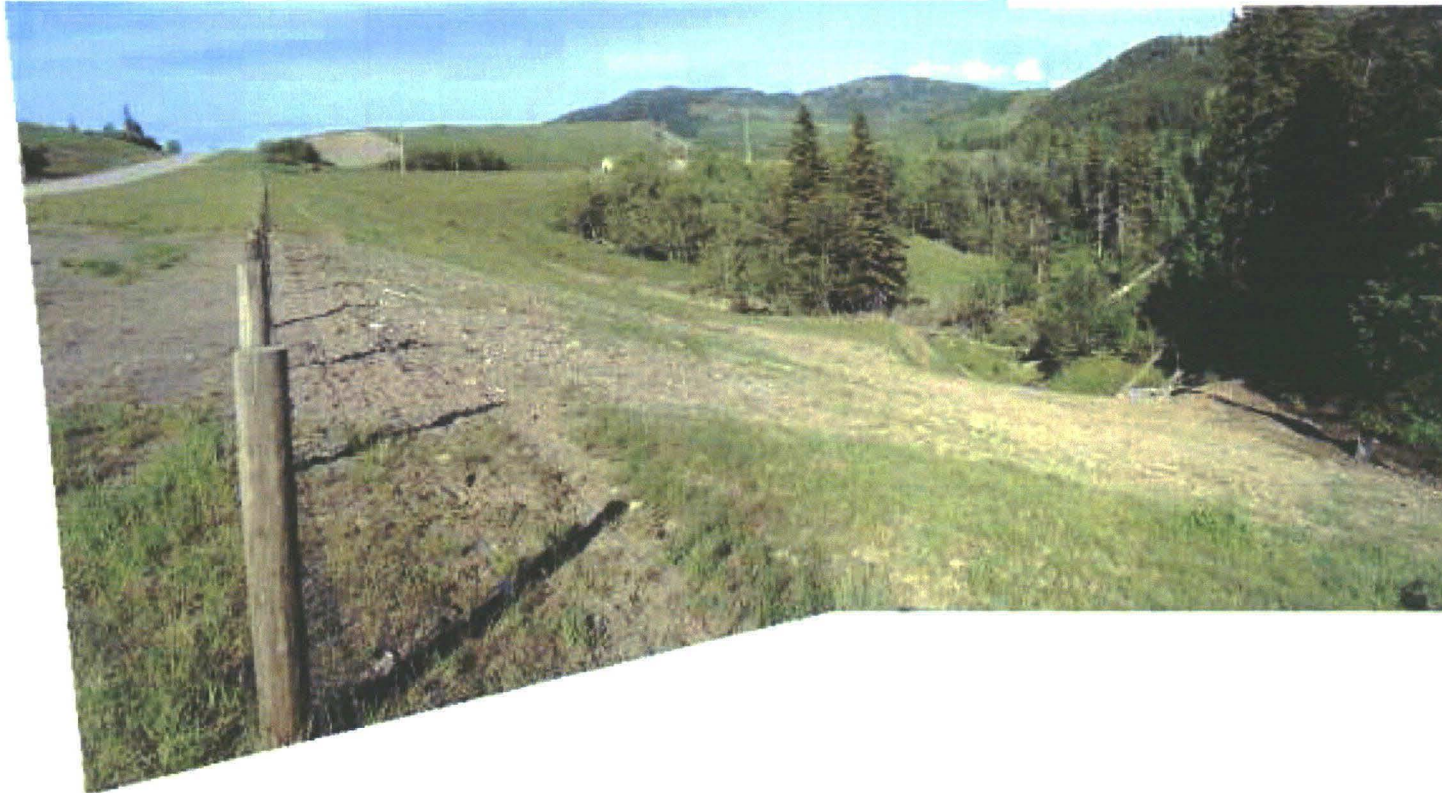
**Photo S33-3 – June 2010**

- The slope was poorly vegetated at the time of the inspection, and it does not appear that the slope was reseeded after the repair. Refer to Photo S33-3.

Looking northeast along the embankment crest. The repaired slope appears stable, but has very little vegetation cover.

The regraded embankment slope areas should be hydroseeded as soon as possible to minimize future erosion of the exposed soils.

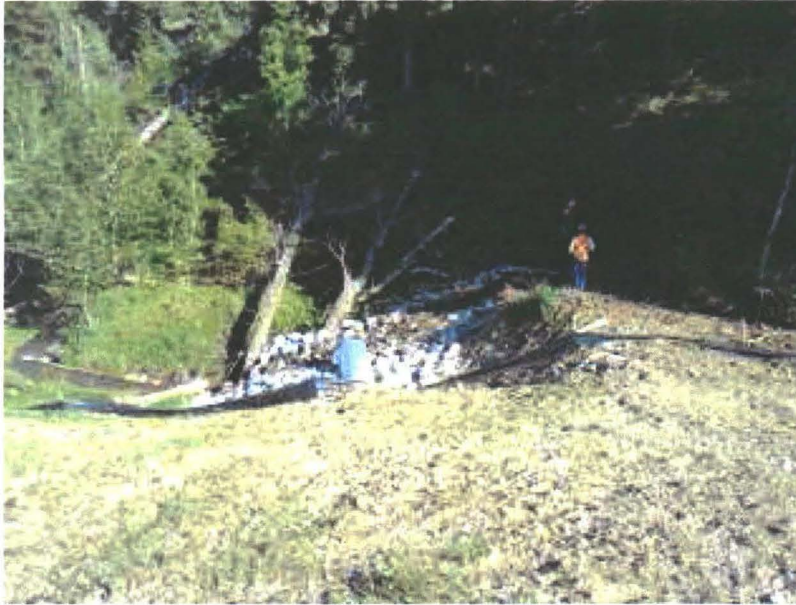
**Photo S33-4 – June 2010**

- The volume of water flowing through the culvert was likely larger than typical, as evidenced by the flow in the ditch to the north of the highway where the water was flowing overtop the regular ditch channel and overland towards the culvert. The water was being directed through the culvert and into the creek to the south of the site area without causing erosion damage. The repaired culvert and armouring appears sufficient to handle the flow at the site (Photo S33-4).

Looking down the embankment fill towards the repaired culvert outlet. The culvert was flowing at several hundred litres/minute at the time of the inspection, and the flow was leaving the site area as intended without causing erosion damage.
