October 31, 2019

Alberta Transportation
2nd Floor, 803 Manning Road NE
Calgary, Alberta
T2E 7M8

Southern Region Geohazard Risk Management Plan
Hwy 1A:02, km 12.52 to 11.91 Call-Out Report
DRAFT

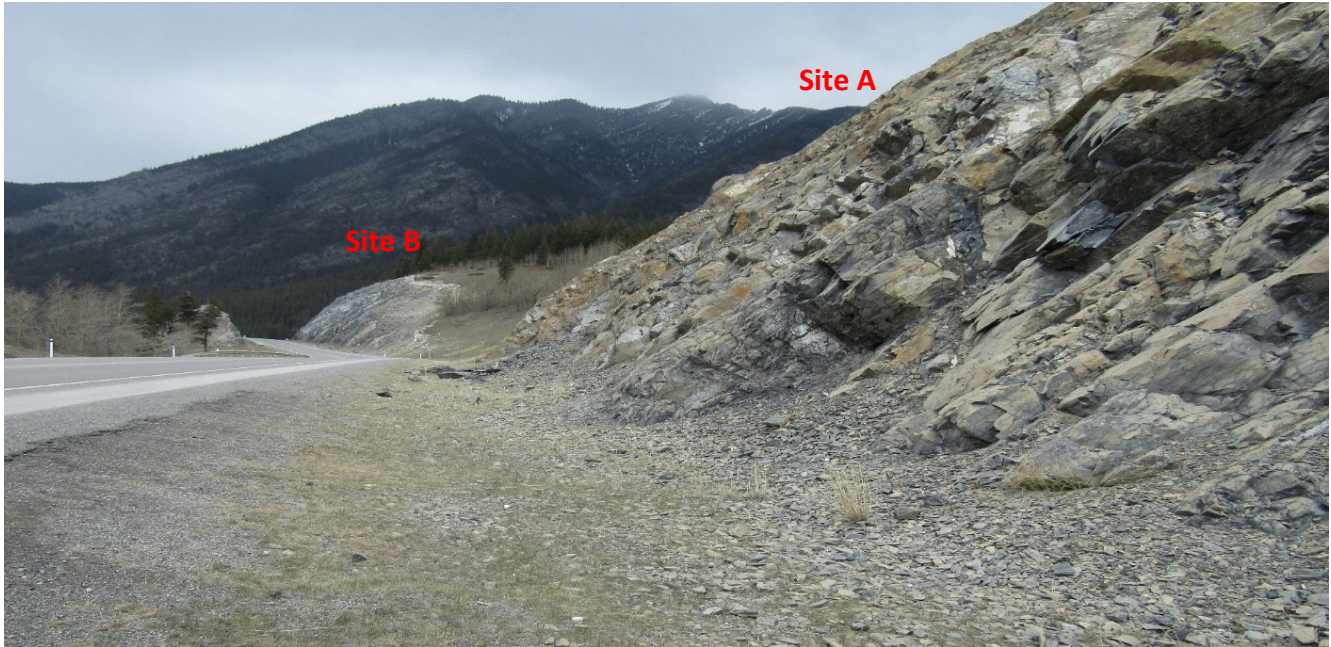
- Bedding planes and jointing on the north side of the highway were dipping towards the highway at approximately 40 degrees, which correlates with the geological map. The bedding plane orientation means that there is the potential for blocks to roll onto the highway, primarily due to wedge and sliding failures of rock blocks due to joint propagation perpendicular to bedding planes. Multiple areas of rockfall were noted at the toe of the slope, generally consisting of gravel sized particles (≤ 75 mm diameter), but with cobble to boulder-sized blocks (> 75 mm) noted in places;

Photo 1 Sites A & B. The rock slopes north of the highway have adverse bedding planes and potential for rock fall onto the road. Photo taken facing northwest on May 7, 2019.

A photogrammetry assessment of the slopes is recommended to identify source zones, risk areas, and potential areas for anchors. Spot bolting of blocks which appear unstable or pose a wedge failure risk is recommended.

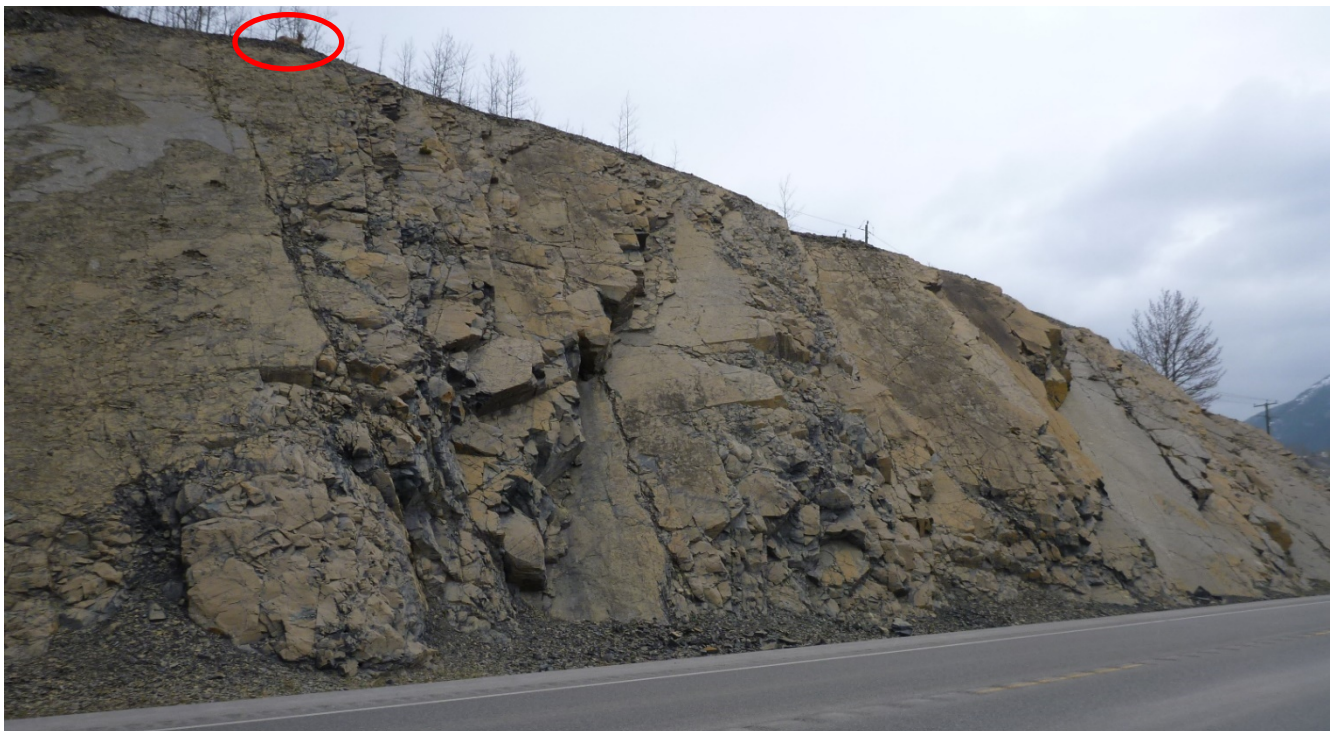
Photo 2 Southeastern section of Site A (north of the highway). Mountain goat at slope crest (red circle). Photo was taken facing northeast on May 7, 2019.

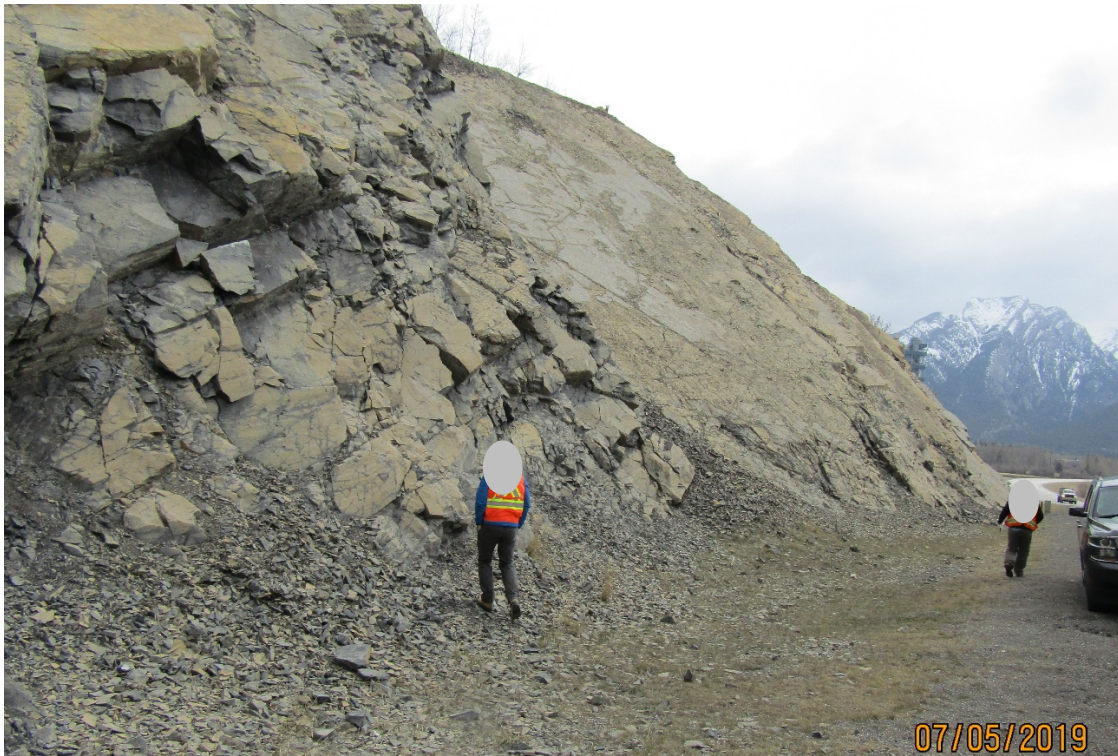
- Catchment ditches are present at both sites; however, they were shallow. The catchment width was estimated to vary between 3 m and 7 m;
- No evidence of existing rock bolting or slope reinforcement was observed at the site; and

Photo 3 Central section of Site A (north of the highway). Rock catchment ditch is shallow. Photo taken facing east on May 7, 2019.

Recommended management options include routine inspection of the cut slopes and ongoing clearance of rockfall debris in the existing shallow to non-existent catchment ditches.

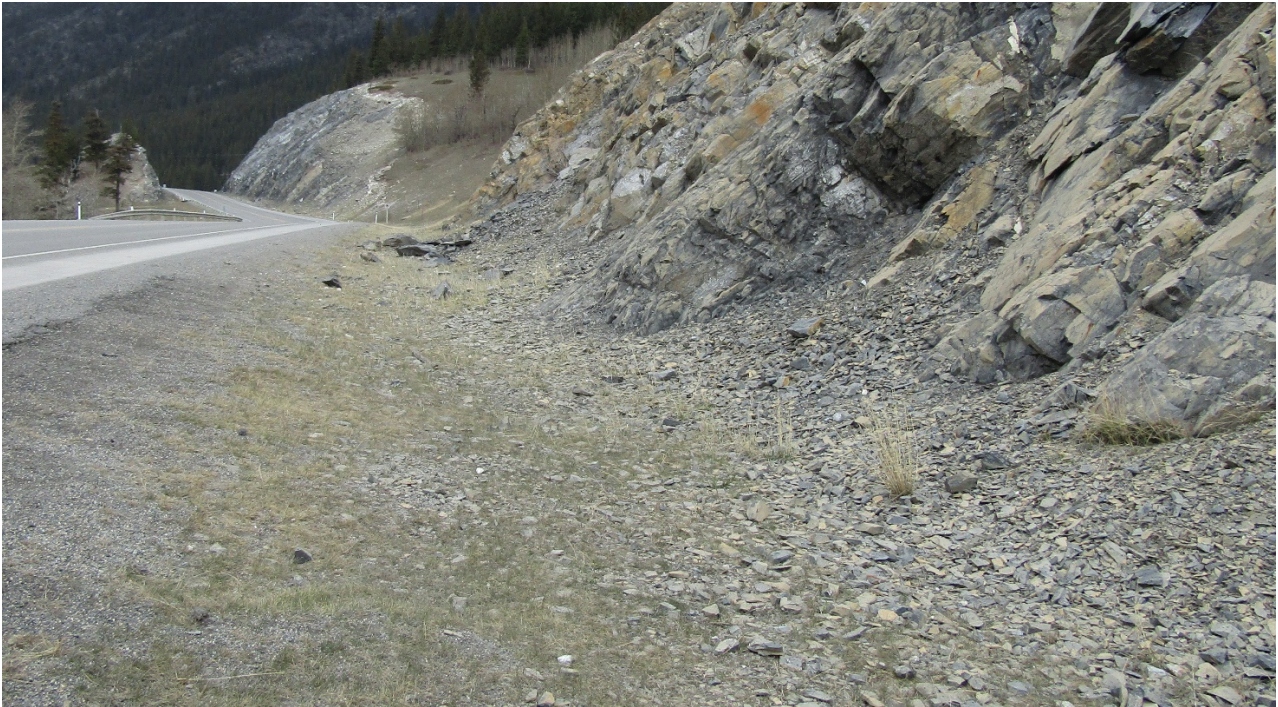
- Probability Factor – A rating of 11 was selected because the slope was active, with ongoing periodic rockfalls, possibly triggered by annually recurring weather conditions. The fallen rocks were generally small-sized, but there was the potential for larger-sized wedge failures, and the geometry of the slopes were such that rocks could possibly bounce onto the road.
- Consequence Factor – A rating of 1 was selected, because rockfall would probably be contained by the existing shallow ditch, if the ditch was cleaned as required to maintain capacity.

Photo 5 Rockfall at the toe of Site A rock slope (north of the highway). Photo was taken facing west on May 7, 2019.

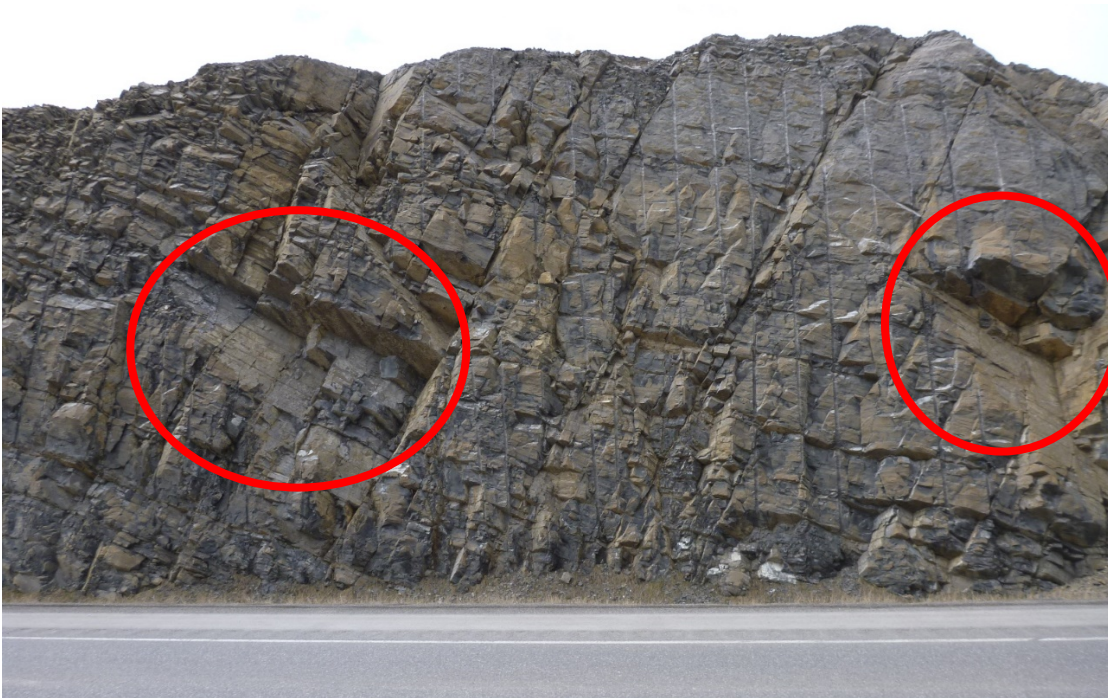
Photo 6 Near vertical rock cut slope at Site A (south of the highway). Areas of historic block failure are shown by red circles. Photo taken facing west on May 7, 2019.

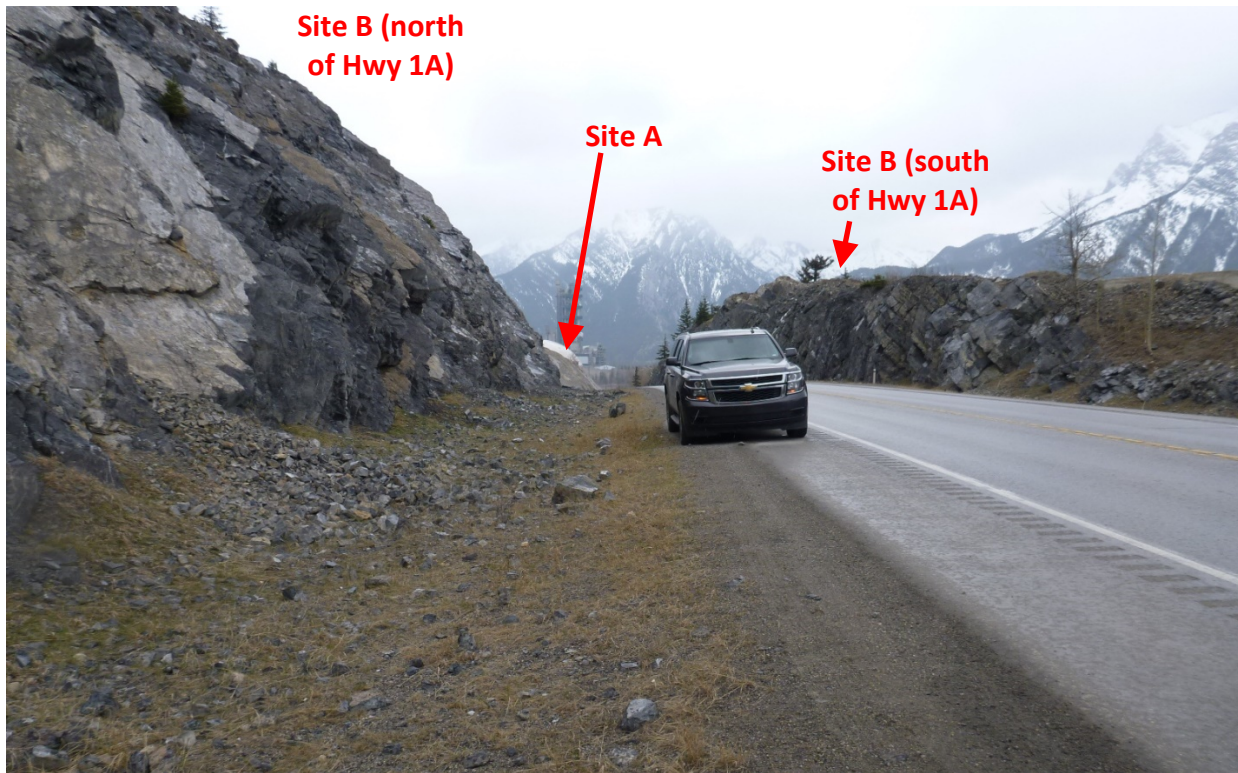
- Probability Factor – As for Site A, a rating of 11 was selected because the slope was active, with ongoing periodic rockfalls.
- Consequence Factor – A rating of 3 was selected because rockfall could damage a vehicle (e.g., flat tire, dent of body of vehicle). Rocks could bounce or roll onto the road surface but likely not with a trajectory that would pass through the windows or windshield of a passing vehicle.

Photo 7 Rockfall towards the highway from adversely dipping bedrock at Site B. Photo taken facing southeast on May 7, 2019.

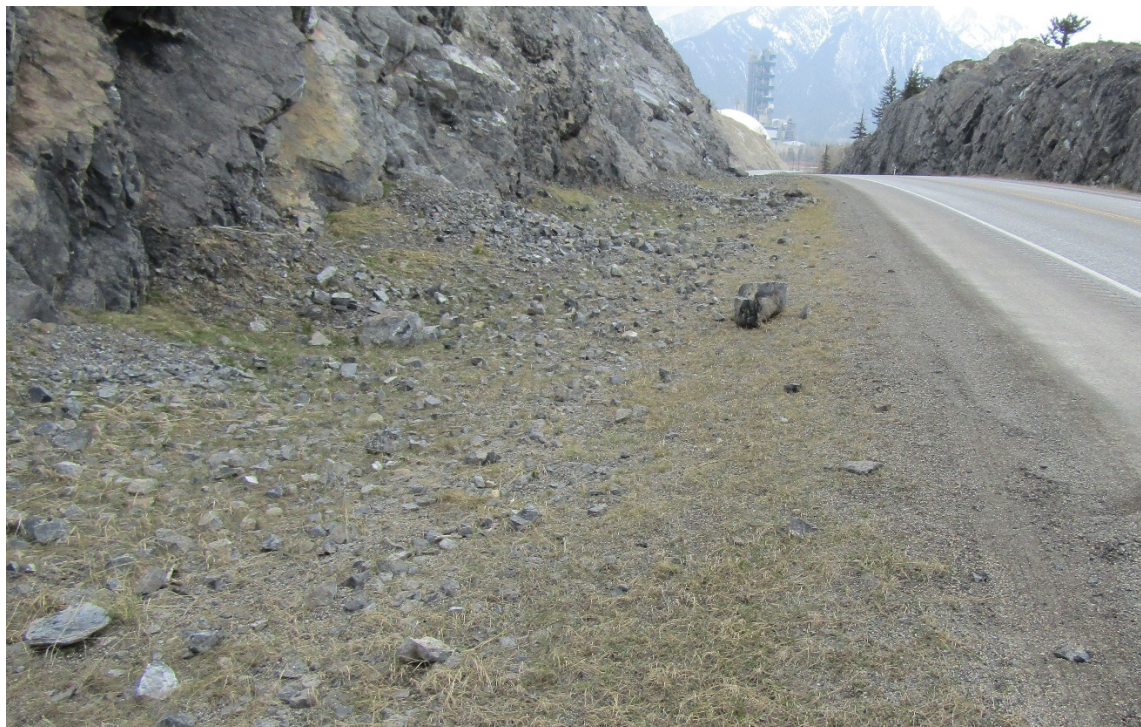
Photo 8 Rockfall in catchment ditch at Site B. Photo taken facing east on May 7, 2019.

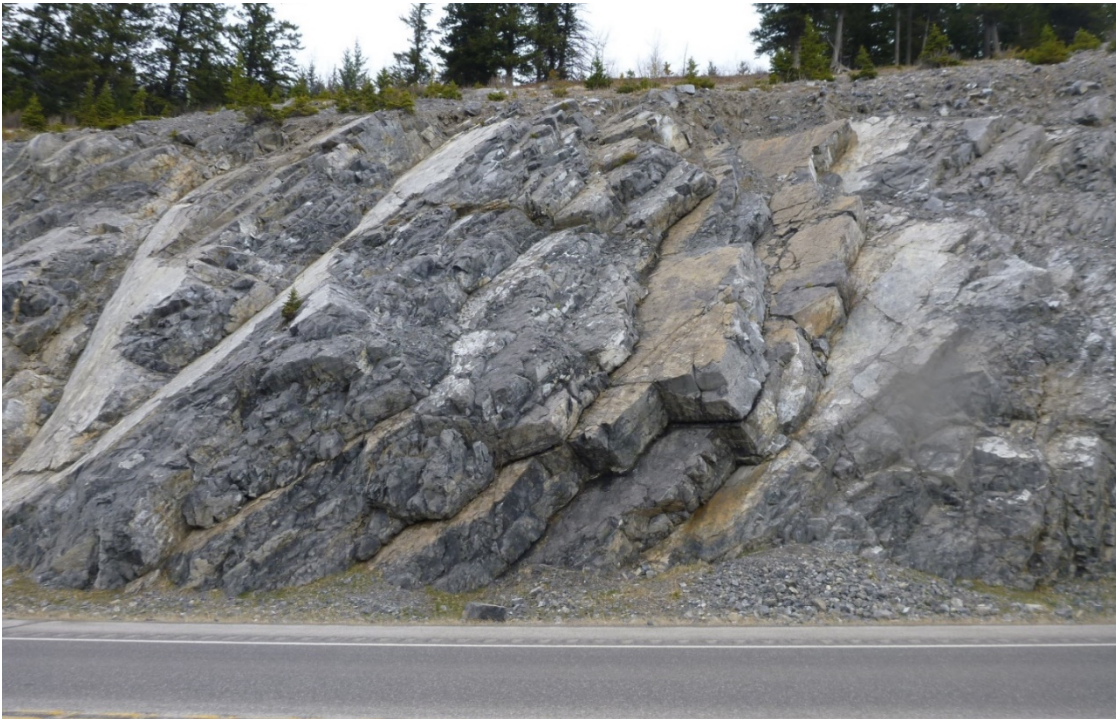
Photo 9 Adversely dipping bedrock at Site B. Photo taken facing north on May 7, 2019.

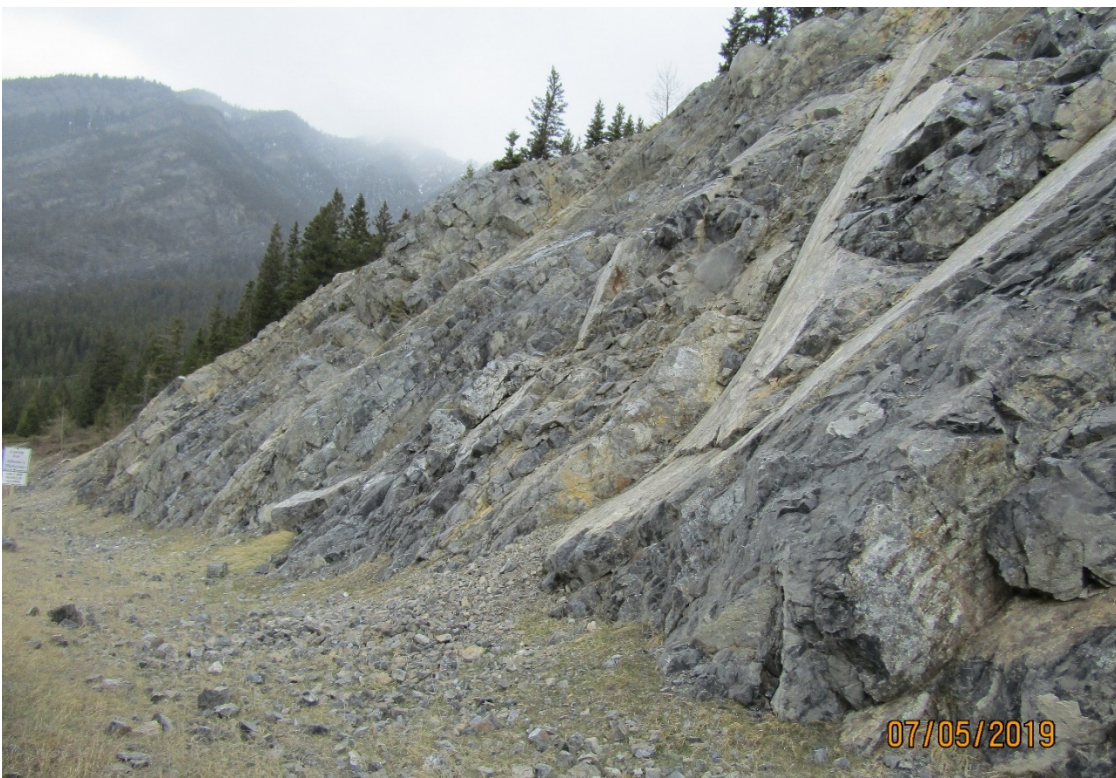
Photo 10 Northwestern section of Site B. Note variation in bedding plane angles. Photo taken facing northwest on May 7, 2019.

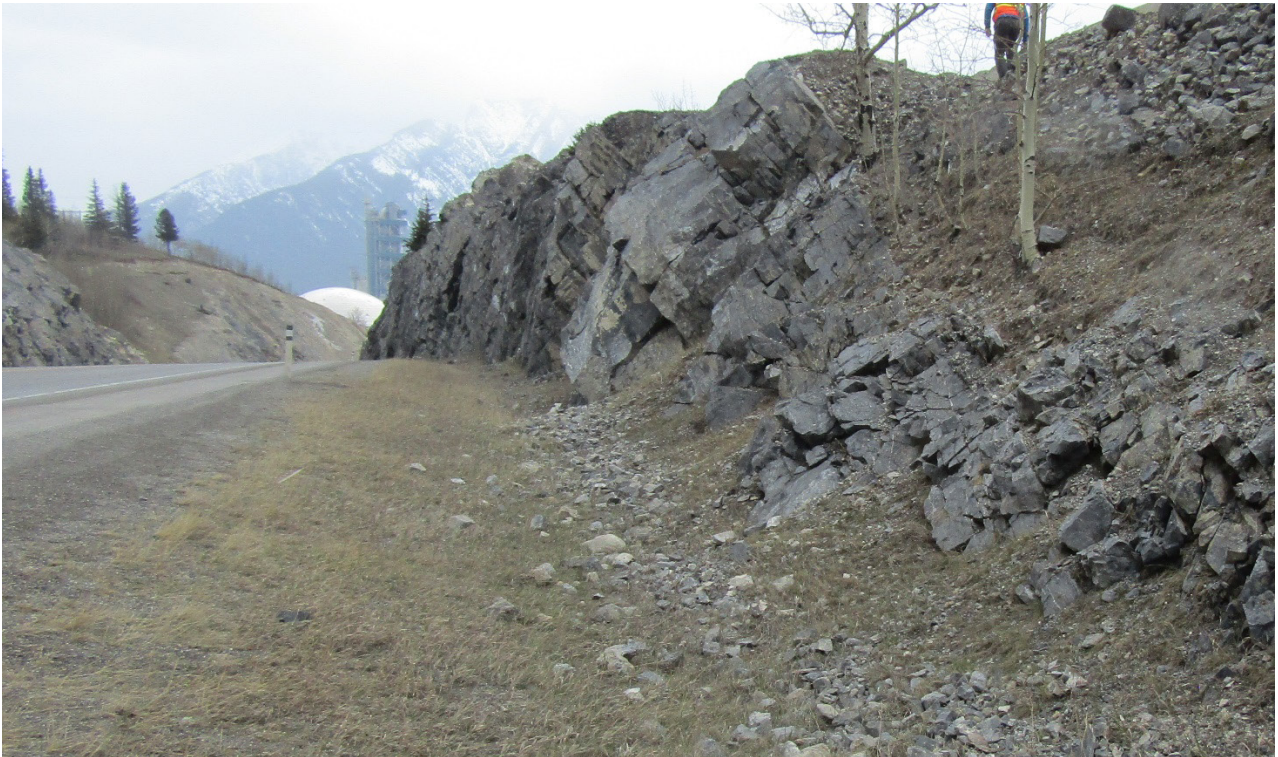
- Rock slopes to the south of the highway are lower in height and dip away from the road, meaning that the potential for rockfalls onto the road is lower;

Photo 11 **Rock cut south of the highway at Site B. Photo taken facing east on May 7, 2019.**
