SITE NUMBER AND NAME: <b>S057 Hwy 1A, Exshaw, Sites A &amp; B</b>		HIGHWAY & KM: 1A:02 km 12.52 to 11.91	PREVIOUS INSPECTION DATE: N/A	INSPECTION DATE: <b>May 7, 2019</b>
LEGAL DESCRIPTION: 13-22-024-09 W5M	NAD 83 COORDINATES: UTM Northing Easting 11 5658509 627178		RISK ASSESMENT: PF: 11 CF: 1 TOTAL: 11 (Site A) PF: 11 CF: 3 TOTAL: 33 (Site B)	
AVERAGE ANNUAL DAILY TRAFFIC: 1600 (Ref. No. 50100258)			CONTRACTOR MAINTENANCE AREA (CMA): 27

NOTES: 1. HORIZONTAL DATUM: NAD83 2. GRID ZONE: UTM Zone 11N 3. IMAGE SOURCE: Bing Maps 2019, Microsoft Corporation	CLIENT	PROJECT	
		SOUTHERN REGION GEOHAZARD RISK MANAGEMENT PROGRAM	
	TITLE	Site Plan Highway 1A, Exshaw Hwy 1A:02, km 12.24	
	SCALE	PROJECT No.	FIG No.
	1:2,000	A05115A03	1

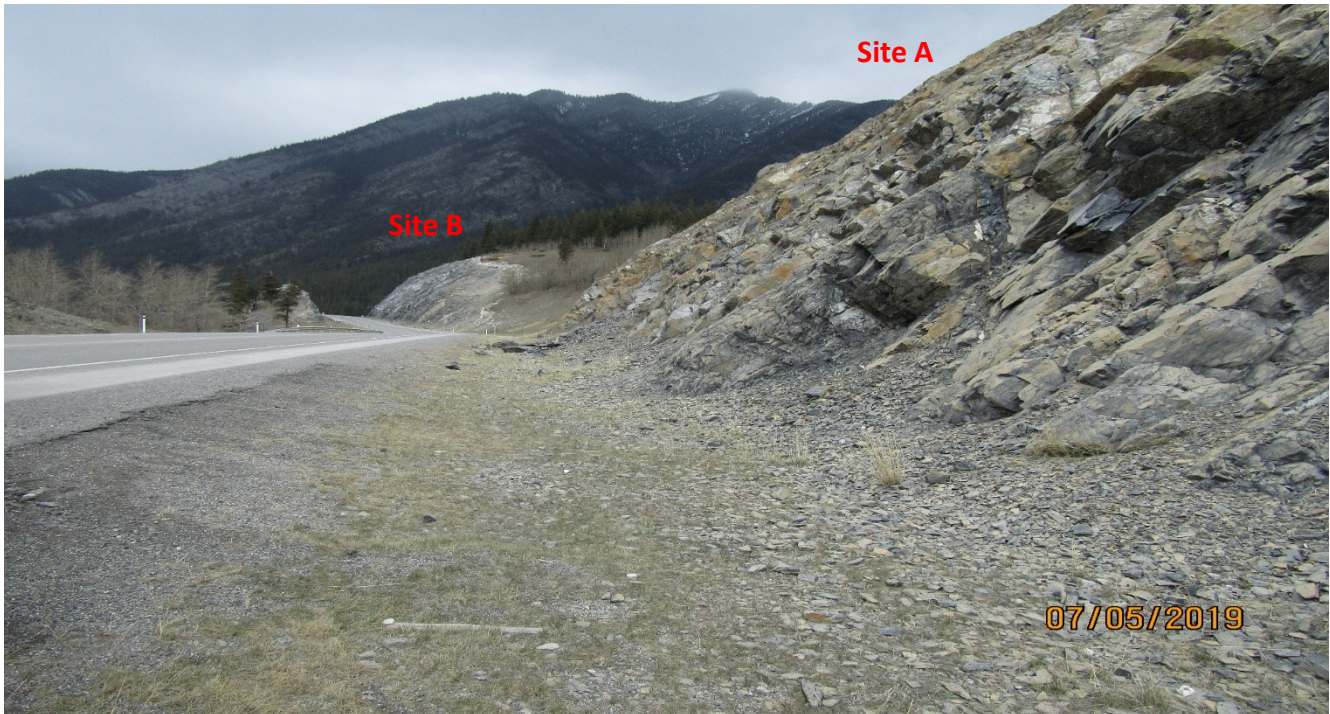
**Photo 1** Sites A and B. Photo taken facing northwest on May 7, 2019.

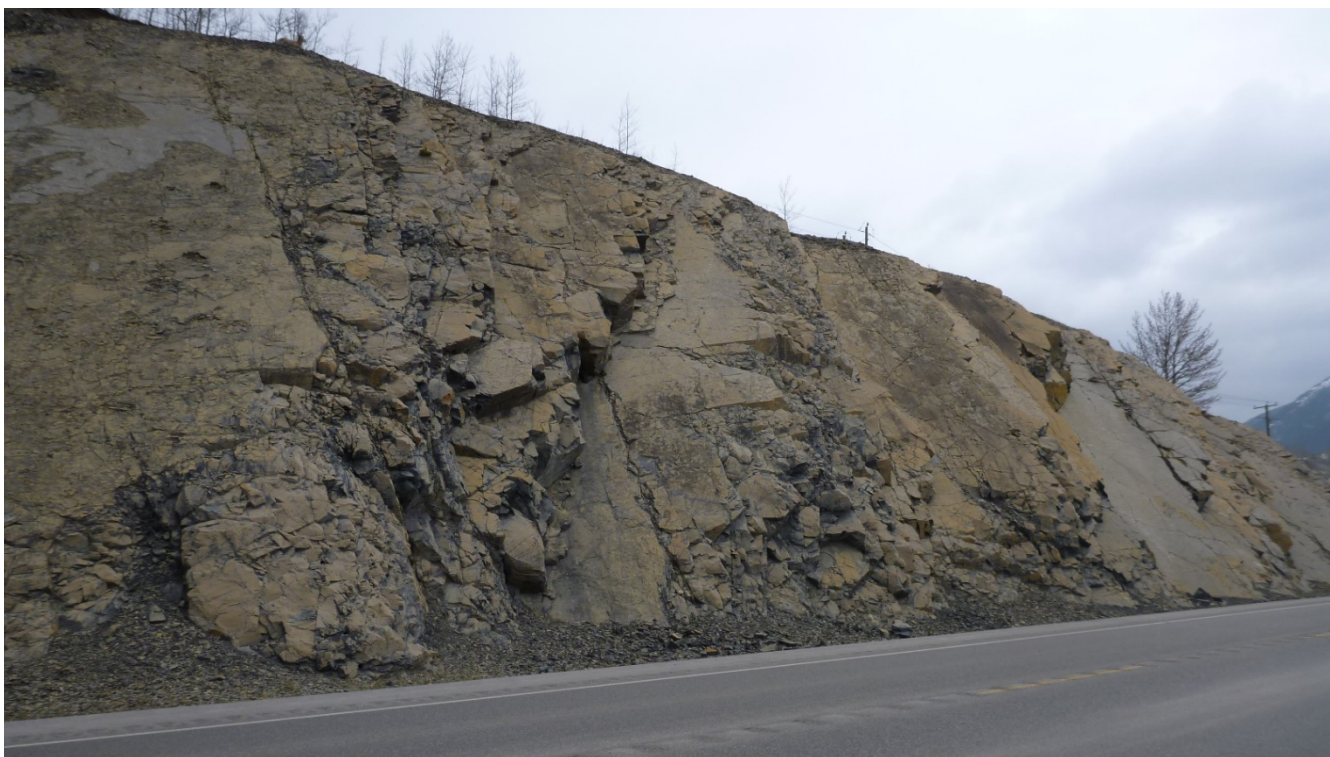
**Photo 2** Southeastern section of Site A. Photo was taken facing northeast on May 7, 2019.

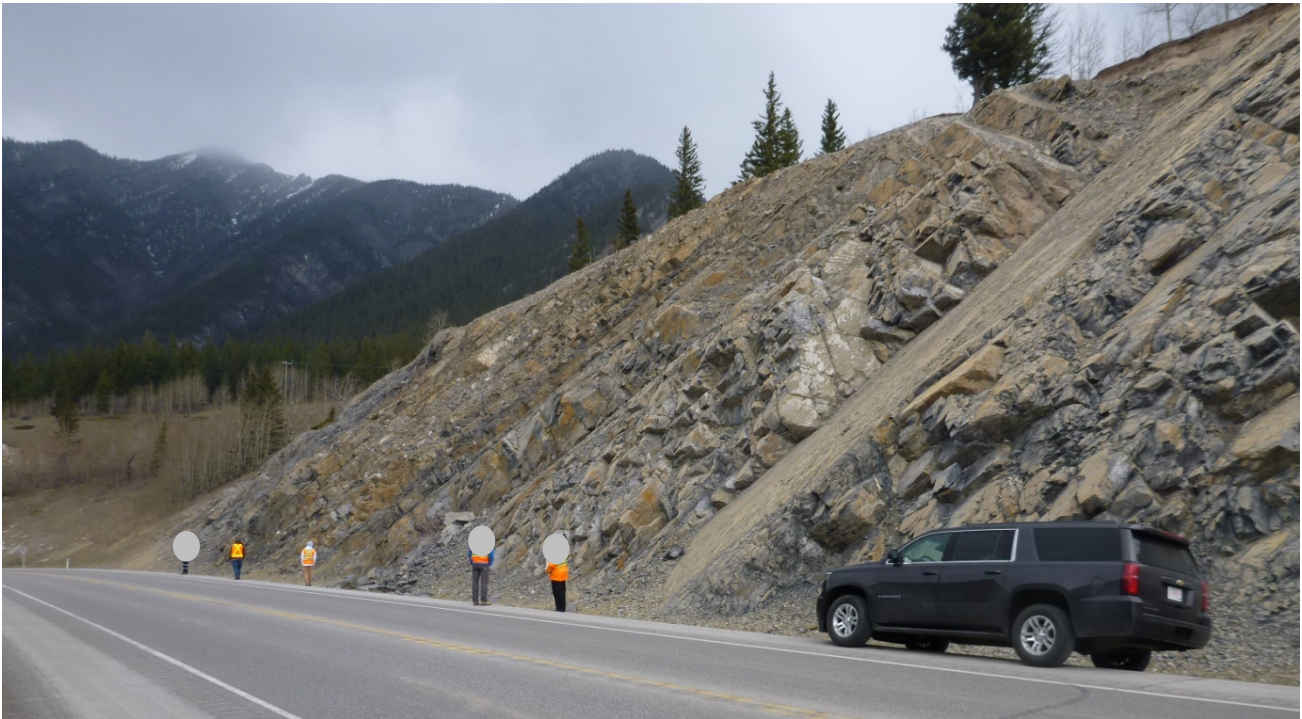
**Photo 3**      **Northwestern section of Site A. Photo was taken facing north on May 7, 2019.**

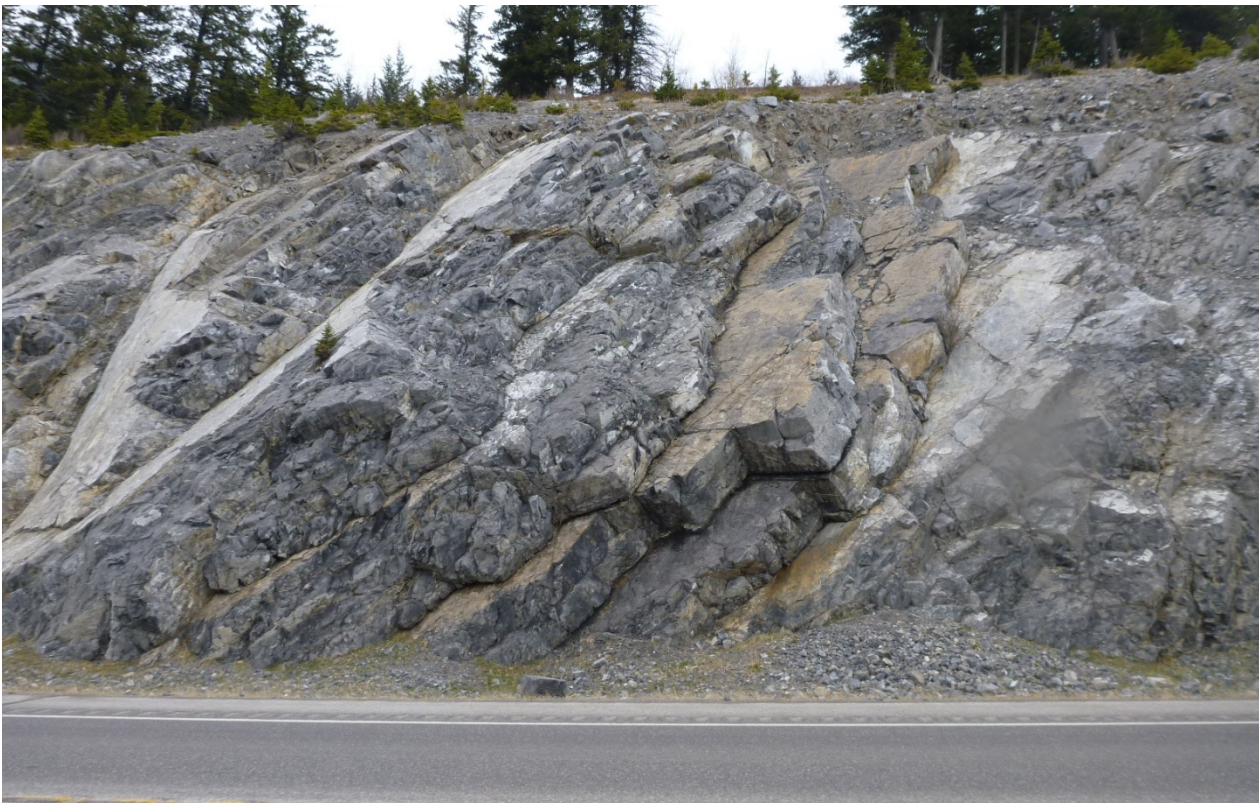
**Photo 4**      **Adversely dipping bedrock at Site B. Photo taken facing north on May 7, 2019.**

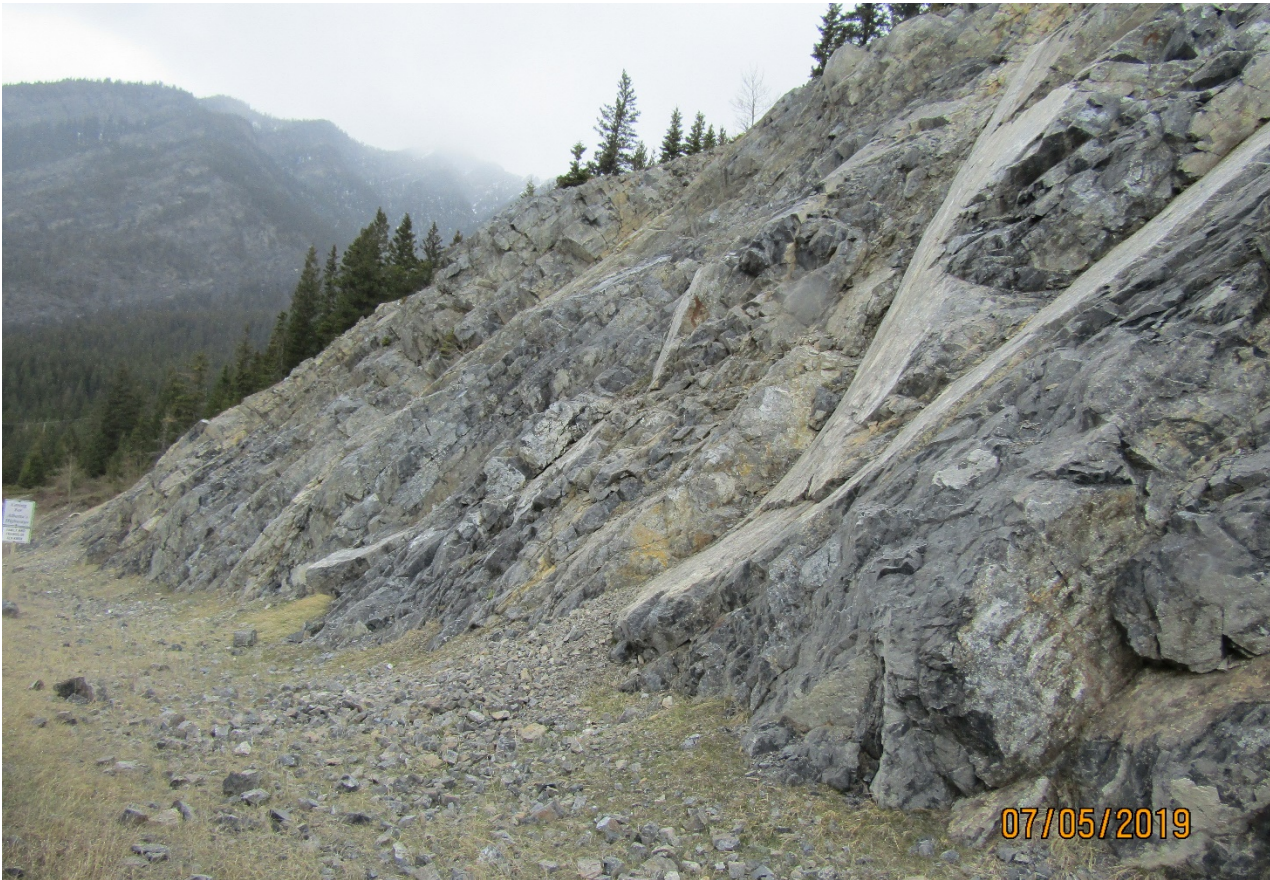
**Photo 5**      **Northwestern section of Site B. Photo was taken facing northwest on May 7, 2019.**
