SOUTHERN REGION GRMP SITE INSPECTION FORM

SITE NUMBER AND NAME:		HIGHWAY & KM:		PREVIOUS		INSPECTION DATE:	
S057 Hwy 1A, Exshaw, Sites A & B		1A:02 km 12.52 to		INSPECTION DATE:		July 6, 2020	
	11.91		May 7, 2019		00.19 0, =0=0		
LEGAL DESCRIPTION:	NAD 83 COORDINATES:			RISK ASSESMENT:			
13-22-024-09 W5M	UTM	Northing	Easting	PF: 11	CF: 1	TOTAL: 11 (Site A)	
	11	5658509	627178	PF: 11	CF: 3	TOTAL: 33 (Site B)	
AVERAGE ANNUAL DAILY TRAFFIC:				CONTRACTOR MAINTENANCE AREA (CMA):			
844 (west), 770 (east) (Ref. No. 50100258)				27

PRIMARY SITE ISSUE: Two rock cut slopes with bedding planes dipping towards the highway. The sites have shallow to non-existent catchment ditches and rockfalls can reach the highway.

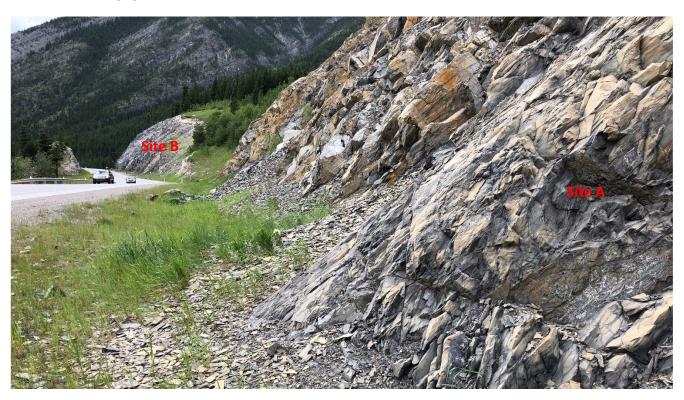
Site A (km 12.52 to 12.34) – Bedrock is sedimentary (limestone or siltstone) with open joints and visible bedding planes (dipping towards the highway at approximately 40 degrees), potential for sliding failure but unlikely to bounce onto the road. Ditch is relatively flat.

Unweathered rockfall debris (up to $0.15 \text{ m} \times 0.65 \text{ m} \times 0.45 \text{ m}$) was noted in the ditch at Site A suggesting rockfalls are ongoing.

Photo 2 Southeastern section of Site A. Photo was taken facing northeast on July 6, 2020.

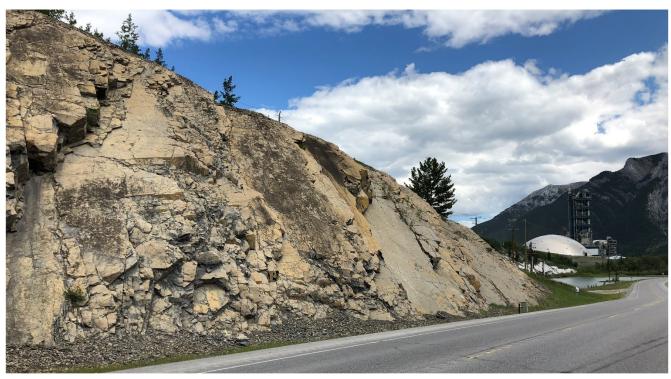
Photo 3 Northwestern section of Site A. Photo was taken facing north on July 6, 2020.

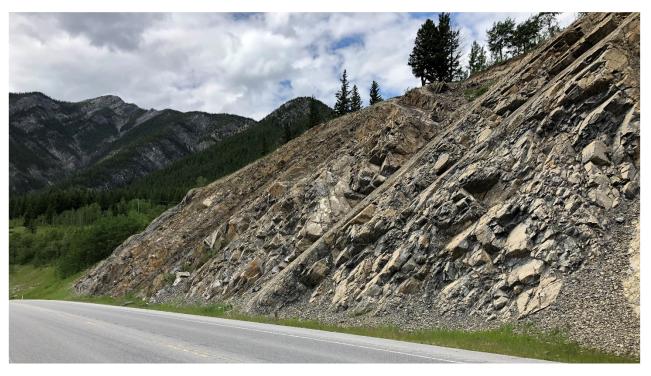
Site B (km 12.26 to 11.91) - Bedrock is sedimentary and similar to Site A (limestone or siltstone) with open joints and visible bedding planes (dipping towards the highway at approximately 40 degrees), mid-sized blocks visible with potential to roll onto the road. Ditch is relatively flat.

Photo 4 Northwestern end of Site B. Photo taken facing north on July 6, 2020.

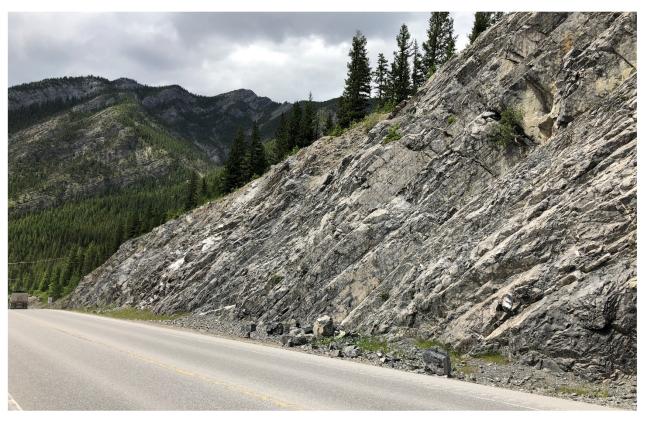
Rockfalls are active and unweathered rockfall debris (up to $0.5 \text{ m} \times 0.65 \text{ m} \times 0.75 \text{ m}$) was noted in the ditch at Site B. Multiple potential loose blocks were visible in the rock mass.

Photo 5 Rockfall debris up to 0.25 m³ in the ditch of Site B. Photo was taken facing northwest on July 6, 2020.

The existing shallow ditches appear to be effective but should be cleaned out regularly.
