SITE NUMBER AND NAME: <b>S057 Exshaw Rockfall, Sites A &amp; B</b>		HIGHWAY & KM: 1A:02 km 12.034	PREVIOUS INSPECTION DATE: July 6, 2020	INSPECTION DATE: <b>May 17, 2022</b>
LEGAL DESCRIPTION: 13-22-24-09 W5M	NAD 83 COORDINATES: UTM Northing Easting 11 5658509 627178		RISK ASSESSMENT: Site A: PF: 11 CF: 2 TOTAL: 22 Site B: PF: 12 CF: 3 TOTAL: 36	
AVERAGE ANNUAL DAILY TRAFFIC: 844 (west) & 770 (east) (Reference No. 50100258)			CONTRACTOR MAINTENANCE AREA (CMA): 27

PROJECT SOUTHERN REGION GEOHAZARD RISK MANAGEMENT PROGRAM		
TITLE Site Plan S057 - Exshaw Rockfall Hwy 1A:02, km 12.034		
SCALE 1:2,500	PROJECT No. A05116A03	FIG No. 1

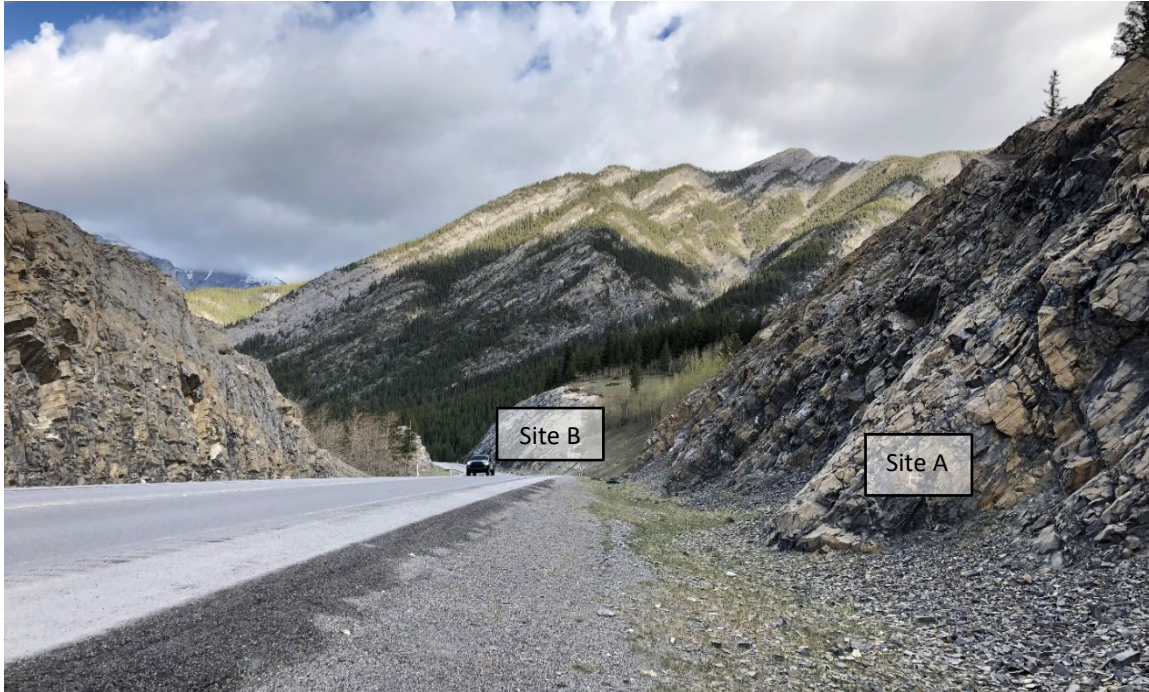
- The bedrock is sedimentary (limestone or siltstone) with open joints and visible bedding planes (dipping towards the highway at approximately 40°) (Photo 1). There is the potential for sliding failure but unlikely to rebound onto the road.
- The ditch is relatively flat and rockfall debris (up to boulders in size) were observed in the ditch. The larger debris (boulders) were observed during the 2020 inspection (Photo 2).
- Fresh (i.e., unweathered) rockfall debris (up to 0.70 m x 0.30 m x 0.50 m) were noted in the ditch, suggesting rockfalls are ongoing. Multiple rocks with open fractures were noted at the brow of the rock slope.
- No significant changes were observed at the site during the 2022 inspection.

**Photo 1** The bedrock at Sites A and B is dipping at approximately 40° and 50°, respectively, towards the highway. Photo taken May 17, 2022, facing north.

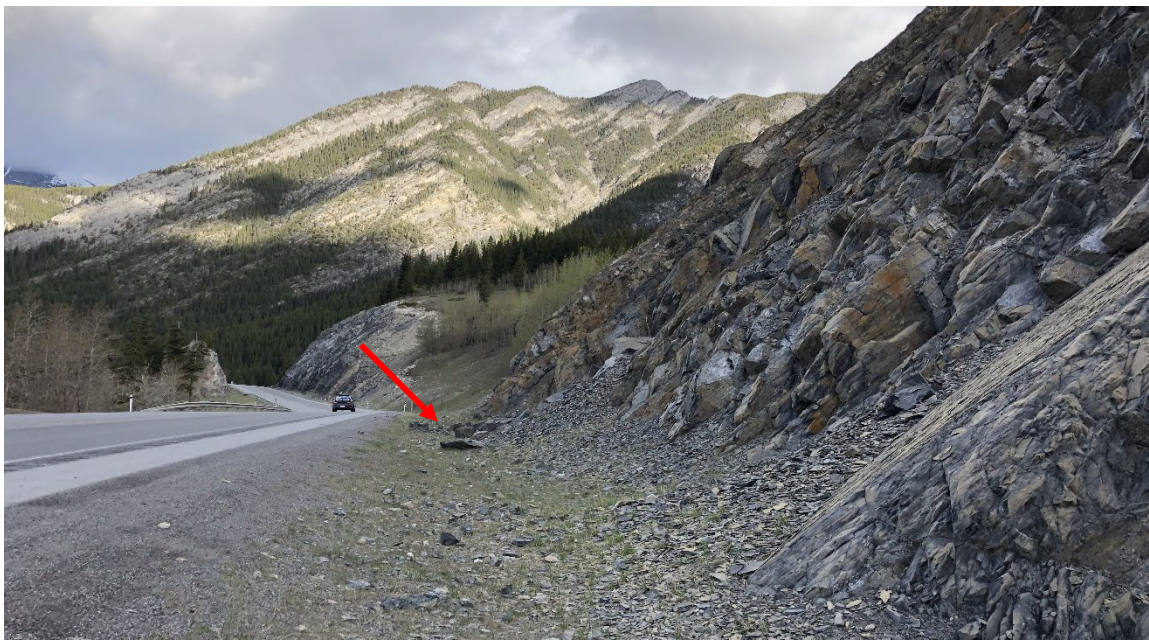
**Photo 2** The north (westbound) ditch at Site A is relatively flat and some rockfall debris was observed at the toe of the slope (larger debris indicated by red arrow). Photo taken May 17, 2022, facing southeast.

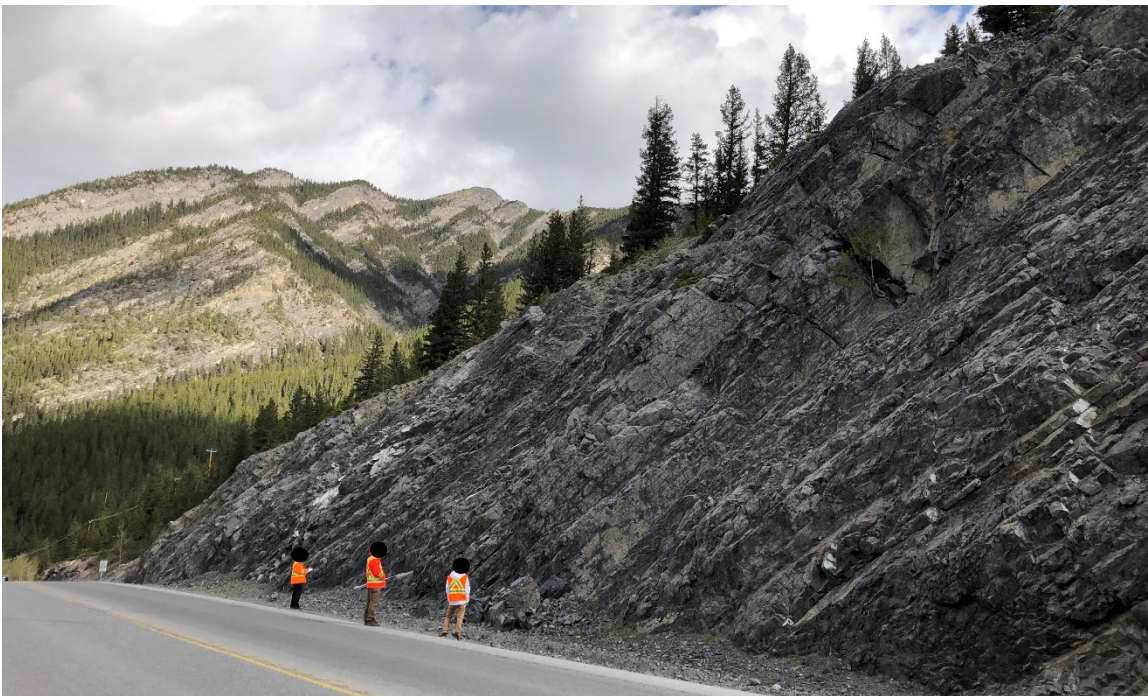
**Photo 4 Northwest end of Site B. Photo taken May 17, 2022, facing north.**

- Ditch is relatively flat and contained multiple gravel and cobble sized debris. The ditch appeared to have been recently graded (Photo 4).
- Rockfalls are active and fresh rockfall debris (up to 1.2 m x 0.60 m x 0.70 m) was noted in the ditch bottom (Photo 5), with smaller debris on the highway surface. Rockfall observed was primarily subangular to angular. Multiple potential loose blocks were visible in the rock mass.

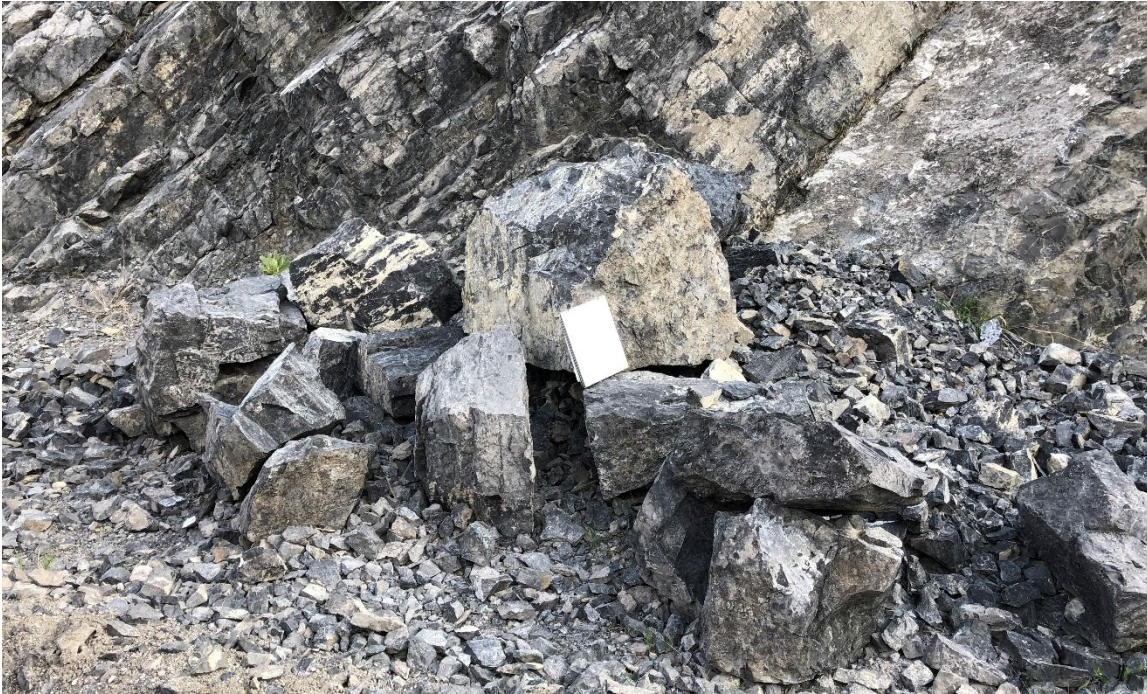
**Photo 5**      **Rockfall debris up to 3.5 m<sup>3</sup> in the ditch of Site B. Photo taken May 17, 2022, facing northwest.**
