SITE NUMBER AND NAME: S057 Exshaw Rockfall, Sites A & B		HIGHWAY & KM: 1A:02 km 12.034	PREVIOUS INSPECTION DATE: May 17, 2022	INSPECTION DATE: May 27, 2024
LEGAL DESCRIPTION: 13-22-24-09 W5M	NAD 83 COORDINATES: UTM Northing Easting 11 5658509 627178		RISK ASSESMENT: Site A: PF: 11 CF: 3 TOTAL: 33 Site B: PF: 12 CF: 3 TOTAL: 36	
AVERAGE ANNUAL DAILY TRAFFIC: 1006 (west) & 931 (east) (Reference No. 50100258)			CONTRACTOR MAINTENANCE AREA (CMA): 27

PROJECT SOUTHERN REGION GEOHAZARD RISK MANAGEMENT PROGRAM		
TITLE Site Plan S057 - Exshaw Rockfall Hwy 1A:02, km 12.034		
SCALE 1:2,500	PROJECT No. A05116A03	FIG No. 1

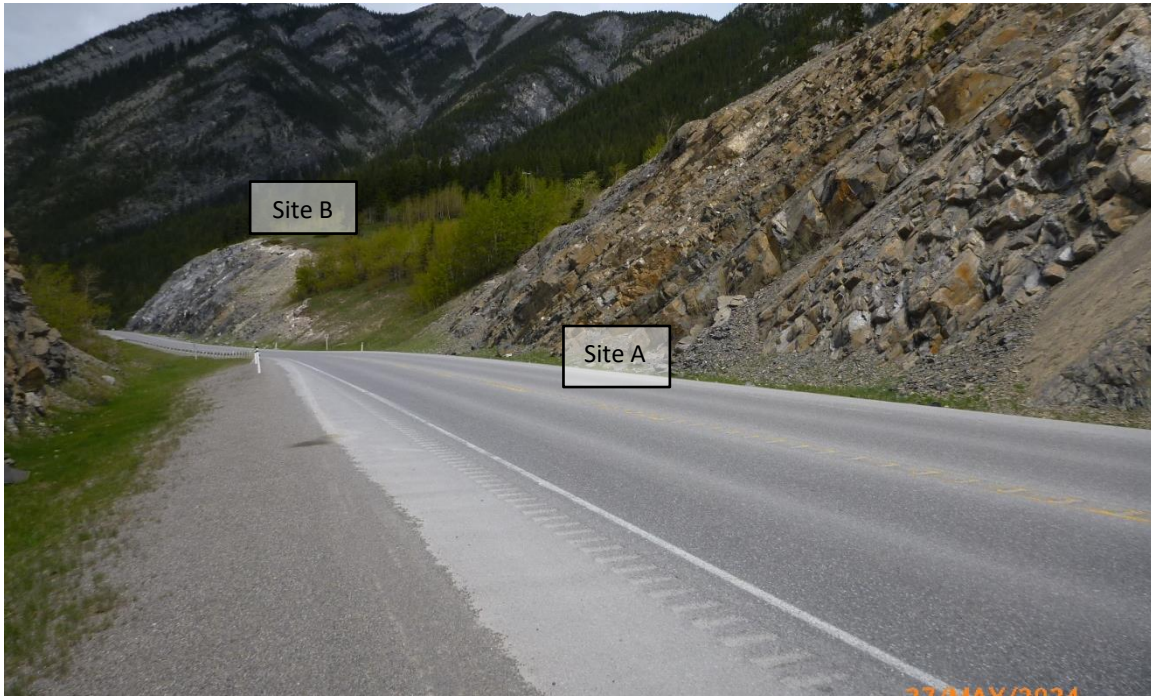
Photo 1 The bedrock at Sites A and B is dipping at approximately 40° and 50°, respectively, towards the highway. Photo taken on May 27, 2024, facing northwest.

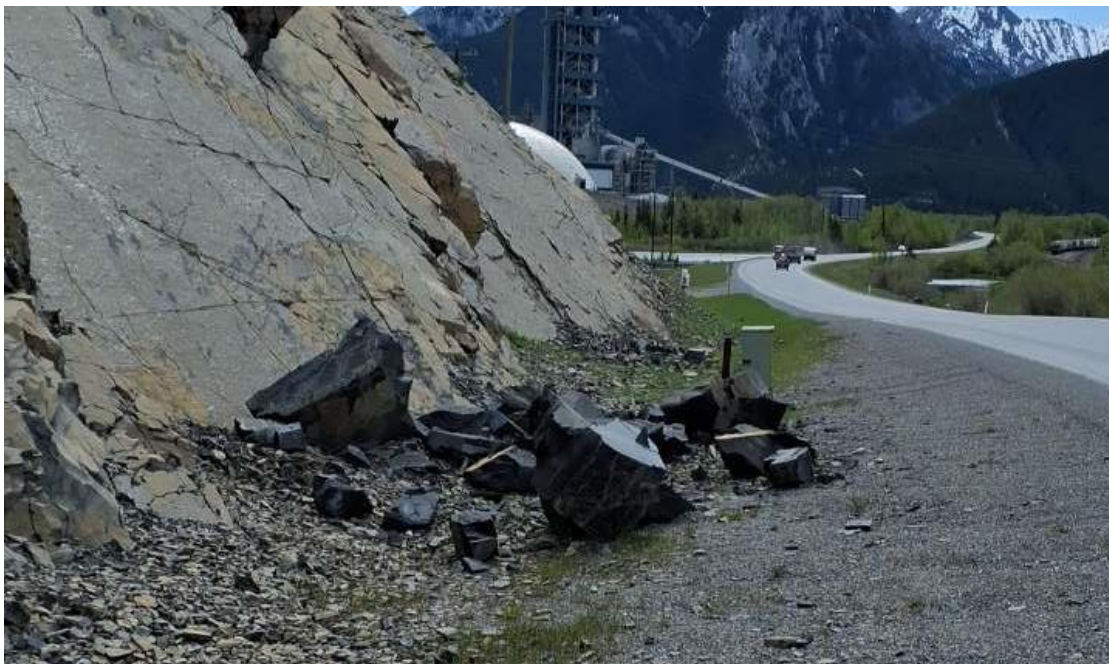
Photo 2 The north (westbound) ditch at Site A, recent rockfall debris in ditch at the south end of the site. Photo taken on May 27, 2024, facing southeast.

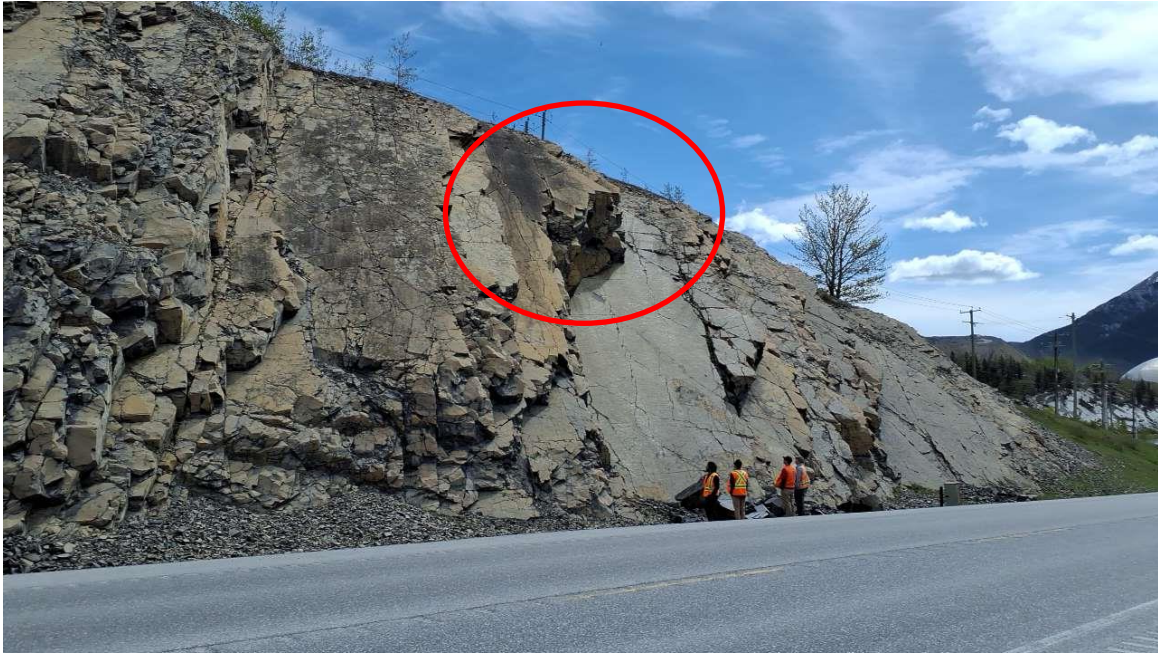
Photo 3 The north (westbound) ditch at Site A. Recent rock fall from area noted with red circle. Photo taken on May 27, 2024, facing northeast.

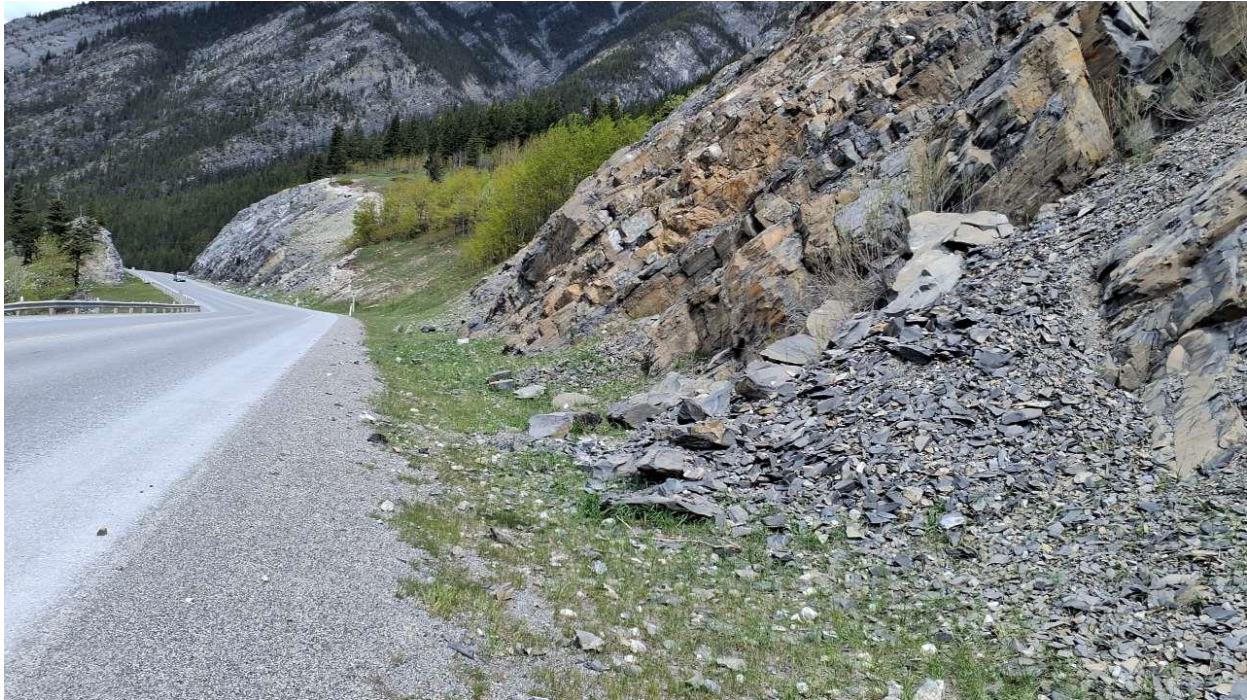
Photo 5 Northwest end of Site A, recent rockfalls and debris fan. Photo taken on May 27, 2024, facing northwest.

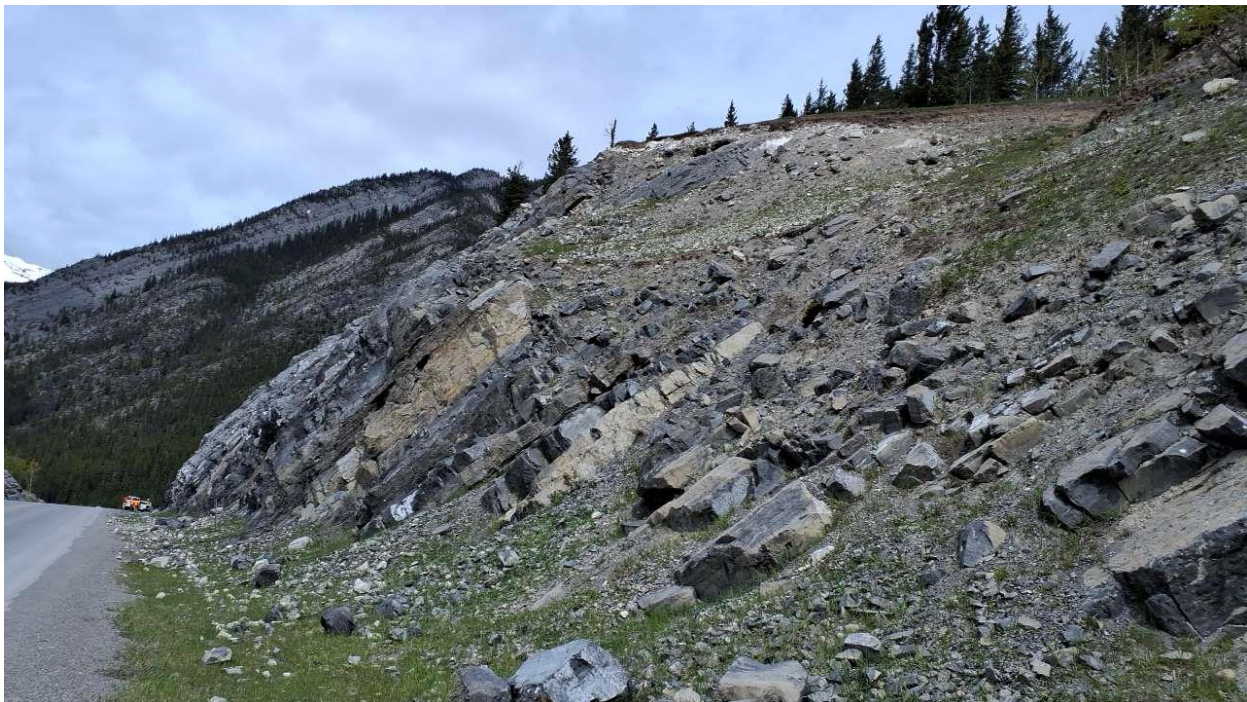
Photo 6 South end of Site B. Loose rock with the potential to fall into the ditch. Photo taken on May 27, 2024 facing northwest.

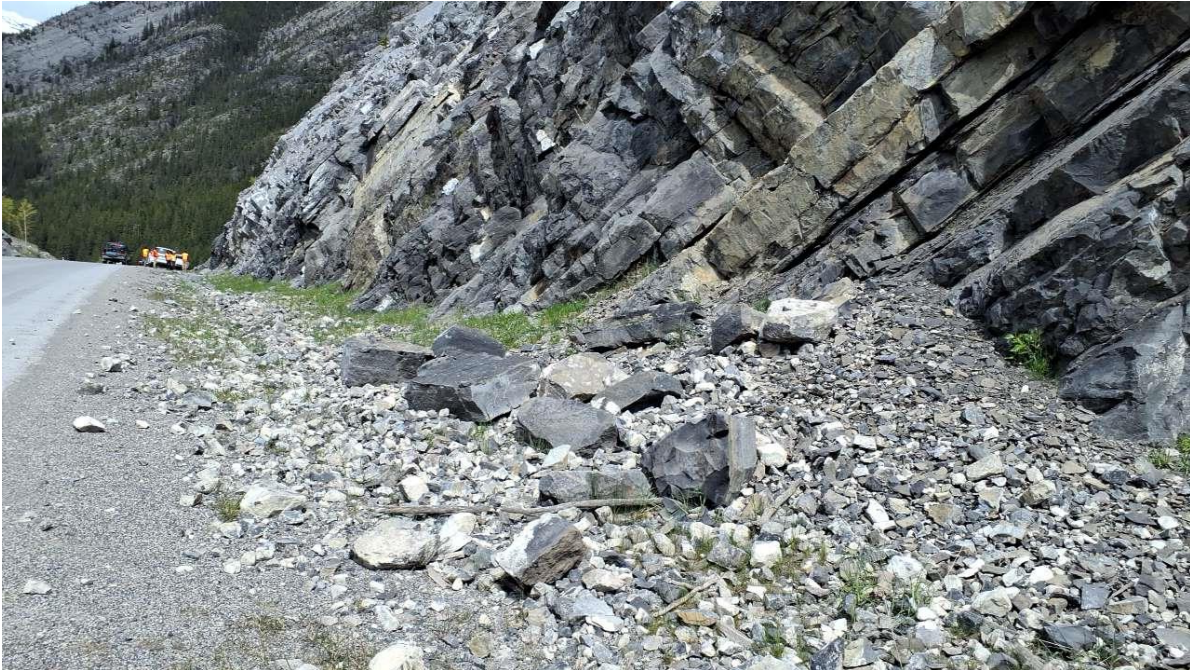
Photo 6 South end of Site B. Rockfall debris in ditch. Photo taken on May 27, 2024 facing northwest.

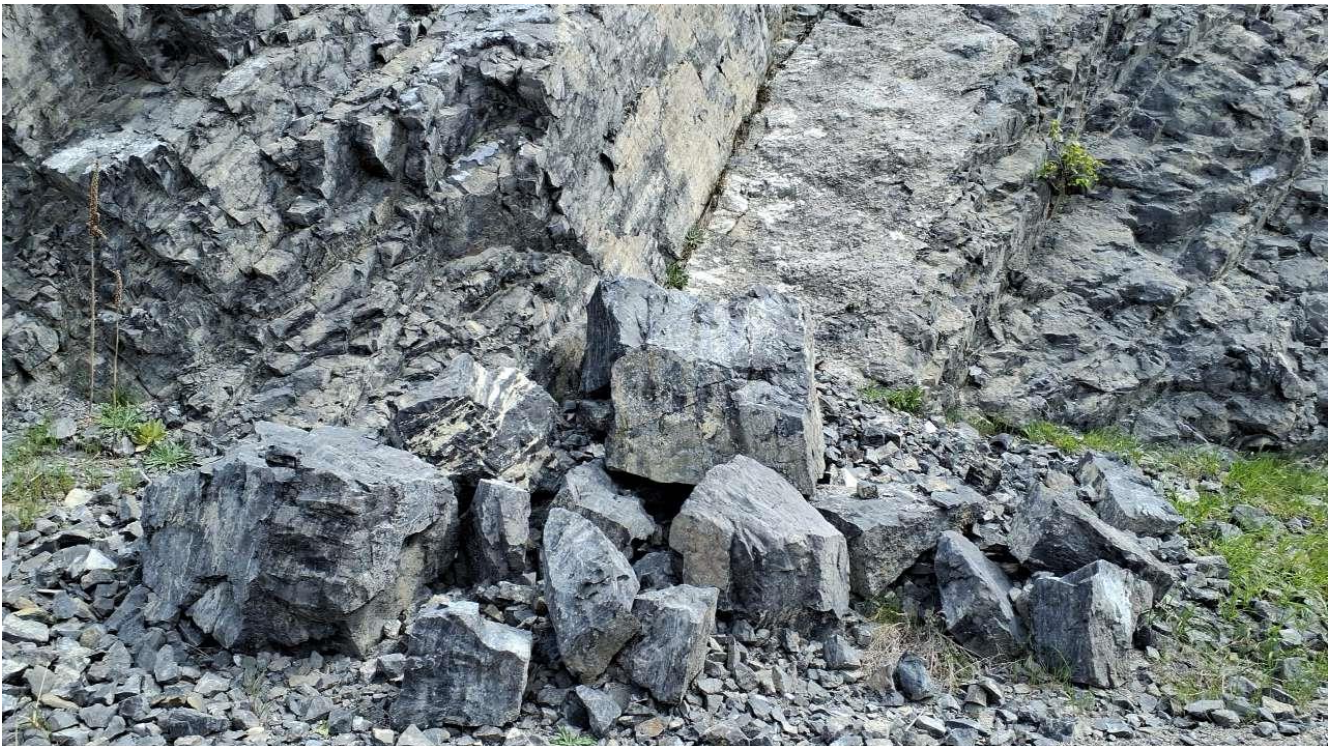
Photo 7 North end of Site B. Rockfall debris in ditch (unchanged from 2022). Photo taken on May 27, 2024 facing northwest.
