SITE NUMBER AND NAME: <b>S004 Willow Creek</b>		HIGHWAY & KM: 2:08, 6.284	PREVIOUS INSPECTION DATE: July 7, 2020	INSPECTION DATE: <b>July 8, 2021</b>
LEGAL DESCRIPTION: 13/14-20-009-26 W4M	NAD 83 COORDINATES: UTM Northing Easting 12 5514351 320169		RISK ASSESMENT: PF: 9 CF: 4 TOTAL: 36	
Average Annual Daily Traffic (AADT): 5460 (north), 6100 (south) (Ref. No. 92080)			CONTRACTOR MAINTENANCE AREA (CMA): 26

PROJECT		
SOUTHERN REGION GEOHAZARD RISK MANAGEMENT PROGRAM		
TITLE		
Site Plan S004 - Willow Creek Hwy 2:08, km 6.284		
SCALE 1:2,000	PROJECT No. A05116A03	FIG No. 1

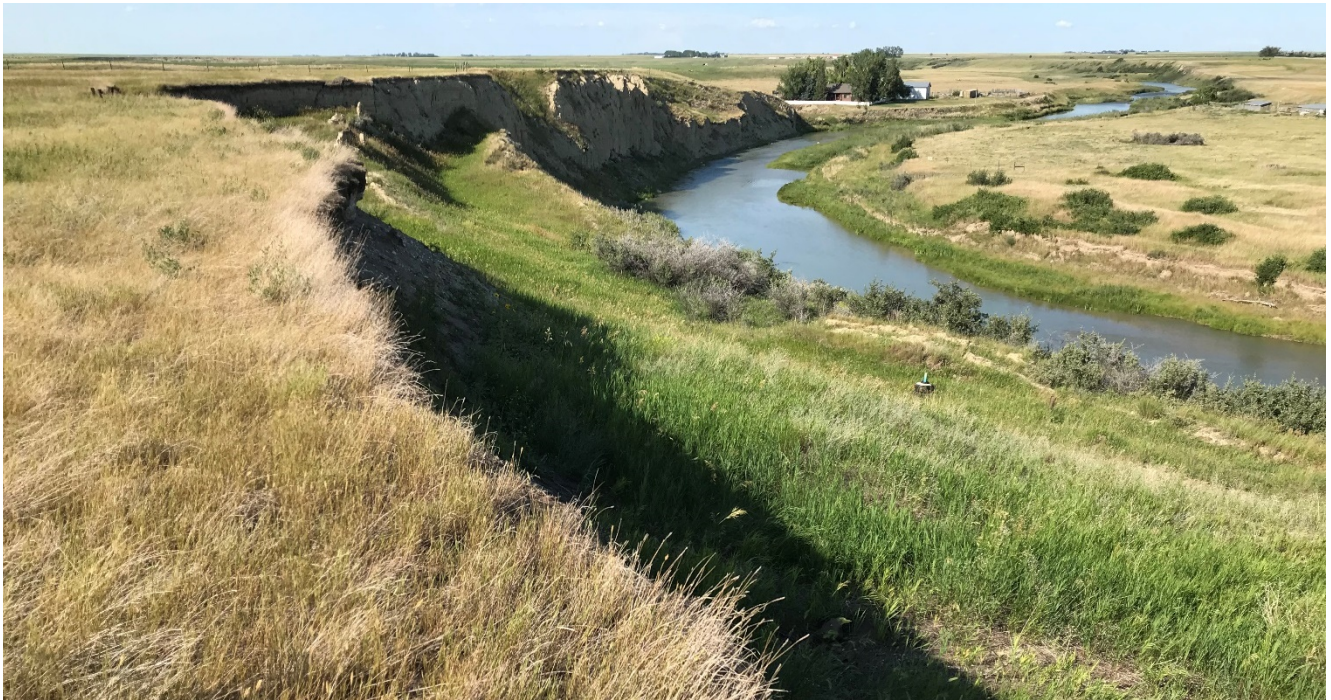
**Photo 1** Slide area. Photo taken facing north on July 8, 2021.

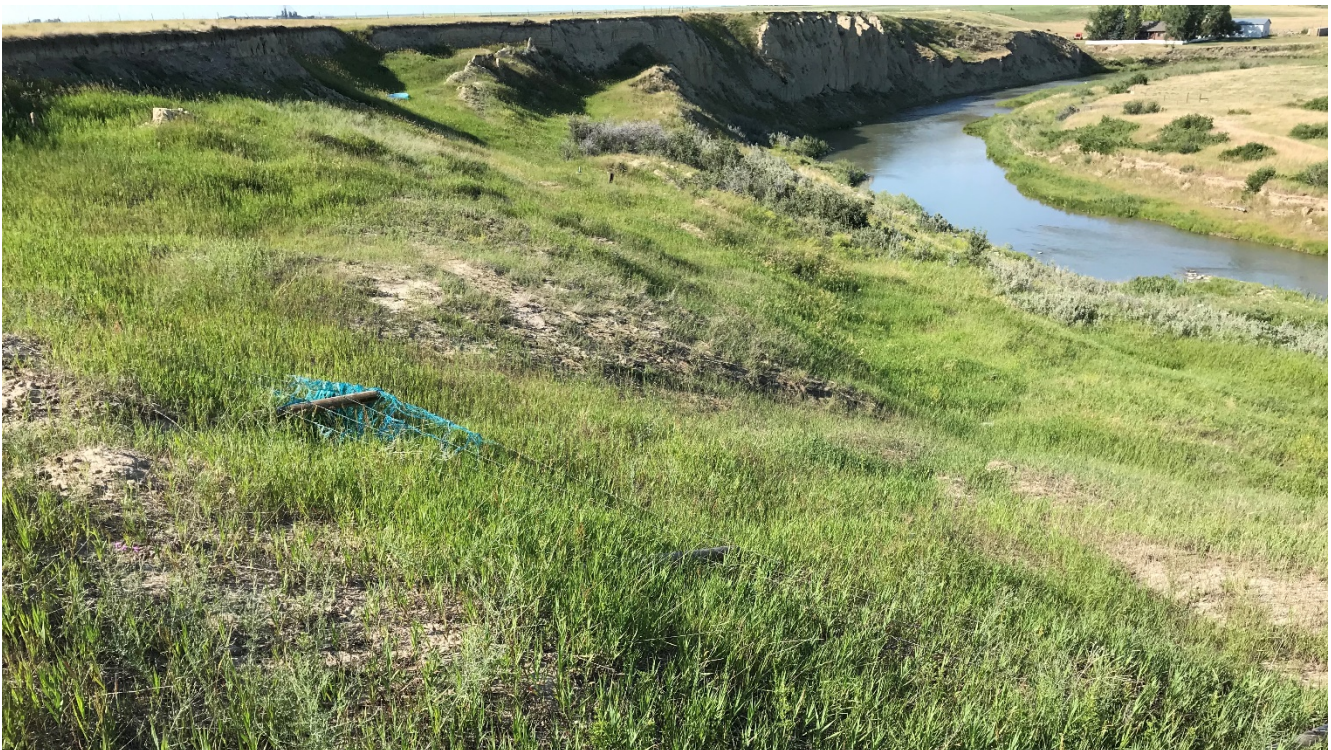
The nature of landsliding (back tilting blocks) suggests a combination of rotational failure and failure along a weak layer at depth. The right flank of the slide (southeastern section) appears to be retrogressing faster. Slide mass below retrogressing head scarp is covered in grass with some bare patches of soil.

**Photo 2** Back tilting blocks in the slide mass. Photo taken facing north on July 8, 2021.

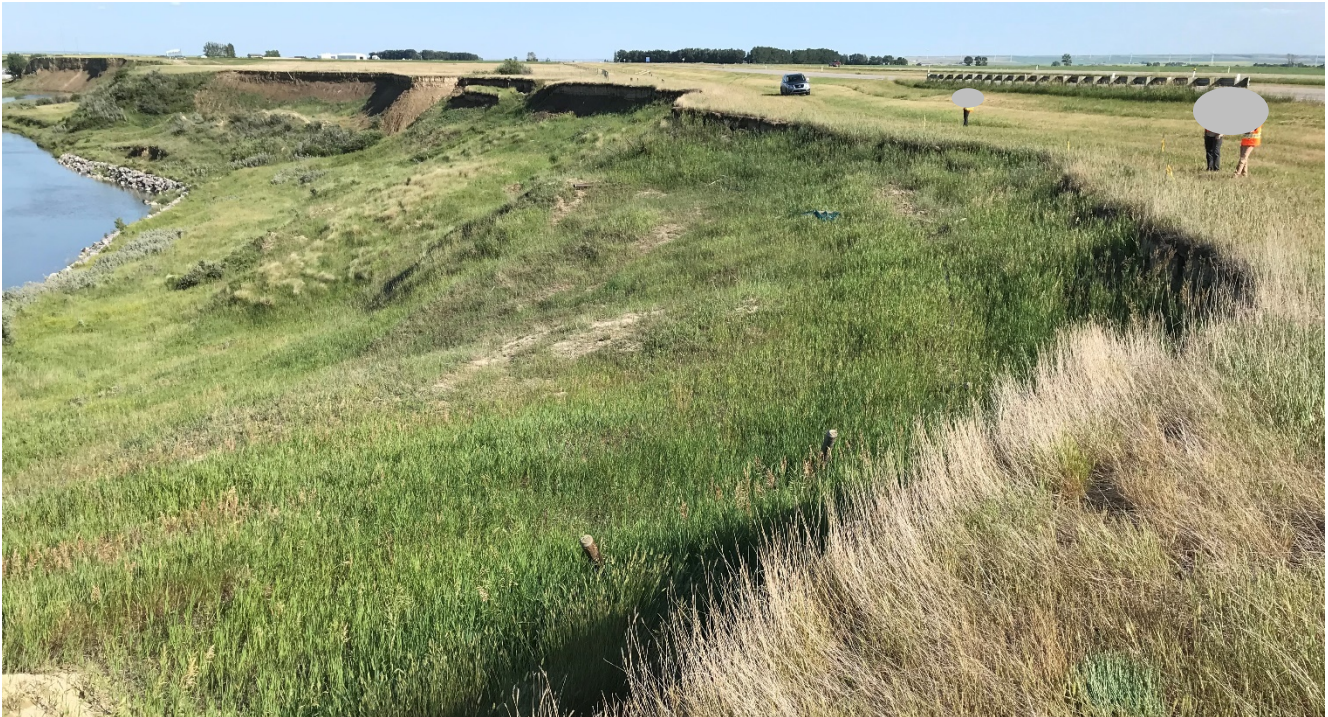
<b>COMMENTS</b>
There has been minimal change in slope retrogression observed between 2019 and 2021. The head scarp is approximately 11 m from the highway at the closest point.
There are four wooden stakes (3 reinstalled, 1 existing) present at the crest of slide that are used to estimate slide retrogression. It is estimated that there has been between 2.3 m and 3.5 m of retrogression into the ditch since 2016. Survey stakes are vulnerable to being knocked over or disturbed.
The head scarp has retrogressed 3 m to 5 m past the fence line. No significant changes were noted in the slide mass in 2021, and the site was well vegetated at the time of the visit. A buried black utility cable is exposed in the slide area.

**Photo 3** Ongoing slide movement retrogressing towards the highway. Photo taken facing southeast on July 8, 2021.
