November 30, 2022

CON0022161 Southern Region GRMP Instrumentation Monitoring
Site S004; H02:08, km 6.284 Willow Creek
Section C – 2022 Fall Readings

PROJECT SOUTHERN REGION GEOHAZARD RISK MANAGEMENT PROGRAM		
TITLE Site Plan S004 - Willow Creek (North of Ft. Macleod) Hwy 2:08, km 6.284		
SCALE 1:2,000	PROJECT No. A05116A03	FIG No. 1

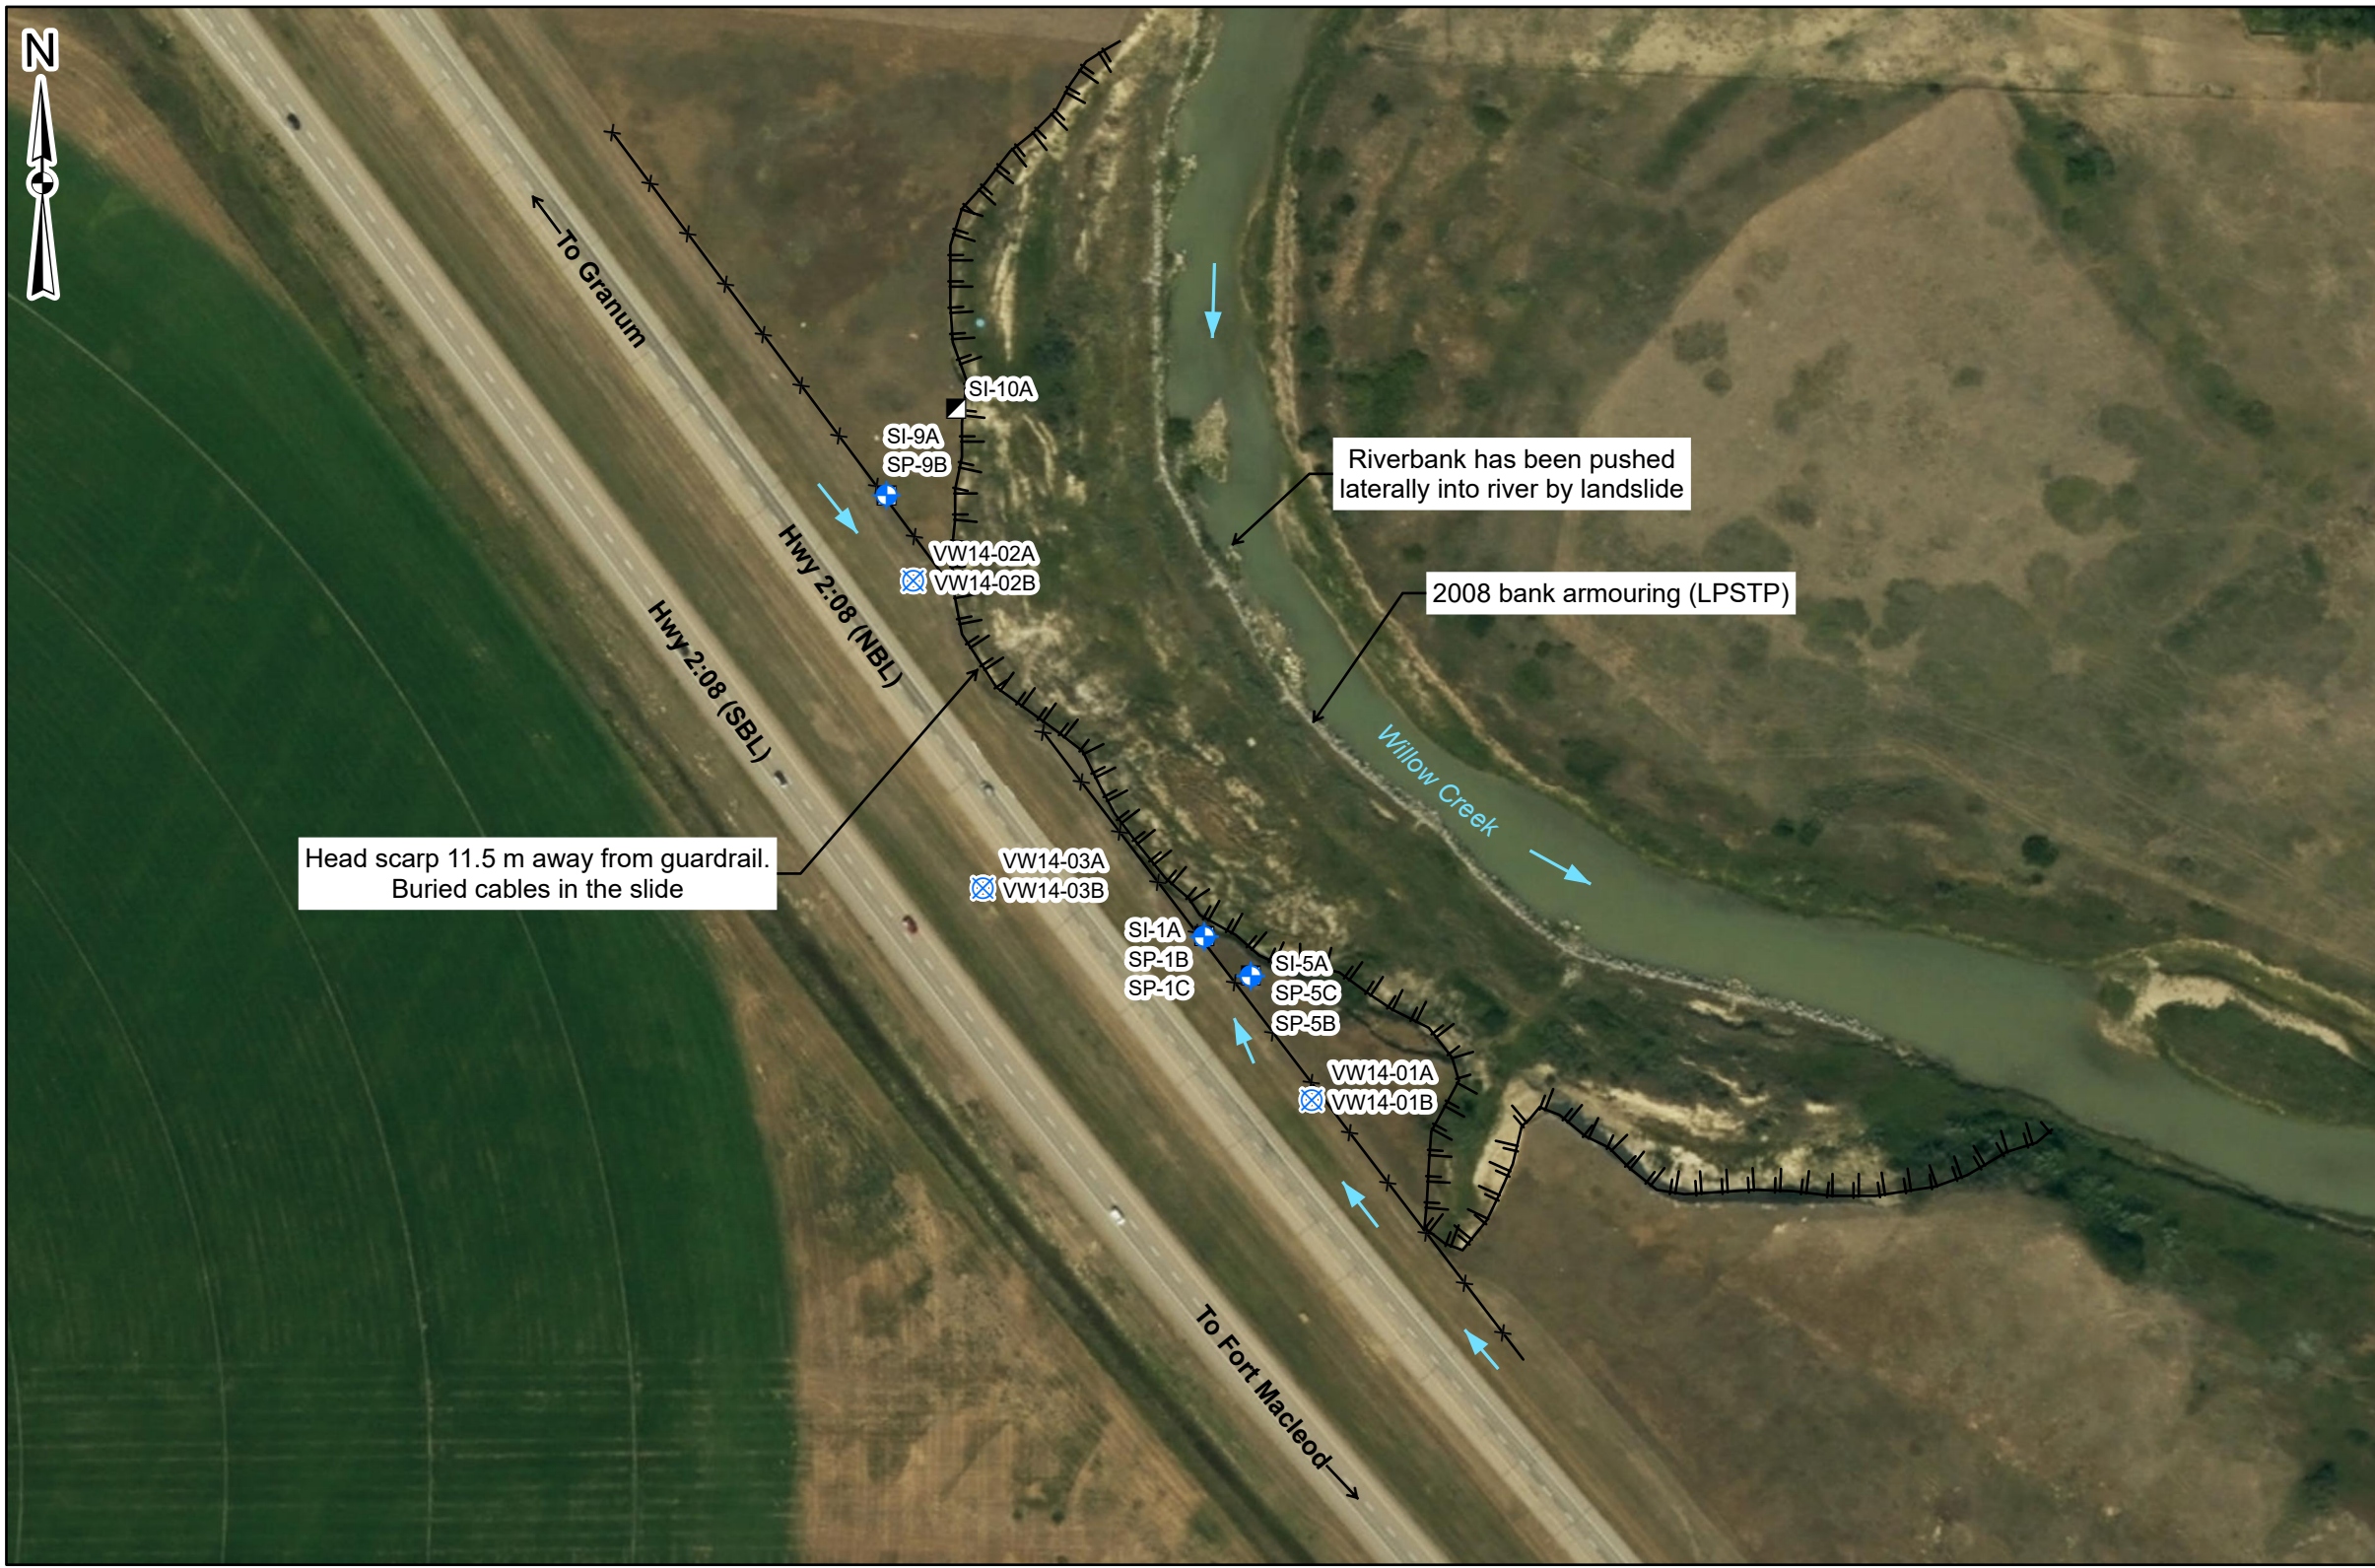
Four wooden stakes located at the crest of the slide are used to estimate slide retrogression. These stakes are susceptible to being knocked over or disturbed. During the July 8, 2021 Section B inspection, it was estimated that the slide has retrogressed between 2.3 m and 3.5 m into the east (northbound lane) ditch since 2016. No additional retrogression was observed during the May 19, 2022 Section B inspection.

The nature of sliding (back-tilting blocks) observed on site suggests a combination of rotational failure and failure along a weak layer at depth. The right (south) flank of the slide appears to be retrogressing faster than other areas of the slide.

Head scarp 11.5 m away from guardrail.
Buried cables in the slide

Riverbank has been pushed laterally into river by landslide

2008 bank armouring (LPSTP)

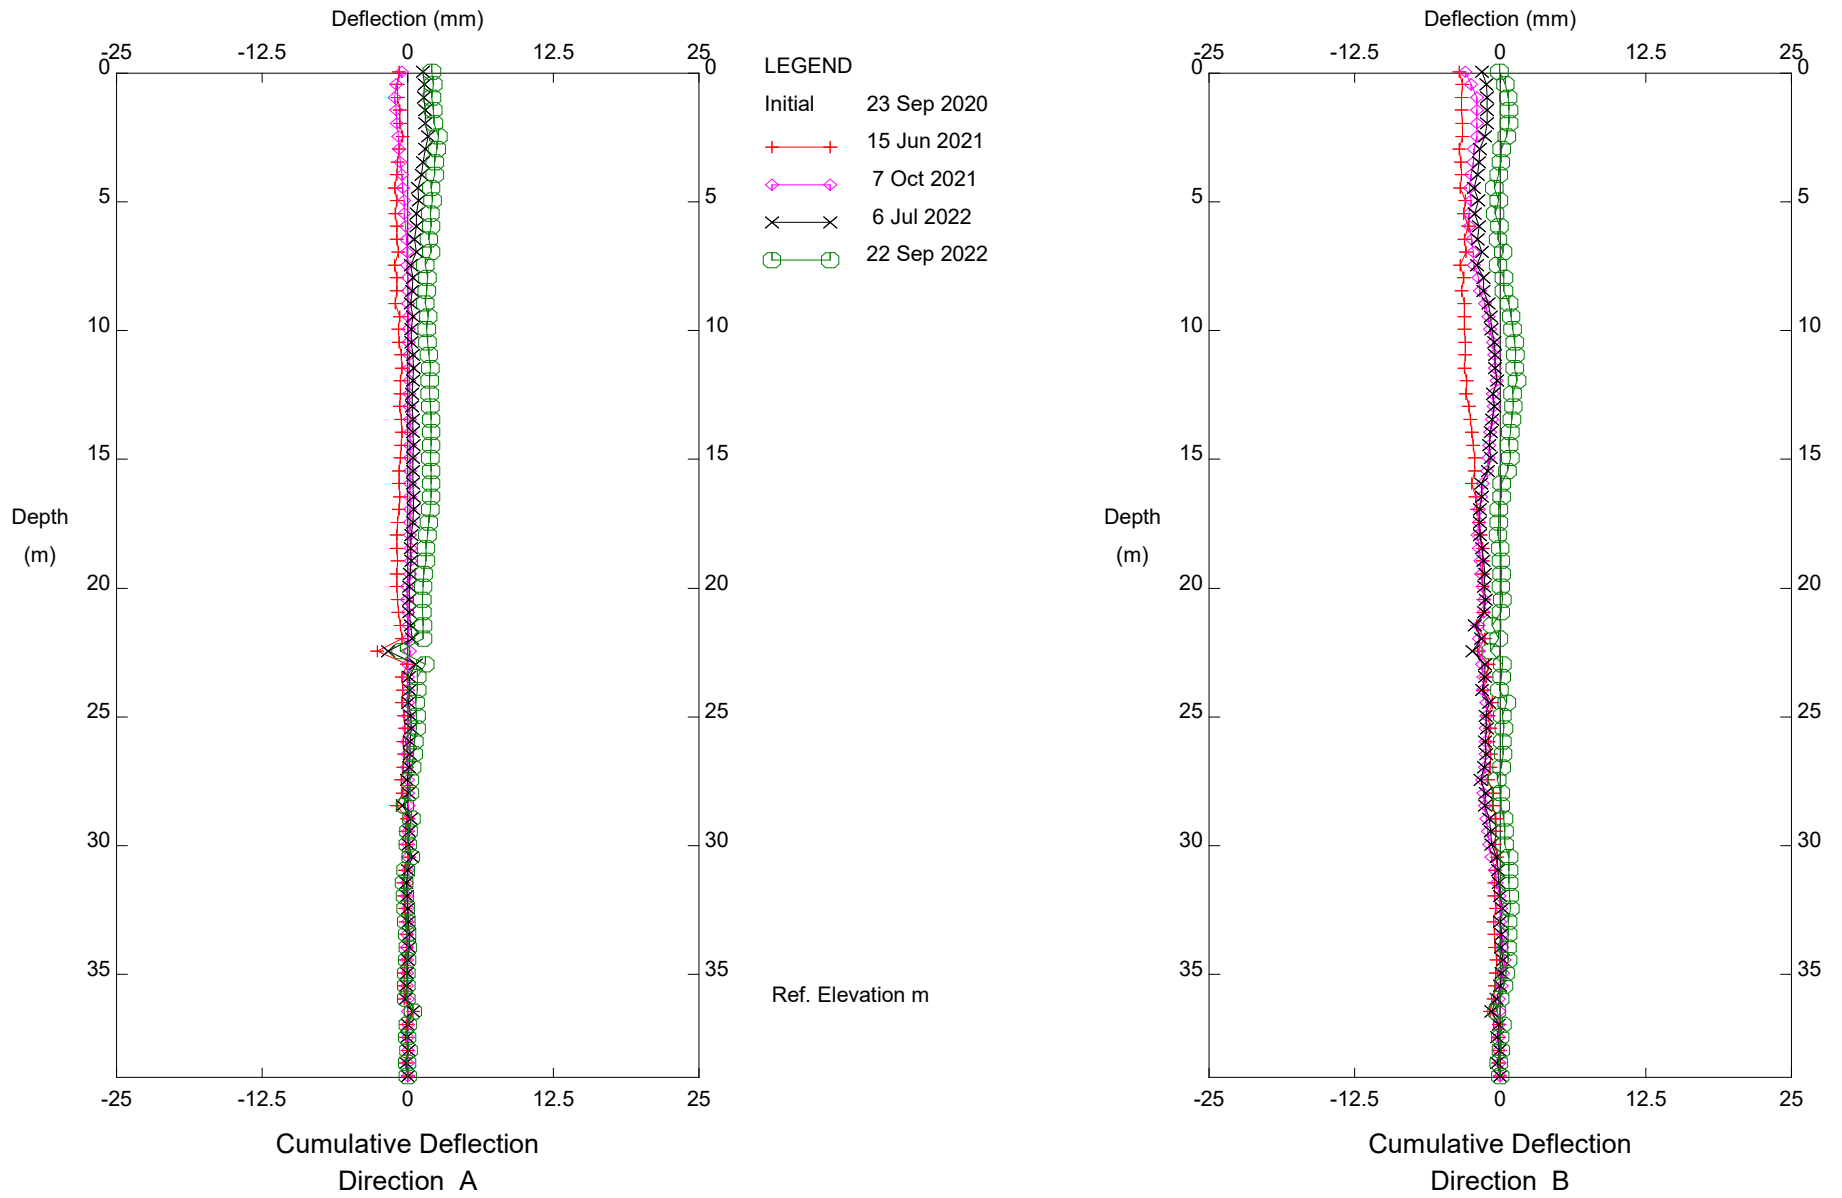
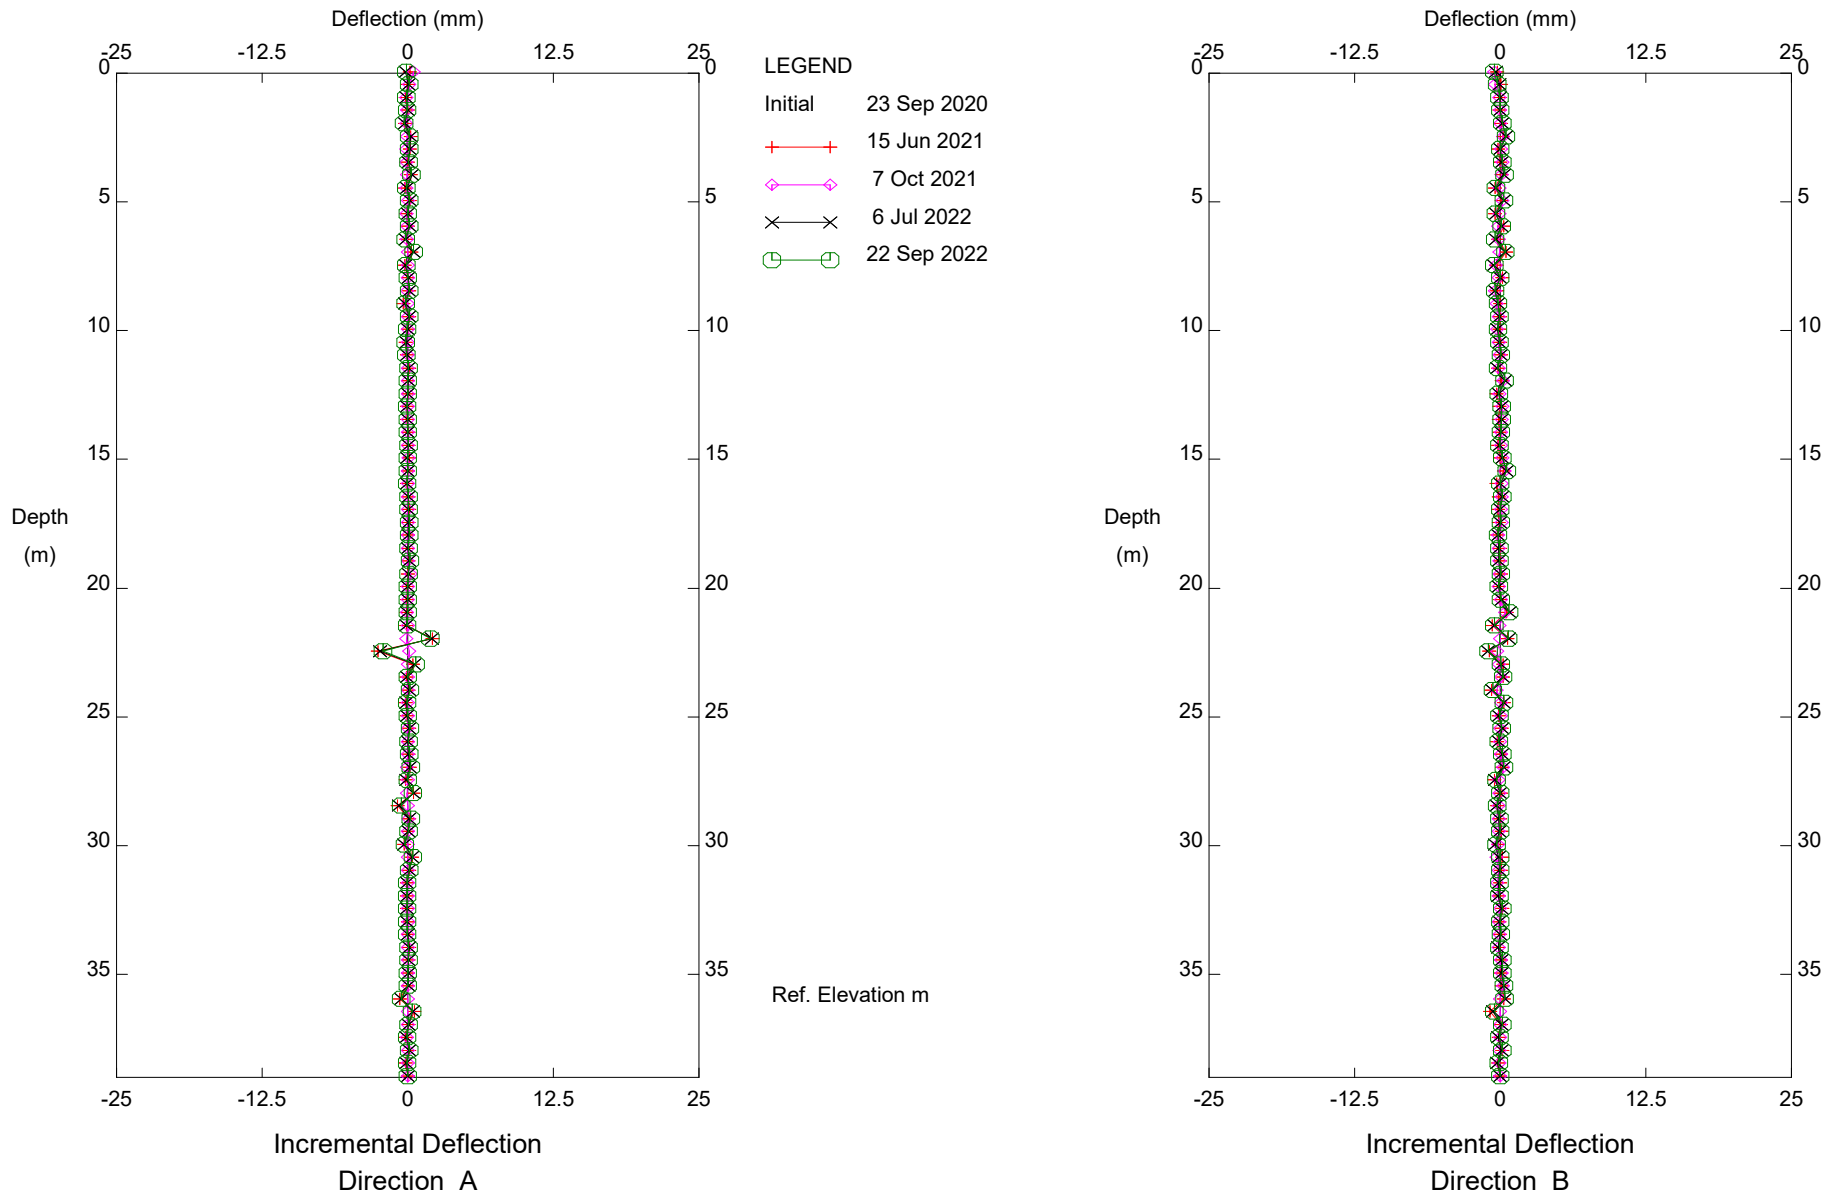
S004; H02:08, Willow Creek, Inclinator SI-1A
Alberta Transportation

- SI-1A is "wavy" with kinks at approximately 22 m, 28 m, and 36 m below ground surface;
- SI-5A is tilted approximately 1.0 m in the A-direction and 1.7 m in the B-direction, and there is also a kink in the casing at approximately 22 m below ground surface; and
- SI-9A is "wavy" with kinks at approximately 5 m, 11 m, and 25 m below ground surface.

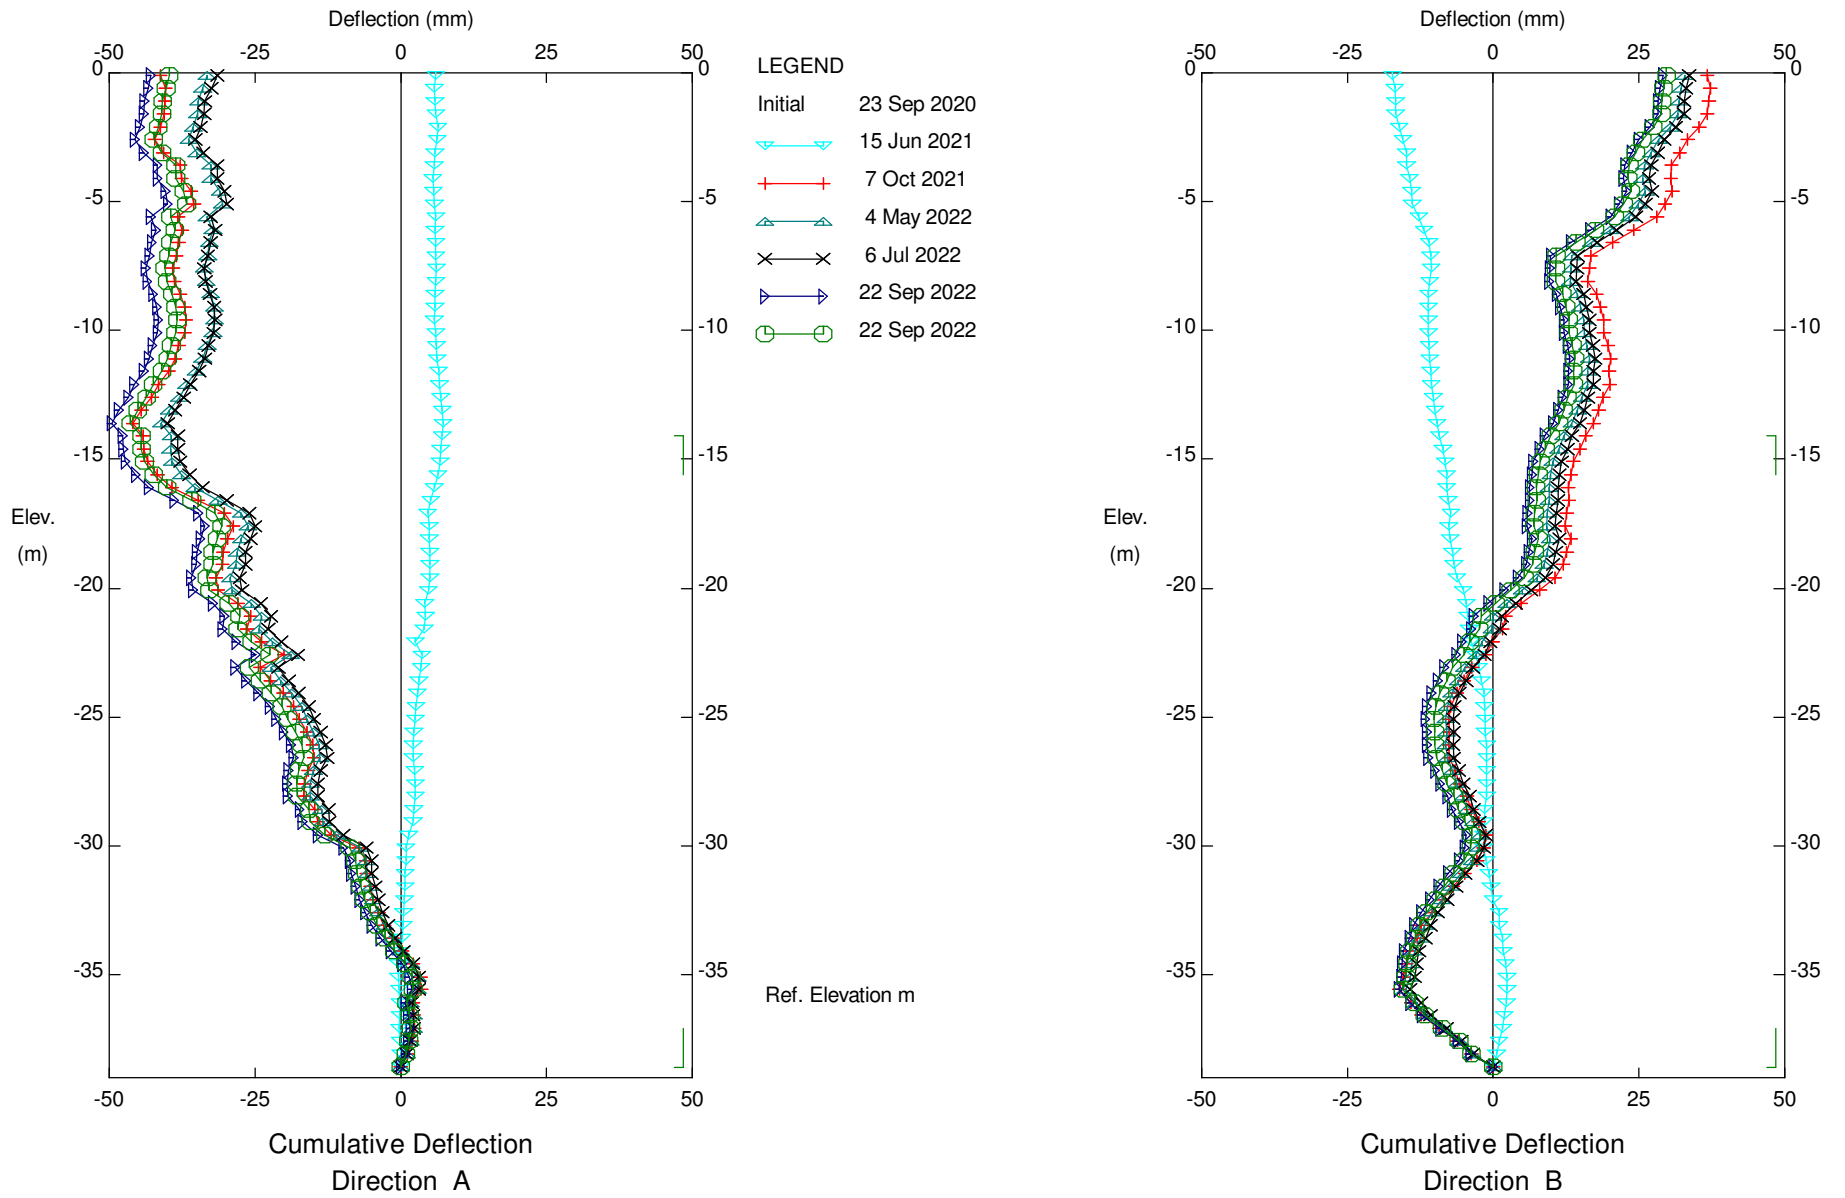
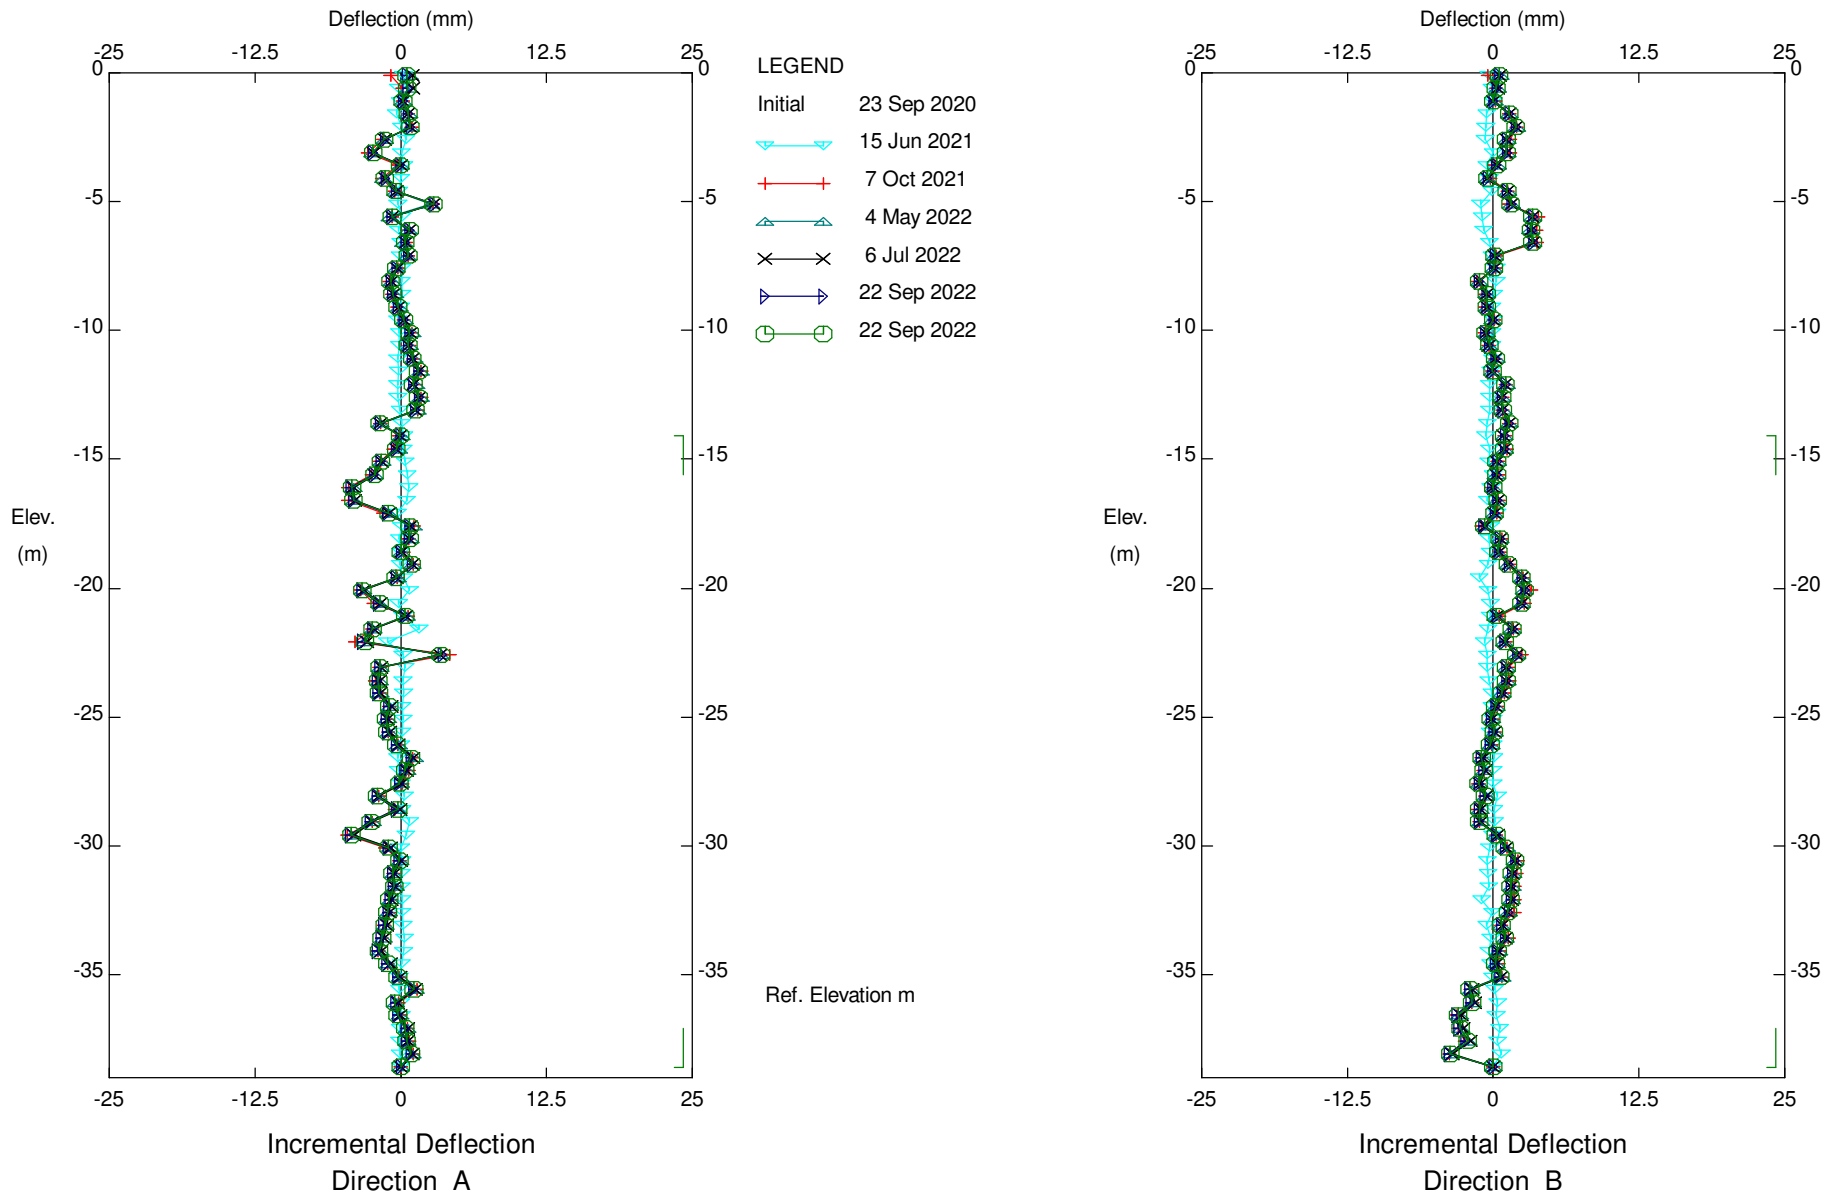
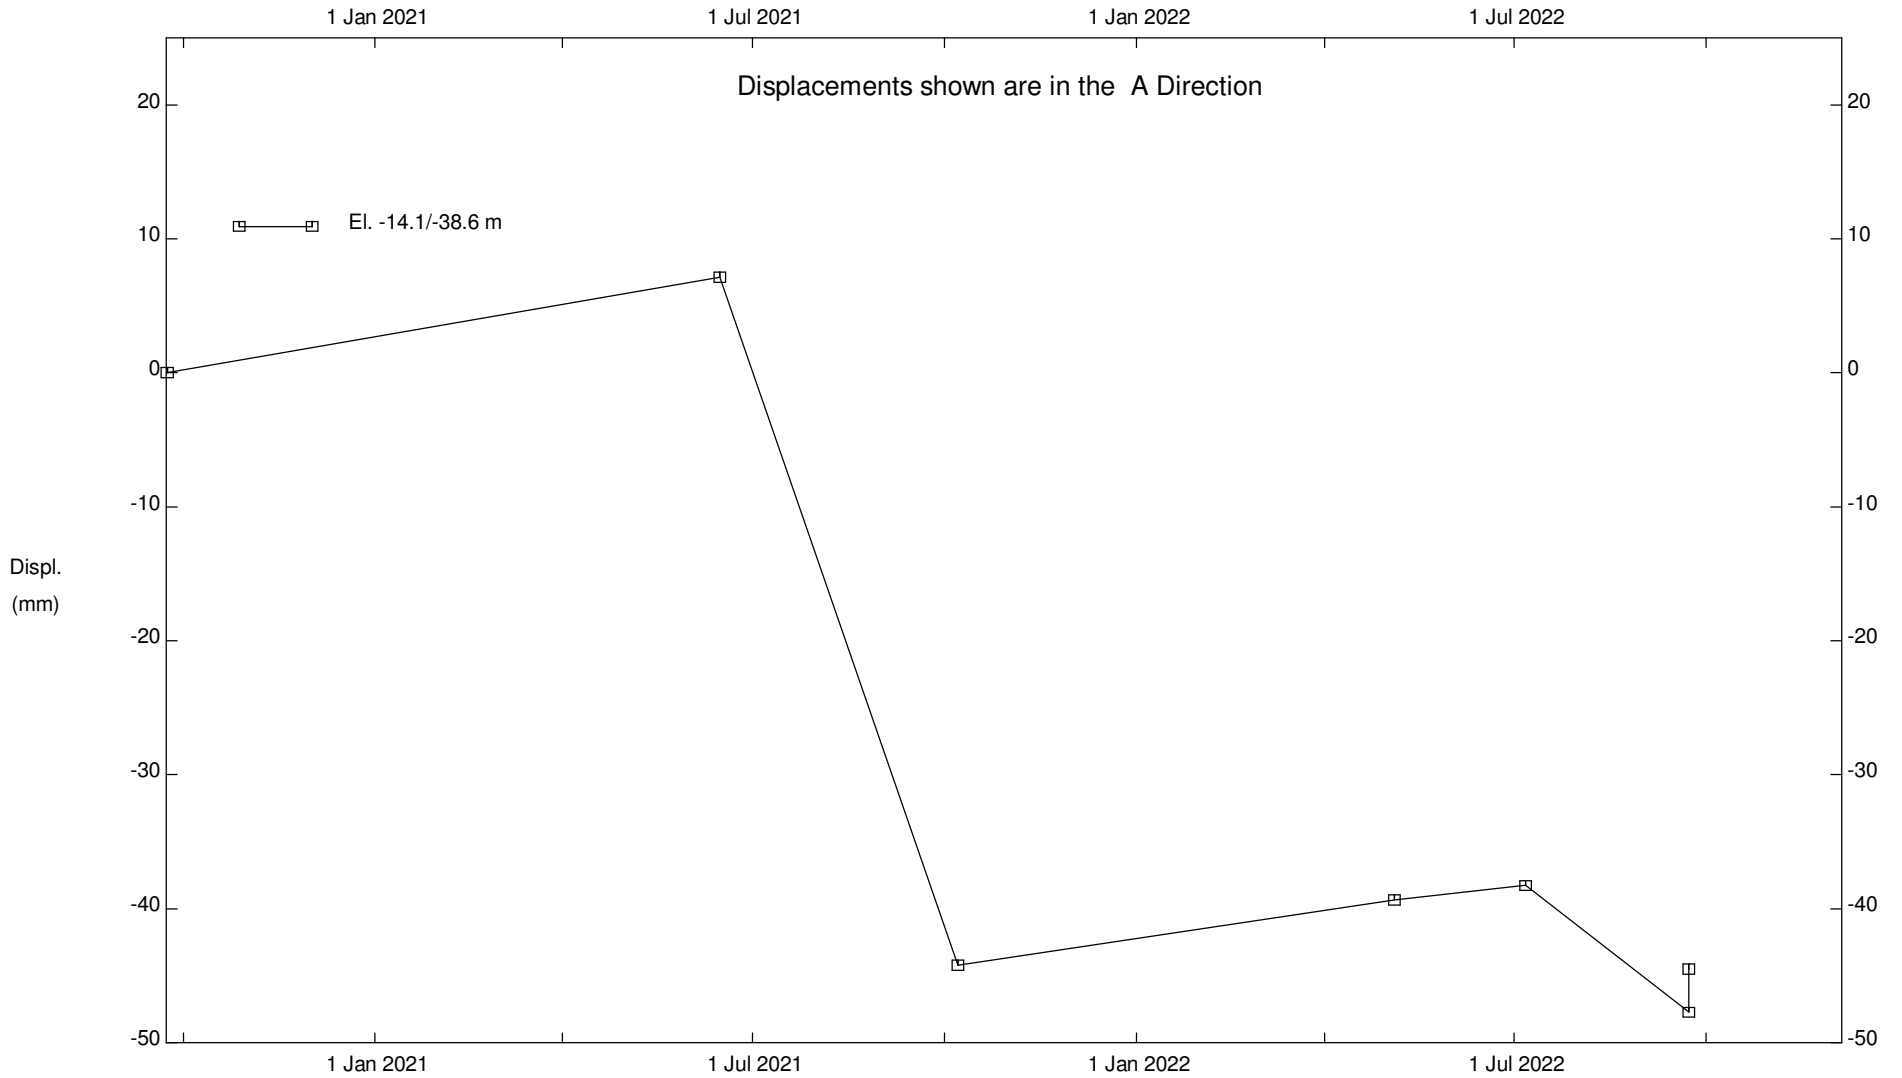
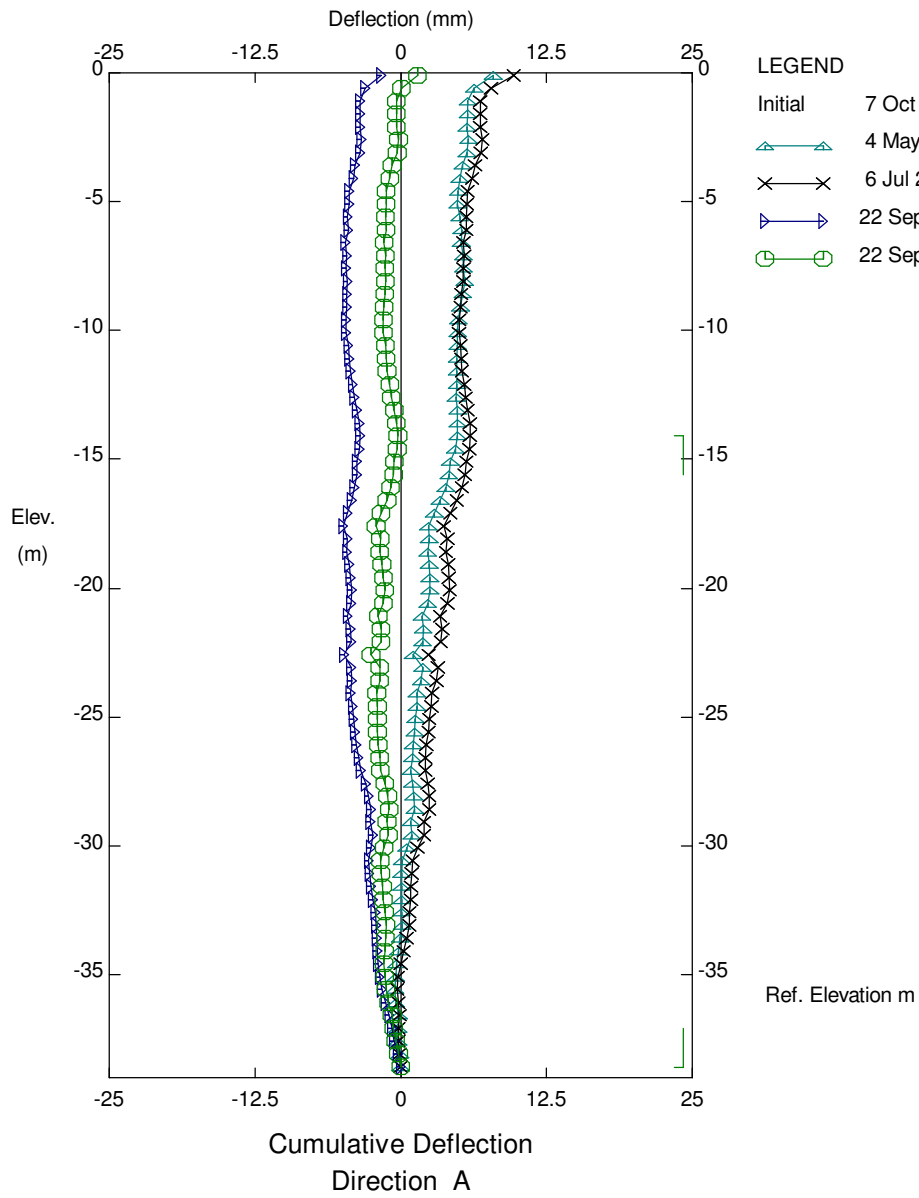
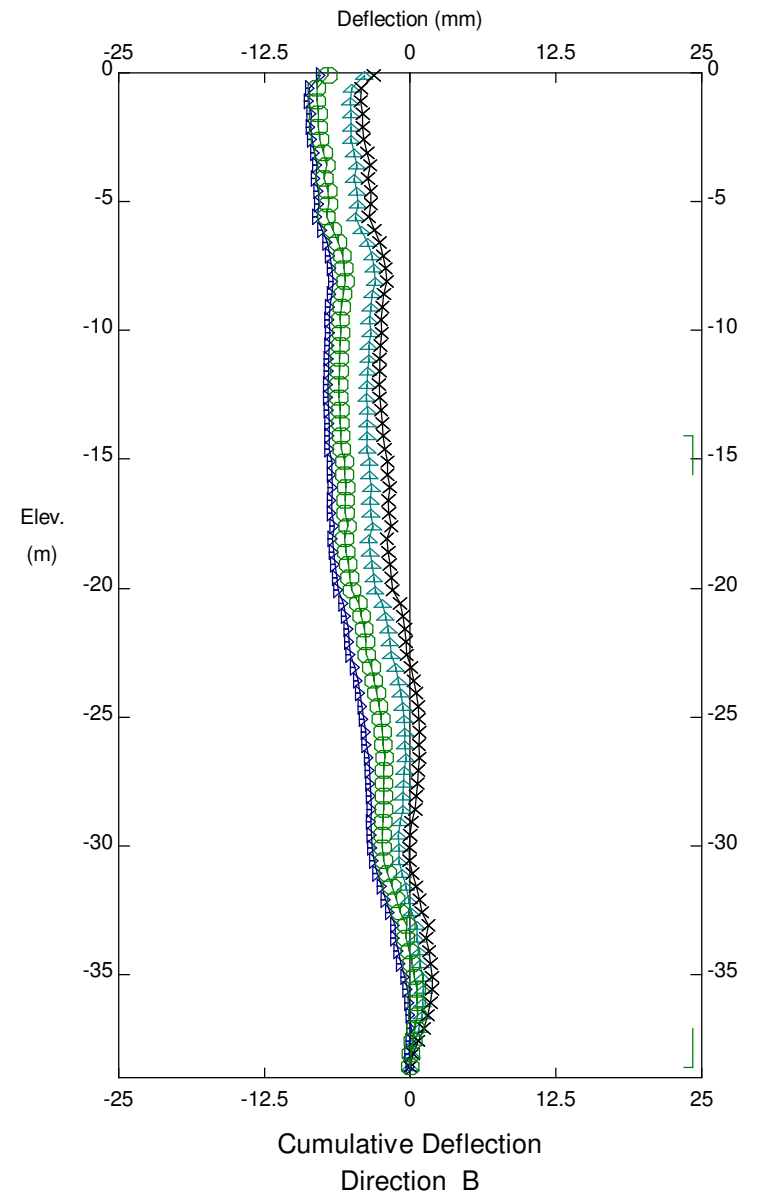
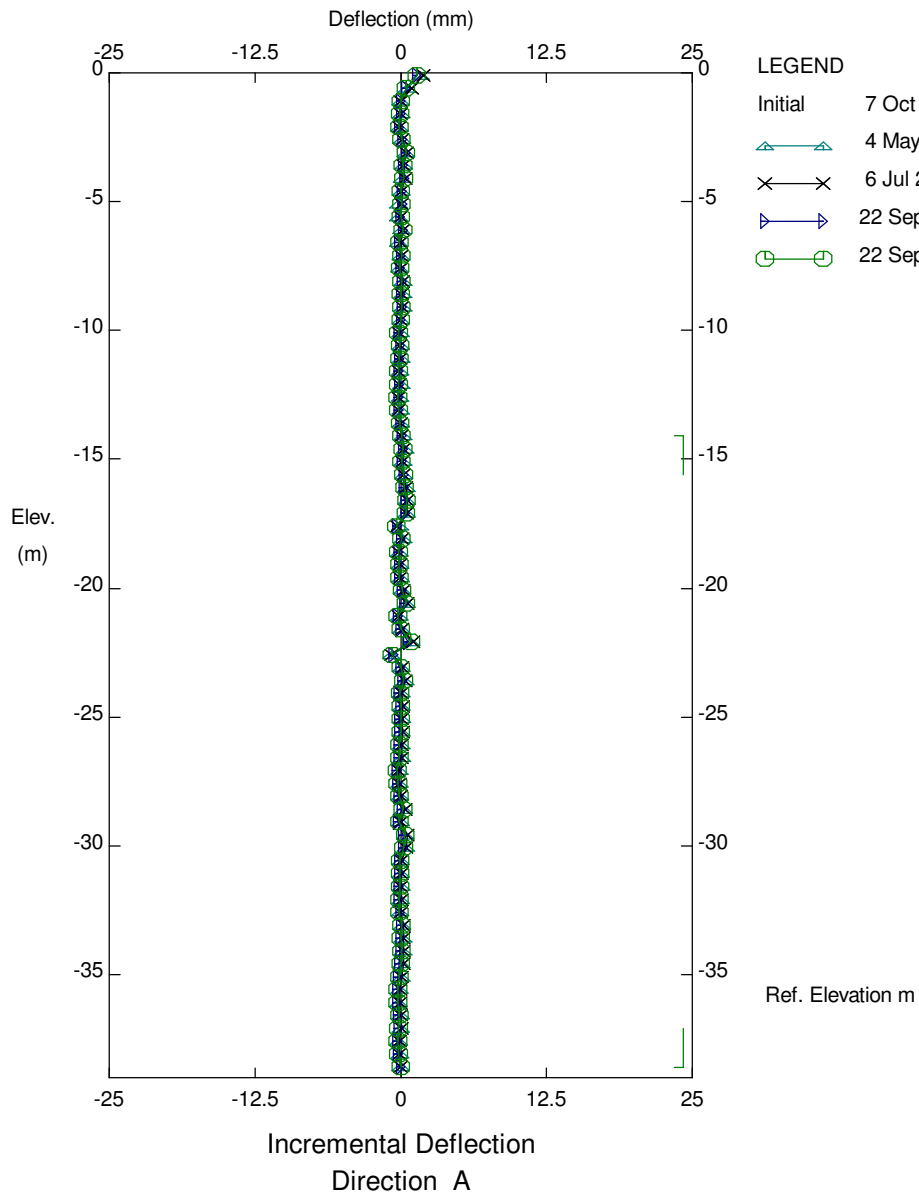
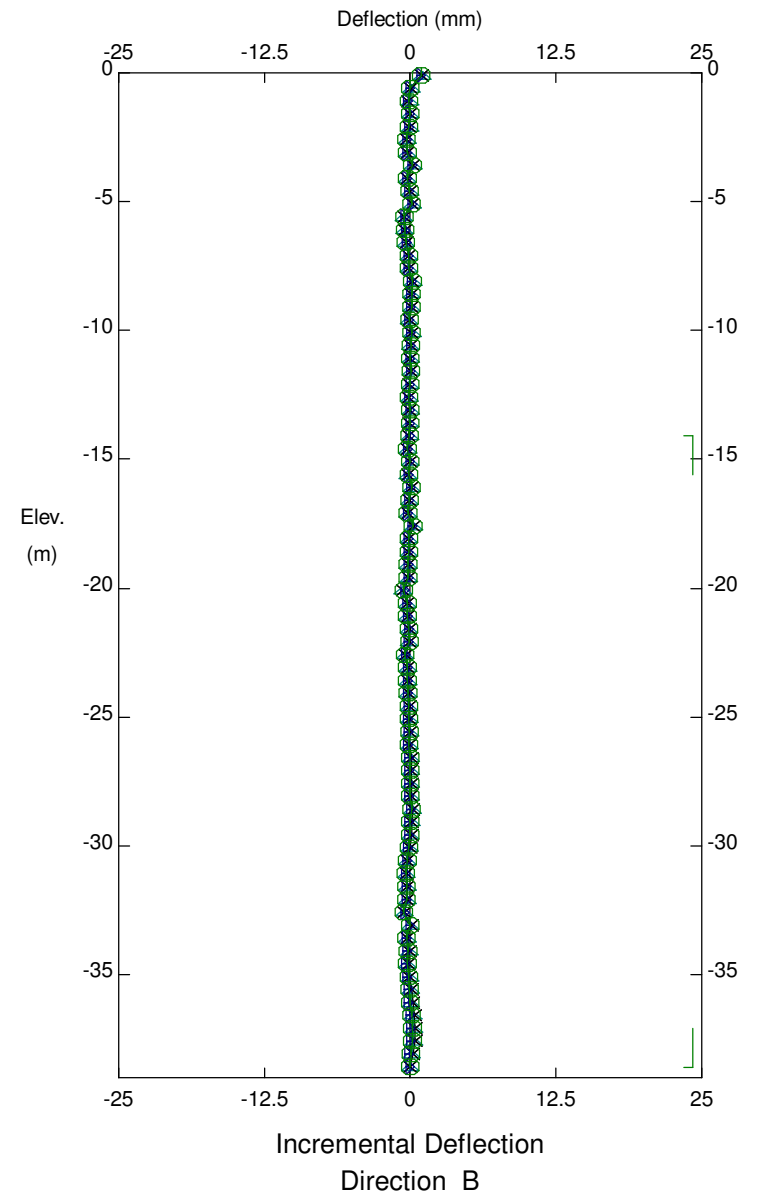
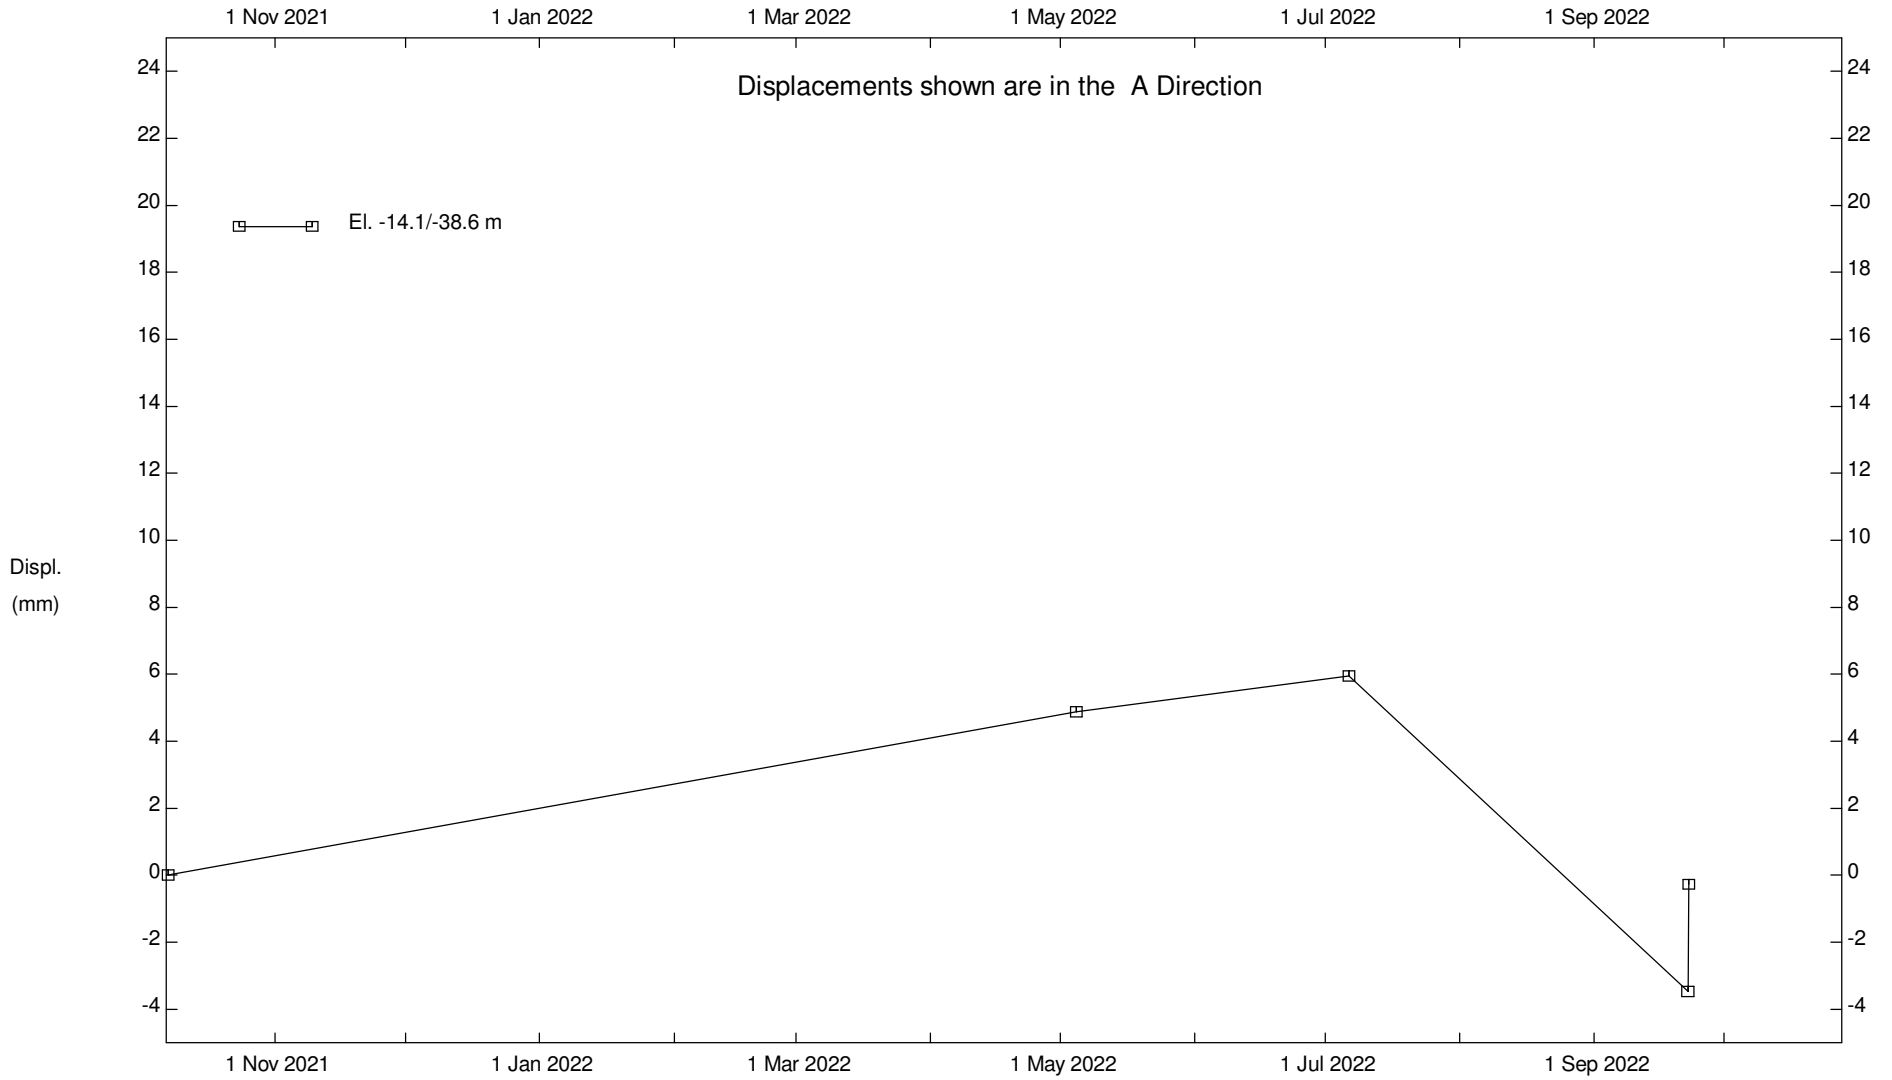
S004; H02:08, Willow Creek, Inclinator SI-5A
 Alberta Transportation

The SI data plots presented herein include data for readings taken with both KCB's new and old SI reading equipment. SI-5A was re-initialized to the October 7, 2021 reading due to the readings not aligning well with the previous readings taken with KCB's old SI reading equipment. Moving forward, only the re-initialized plots will be included.

Distributed movement has been recorded in SI-5A from an approximate depth of 14 m to the base of the instrument. However, given the data is difficult to interpret, more data is needed to assess the movement trends for this instrument.
