November 30, 2022

CON0022161 Southern Region GRMP Instrumentation Monitoring
Site S004; H02:08, km 6.284 Willow Creek
Section C – 2022 Fall Readings

PROJECT SOUTHERN REGION GEOHAZARD RISK MANAGEMENT PROGRAM		
TITLE Site Plan S004 - Willow Creek (North of Ft. Macleod) Hwy 2:08, km 6.284		
SCALE 1:2,000	PROJECT No. A05116A03	FIG No. 1

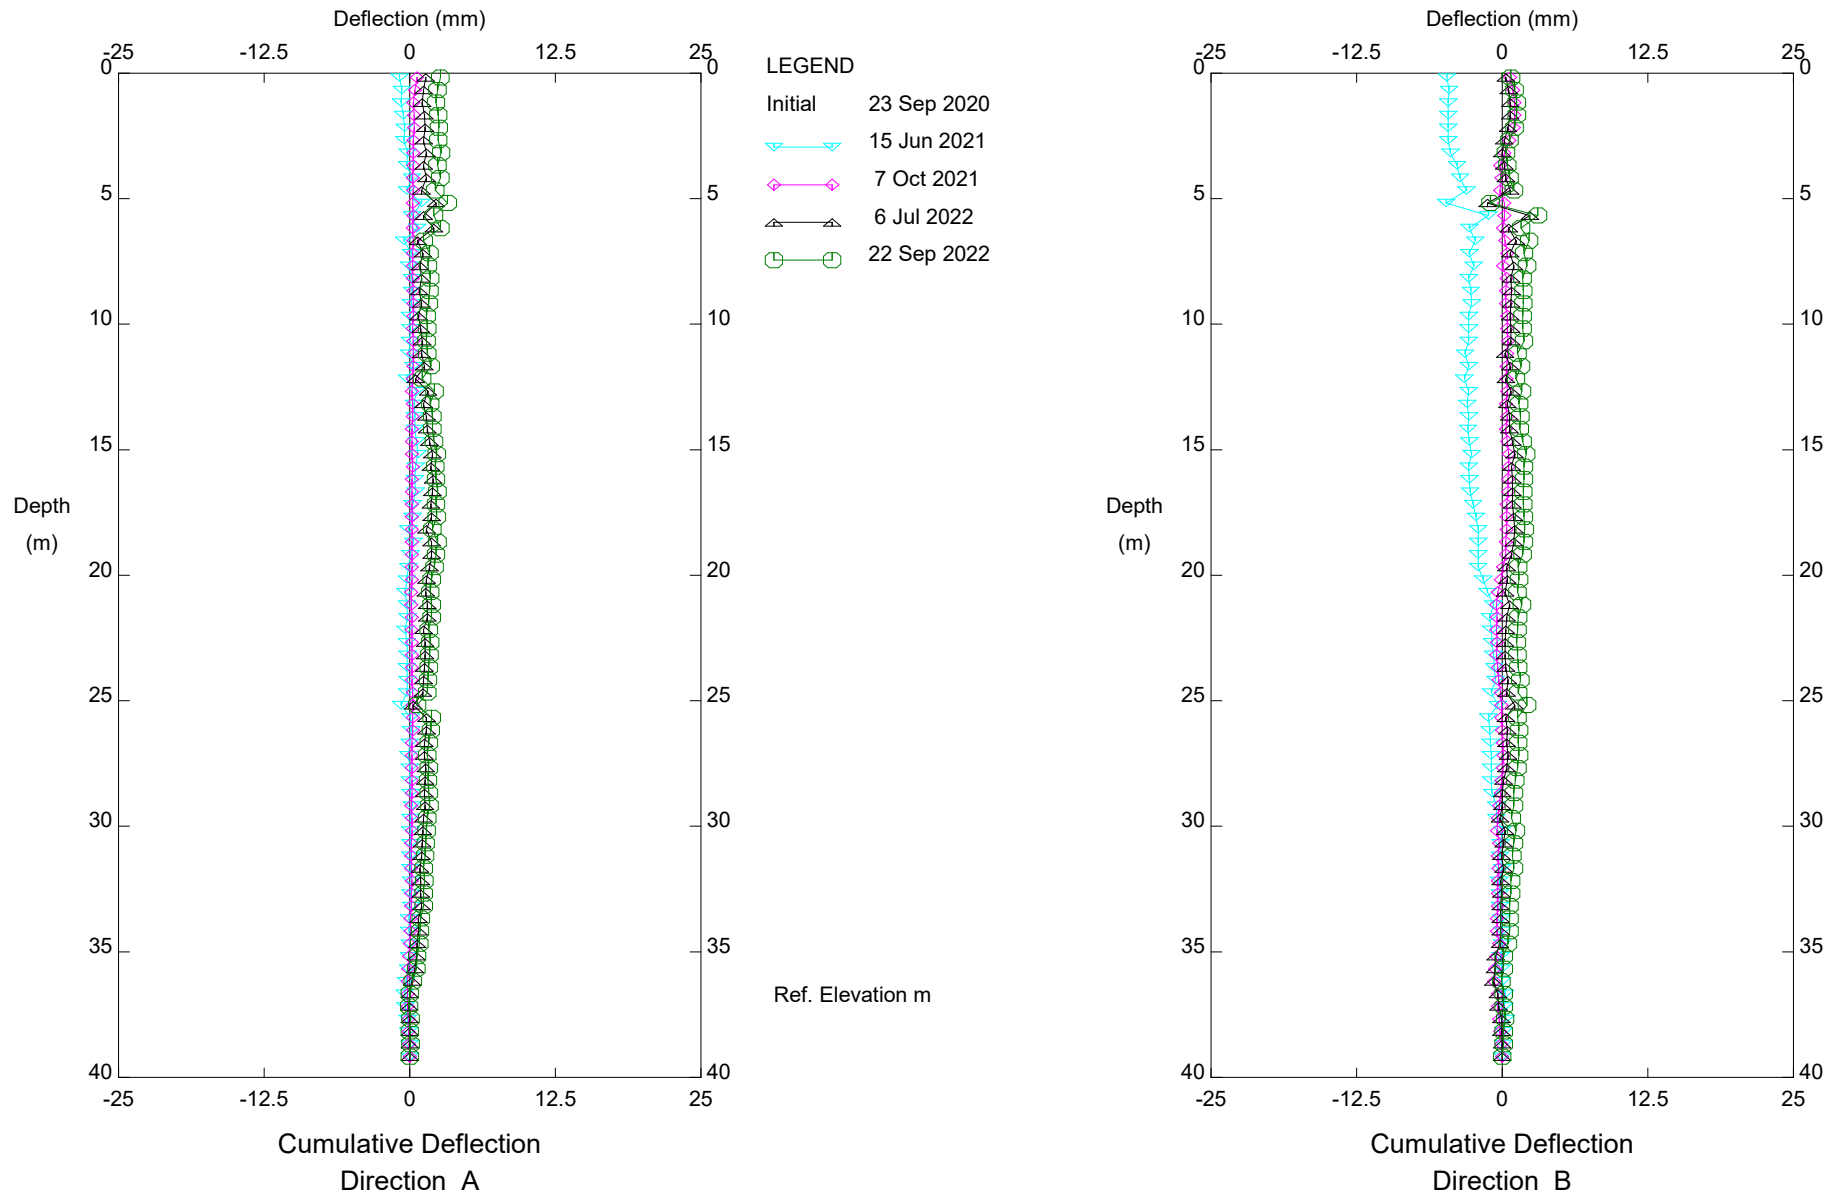
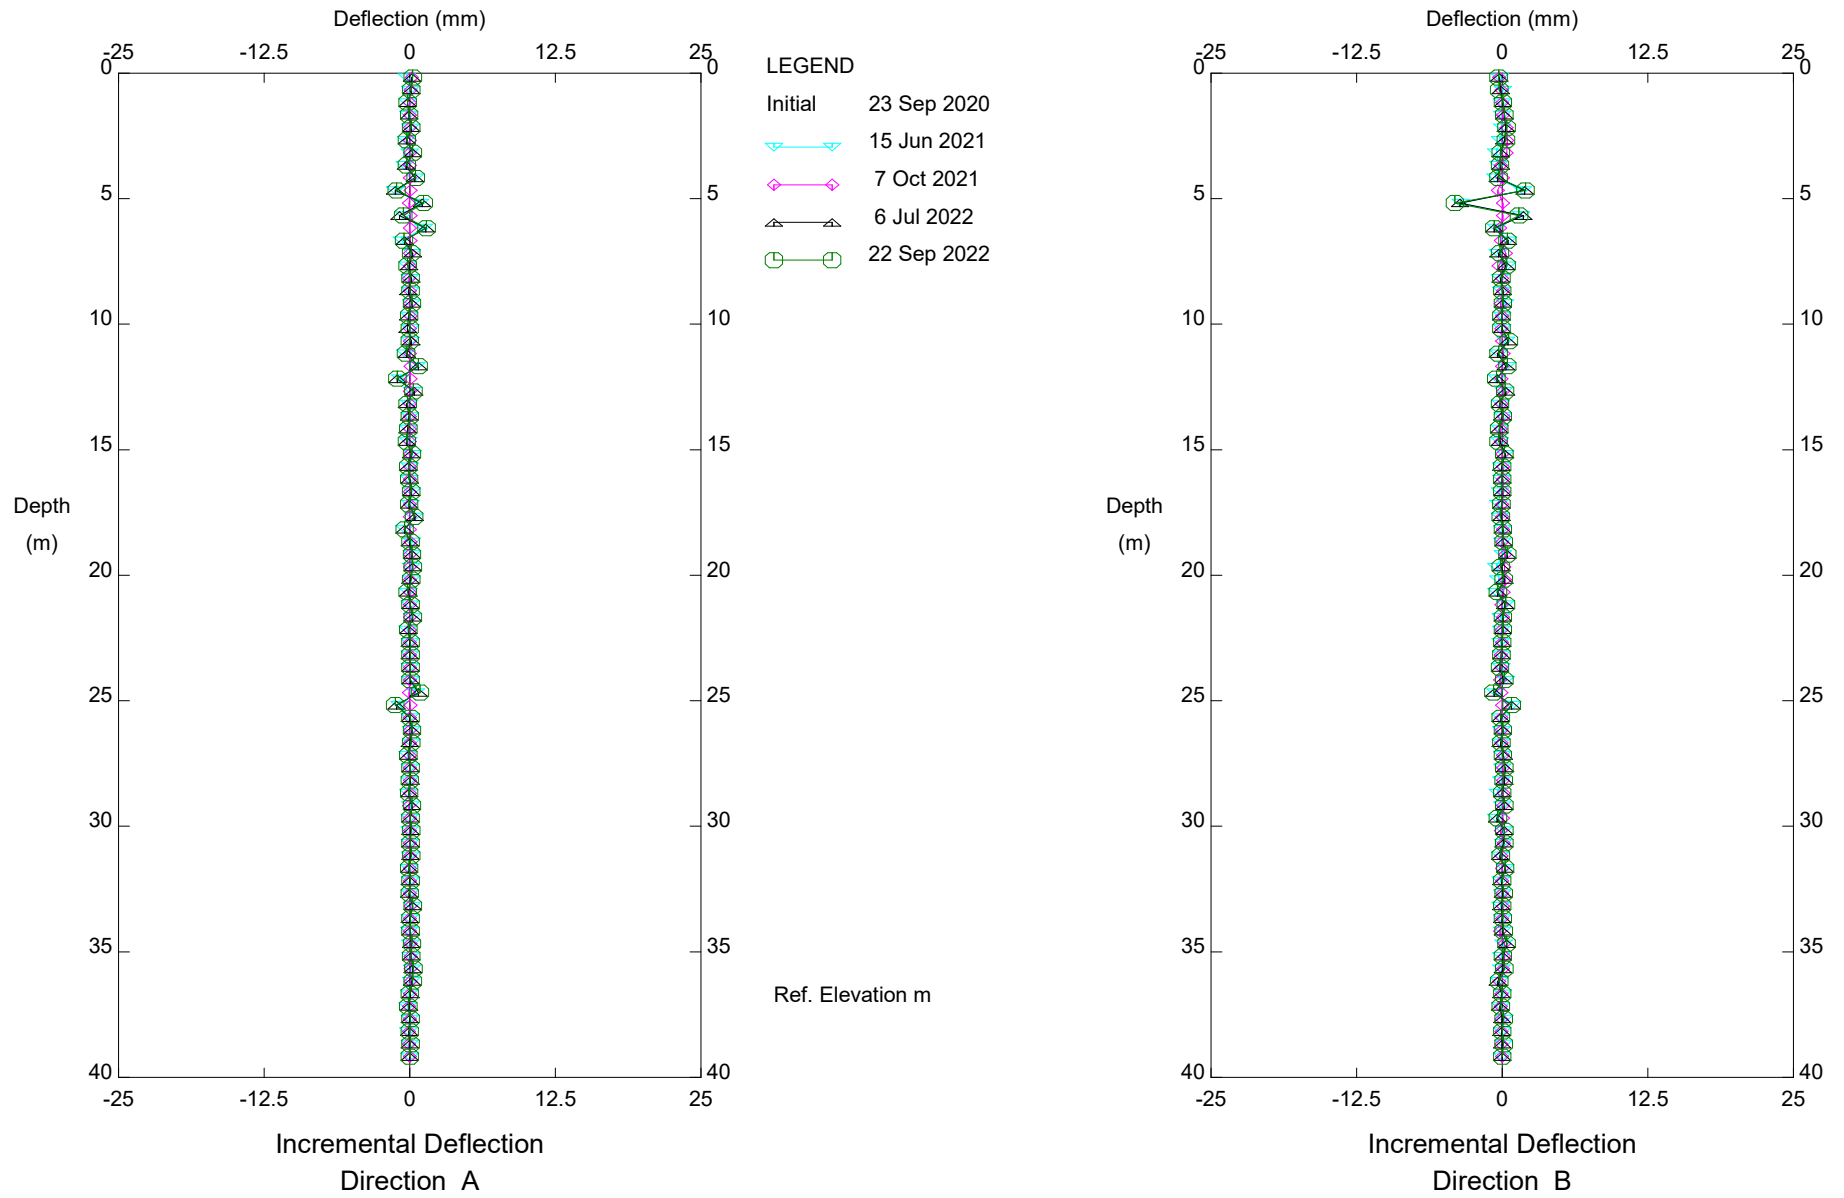
S004; H02:08, Willow Creek, Inclinator SI-9A
Alberta Transportation

- SI-1A is "wavy" with kinks at approximately 22 m, 28 m, and 36 m below ground surface;
- SI-5A is tilted approximately 1.0 m in the A-direction and 1.7 m in the B-direction, and there is also a kink in the casing at approximately 22 m below ground surface; and
- SI-9A is "wavy" with kinks at approximately 5 m, 11 m, and 25 m below ground surface.

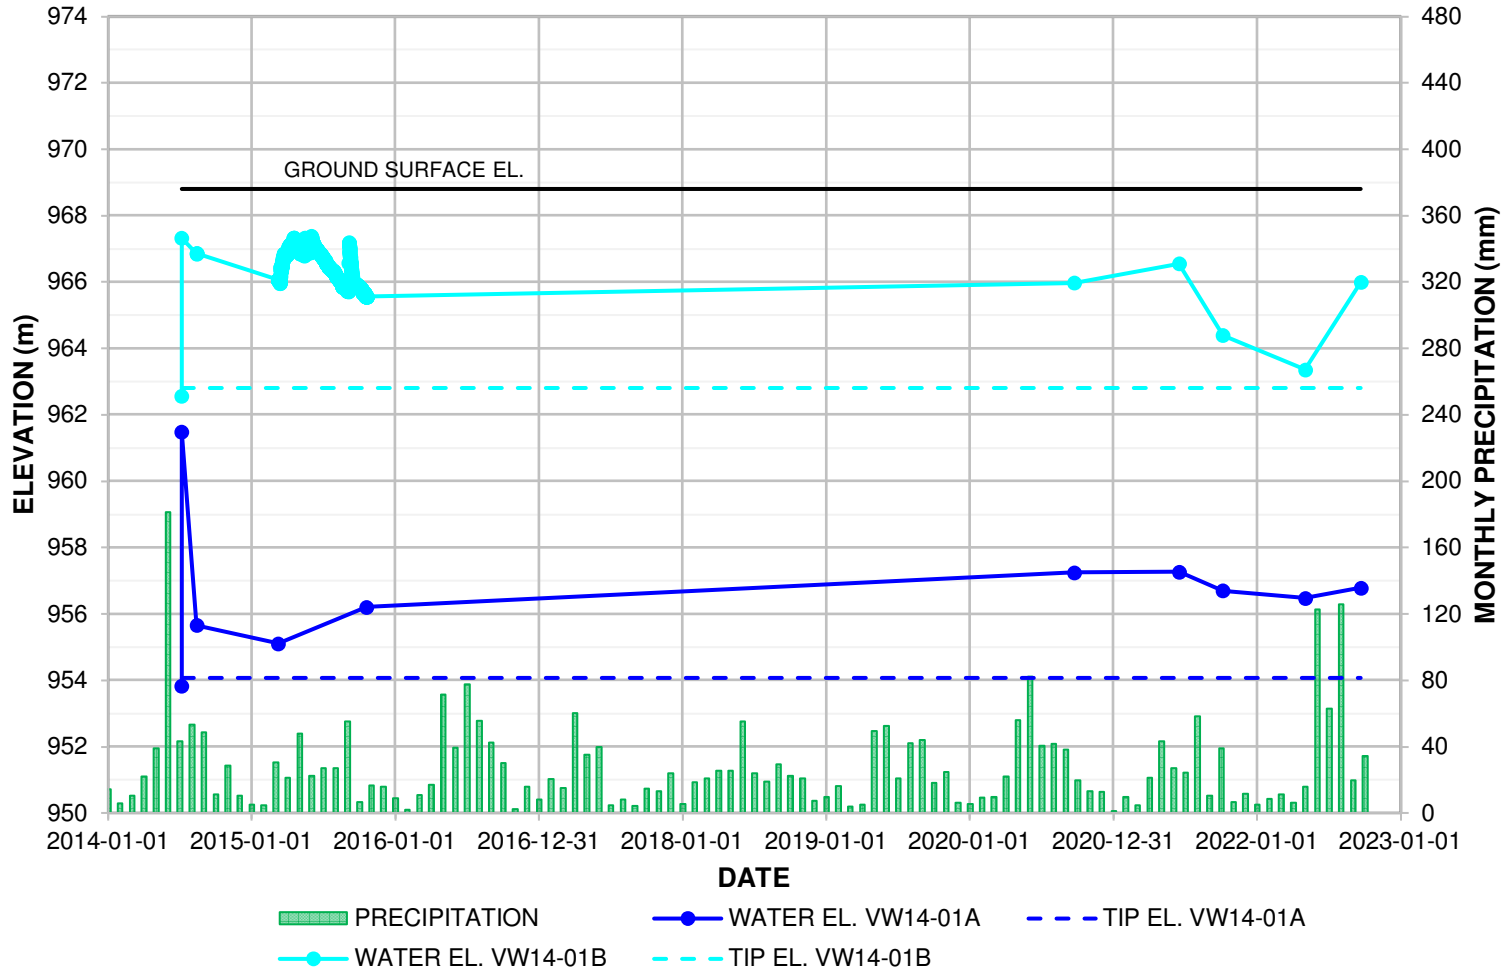
VW14-01A AND VW14-01B

Generally, relatively steady water levels (± 0.3 m) have been recorded in the deeper VWPs (VW14-01A and VW14-02A) since KCB took over the readings in 2020, except VW14-03A which is installed below

The upper VWP's (VW14-01B through VW14-03B) appear to more be response than the lower VWP's to changes in groundwater conditions. The 2.6 m to 1.0 m increase recorded in VW14-01B and VW14-03B between the spring and fall 2022 readings could be due to wet weather in mid-2022. It is unclear why a similar increase was not recorded in VW14-02B.

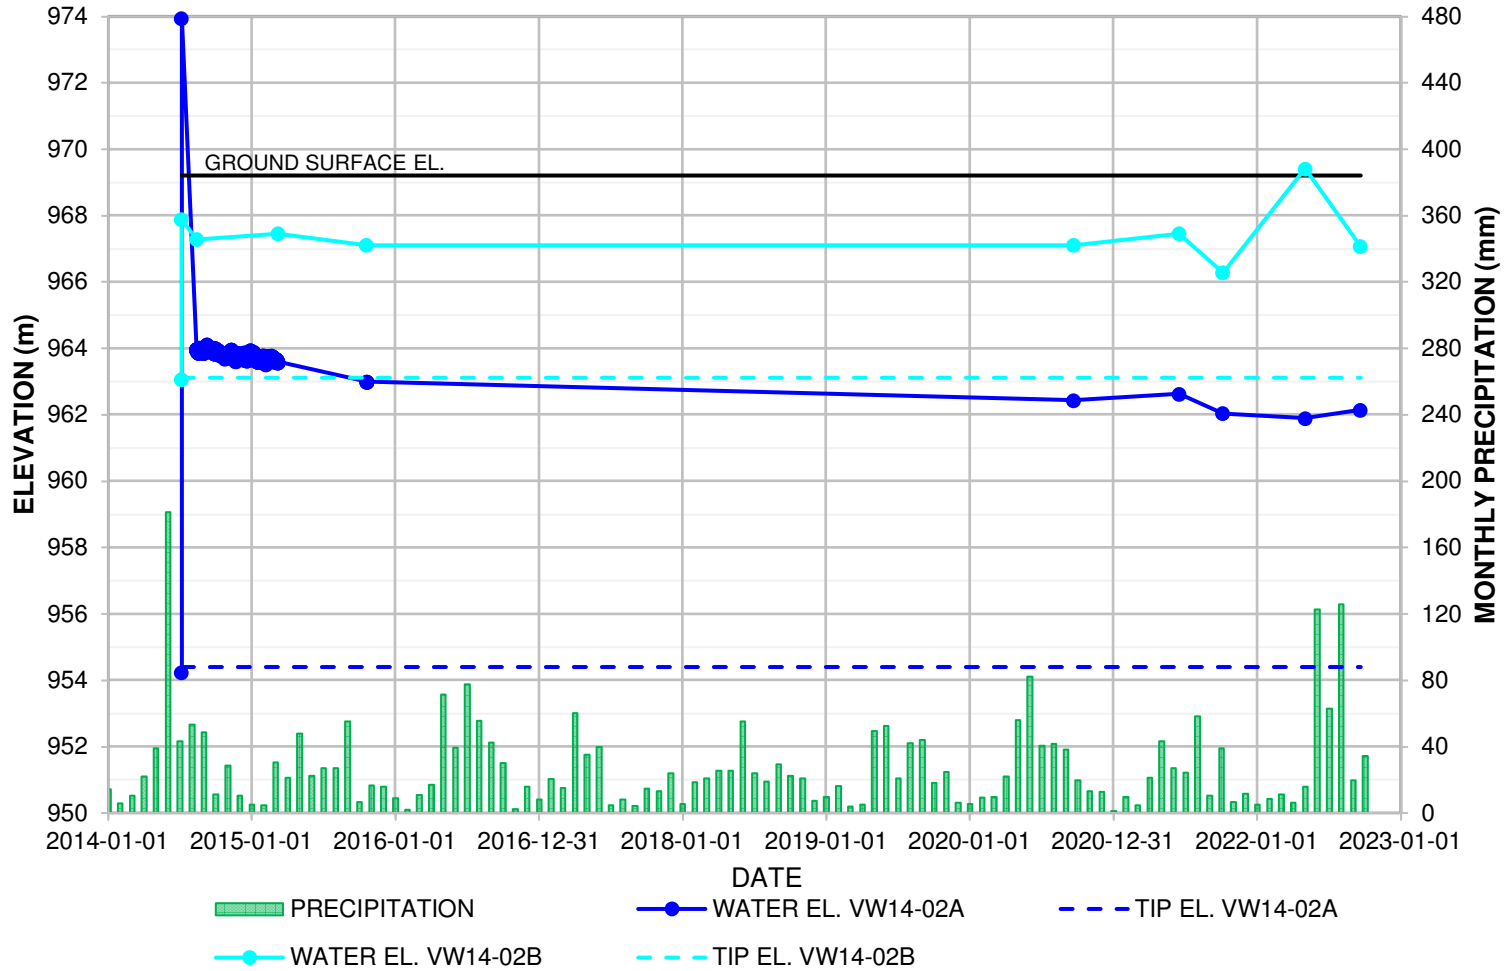
VW14-02A AND VW14-02B

A 2.9 m increase was recorded in VW14-02B between the fall 2021 and spring 2022 readings followed by a 2.3 m decrease between the spring and fall 2022 readings. These readings are inconsistent with readings from the other piezometers at this site. More data is needed to assess trends for this instrument.

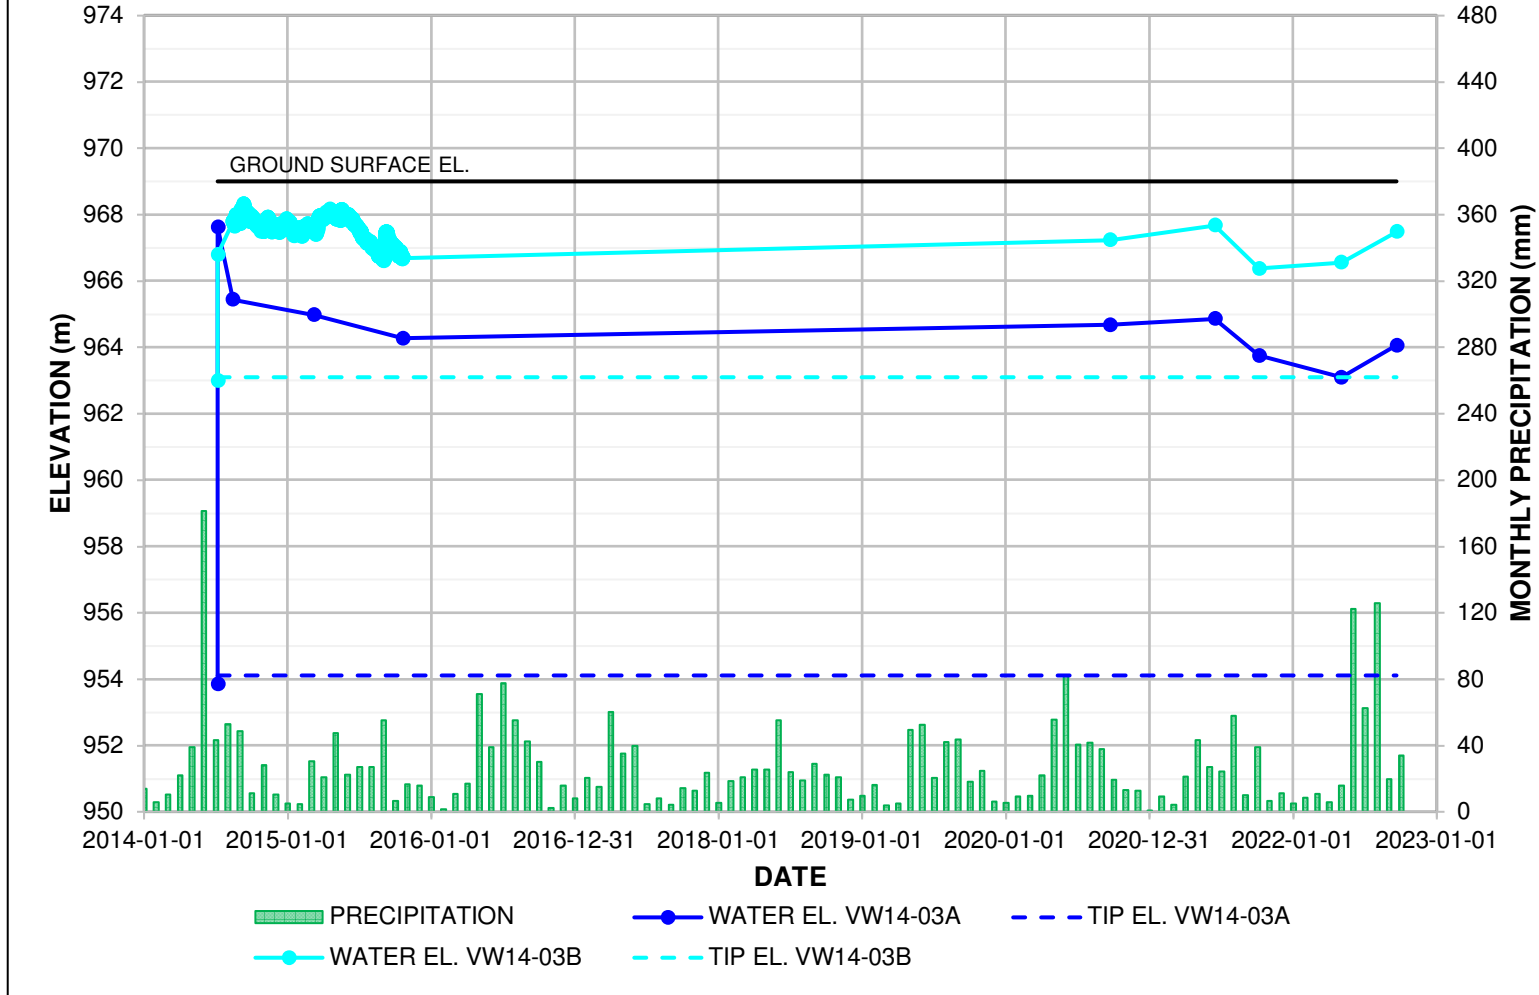
VW14-03A AND VW-03B

the highway median. The other VWP's are installed at the crest of slide where water can drain more freely. VW14-03A may have more response to changes in precipitation due to water ponding and infiltrating into the highway median.

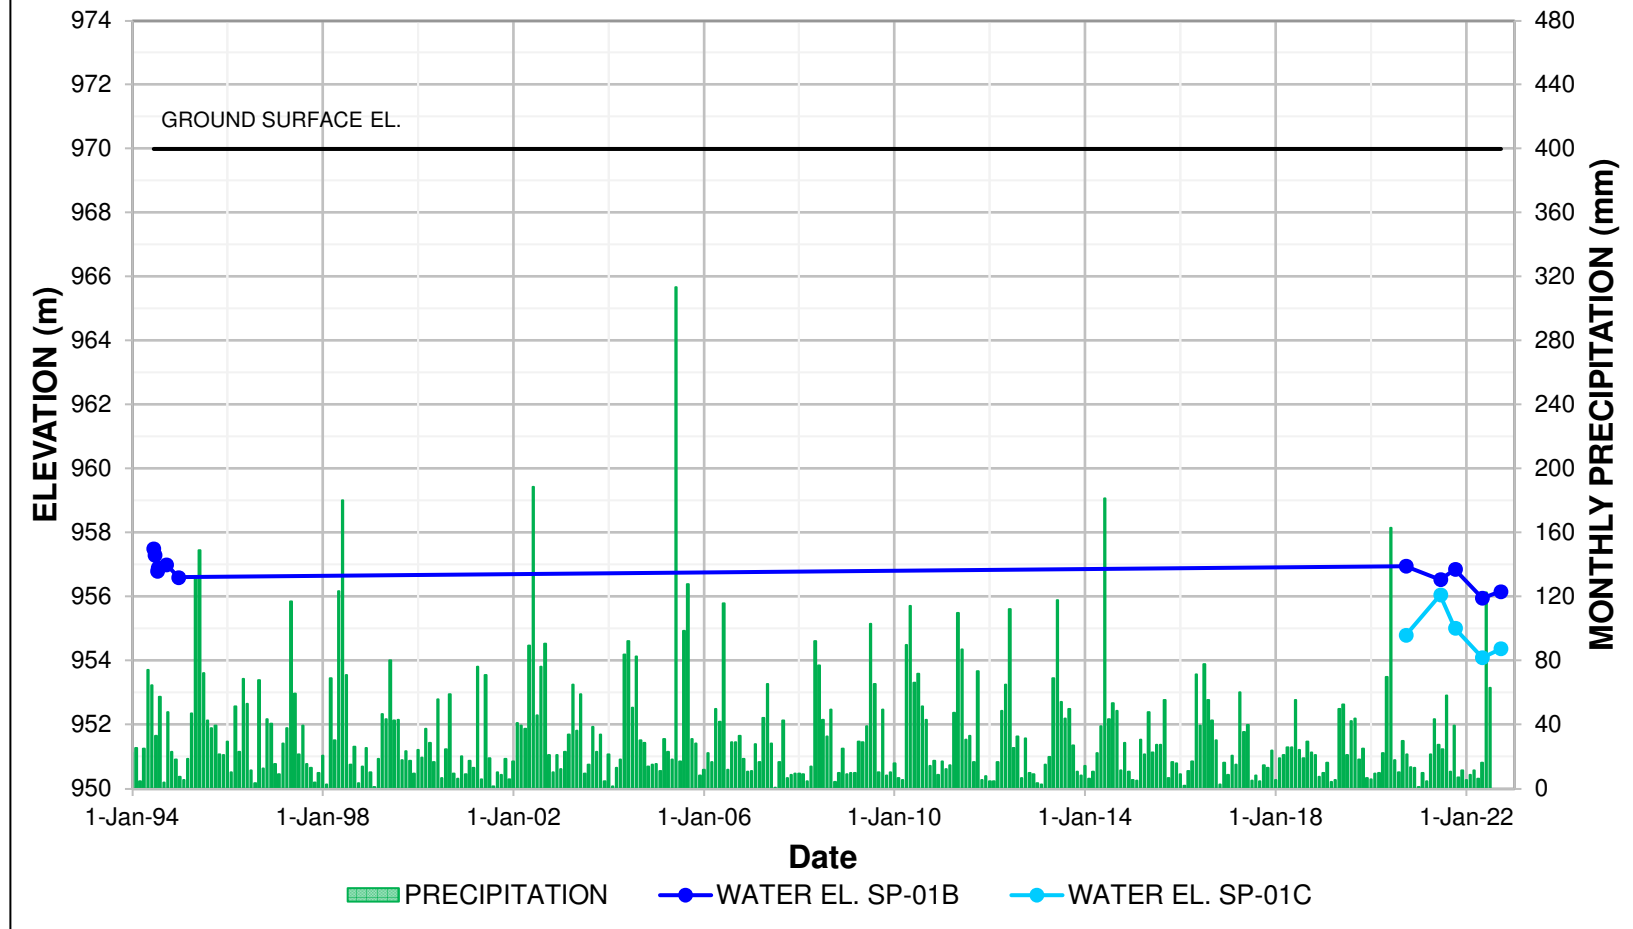
SP-01B AND SP-01C

Since KCB took over reading the instruments in 2020, an overall decrease of 0.6 m to 1.7 m has been recorded in the SPs. This decrease in water level could be attributed to dry weather from late-2020 until early 2022. Between the spring and fall 2022 readings, a 0.2 m to 0.3 m increase was recorded in SP-01B, SP-01C, and SP-05B likely in response to wet weather in mid-2022. Screen elevations have not been provided for the SPs, which makes data interpretation difficult. The 1994 reading for SP-05C was most likely bad as it is approximately 10 m lower than the previous and current readings.

No instrument repairs are required. However, during the fall 2022 readings, a 4" diameter polyvinyl-chloride (PVC) pipe was installed at SP-1C. To protect this instrument, the annulus between the instrument and PVC pipe should be backfilled with granular material (gravel or sand).

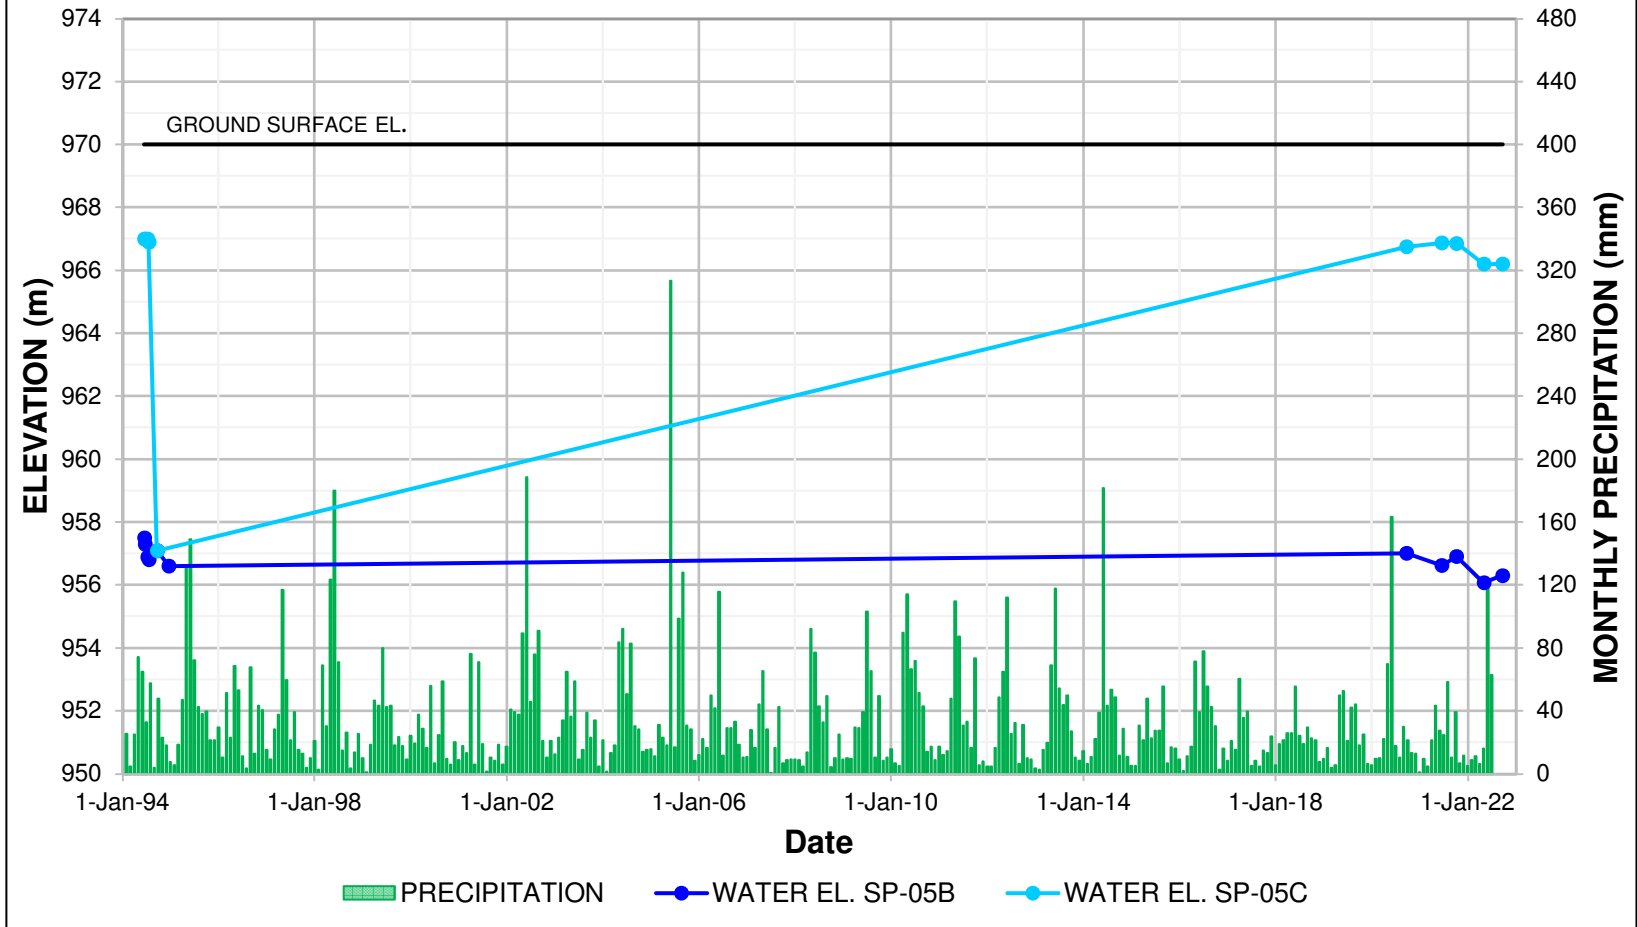
SP-05B AND SP-05C

1. MONTHLY PRECIPITATION DATA OBTAINED FROM THE ALBERTA CLIMATE INFORMATION SERVICE (ACIS) DATABASE, REFERENCING LEGAL SUBDIVISION TWP009-26-W4.
2. THE 1994 READING FOR SP-05C APPEARS TO BE BAD DATA.
3. THE INSTRUMENTS WERE NOT READ BETWEEN OCTOBER 2015 AND SEPTEMBER 2020.
