| SITE NUMBER AND NAME: S004 Willow Creek (North of Fort Macleod) | | HIGHWAY & KM: 2:08, 6.284 | PREVIOUS INSPECTION DATE: July 8, 2021 | INSPECTION DATE: May 19, 2022 |

| PRIMARY SITE ISSUE: Landslide at outside bend of Willow Creek (slope crest retrogressing), possibly due to infiltration from irrigation activities on farmland on the opposite side of Hwy 2. Landsliding has retrogressed into eastbound lane ditch, causing ditch flows to discharge onto the slide surface. | | |

| PROJECT SOUTHERN REGION GEOHAZARD RISK MANAGEMENT PROGRAM | | |
| TITLE Site Plan S004 - Willow Creek (North of Fort Macleod) Hwy 2.08, km 6.284 | | |

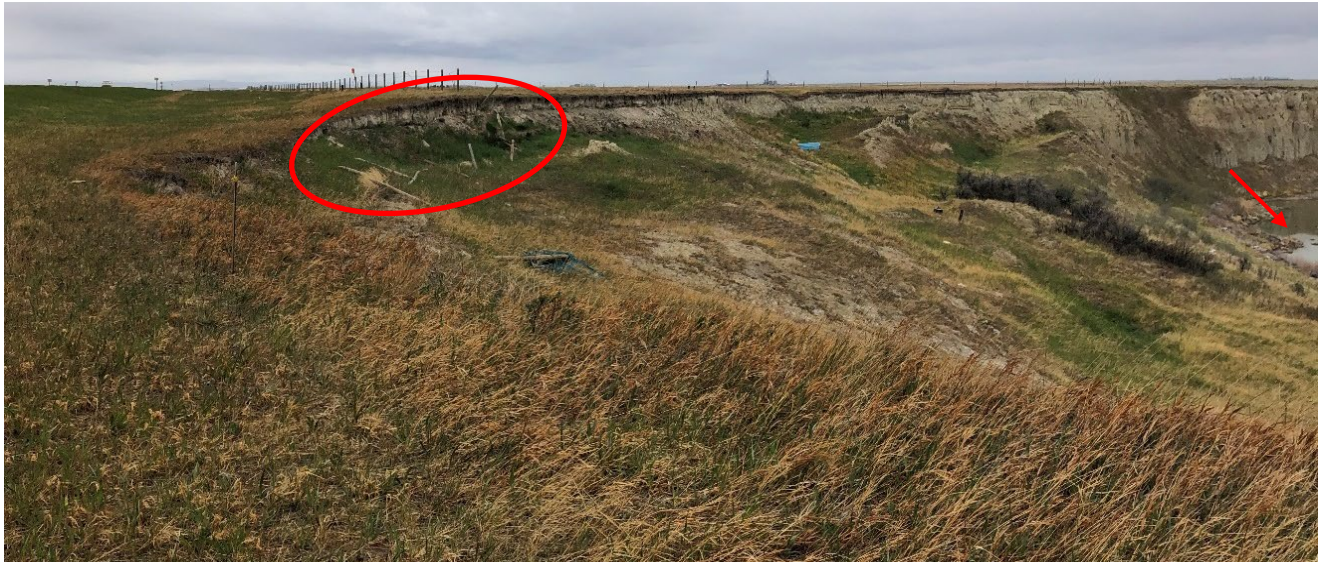
- Photo 1** An overview of the slide area. Willow Creek is at the toe of the slope (indicated by red arrow) and instruments can be seen in the slide zone (indicated by red circle). Photo taken May 19, 2022 facing north.

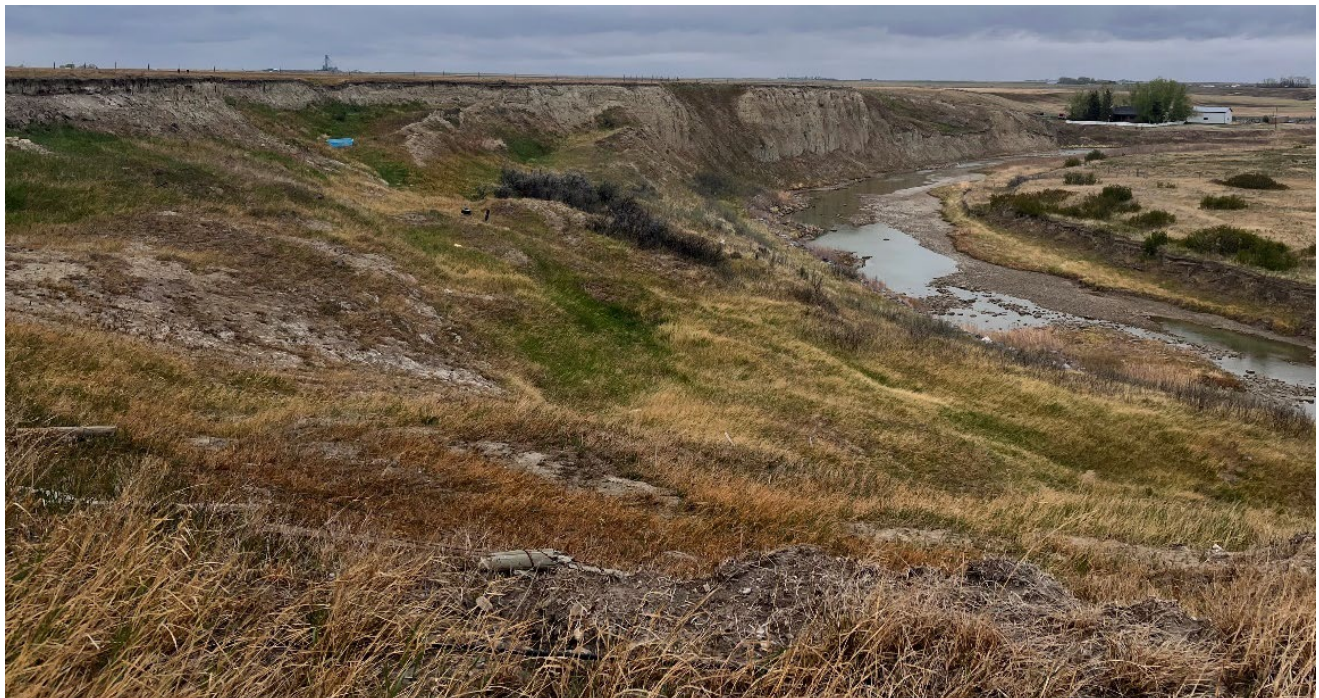
The nature of the slide (i.e., back tilting blocks) suggests a combination of rotational and translational failure along a deep weak layer. The right flank of the slide (southeast) appears to be retrogressing faster than the left flank (northwest).

The creek armouring completed in 2008 is in good condition. However, continued slope movement is displacing the armouring eastward across creek, straightening a former curved zone of creek bank. The riprap is exposed due to low water levels and needs maintenance to the vanes.

- Photo 2** View of Willow Creek and creek armoring from the head of the slide. Back tilting blocks are visible in the slide mass. Photo taken May 19, 2022 facing northeast.

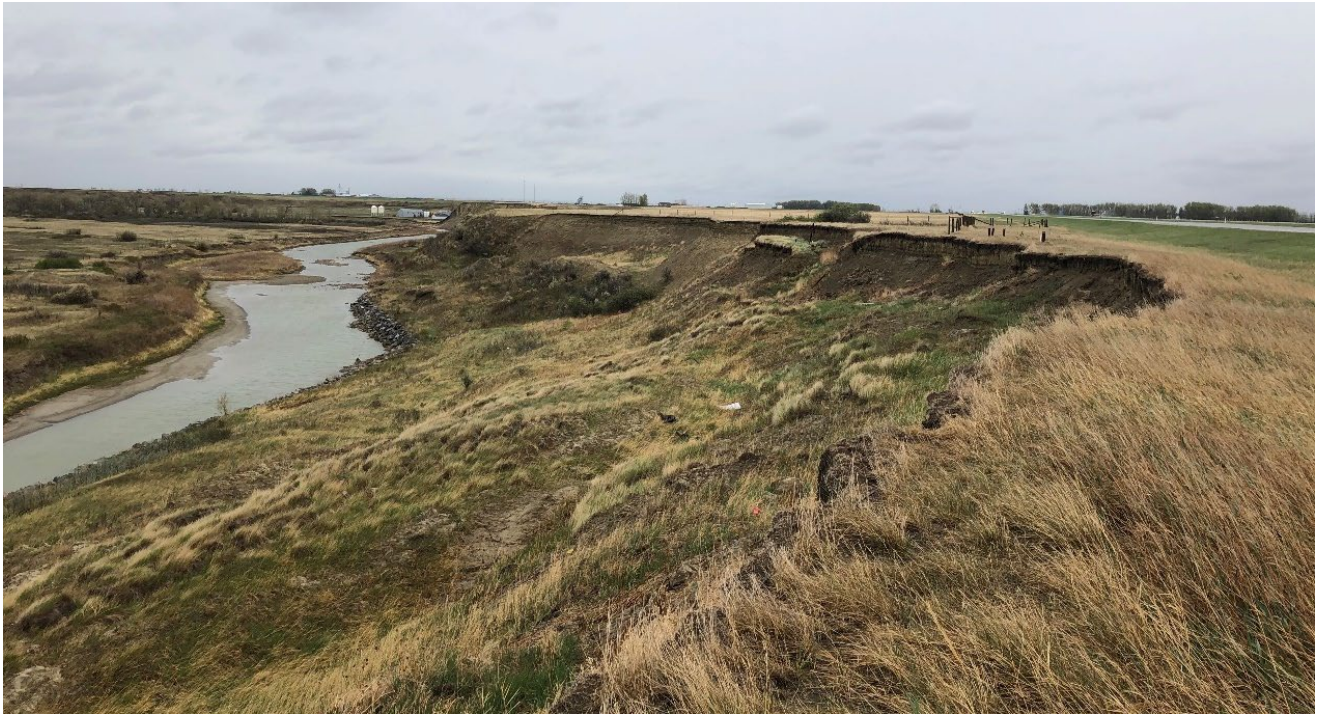
Photo 3 View of the slide from the left (north) flank of the slide. The head of the slide is retrogressing towards the highway. Photo taken May 19, 2022 facing southeast.

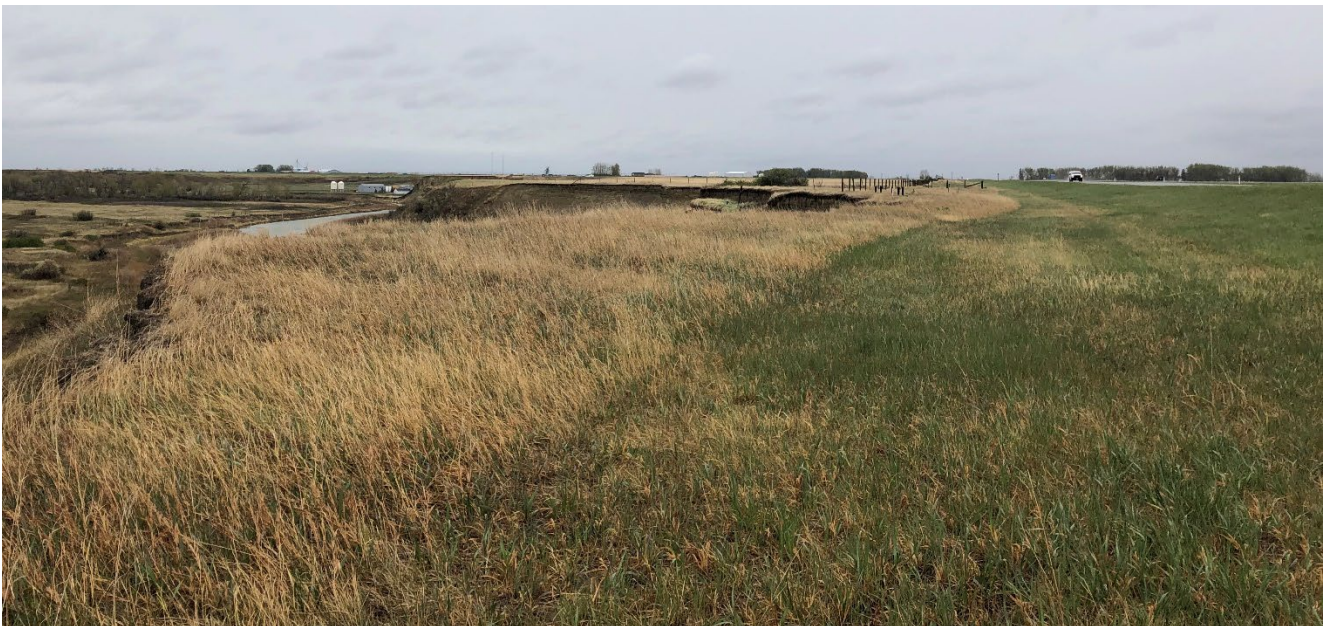
| There has been minimal change in slope retrogression observed between 2019 and 2022. The head scarp is approximately 11 m to 12 m from the guardrail at the closest point. South of the main slide, the right flank has retrogressed to approximately 16 m from the guardrail. There are four wooden stakes (3 re-installed, 1 existing) present at the head scarp that are used to estimate slide retrogression. It is estimated that there has been 2.3 m to 3.5 m of retrogression into the ditch since 2016. |

Photo 4 The head of the slide is retrogressing towards the highway. Photo taken May 19, 2022 facing south.
