December 1, 2023

CON0022161 Southern Region GRMP Instrumentation Monitoring
Site S004; H02:08, km 6.284 Willow Creek
Section C – 2023 Fall Readings

PROJECT SOUTHERN REGION GEOHAZARD RISK MANAGEMENT PROGRAM		
TITLE Site Plan S004 - Willow Creek (North of Ft. Macleod) Hwy 2:08, km 6.284		
SCALE 1:2,000	PROJECT No. A05116A03	FIG No. 1

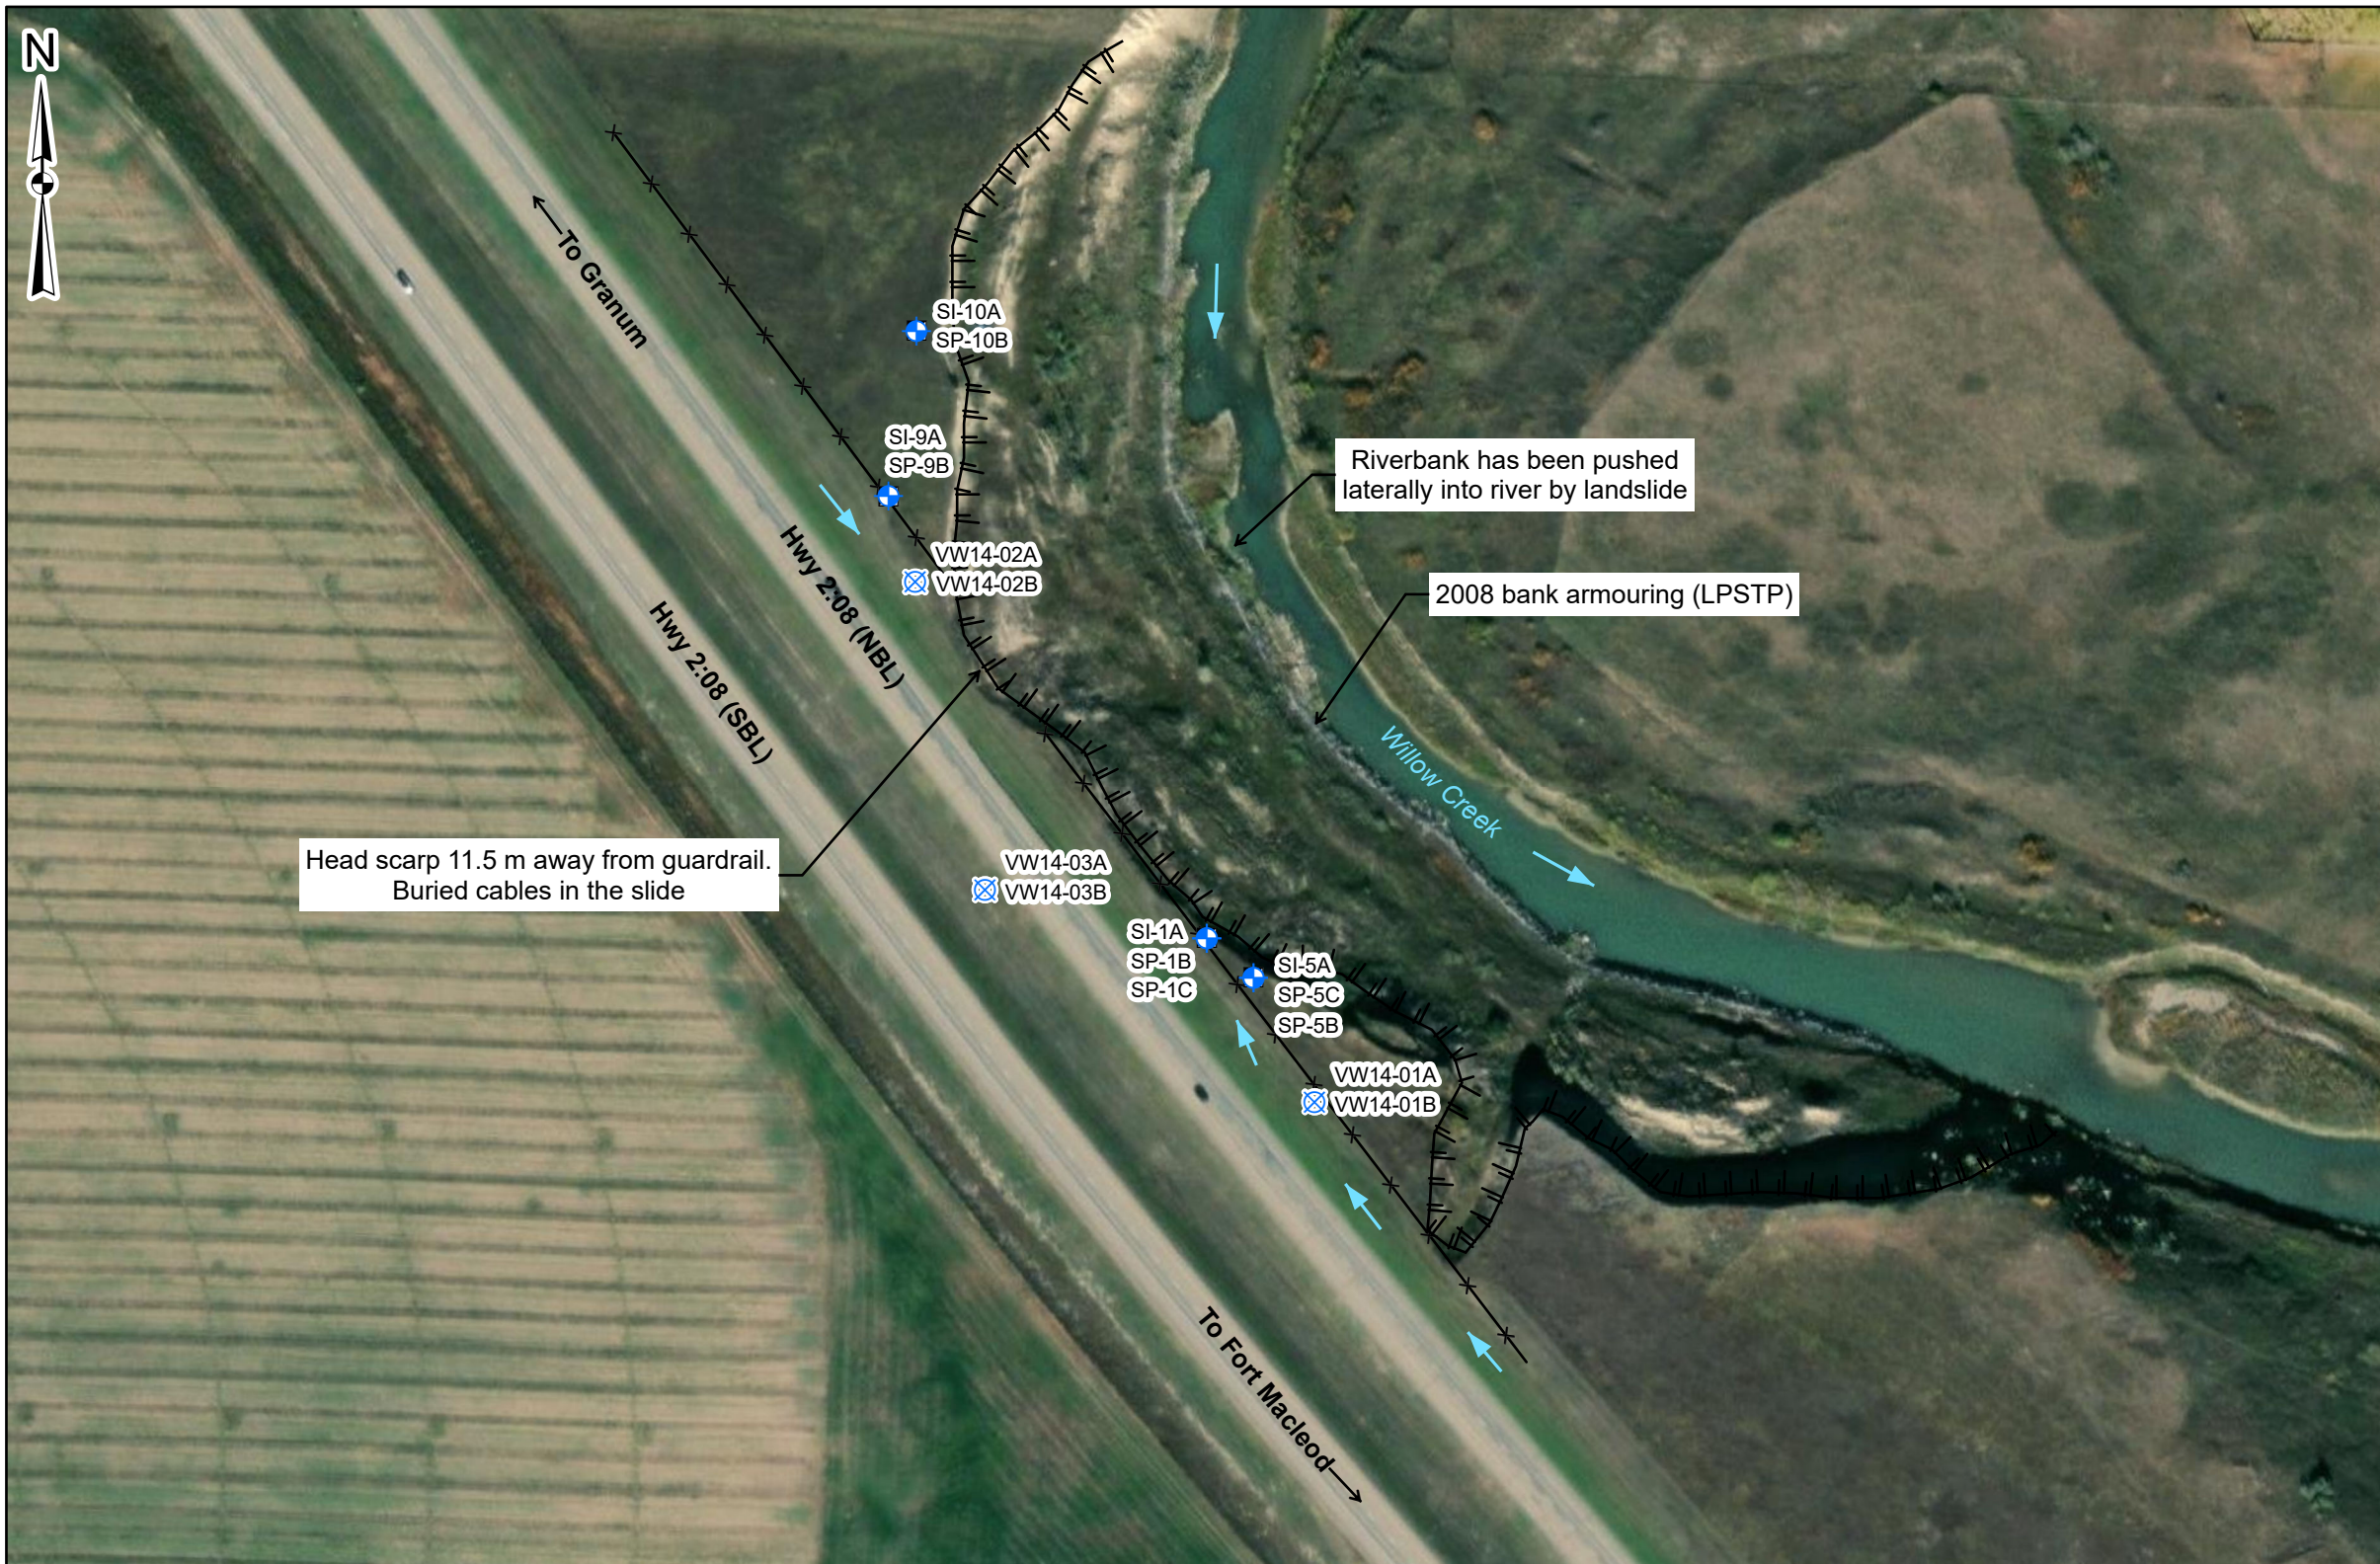
The geohazard at the S004 site consists of a landslide at the outside bend of Willow Creek with the slope crest retrogressing into the northbound lane ditch of Hwy 02:08. Previous remedial actions at the site include soil nailing, grading, bioengineering (live staking), and bank armoring in 2008. A guardrail was also installed in 2014.

The nature of sliding (back tilting blocks) observed on site suggests a combination of rotational failure and failure along a weak layer at depth. The right (south) flank of the slide appears to be retrogressing faster than other areas of the slide.
