SITE NUMBER AND NAME: S004 Willow Creek (North of Fort Macleod)		HIGHWAY & KM: 2:08, 6.284	PREVIOUS INSPECTION DATE: May 19, 2022	INSPECTION DATE: May 10, 2023
LEGAL DESCRIPTION: 13/14-20-09-26-W4M	NAD 83 COORDINATES: UTM Northing Easting 12 5514351 320169		RISK ASSESMENT: PF: 9 CF: 4 TOTAL: 36	
Average Annual Daily Traffic (AADT): 4600 (north) & 5440 (south) (Reference No. 92080)			CONTRACTOR MAINTENANCE AREA (CMA): 26

PROJECT
SOUTHERN REGION GEOHAZARD RISK MANAGEMENT PROGRAM

TITLE
Site Plan
S004 - Willow Creek (North of Fort Macleod)
Hwy 2.08, km 6.284

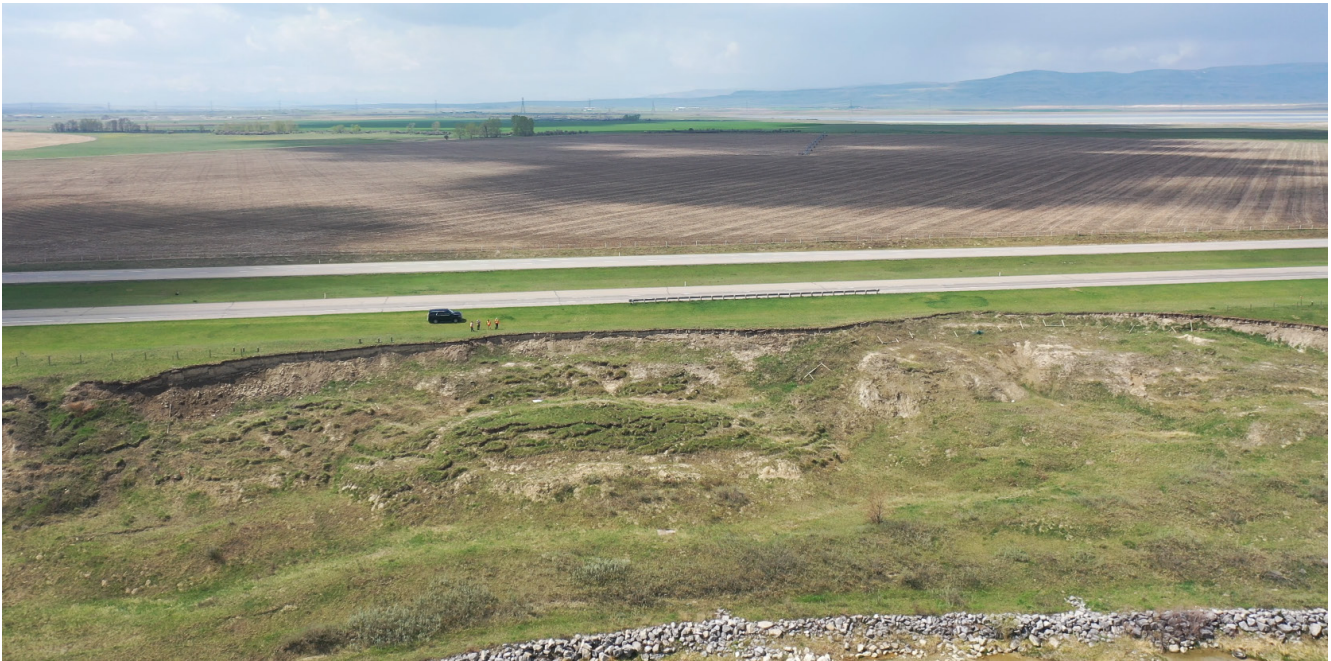
Photo 1 Slide area. Photo taken facing west on May 10, 2023.

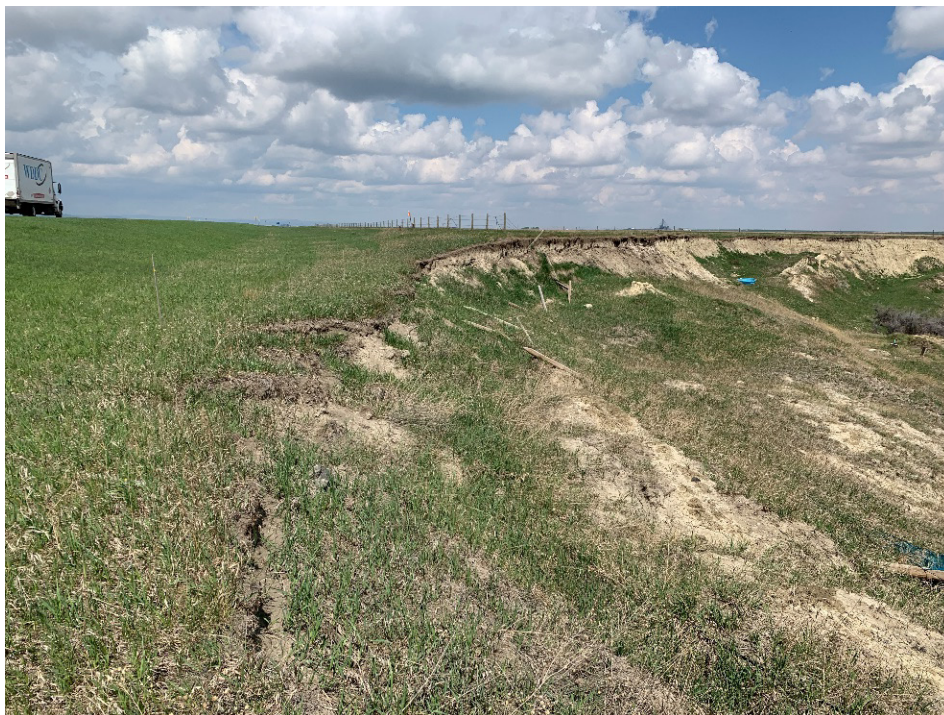
The head scarp has retrogressed 3 m to 5 m past the fence line. The slide zone is actively being undermined and material from the topsoil mat is sloughing into the slide zone over time. No significant changes were noted in the slide mass during the 2023 inspection.

Photo 2 Head scarp located up to 5 m past the fence line. Photo taken facing north on May 10, 2023.

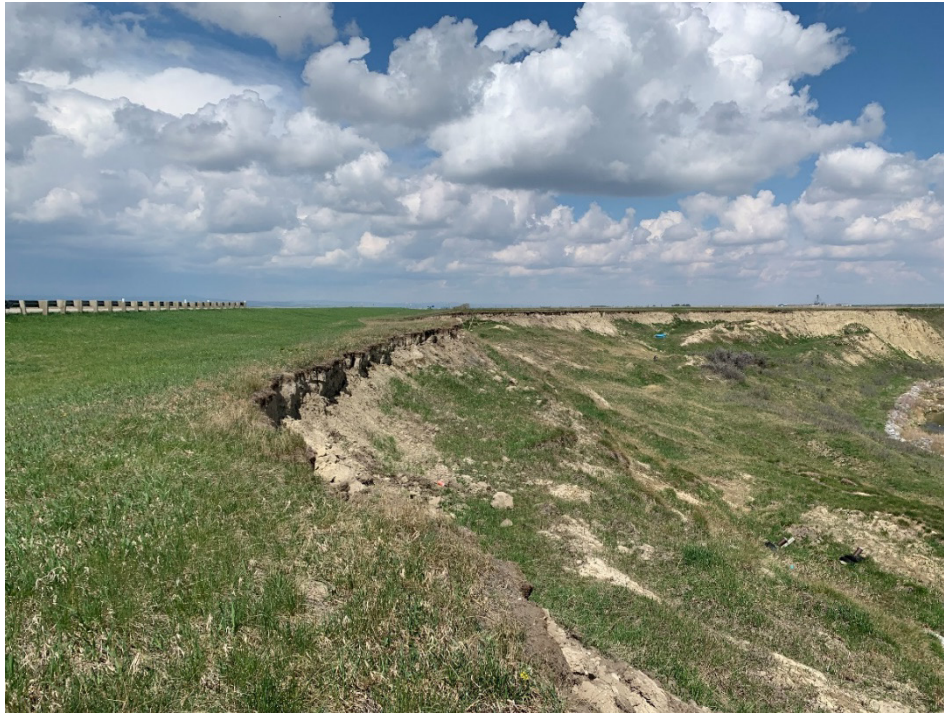
The nature of the slide (i.e., back tilting blocks) suggests a combination of rotational and translational failure along a deep weak layer. The right flank of the slide (southeast) appears to be retrogressing faster than the left flank (northwest).

Photo 3 Back tilting blocks are visible in the slide mass. Photo taken facing north on May 10, 2023.

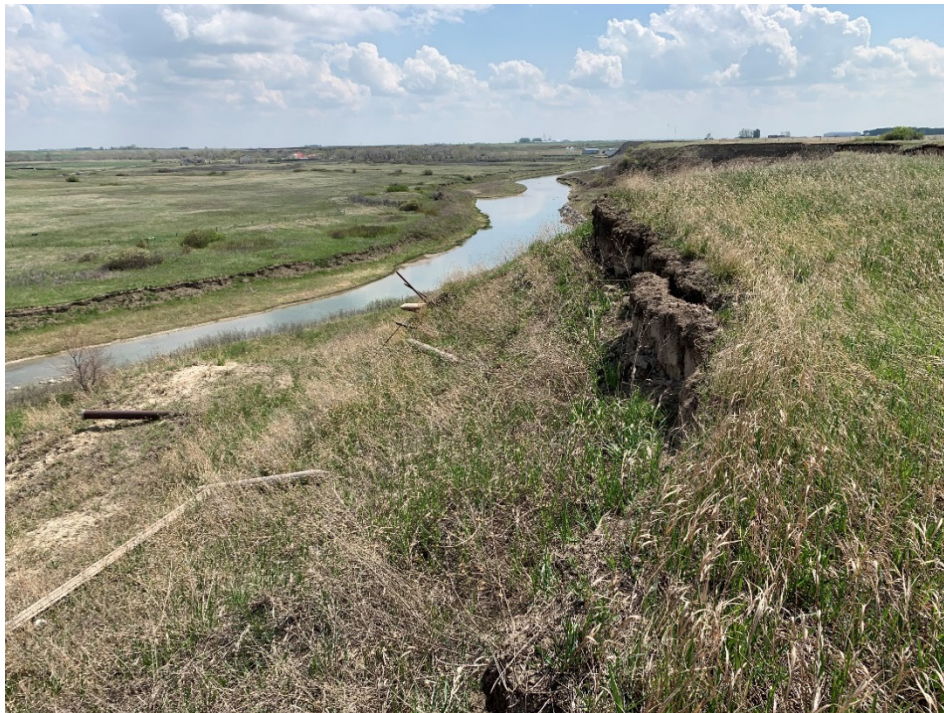
There has been minimal change in slope retrogression observed between 2019 and 2023. The head scarp is approximately 11 m to 12 m from the guardrail at the closest point. South of the main slide, the right flank has retrogressed to approximately 16 m from the guardrail. There are four wooden stakes present at the head scarp that are used to estimate slide retrogression. It is estimated that there has been 2.5 m to 3.5 m of retrogression into the ditch since 2016.

Photo 4 Ongoing slide movement retrogressing towards the highway. Photo taken facing southeast on May 10, 2023.

- A geotechnical site investigation should be completed to assess the subsurface conditions (i.e., stratigraphy and groundwater conditions).
- Preliminary engineering should be completed to assess repair options for the site. Potential repair options for this site include: diverting surface water away from the slide zone; or installing horizontal drains connected to a seepage collection curtain. The seepage collection curtain would need to be assessed for potential impact to the farmland and reservoir on the west side of the highway. A proposal for this work was issued in March 2023.
