July 14, 2023

CON0022161 Southern Region GRMP Instrumentation Monitoring
Site S004; H02:08, km 6.284 Willow Creek
Section C – 2023 Spring Readings

PROJECT SOUTHERN REGION GEOHAZARD RISK MANAGEMENT PROGRAM		
TITLE Site Plan S004 - Willow Creek (North of Ft. Macleod) Hwy 2:08, km 6.284		
SCALE 1:2,000	PROJECT No. A05116A03	FIG No. 1

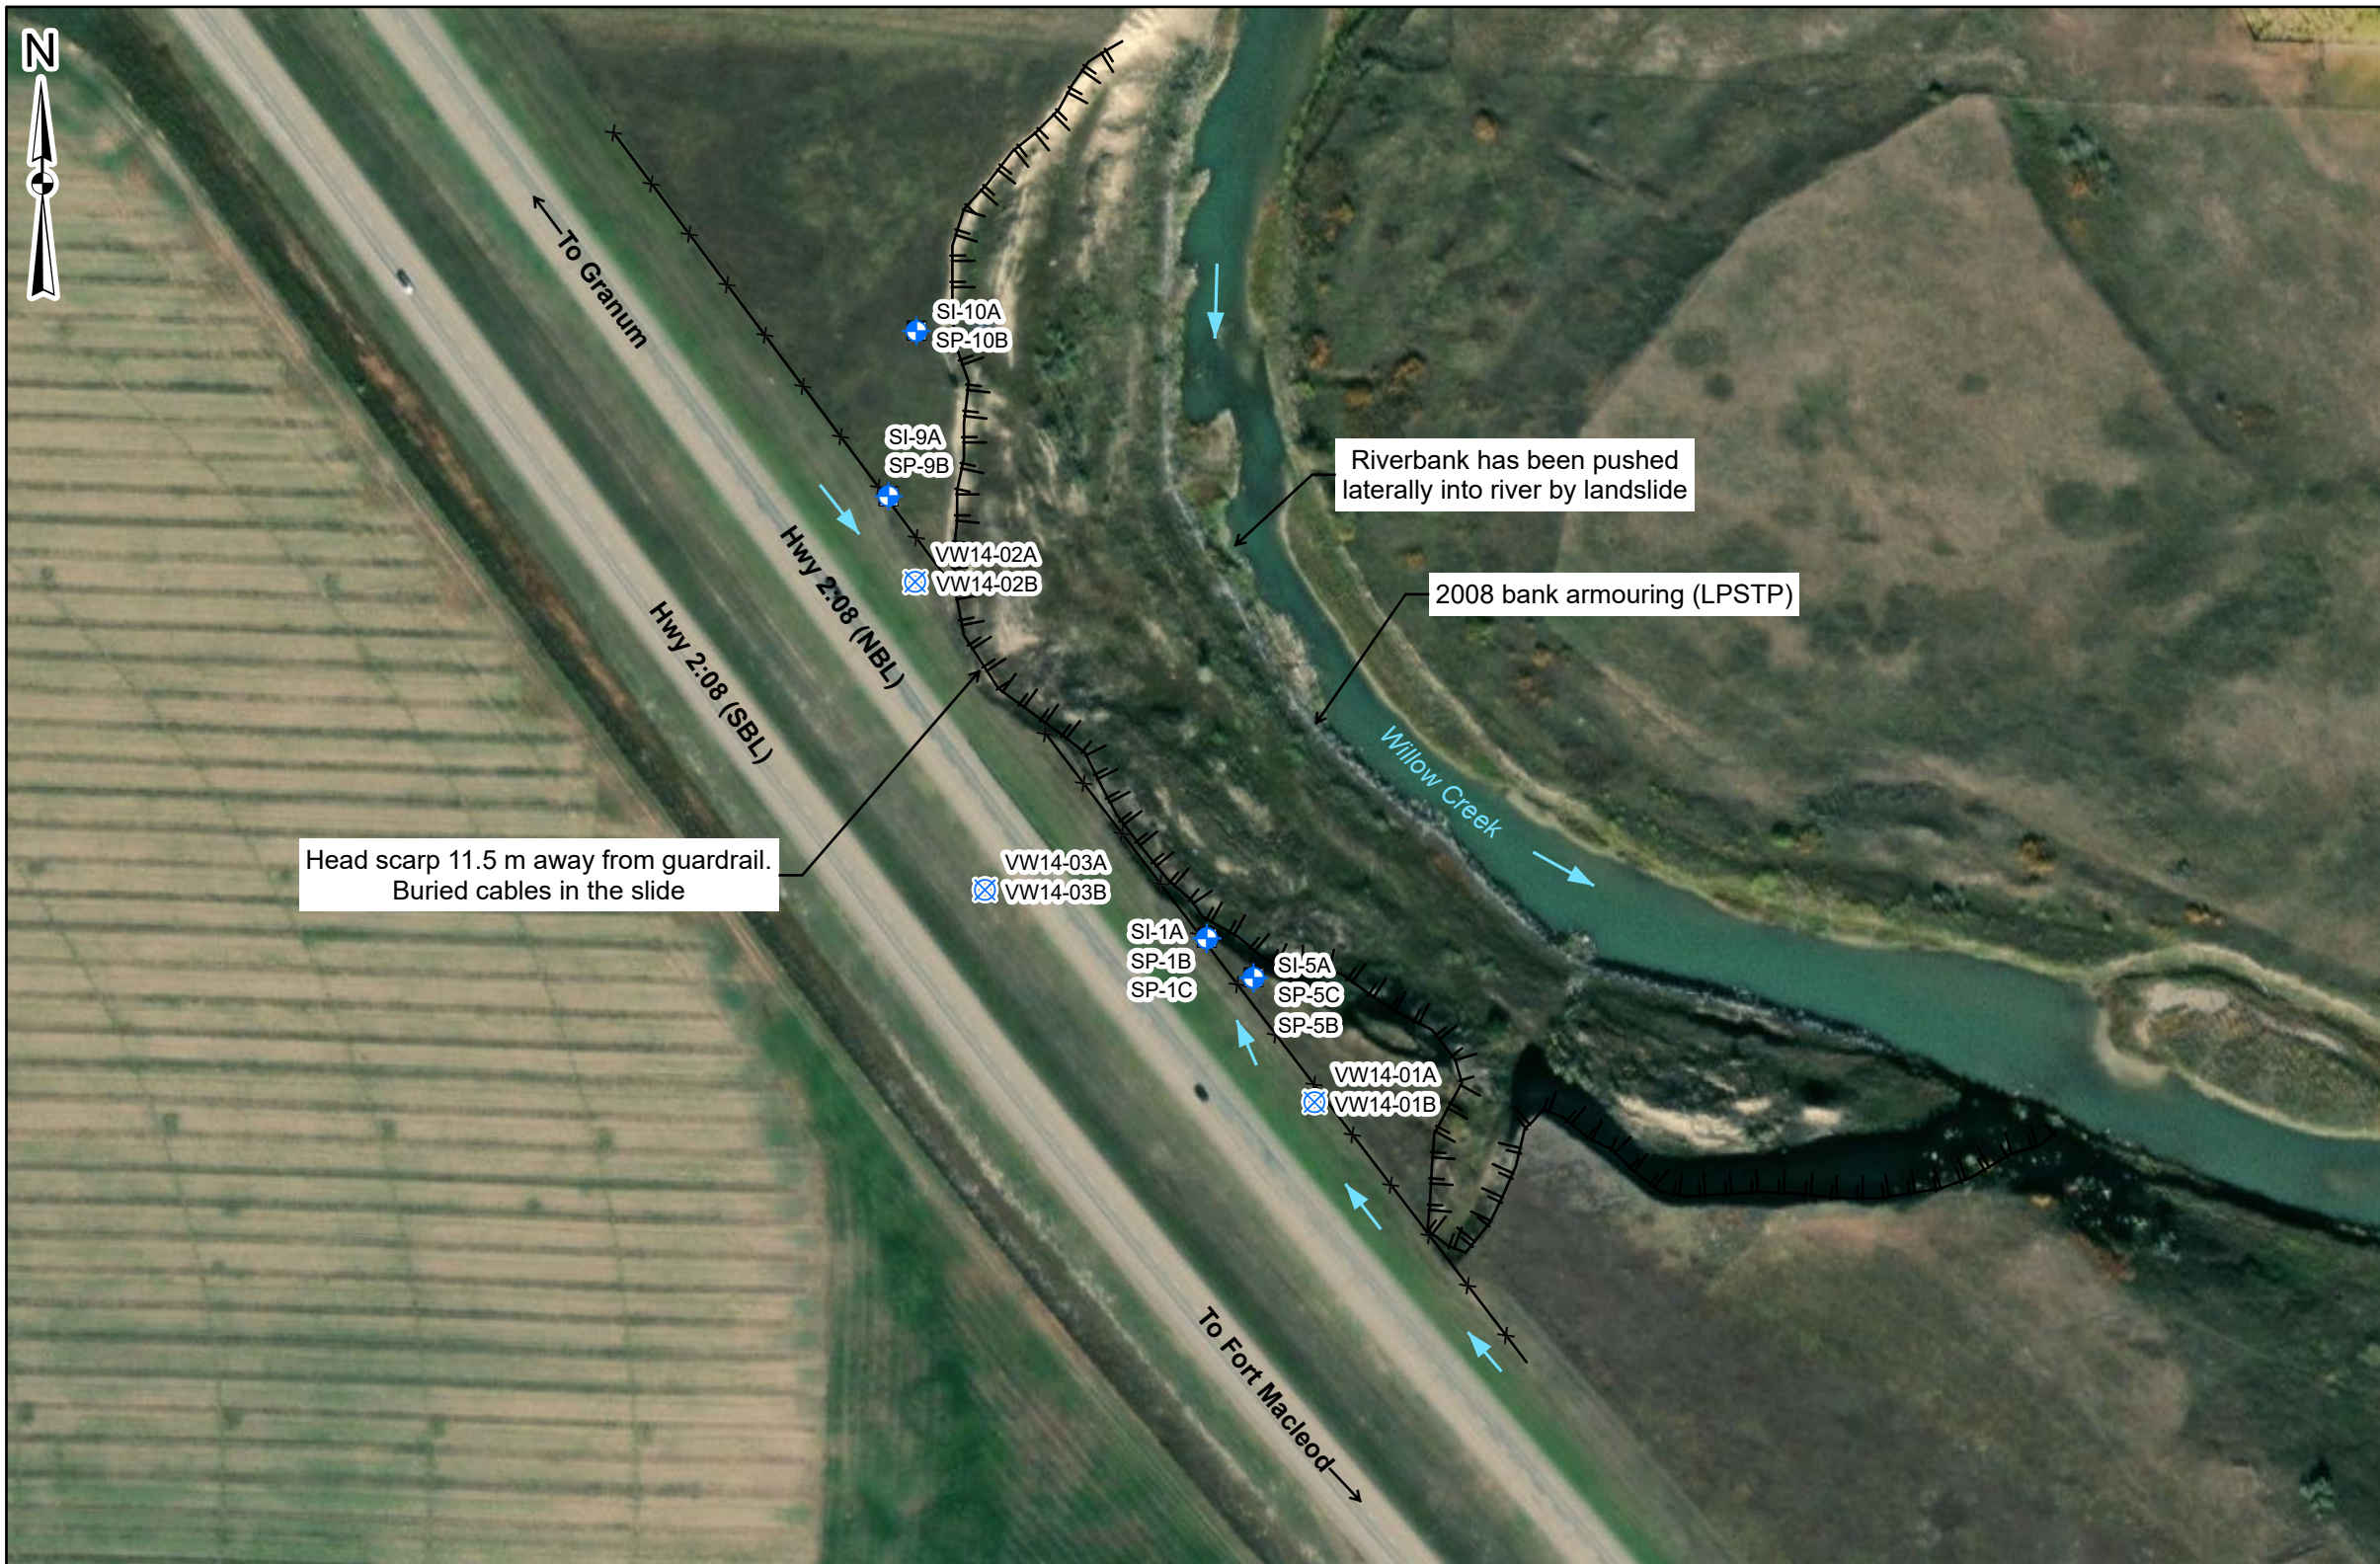
The geohazard at the S004 site consists of a landslide at the outside bend of Willow Creek with the slope crest retrogressing into the northbound lane ditch of Hwy 02:08. Previous remedial actions at the site include soil nailing, grading, bioengineering (live staking), and bank armouring in 2008. A guardrail was also installed in 2014.

Four wooden stakes located at the crest of the slide are used to estimate slide retrogression. These stakes are susceptible to being knocked over or disturbed. During the July 8, 2021, Section B inspection, it was estimated that the slide has retrogressed between 2.3 m and 3.5 m into the east (northbound lane) ditch since 2016. No additional retrogression was observed during the June 14, 2023, Section B inspection.

The nature of sliding (back tilting blocks) observed on site suggests a combination of rotational failure and failure along a weak layer at depth. The right (south) flank of the slide appears to be retrogressing faster than other areas of the slide.
