November 29, 2024

**Alex Frotten, P.Eng.**  
**Construction Engineer – Delivery Services Division (Southern Region)**

**CON0022161 Southern Region GRMP Instrumentation Monitoring**  
**Site S004; H02:08, km 6.284 Willow Creek**  
**Section C – 2024 Fall Readings**

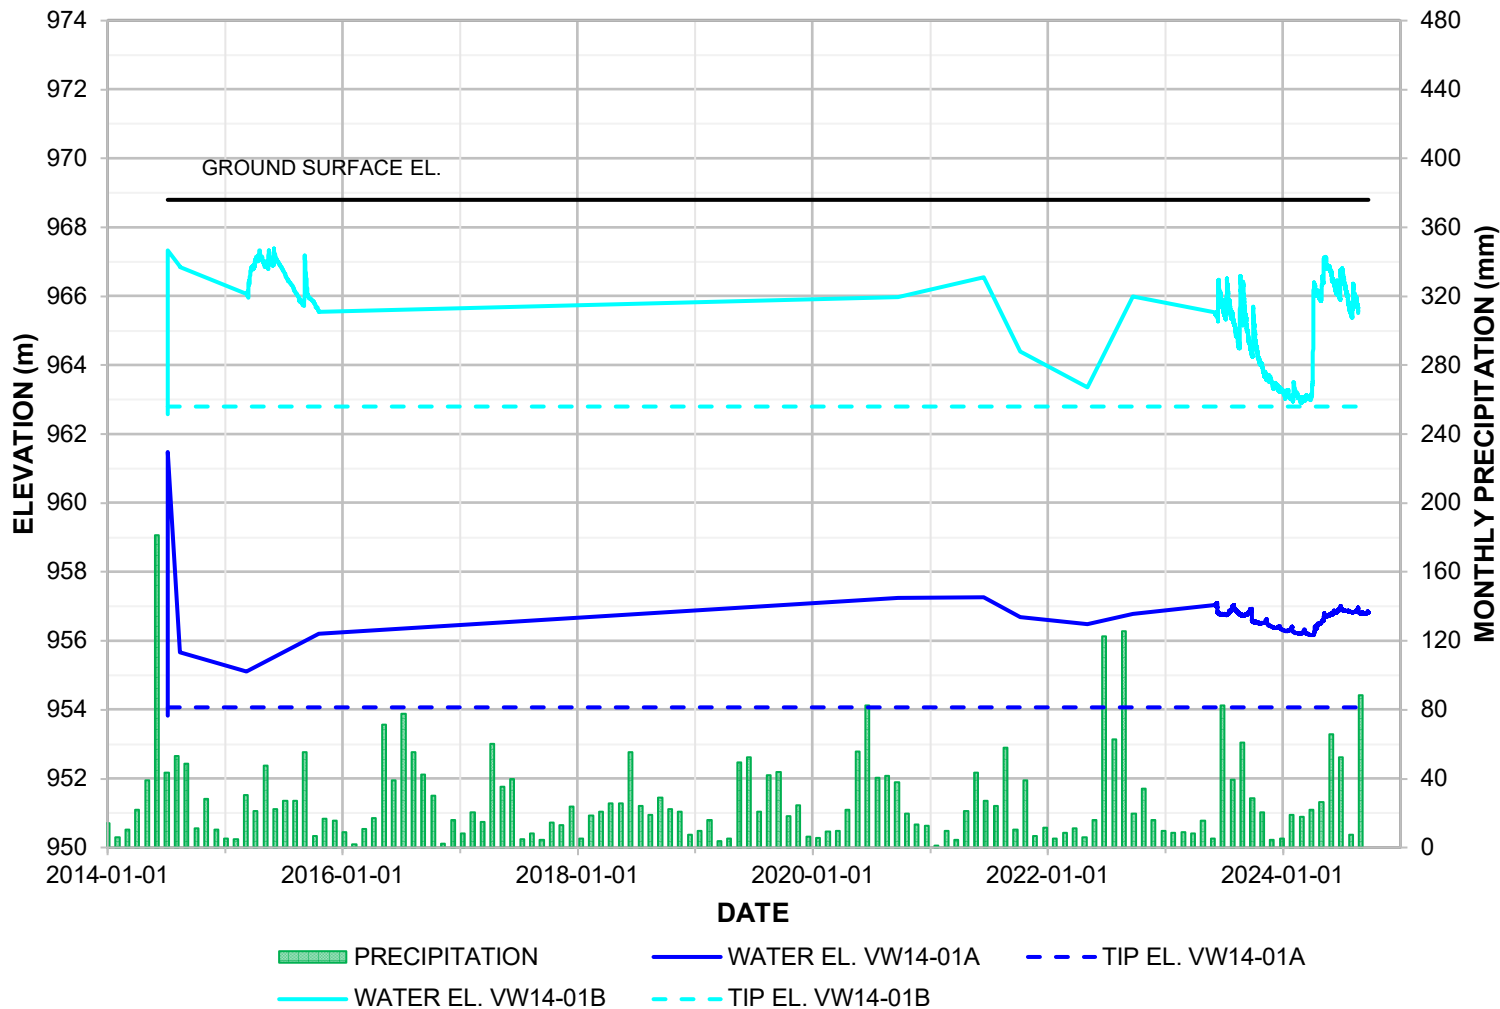
### VW14-01A AND VW14-01B

Generally, all six VWPs measured groundwater decreased between spring and fall 2024 with the largest decrease in water level measured to be 1.1 m measured in VWP14-03B. Rainfall data from station T009R26W4 only included data up to August 31, 2024, at the time of writing this report. Based on the data available, rainfall and snow melt seem to contribute to the rise in water levels in the VWPs, with a decrease in water level observed over the summer season. VWP14-01B responds the most to precipitation, with sharp water level increases after precipitation events.

Water levels recorded in the nested VWP's installed between the highway and crest of the slide (VW14-01A/B and VW14-02A/B) varied from an approximate depth of 1.3 m to 1.7 m below ground surface in the upper "B" tips and 7.0 m to 12.1 m below ground surface in the lower "A" tips. Both the upper "A" tips have a similar elevation (El. 962.8 m and El. 963.1 m, respectively), and both the lower "B" tips have a similar tip elevation (El. 954.1 m and El. 954.4 m, respectively).

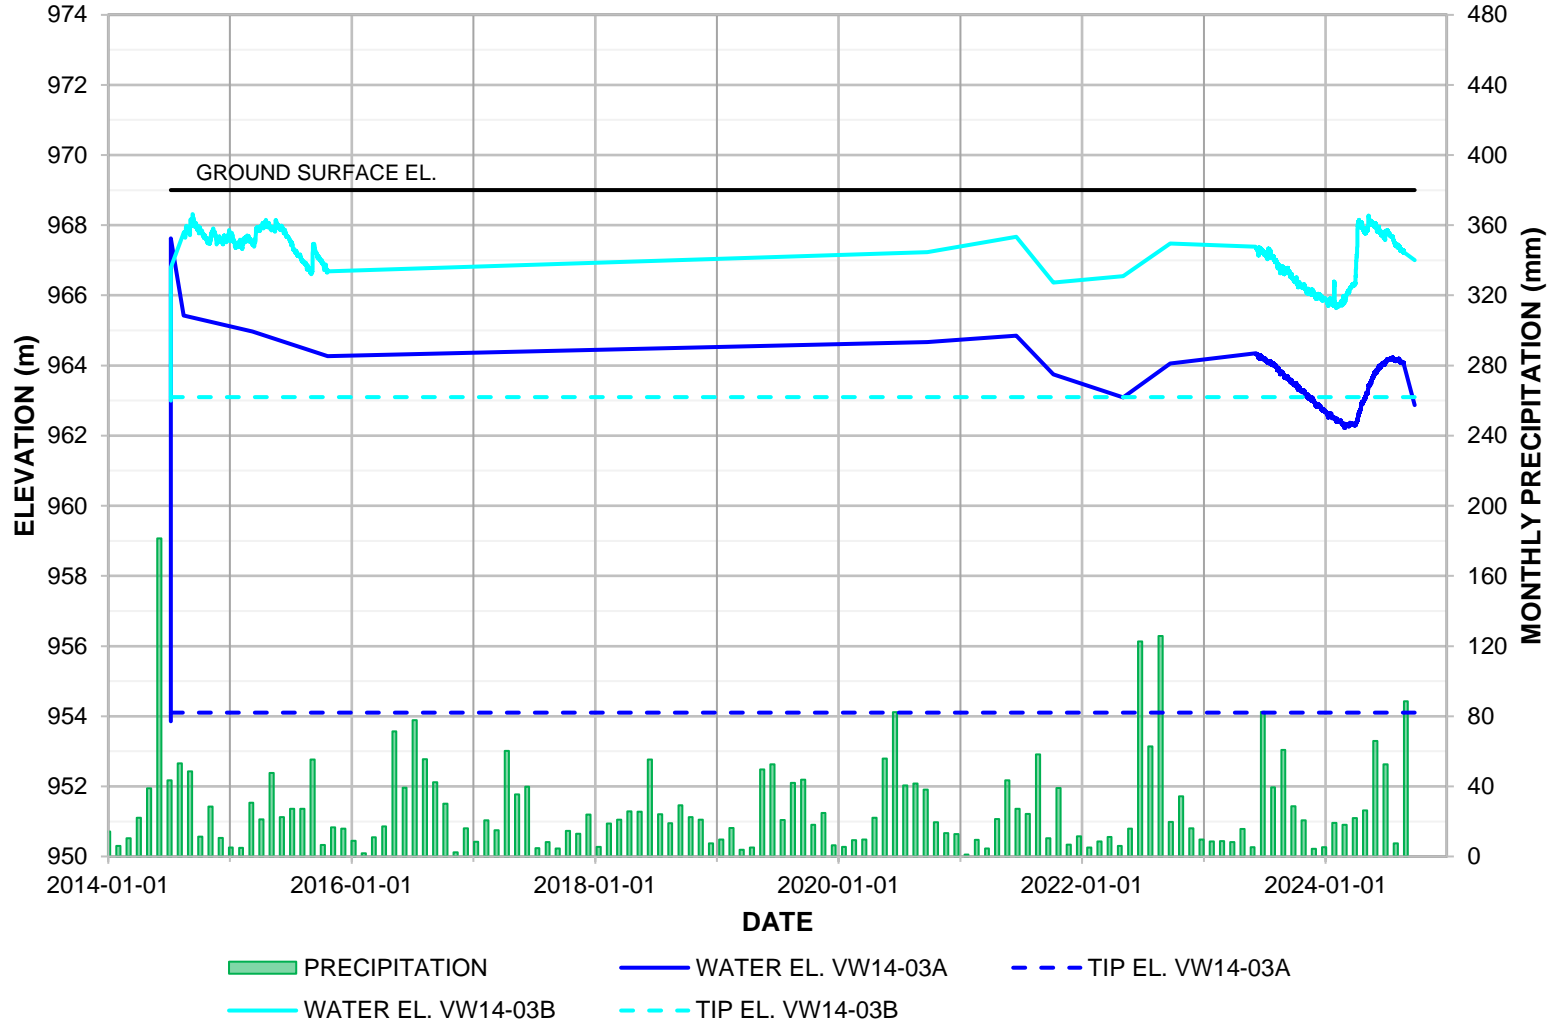
### VW14-03A AND VW-03B

Water levels recorded in the nested VWP's installed in the median ditch of Hwy 02:08 (VW14-03A/B) were at approximate depths of 0.9 m and 5.5 m below ground surface in the upper "B" tip and the lower "A" tip, respectively.

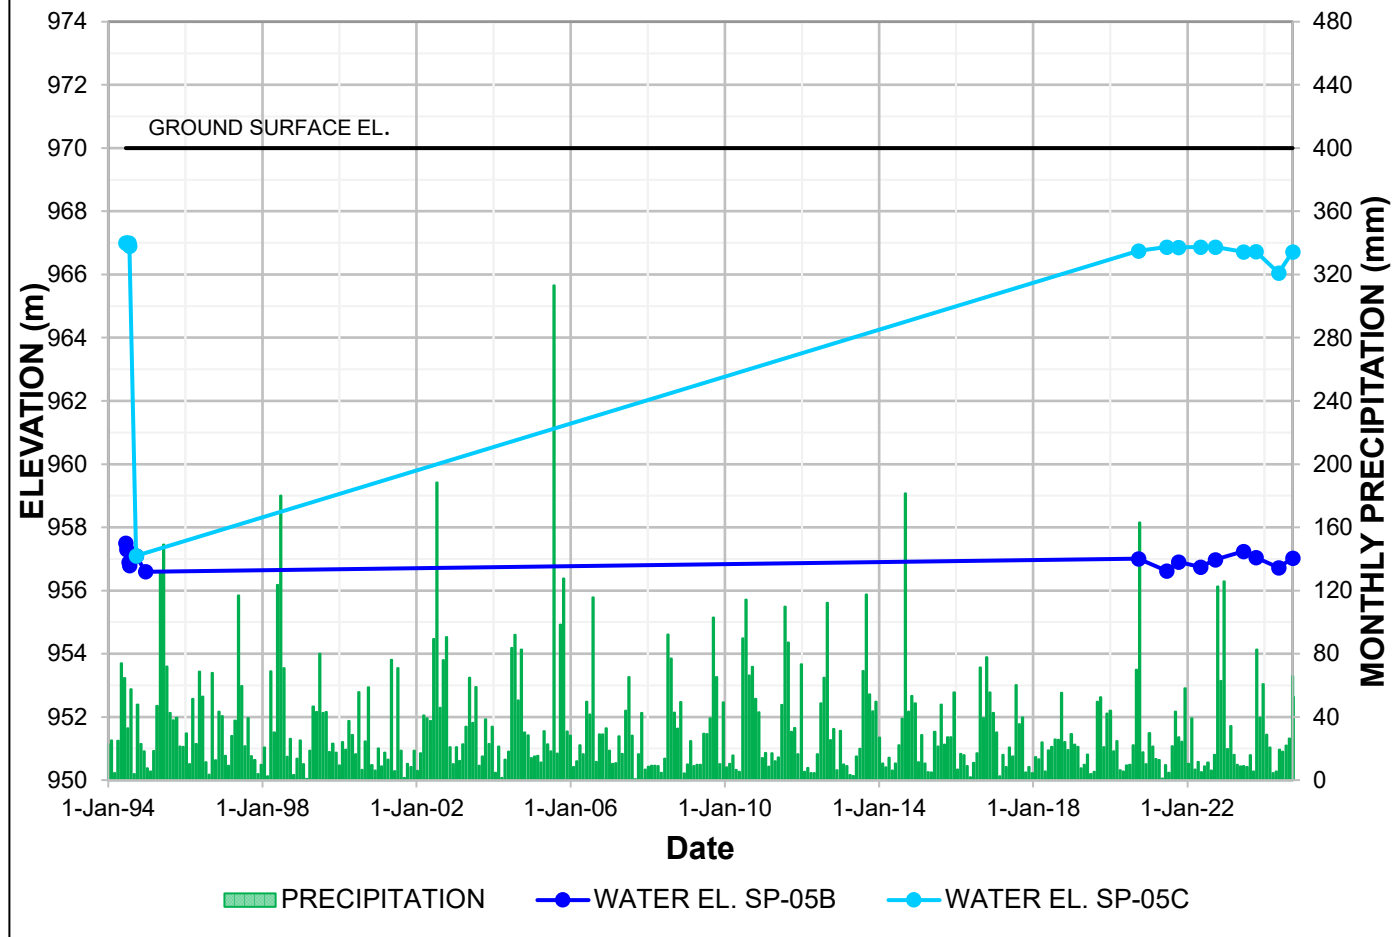
## SP-05B AND SP-05C

The 1994 reading for SP-05C was most likely inaccurate as it is approximately 10 m lower than the previous and current readings.

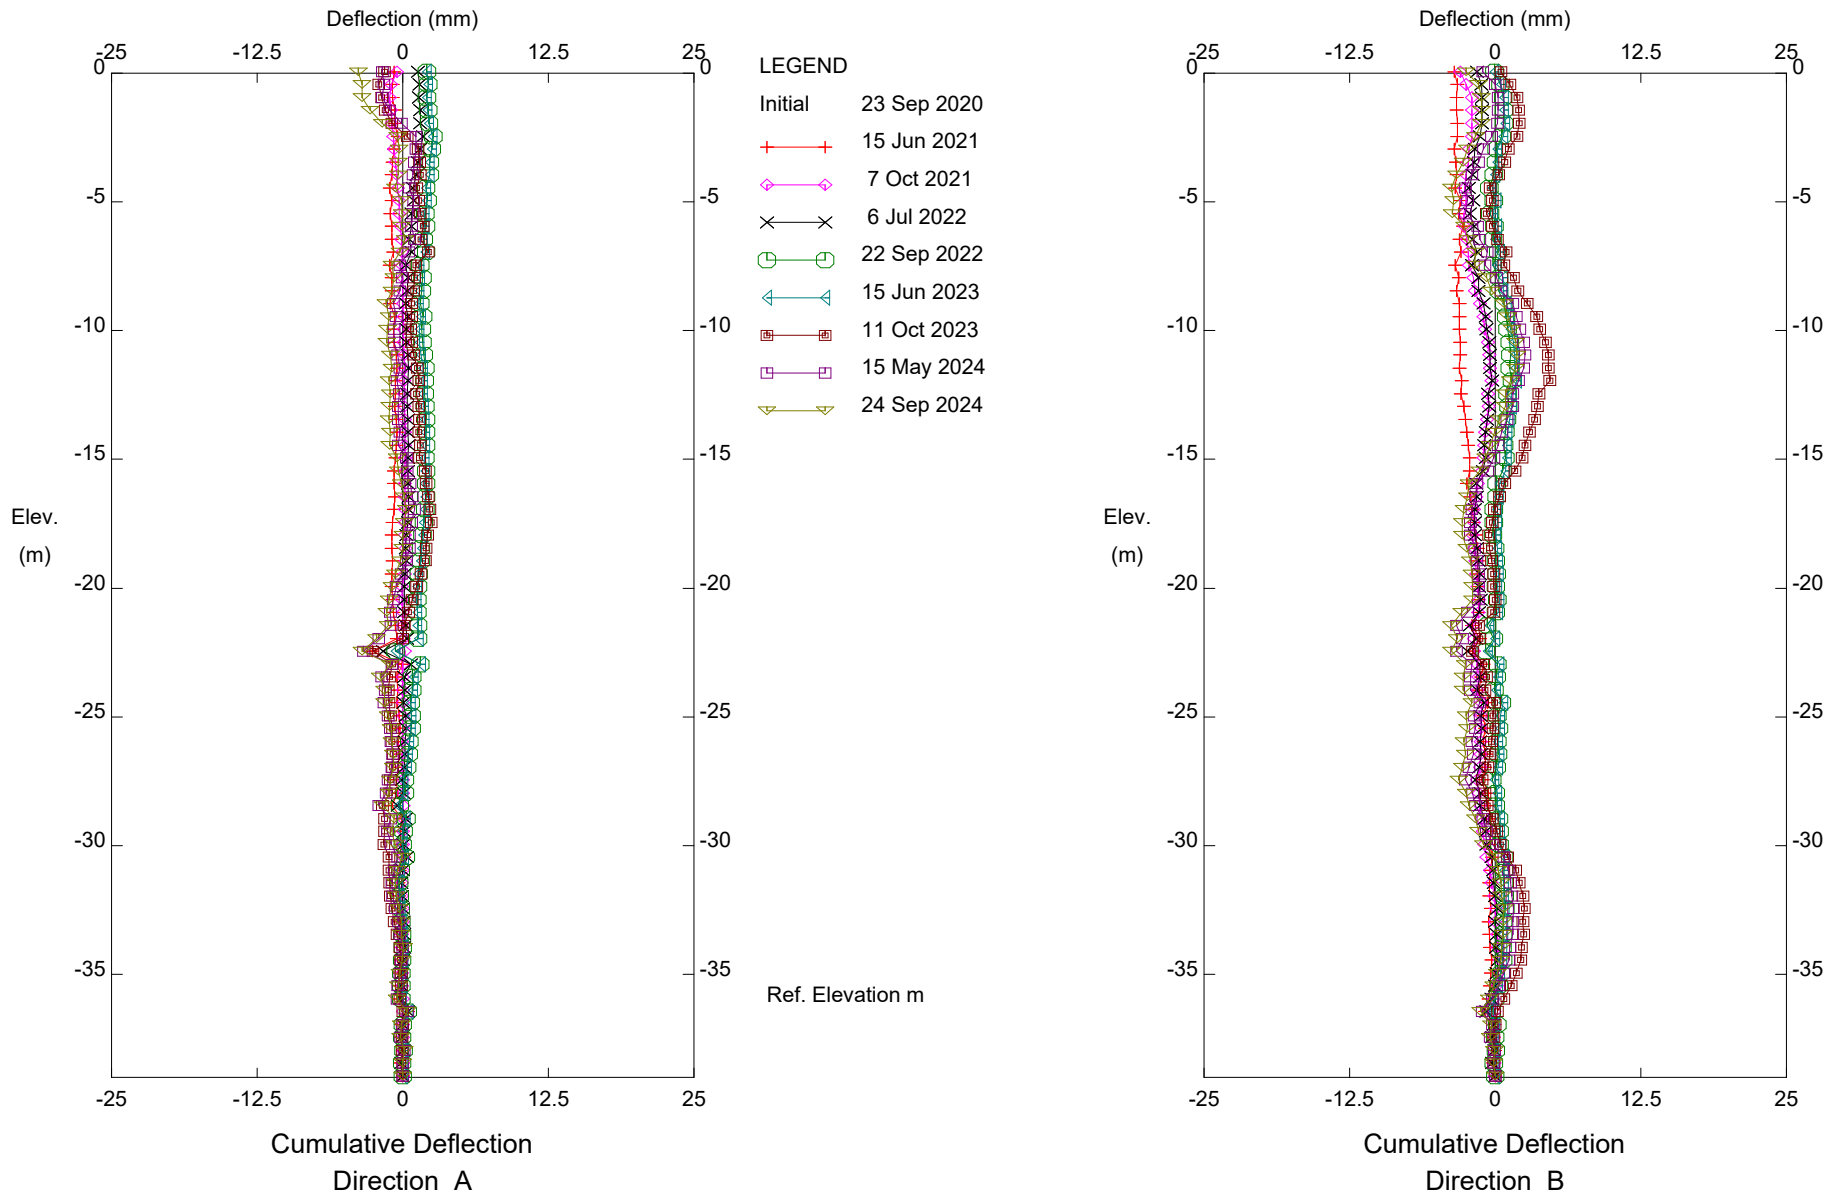
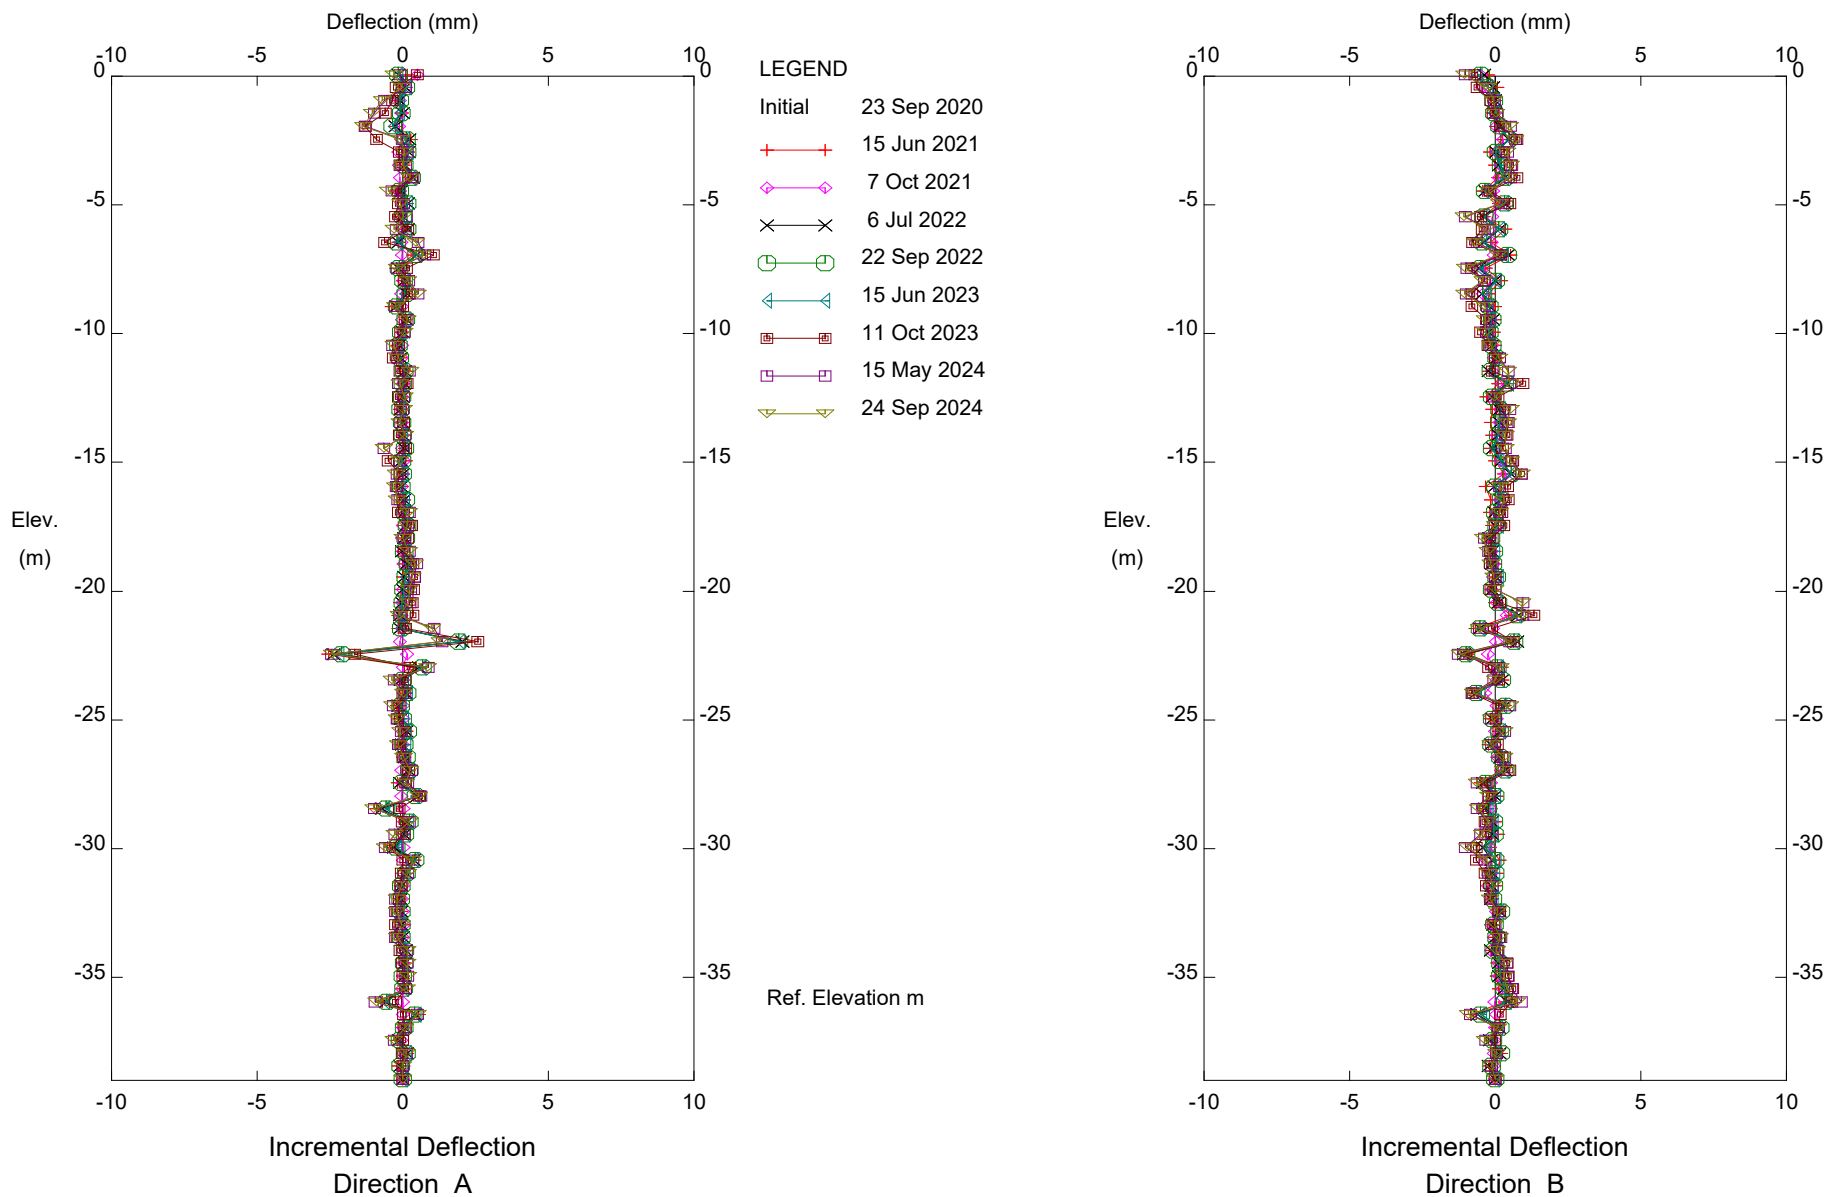
S004; H02:08, Willow Creek, Inclinometer SI-1A  
 Alberta Transportation

- SI-1A is “wavy” with kinks at approximately 22 m, 28 m, and 36 m below ground surface;
- SI-5A is tilted approximately 1.0 m in the A-direction and 1.7 m in the B-direction, and there is also a kink in the casing at approximately 22 m below ground surface; and
- SI-9A is “wavy” with kinks at approximately 5 m, 11 m, and 25 m below ground surface.
- SI-10A is “wavy” with kinks at approximately 5 m and 25 m below ground surface.

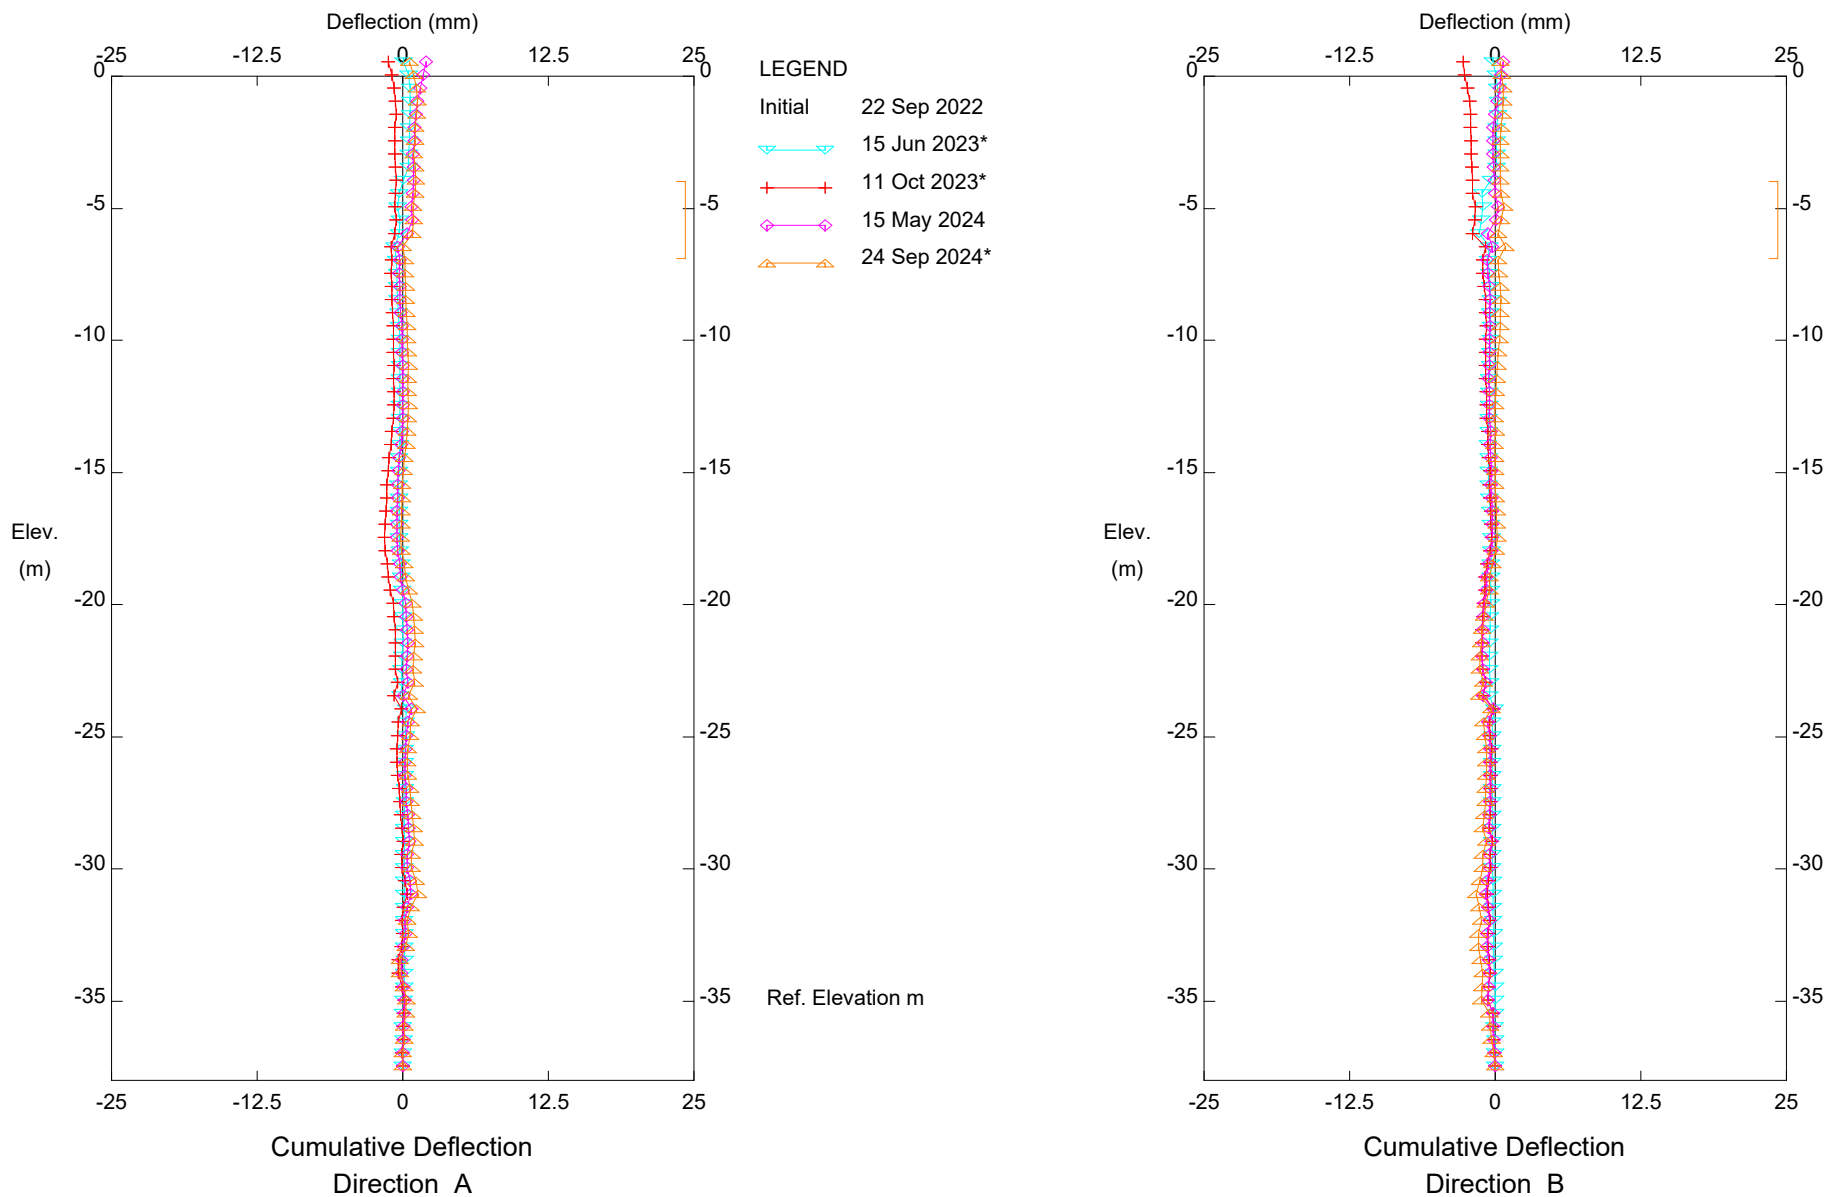
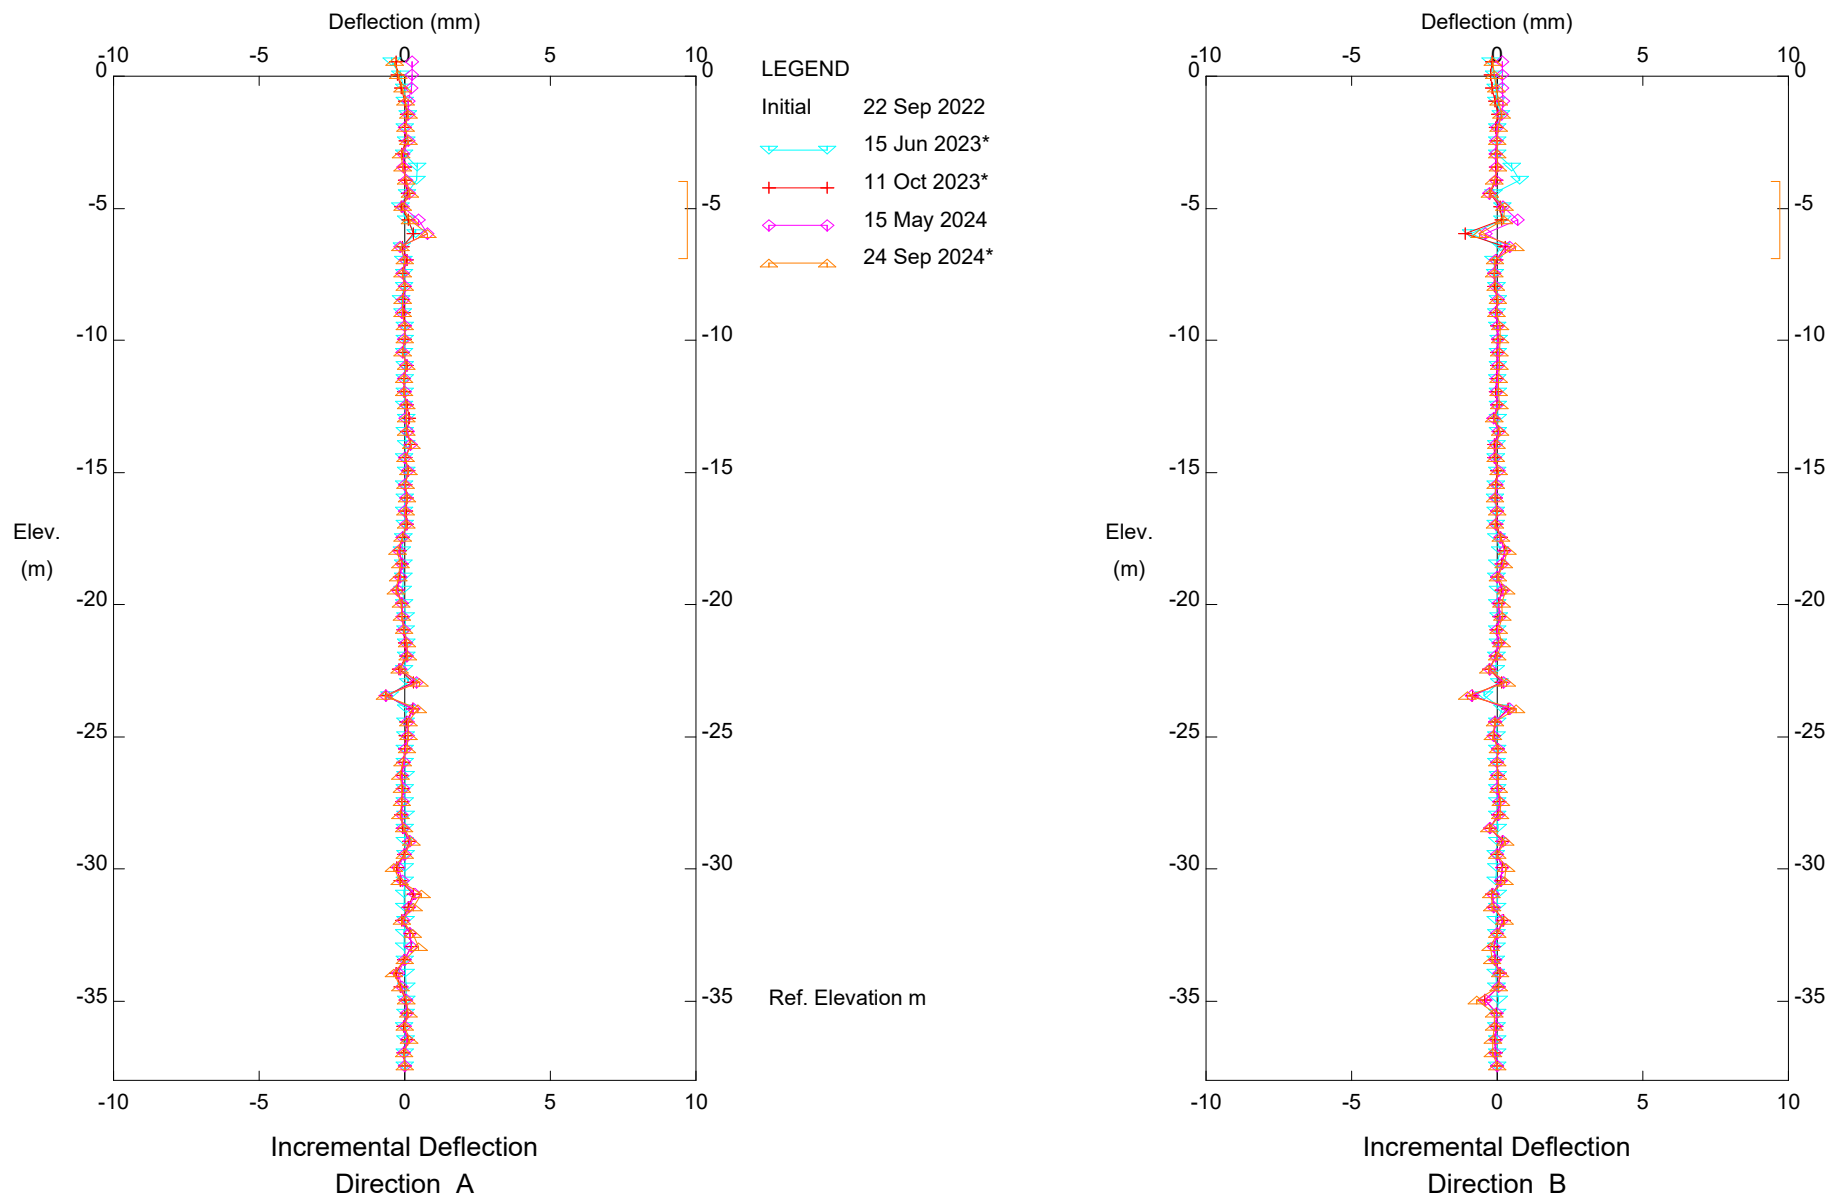
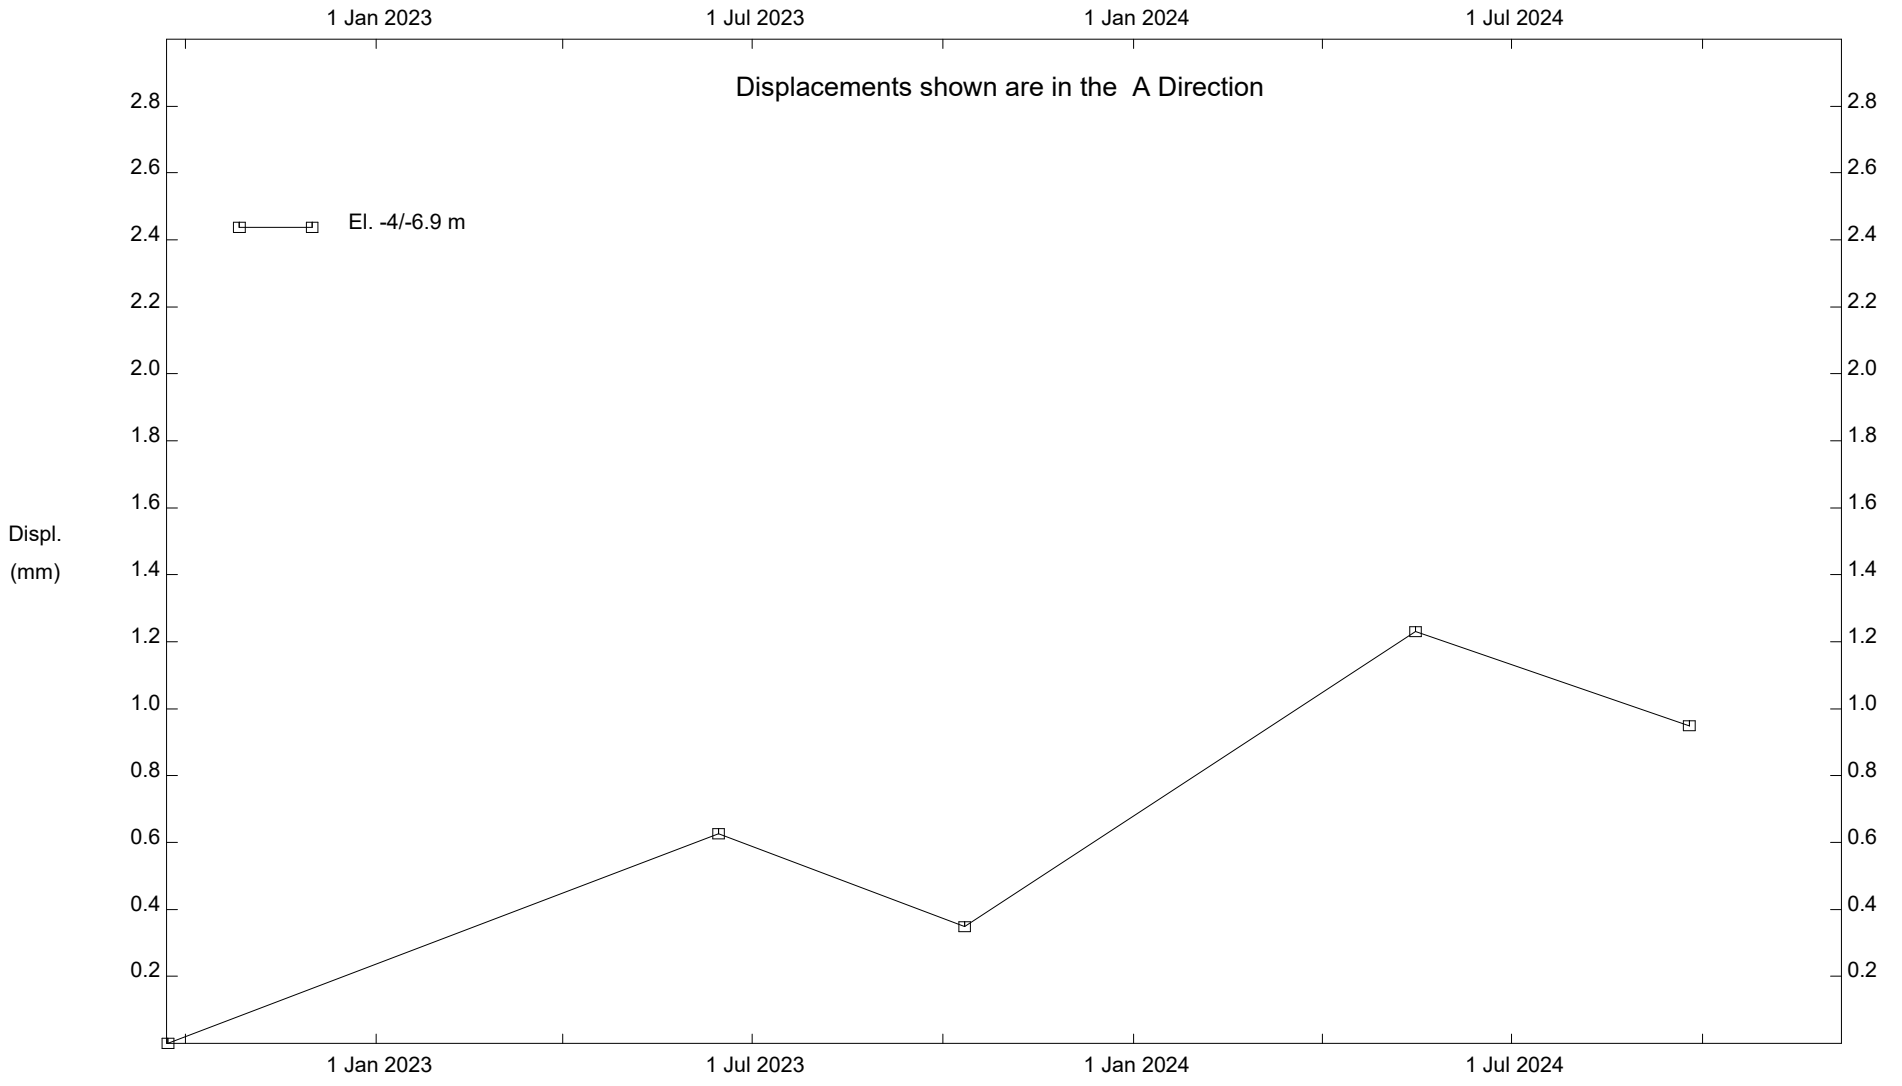
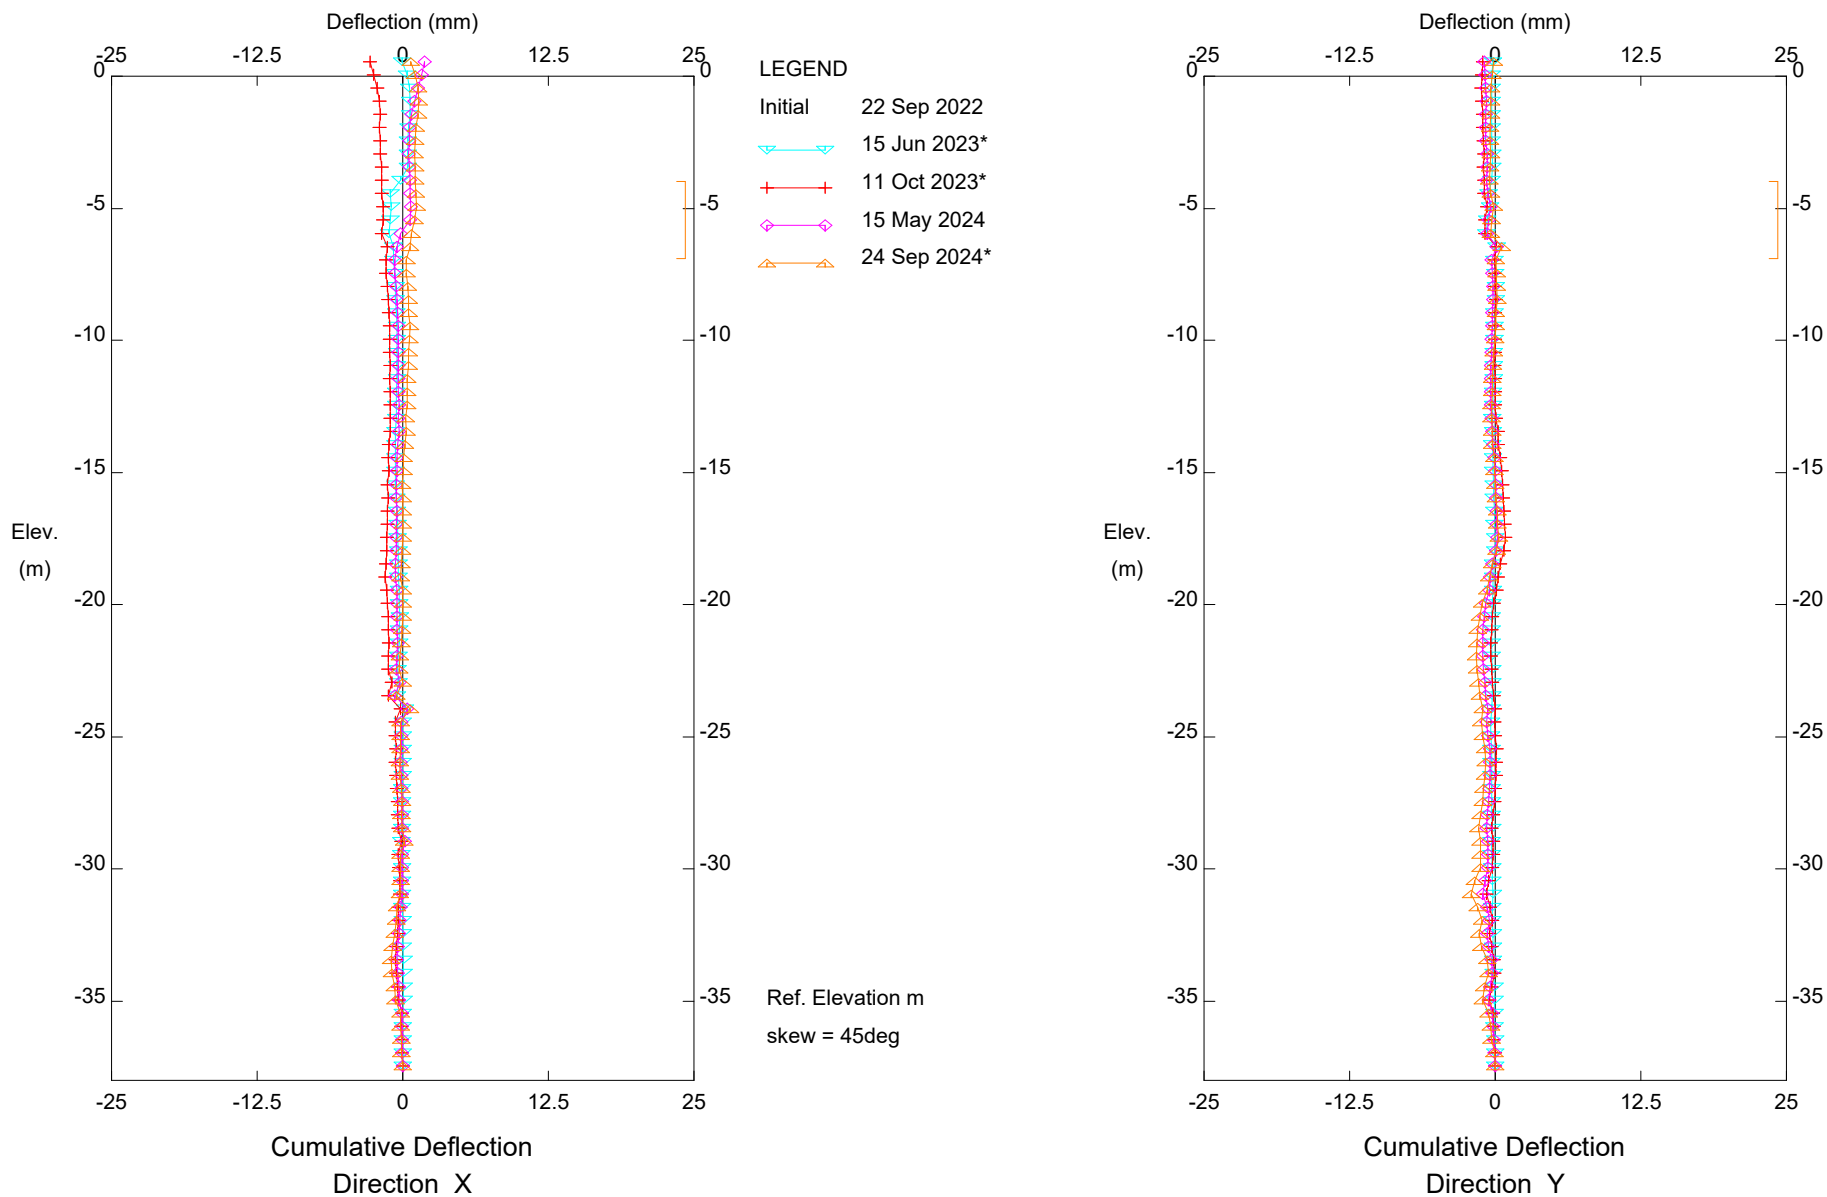
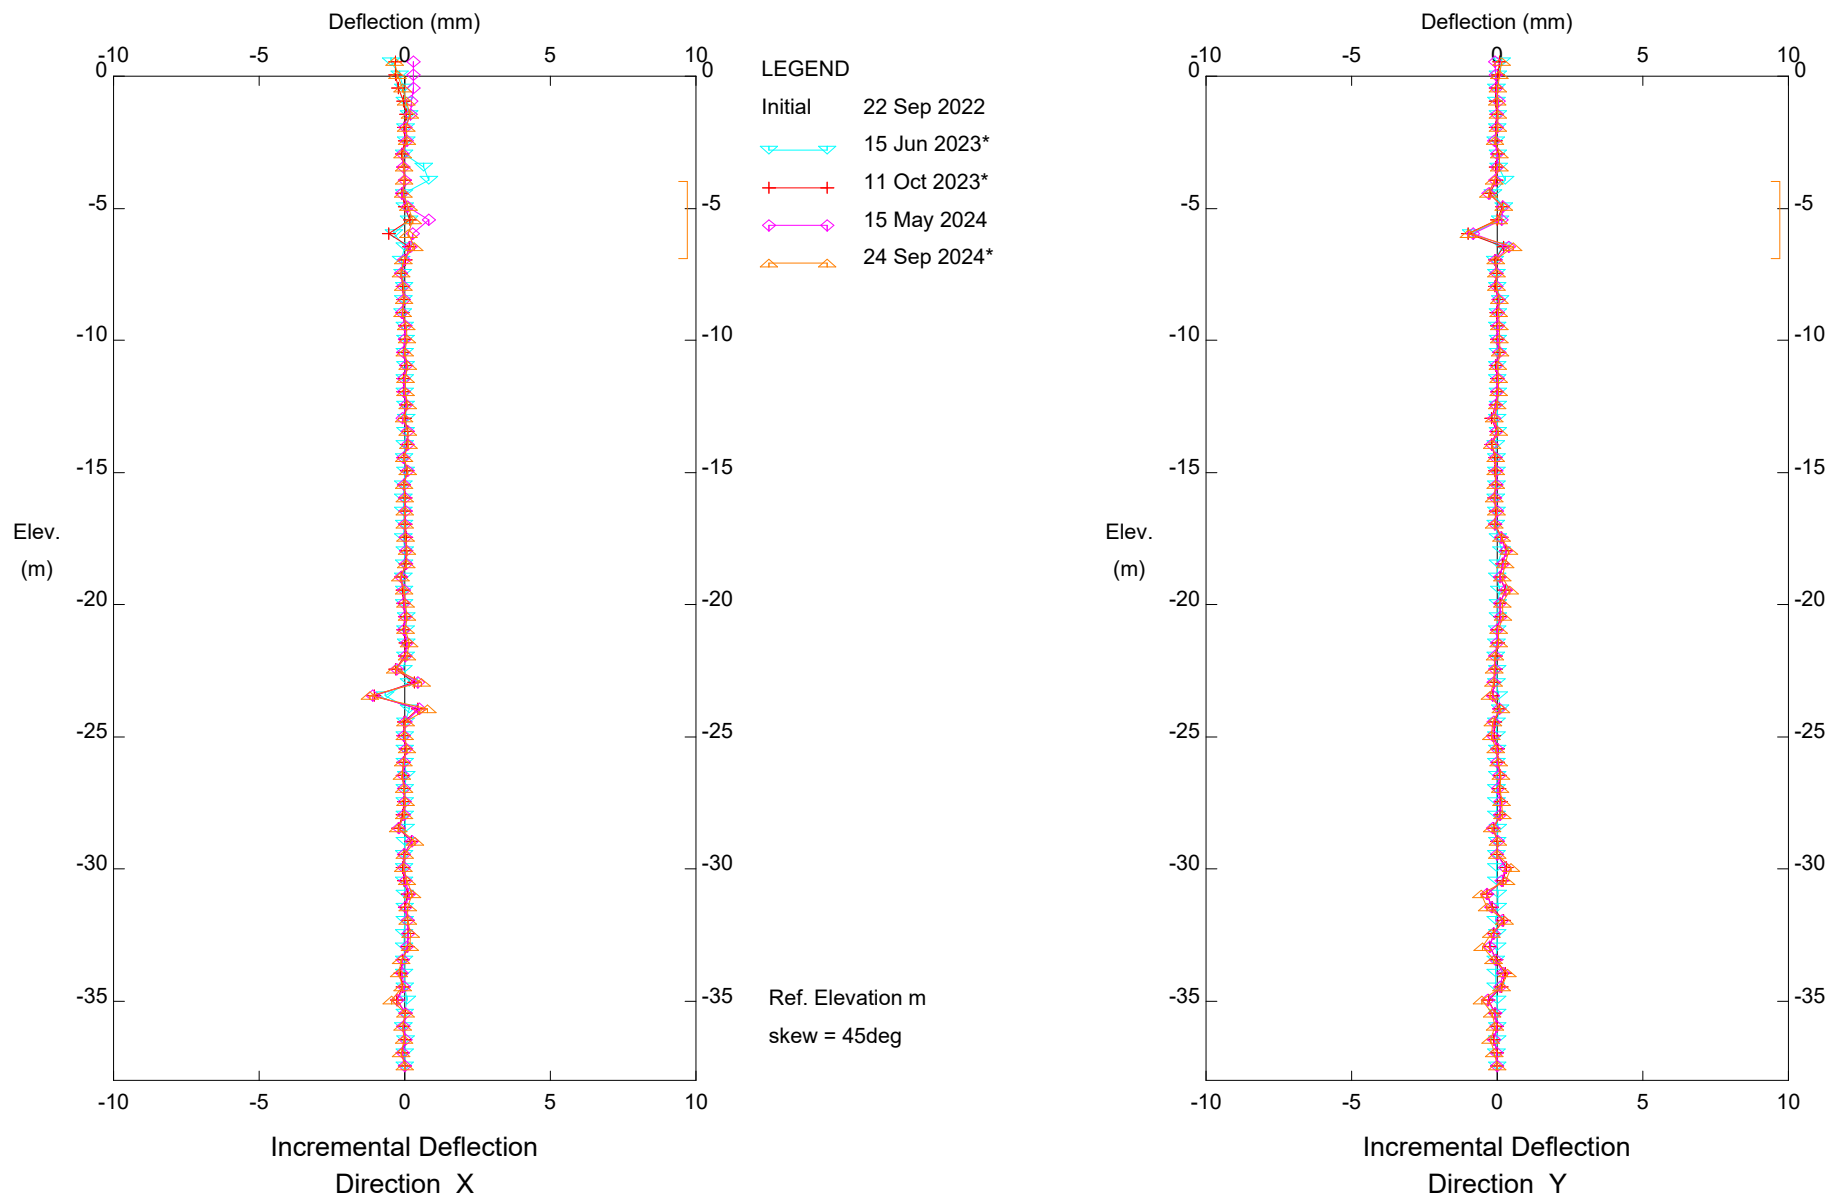
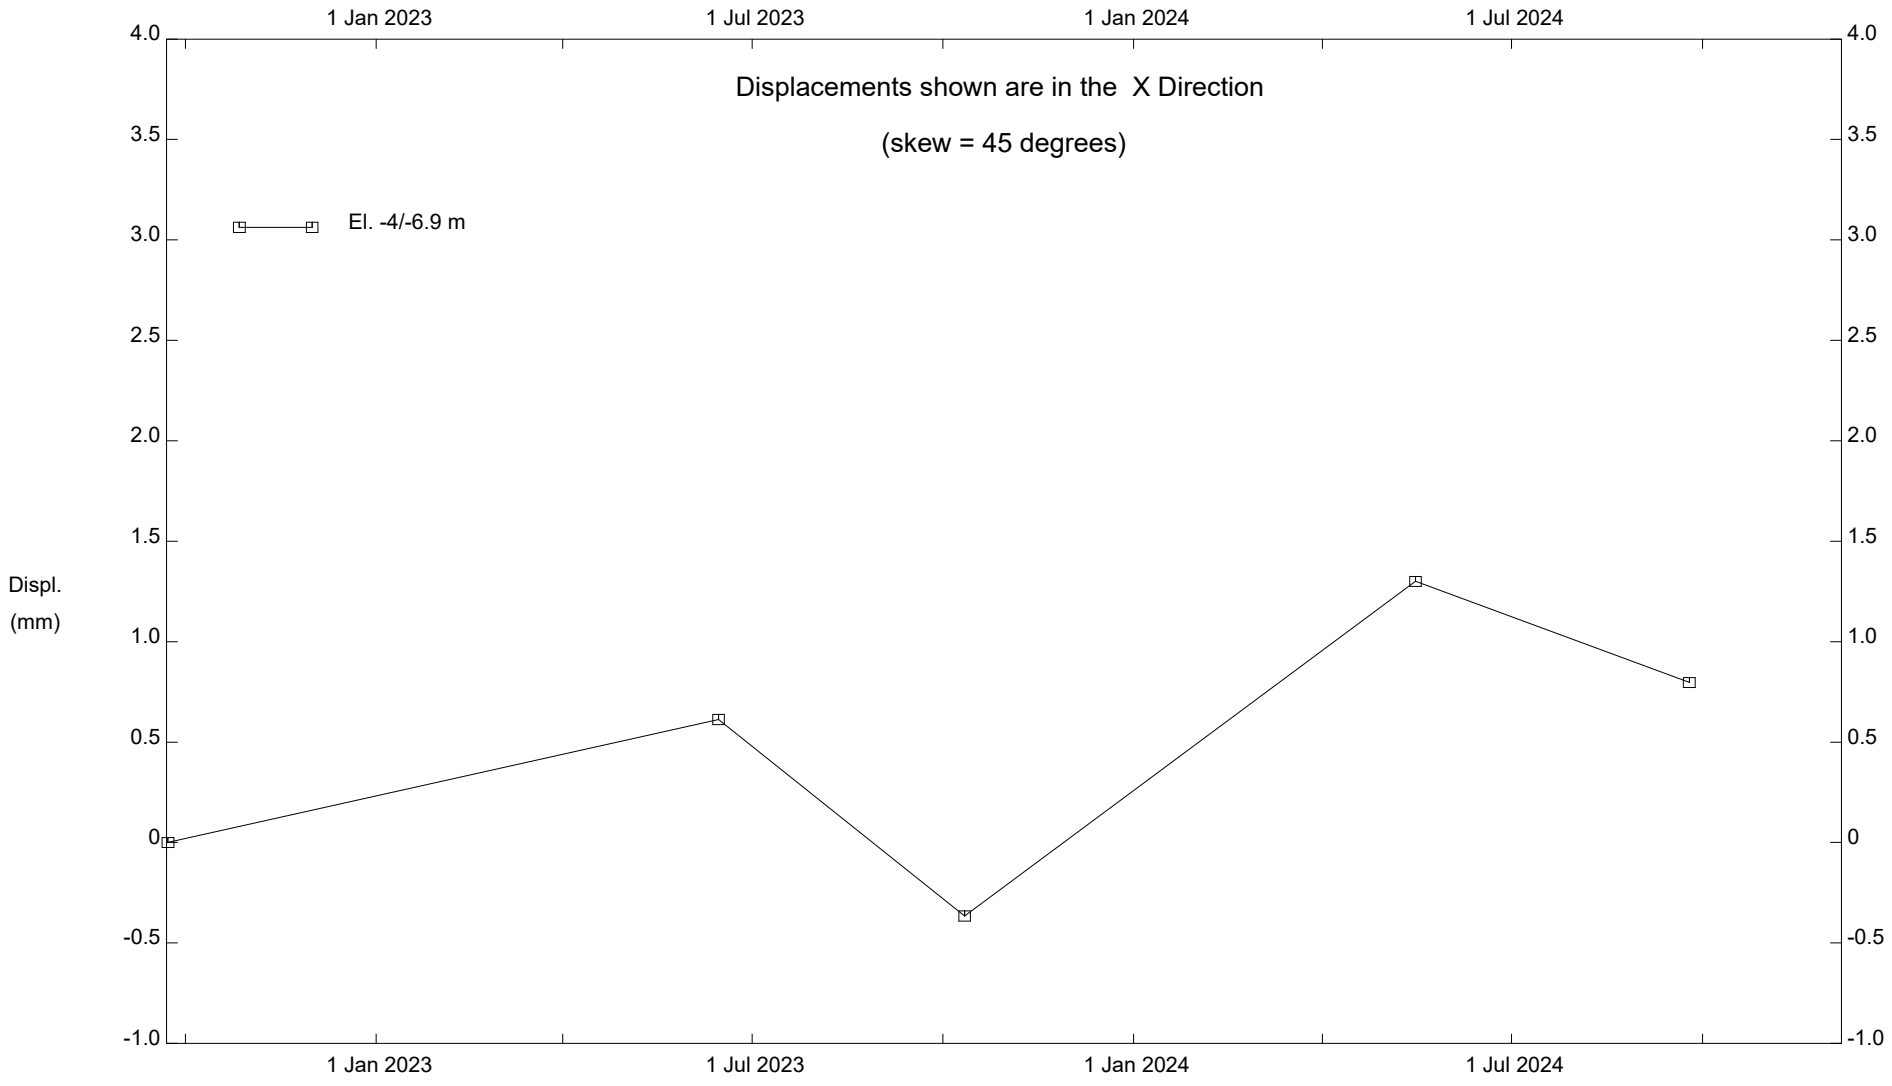
Alberta Southern Region, Inclinator S04 SI-10A

Raw data recorded before September 2020 for the operable SIs (SI-1A, SI-5A, SI-9A, and SI-10A) has not been provided to KCB for review. However, historical reports prepared by the previous consultant between 1999 and 2003 did not report significant movements in these SIs, which is not considered unusual because these SIs are located outside the slide mass. No discernible movement has been recorded in SI-1A, SI-5A, or SI-9A since they were re-initialized to the September-2020 readings when KCB took over the readings at the site and changed the SI reading equipment. Readings in SI-10A note a possible shear plane at a depth of approximately 6 m below ground surface; more data is needed to assess movement trends for this instrument.
