**SOUTHERN REGION GRMP
SITE INSPECTION FORM**

SITE NUMBER AND NAME: S004 Willow Creek (North of Fort Macleod)		HIGHWAY & KM: 2:08, 6.284	PREVIOUS INSPECTION DATE: May 10, 2023	INSPECTION DATE: May 29, 2024
LEGAL DESCRIPTION: 13/14-20-09-26-W4M	NAD 83 COORDINATES: UTM Northing Easting 12 5514351 320169		RISK ASSESMENT: PF: 9 CF: 4 TOTAL: 36	
Average Annual Daily Traffic (AADT): 5000 (north) & 5720 (south) (Reference No. 92080)			CONTRACTOR MAINTENANCE AREA (CMA): 26

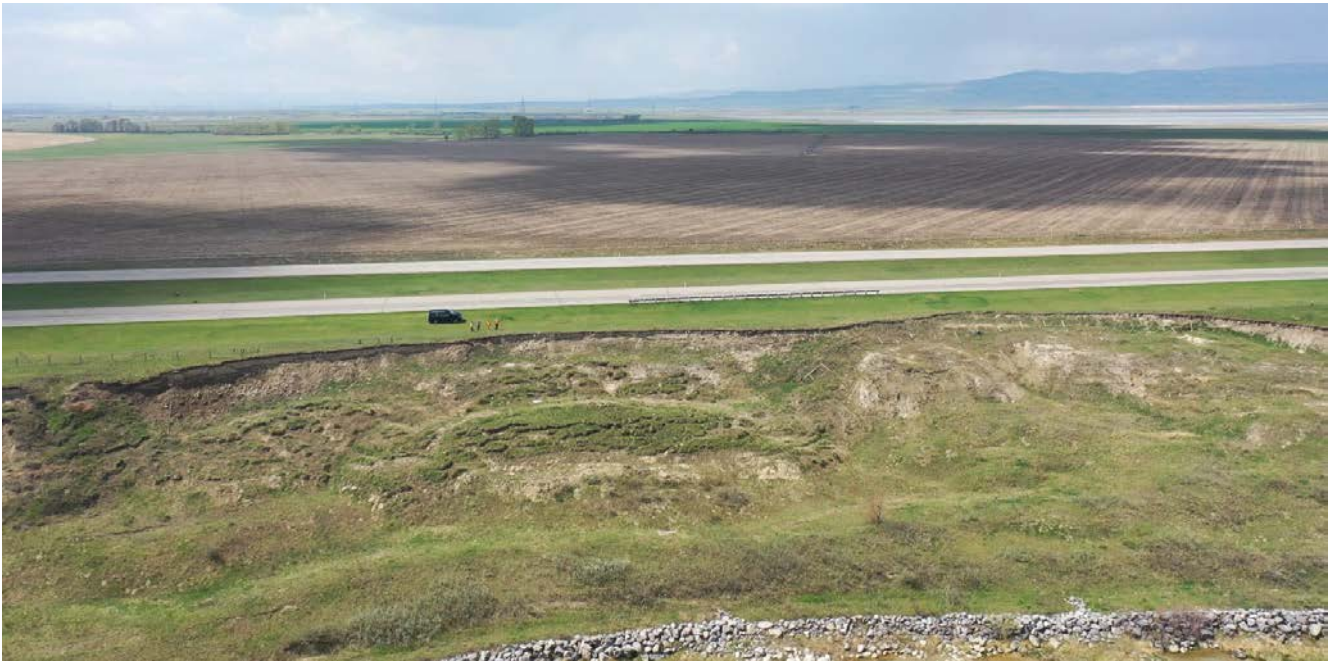
Photo 1 Slide area. Photo taken facing west on May 10, 2023.

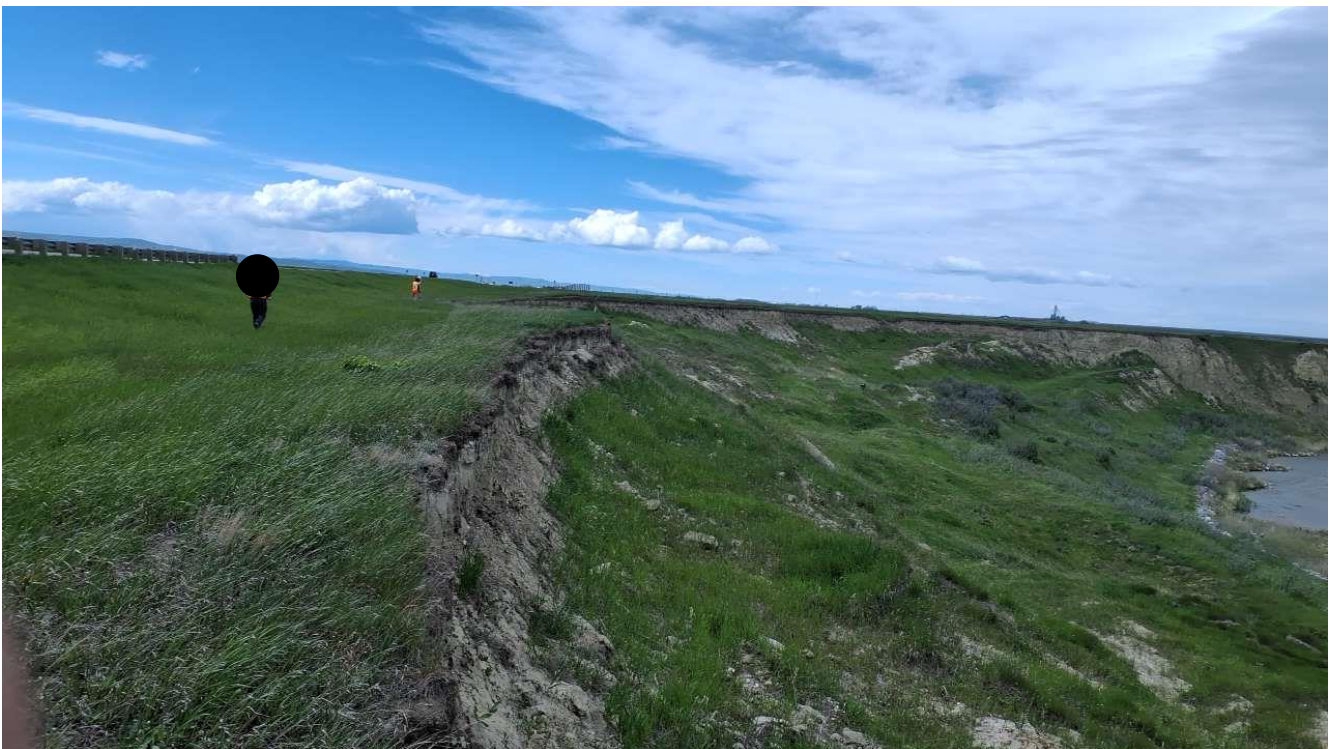
The head scarp has retrogressed 3 m to 5 m past the fence line. The slide zone is actively being undermined and material from the topsoil mat is sloughing into the slide zone over time. No significant changes were noted in the slide mass during the 2024 inspection.

Photo 2 Head scarp located up to 5 m past the fence line. Photo taken facing north on May 29, 2024.

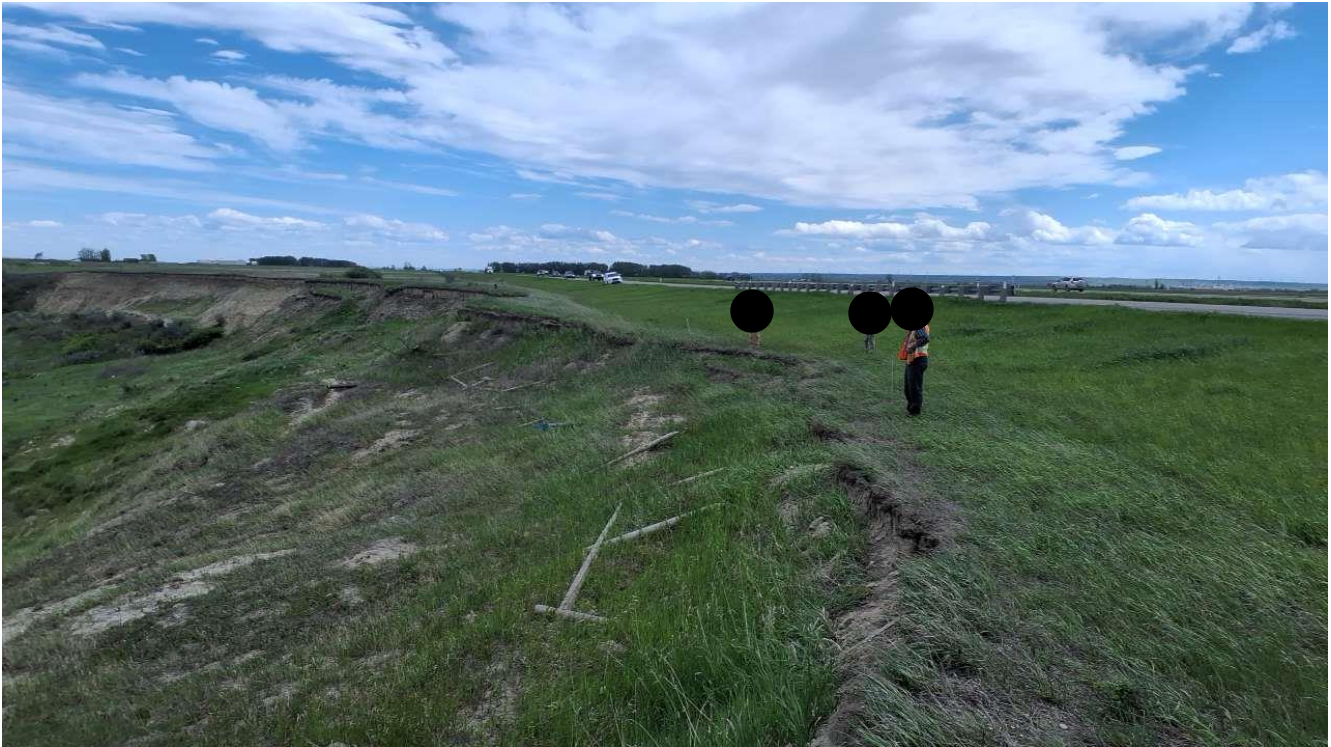
Photo 3 Head scarp located up to 5 m past the fence line. Photo taken facing south on May 29, 2024.
