July 10, 2024

Alberta Transportation and Economic Corridors
2nd Floor, 803 Manning Road N.E.
Calgary, Alberta
T2E 7M8

CON0022161 Southern Region GRMP Instrumentation Monitoring
Site S004; H02:08, km 6.284 Willow Creek
Section C – 2024 Spring Readings

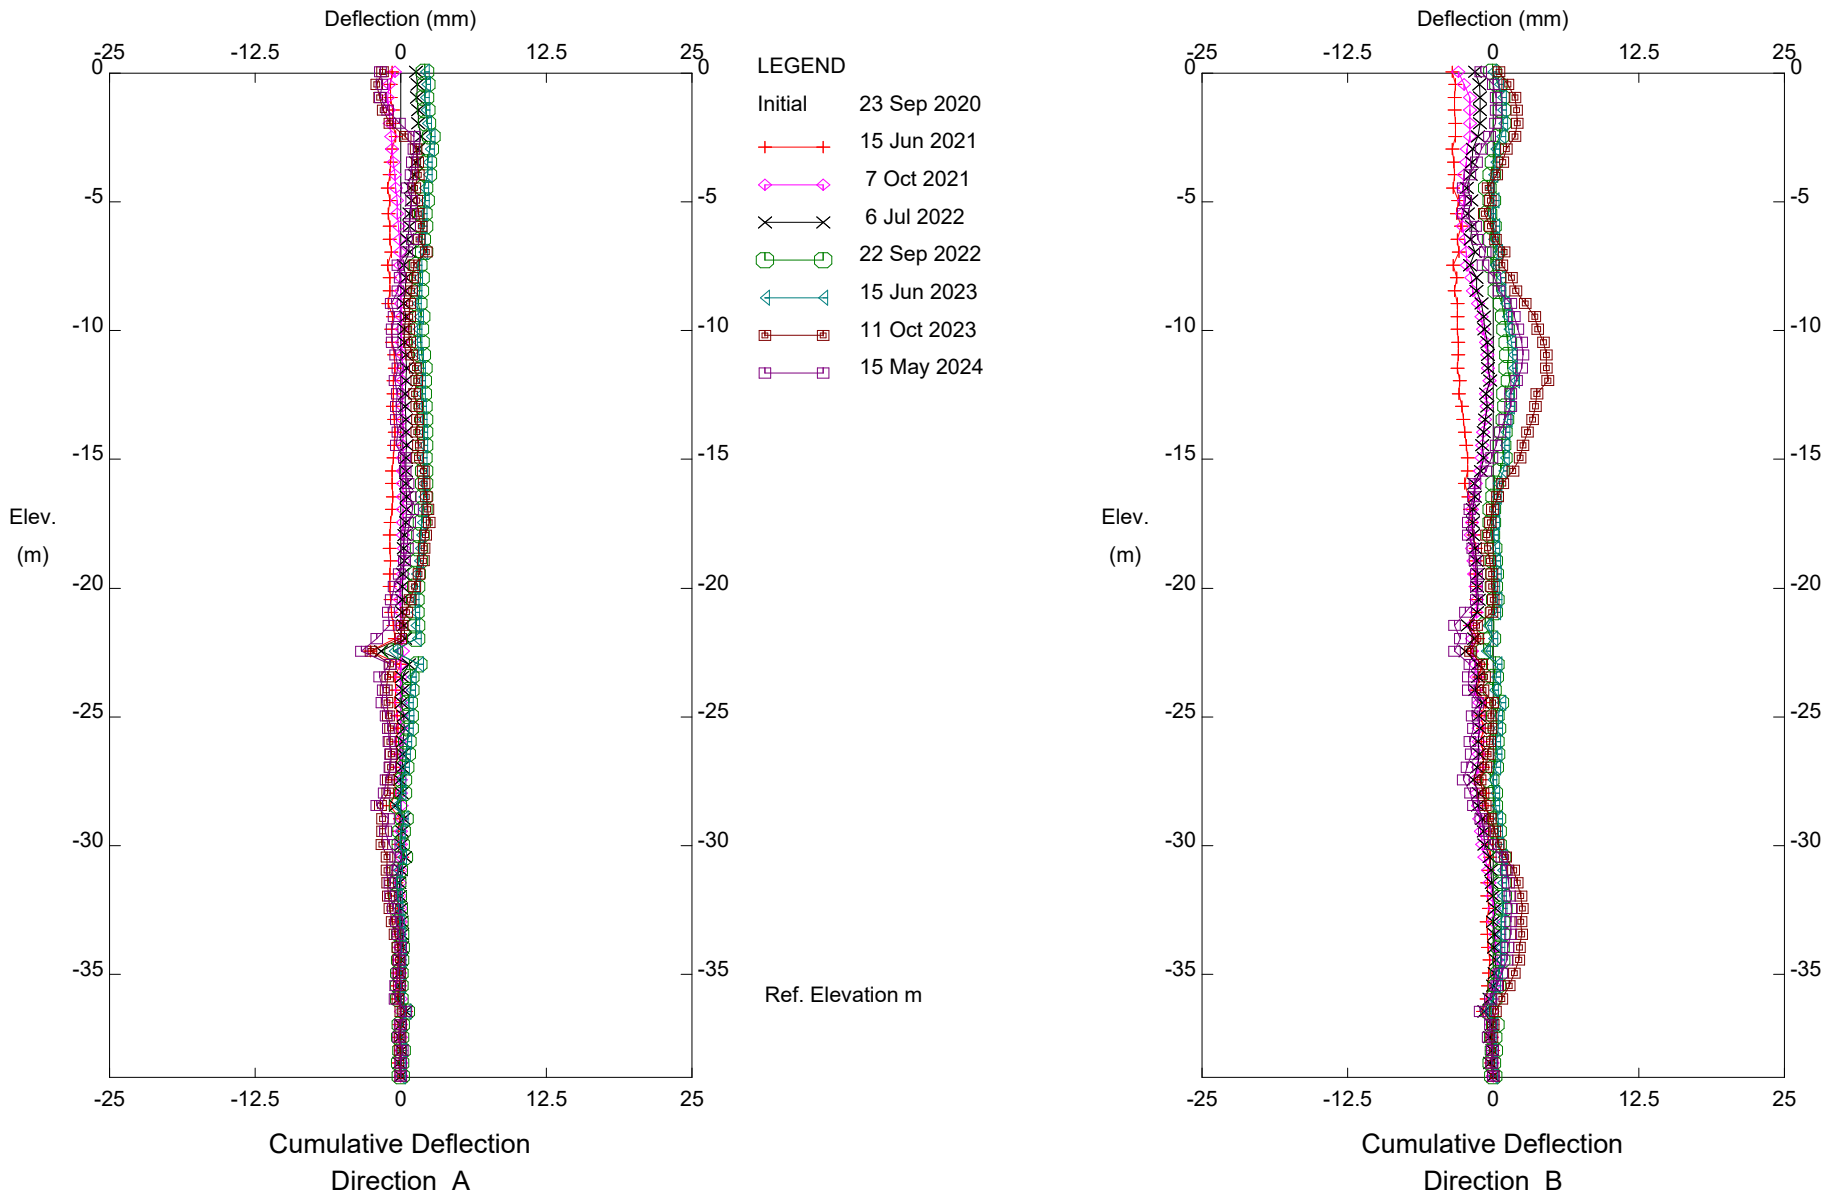
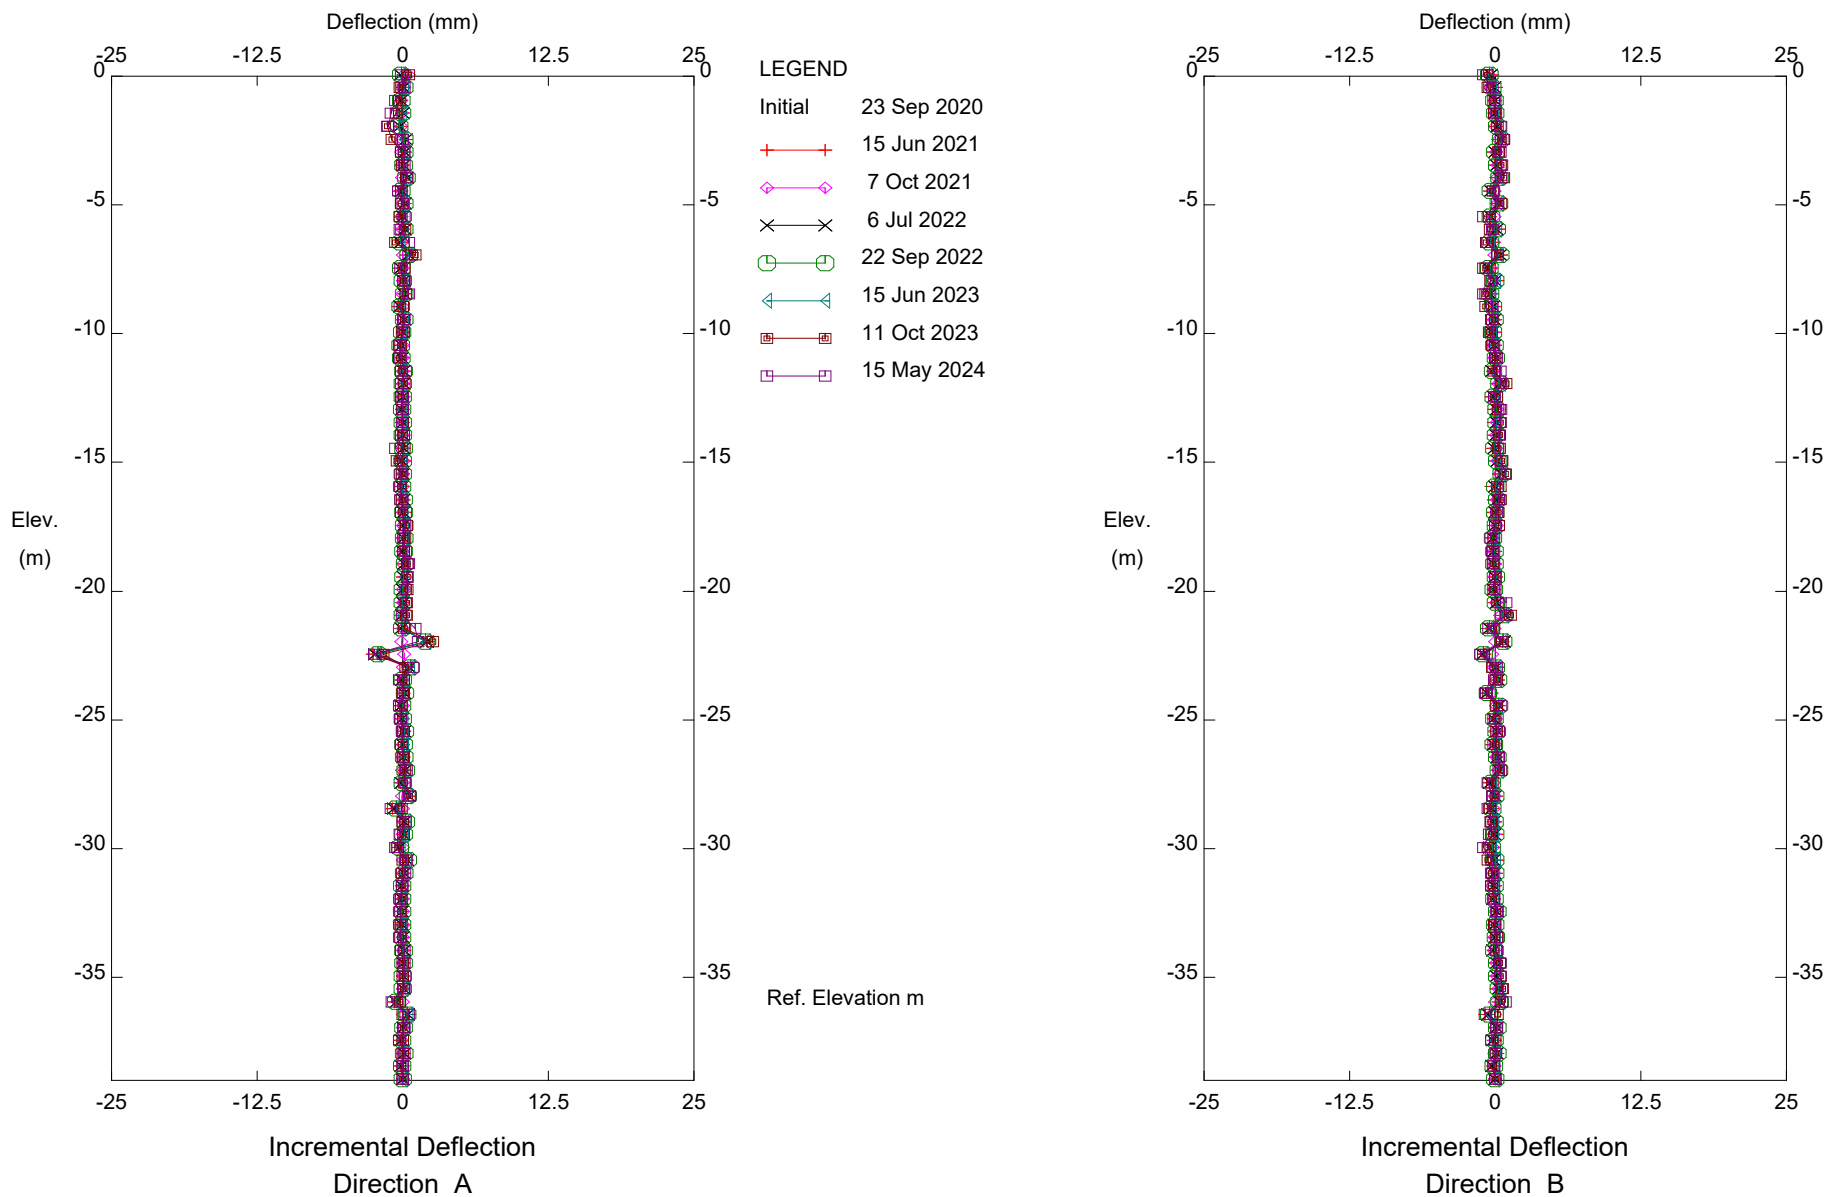
S004; H02:08, Willow Creek, Inclinator SI-1A
 Alberta Transportation

- SI-1A is “wavy” with kinks at approximately 22 m, 28 m, and 36 m below ground surface;
- SI-5A is tilted approximately 1.0 m in the A-direction and 1.7 m in the B-direction, and there is also a kink in the casing at approximately 22 m below ground surface; and
- SI-9A is “wavy” with kinks at approximately 5 m, 11 m, and 25 m below ground surface.
- SI-10A is “wavy” with kinks at approximately 5 m and 25 m below ground surface.

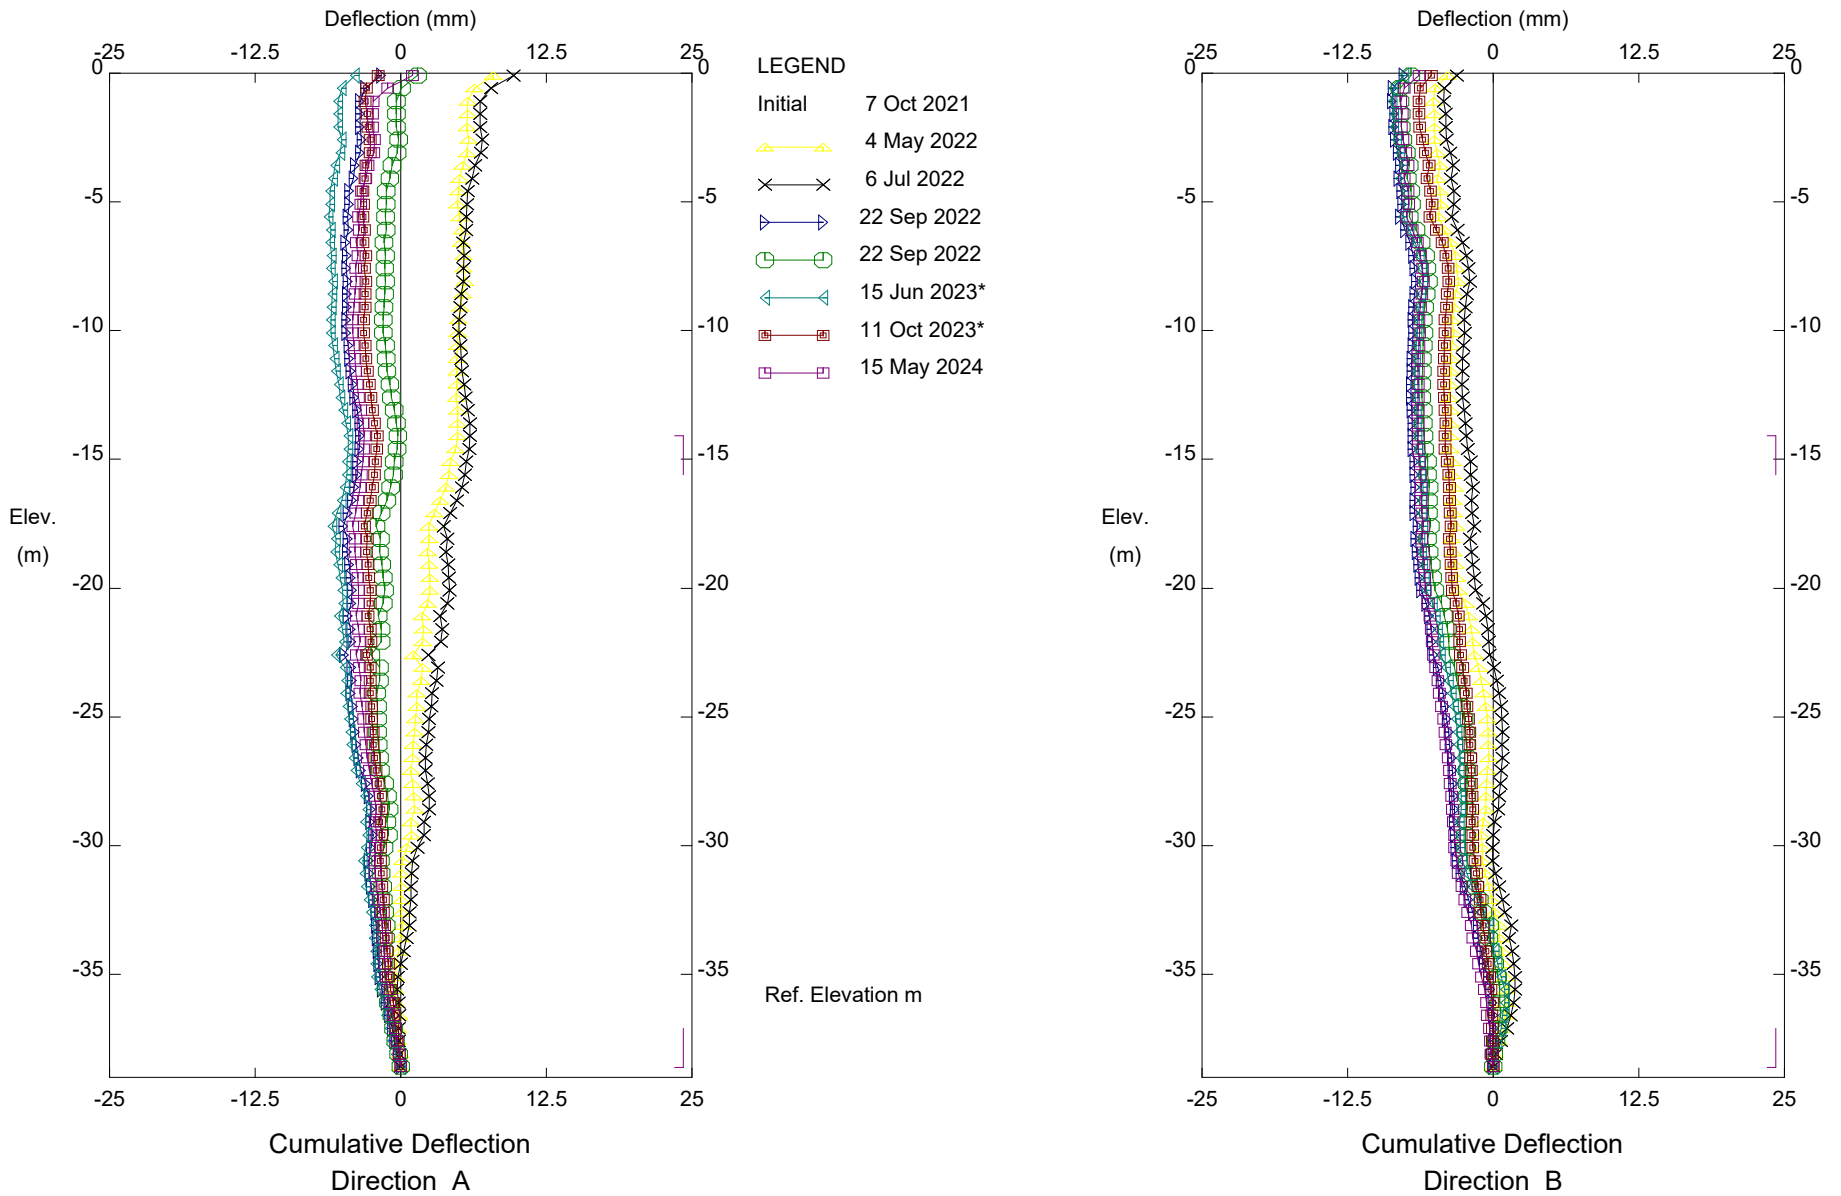
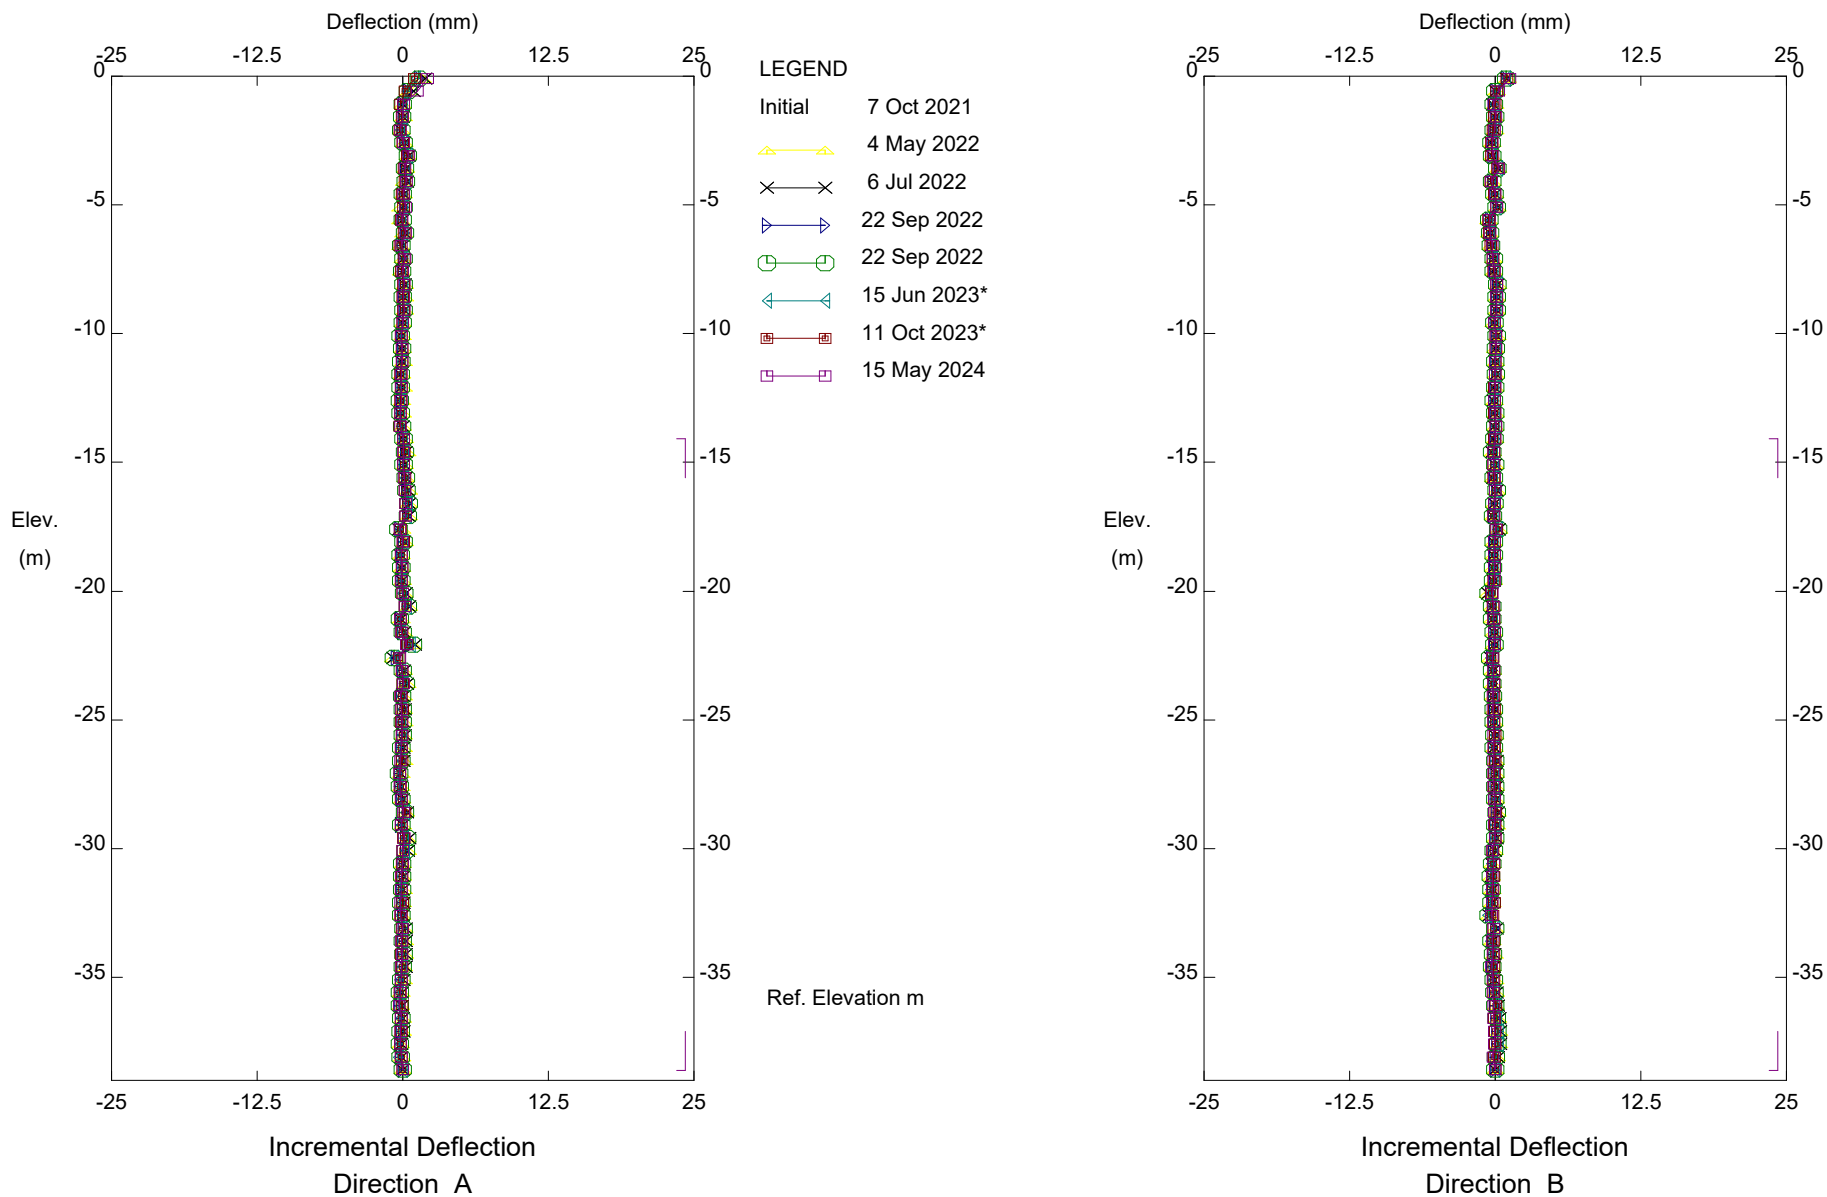
S004; H02:08, Willow Creek, Inclinator SI-5A

Distributed movement has been recorded in SI-5A from an approximate depth of 14 m to the base of the instrument. However, given the data is difficult to interpret, more data is needed to assess the movement trends for this instrument.

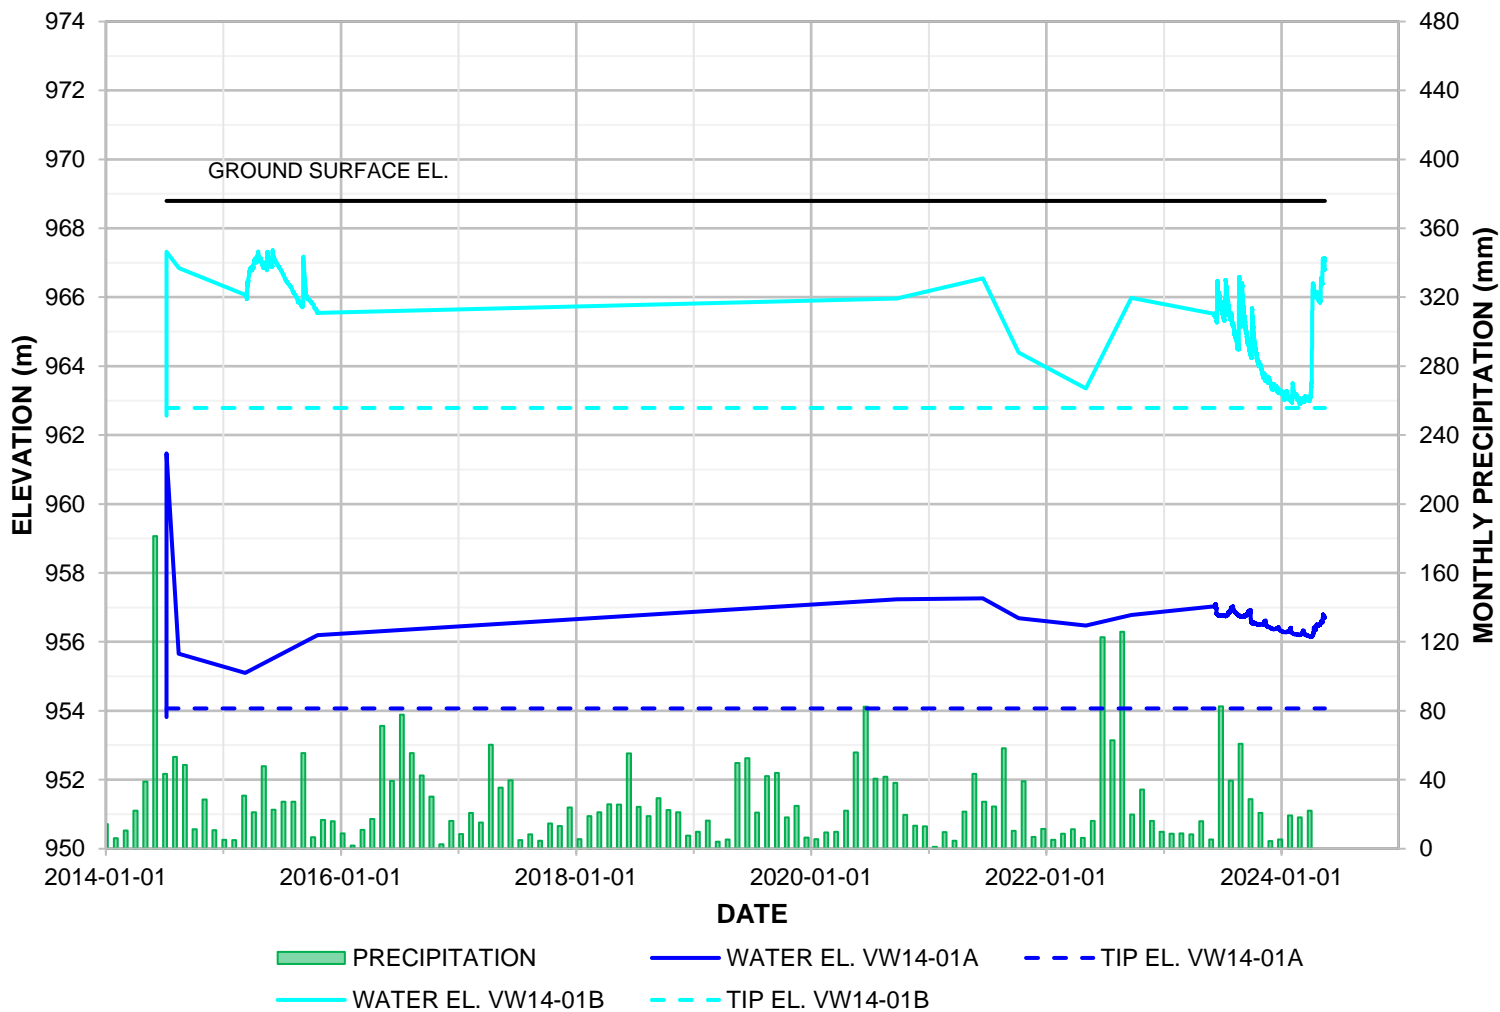
VW14-01A AND VW14-01B

Generally, all six VWPs measured groundwater increases starting in 2024 with the most increase seen in late March/early April 2024 of up to 4 m as measured in VW14-01B. VW14-02B recorded the highest water level based on the data available, however previously no data loggers were installed which provides a limited data set. Rainfall data from station T009R26W4 only included data up to March 31, 2024, at the time of writing this report. Based on the data available, rainfall and snow melt have contributed to the rise in water levels in the VWPs. Water level responses to rainfall will be commented on in the fall 2024 report once the data is available.

Water levels recorded in the nested VWP's installed between the highway and crest of the slide (VW14-01A/B and VW14-02A/B) varied from an approximate depth of 1.3 m to 1.7 m below ground surface in the upper "B" tips and 7.0 m to 12.1 m below ground surface in the lower "A" tips. Both the upper "A" tips have a similar elevation (El. 962.8 m and El. 963.1 m, respectively), and both the lower "B" tips have a similar tip elevation (El. 954.1 m and El. 954.4 m, respectively).

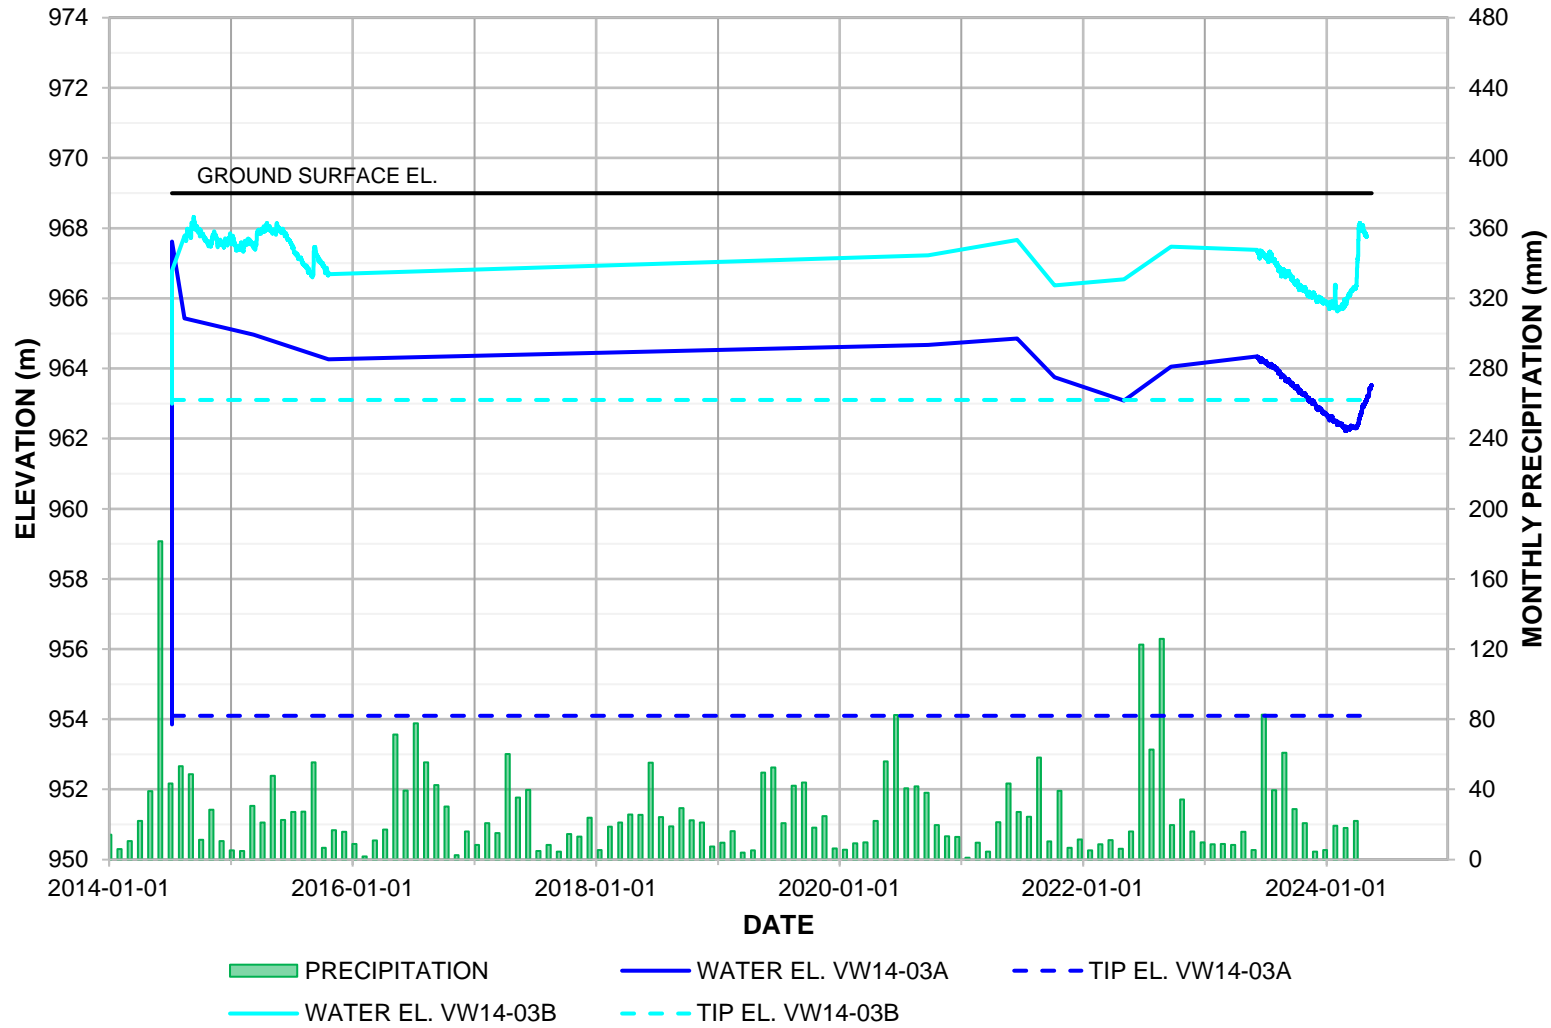
VW14-03A AND VW-03B

Water levels recorded in the nested VWP's installed in the median ditch of Hwy 02:08 (VW14-03A/B) were at approximate depths of 0.9 m and 5.5 m below ground surface in the upper "B" tip and the lower "A" tip, respectively.

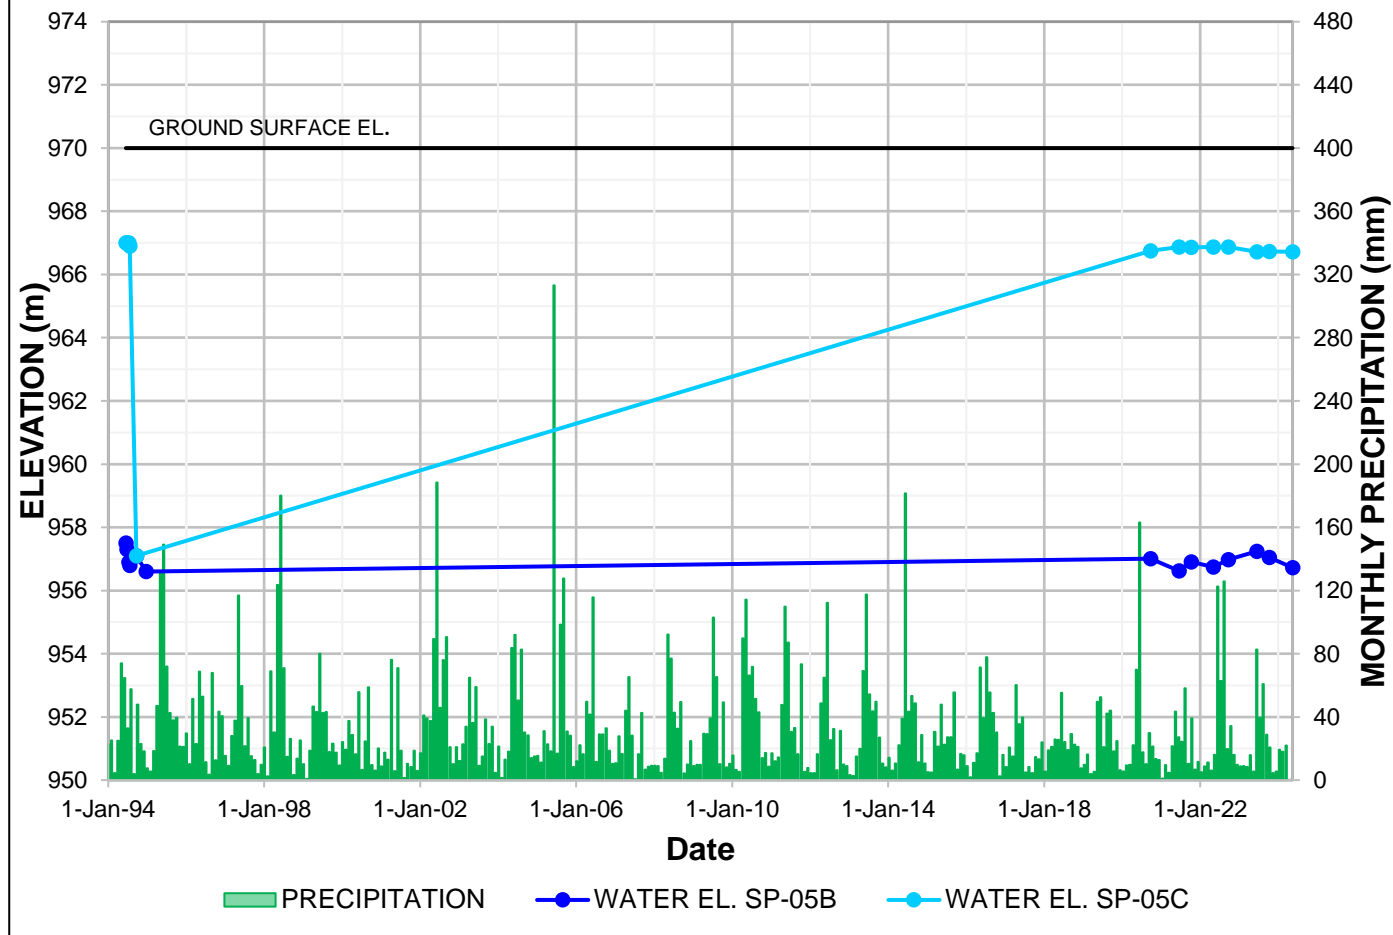
SP-05B AND SP-05C

The 1994 reading for SP-05C was most likely bad as it is approximately 10 m lower than the previous and current readings.
