SITE NUMBER AND NAME: <b>S028 Slide East of Lundbreck Falls</b>		HIGHWAY & KM: 3A:06, 2.367	PREVIOUS INSPECTION DATE: June 1, 2017	INSPECTION DATE: <b>May 10, 2019</b>
LEGAL DESCRIPTION: 06/07-27-007-02 W5M	NAD 83 COORDINATES: UTM Northing Easting 11 5496507 702877		RISK ASSESMENT: PF: 9 CF: 4 TOTAL: 36	
AVERAGE ANNUAL DAILY TRAFFIC (AADT): 190 (east), 230 (west), (Ref No. 75050, 75060)			CONTRACTOR MAINTENANCE AREA (CMA): 26

PROJECT	SOUTHERN REGION GEOHAZARD RISK MANAGEMENT PROGRAM	
TITLE	Site Plan S028 - Slide East of Lundbreck Falls Hwy 3A:06, km 2.367	
SCALE	PROJECT No.	FIG No.
1:1,000	A05115A03	1

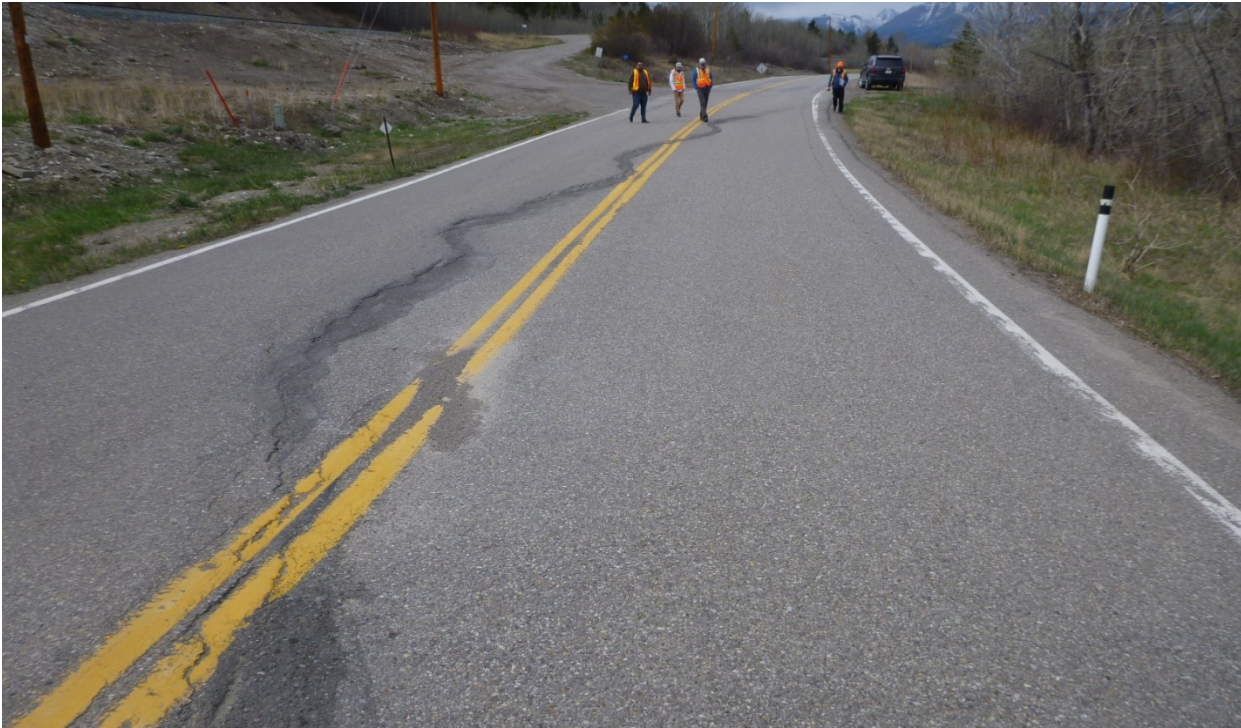
**Photo 1** East flank of landslide zone. Note crack sealing on pavement. Photo taken facing northeast on May 10, 2019.

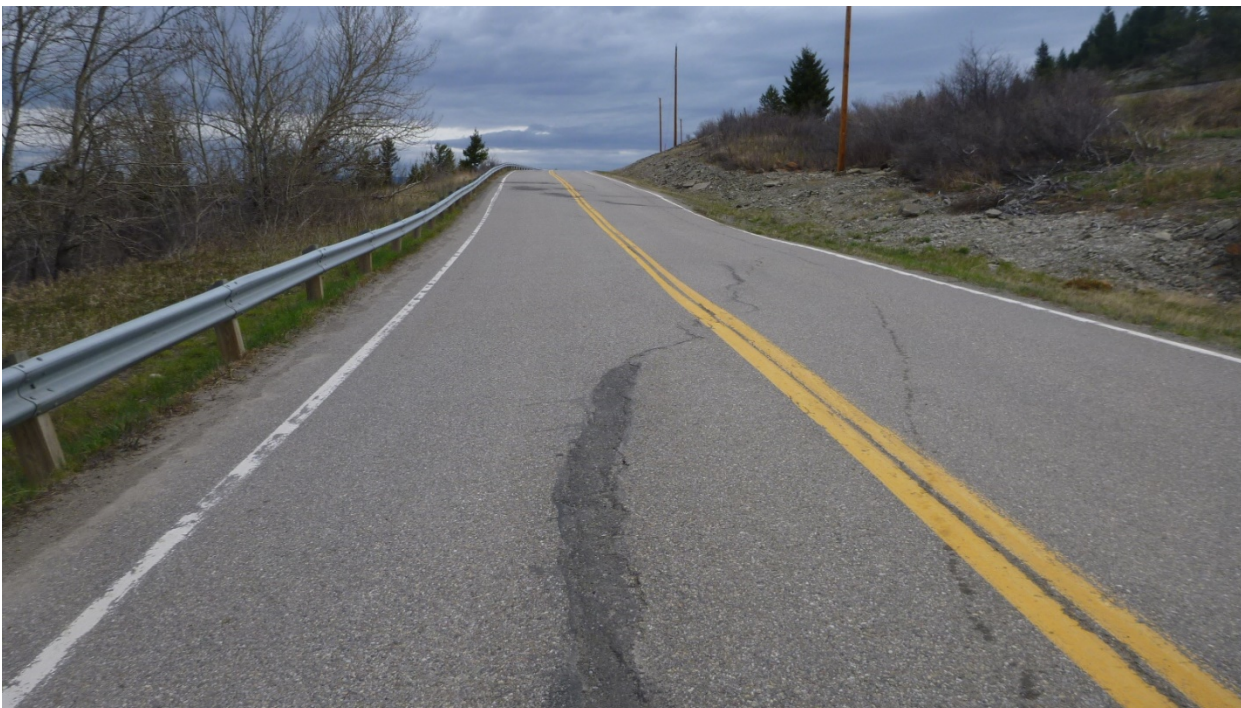
**Photo 2** West flank of landslide zone. Note crack sealing on pavement. Photo taken facing southwest on May 10, 2019.

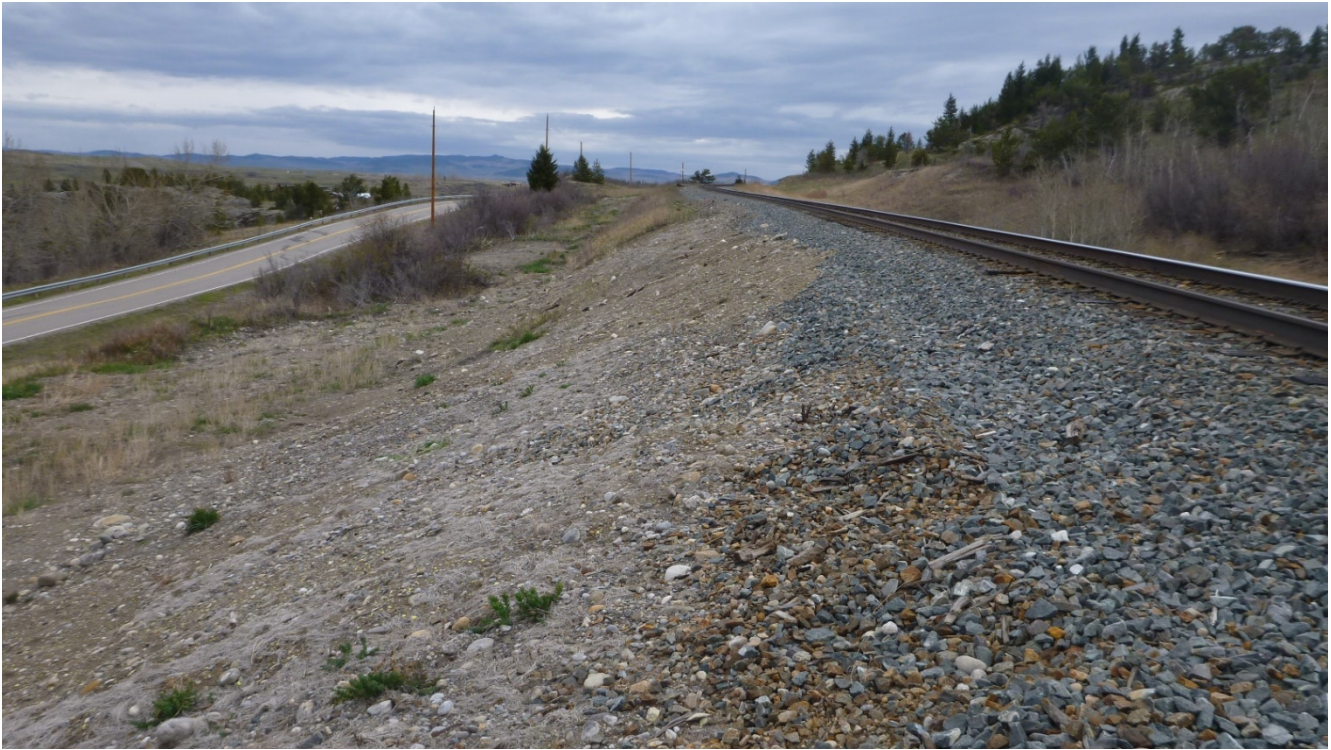
**Photo 3** CP Rail embankment upslope of the slide. Photo taken facing southwest on May 10, 2019.
