June 28, 2019

Alberta Transportation
 2nd Floor, 803 Manning Road NE
 Calgary, Alberta
 T2E 7M8

**CON0017609 Southern Region GRMP Instrumentation Monitoring
 Site S028; H3A:06 km 2.4, Slide East of Lundbreck Falls
 Section C - 2019 Spring Readings
 DRAFT**

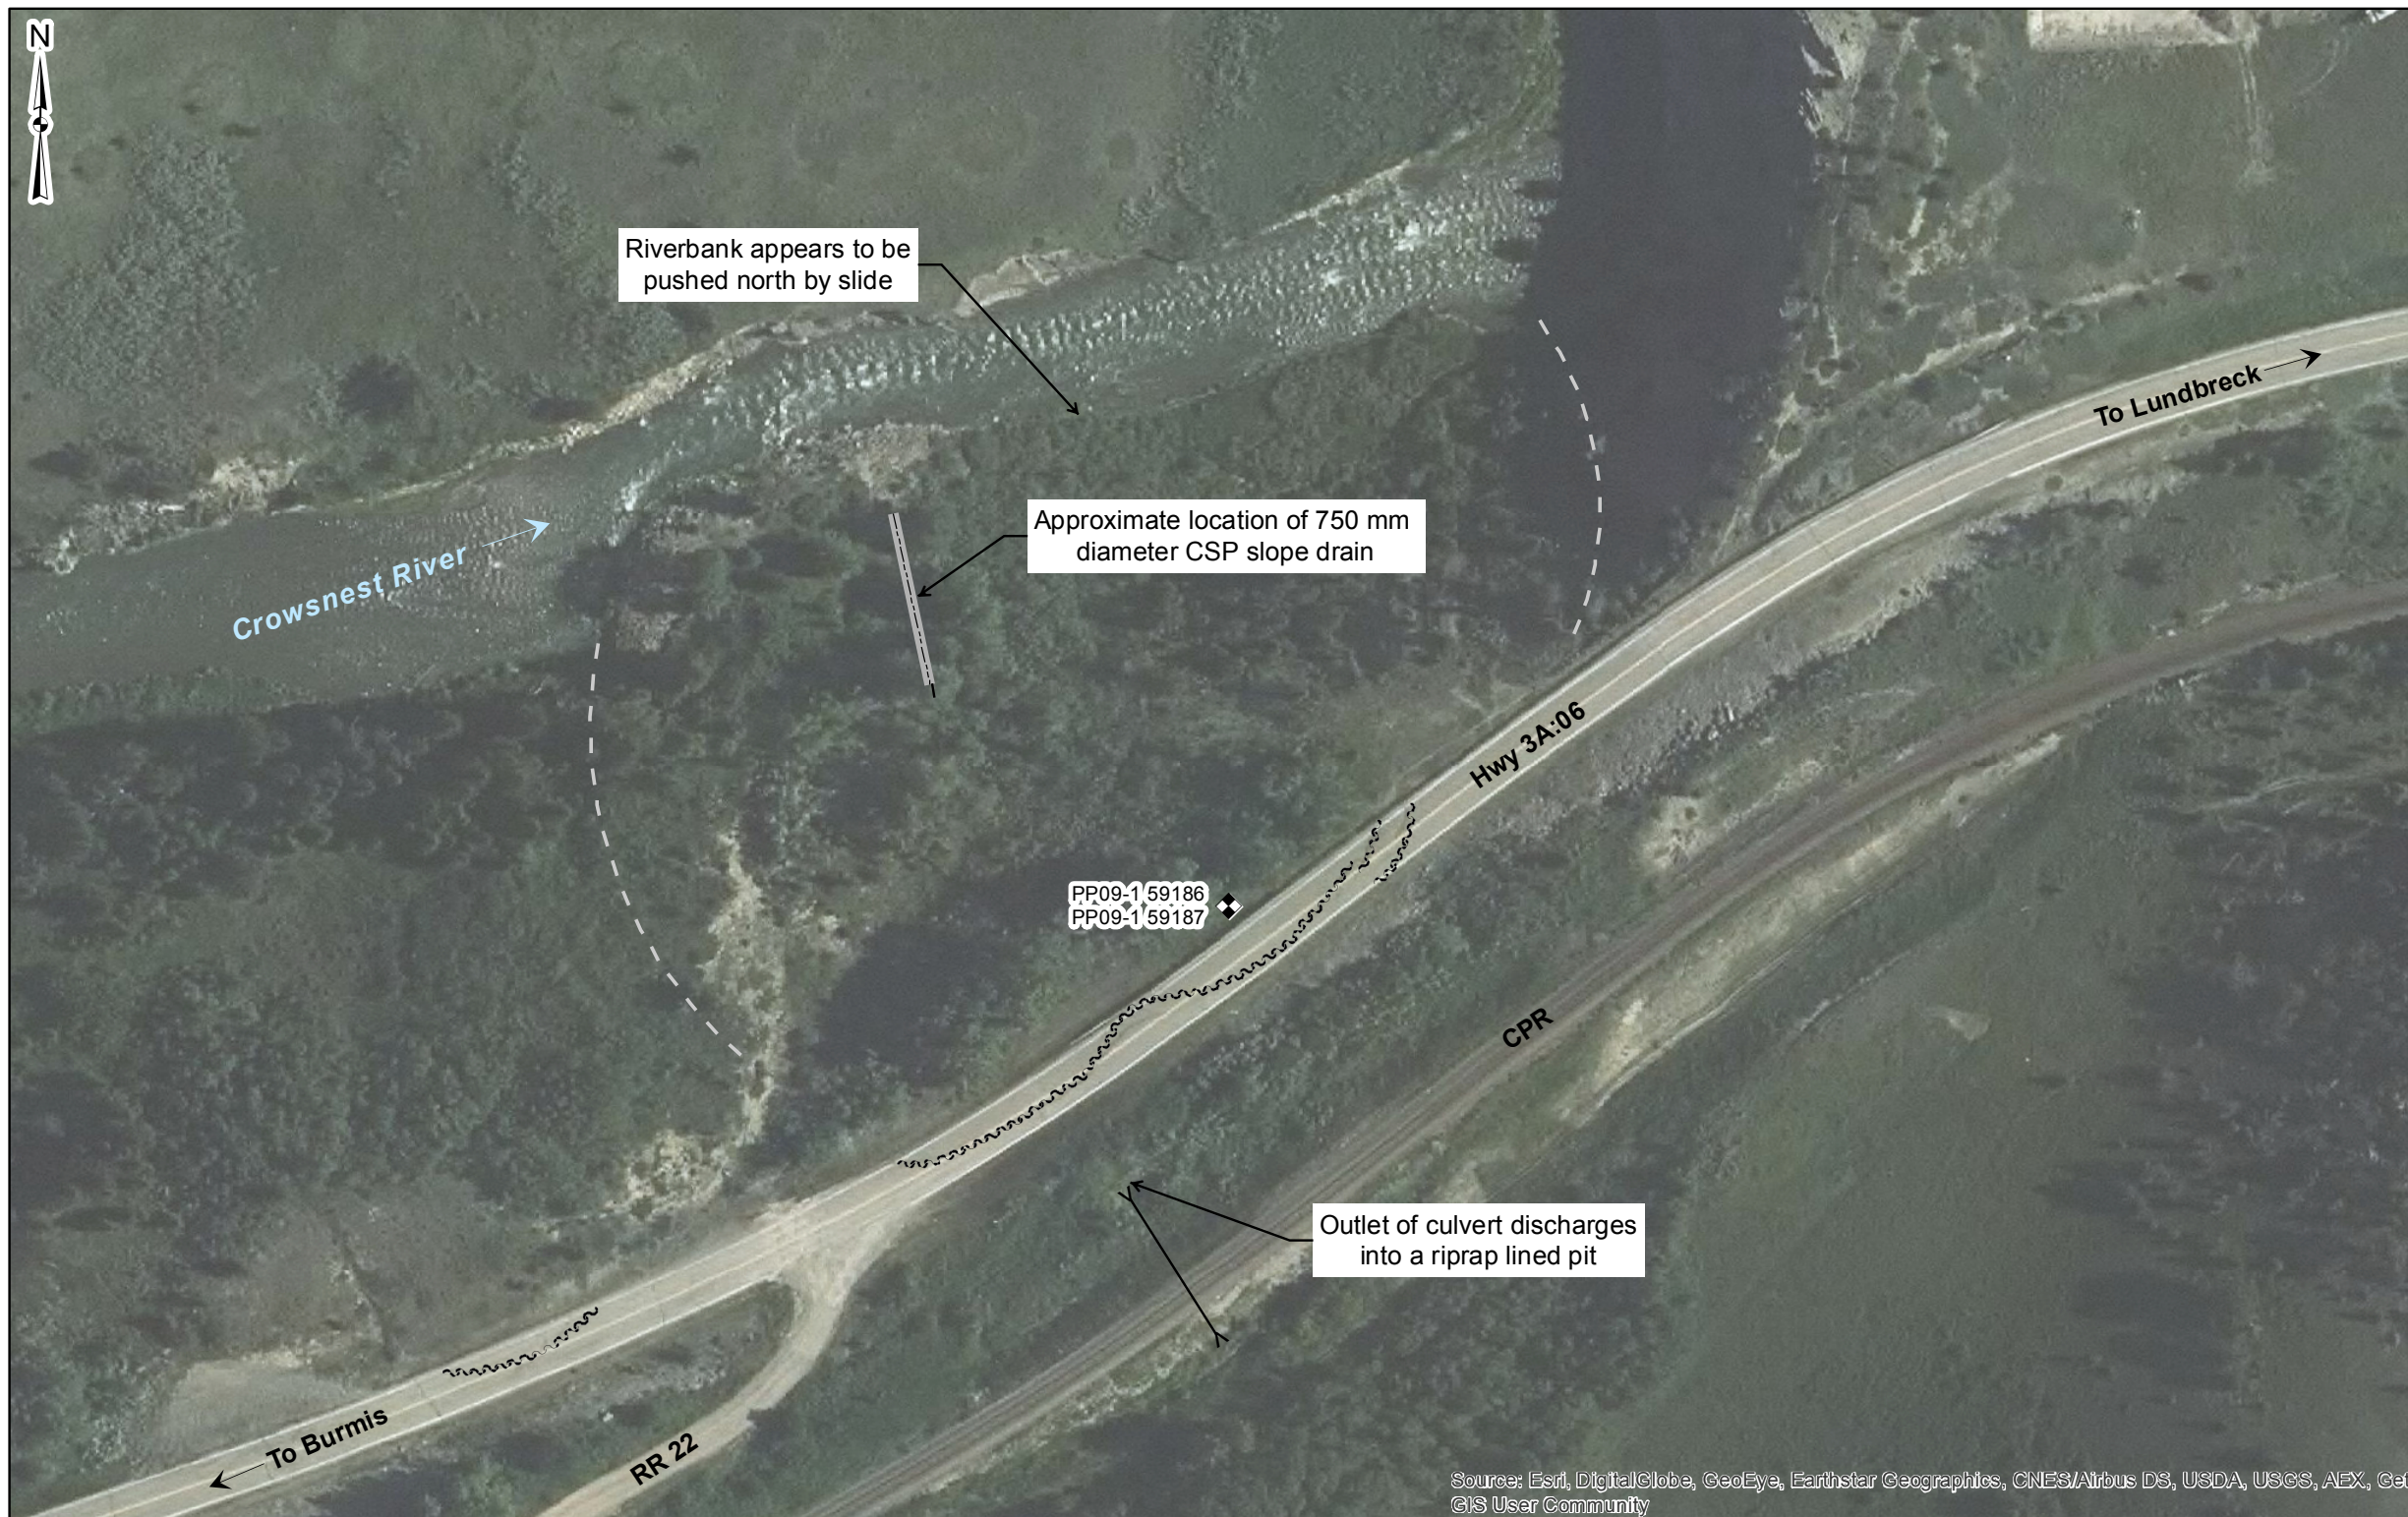
PROJECT	SOUTHERN REGION GEOHAZARD RISK MANAGEMENT PROGRAM	
TITLE	Site Plan S028 - Slide East of Lundbreck Falls Hwy 3A:06, km 2.367	
SCALE	PROJECT No.	FIG No.
1:1,250	A05115A03	1

The geohazard at this site consists of a landslide approximately 6 to 12 m deep, seated in bedrock above the Crowsnest River and impacting approximately 100 m of Highway 3A. A 450-mm-diameter corrugated steel pipe (CSP) culvert which discharges into a 750 mm diameter CSP culvert partway down the slope appears to function as slope drainage. Patching of the cracks was carried out in mid-2014. A summary of the status of site instrumentation is provided in Tables 1.1 and 1.2. Both PNs are located on the north shoulder of the road, as shown on Figure 1.
