SITE NUMBER AND NAME: S028 Slide East of Lundbreck Falls		HIGHWAY & KM: 3A:06, 2.367	PREVIOUS INSPECTION DATE: May 10, 2019	INSPECTION DATE: May 20, 2022
LEGAL DESCRIPTION: 06/07-27-007-02 W5M	NAD 83 COORDINATES: UTM Northing Easting 11 5496507 702877		RISK ASSESMENT: PF: 9 CF: 4 TOTAL: 36	
AVERAGE ANNUAL DAILY TRAFFIC (AADT): 190 (east) & 230 (west), (Reference No. 75050 & 75060)			CONTRACTOR MAINTENANCE AREA (CMA): 26

PROJECT SOUTHERN REGION GEOHAZARD RISK MANAGEMENT PROGRAM		
TITLE Site Plan S028 - Slide East of Lundbreck Falls Hwy 3A:06, km 2.367		
SCALE 1:1,000	PROJECT No. A05116A03	FIG No. 1

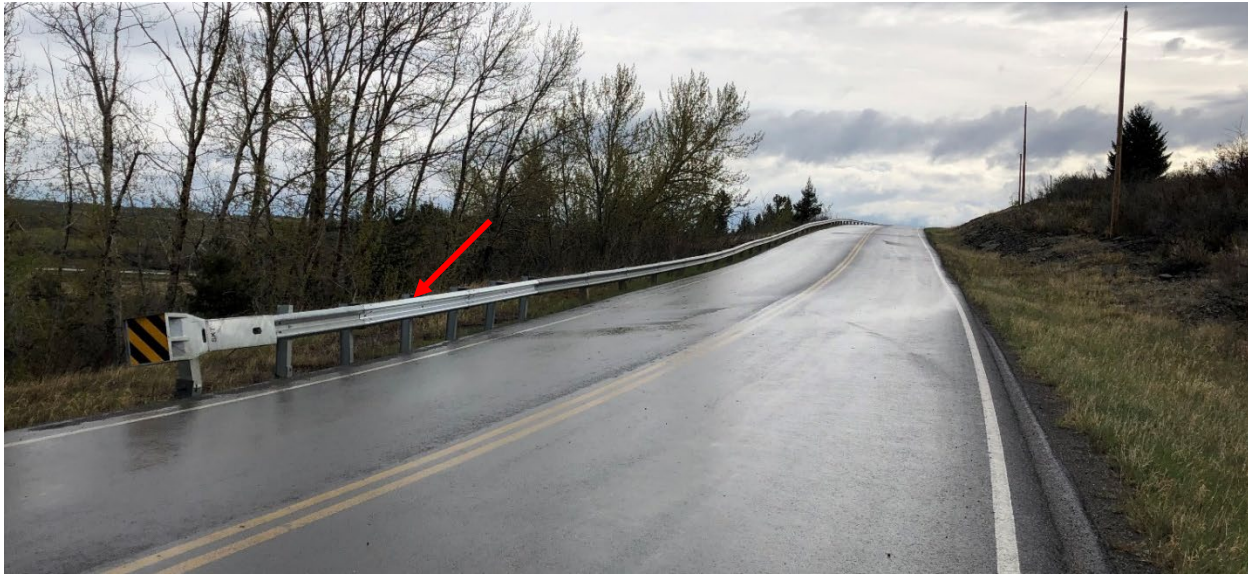
COMMENTS
The slide appears active due to the ongoing pavement cracking observed in the highway surface.
Highway 3A:06 is a minor road with a low traffic volume. The highway has viable detour options if the road condition deteriorates to the point where the highway would need to be closed.
The highway was resurfaced in summer 2020. It appears as though sections of the guardrail were replaced during the highway resurfacing project.
During the 2022 site visit, new transverse and longitudinal pavement cracks were observed through the new pavement surface due to continued landslide movements. The pavement cracking pattern was similar to the pavement cracking observed prior to summer 2020 (Photos 1 and 2).

- Photo 1** Longitudinal and transverse cracks visible through the 2020 pavement patch in the right flank of landslide zone. Section of the guardrail (indicated by red arrow) were replaced between the 2019 and 2022 inspections. Photo taken May 20, 2022, facing northeast.

- Inspections should be completed by the MCI and every two-years as part of the Southern Region GRMP Section B inspections. Hwy 3A is a low traffic road and, as long as slide movements are slow, continued patching and maintenance could address pavement roughness concerns.
- The guardrail is low in several locations and could be raised to a more suitable height.
- The slide could be repaired with:
 - Slope reconstruction with geosynthetic reinforced gravel, including either a shear key or pile wall extending to below historic zones of movement; and
 - Improved subsurface drainage (drainage trenches or buried subsurface drains). Surface water drainage should be improved along the highway to minimize infiltration into the slide zone.

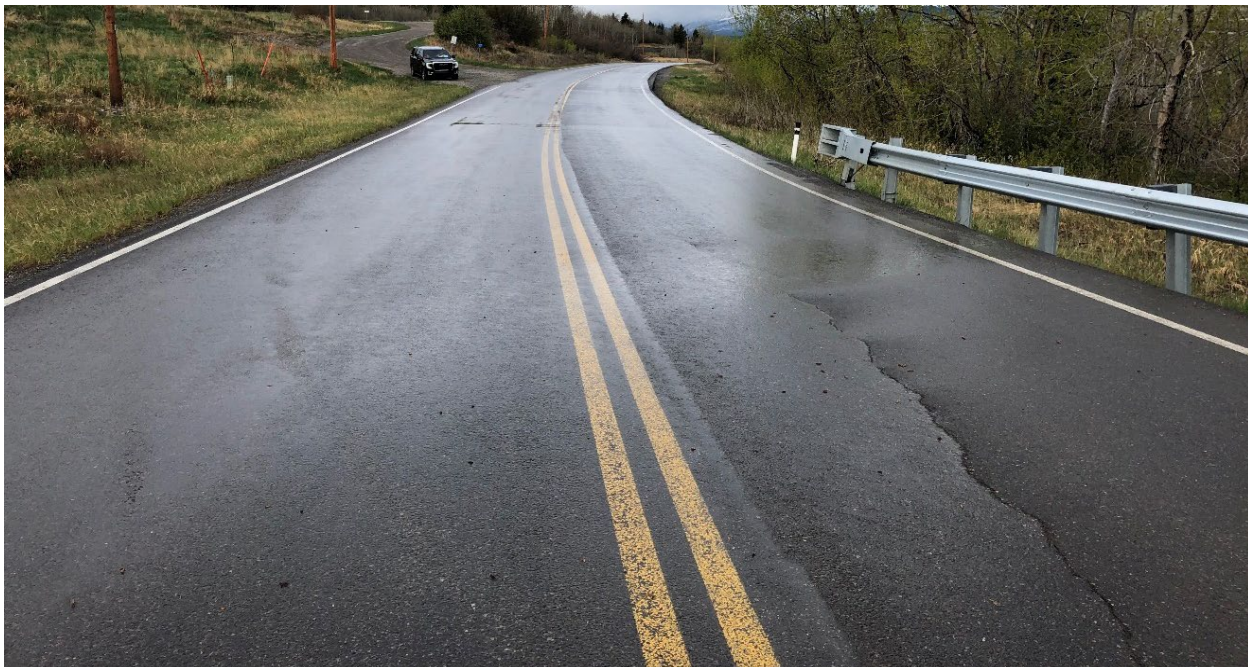
- Photo 2** Longitudinal and transverse cracks visible through the 2020 pavement patch in the left flank of landslide zone. Photo taken May 20, 2022, facing southwest.
