SITE NUMBER AND NAME: <b>S015 Crowsnest Rockfall</b>		HIGHWAY & KM: 3:02, 3.431	PREVIOUS INSPECTION DATE: June 1, 2017	INSPECTION DATE: <b>May 10, 2019</b>
LEGAL DESCRIPTION 14-05-008-05 W5M	NAD 83 COORDINATES: UTM Northing Easting 11 5499651 669776		RISK ASSESMENT: PF: 15 CF: 2 TOTAL: 30	
AVERAGE ANNUAL DAILY TRAFFIC (AADT): 4630 (west), 4630 (east) (Ref. No. 70000005)			CONTRACTOR MAINTENANCE AREA (CMA): 26

PRIMARY SITE ISSUE: Rockfall hazard; debris falling down a ravine onto the highway.

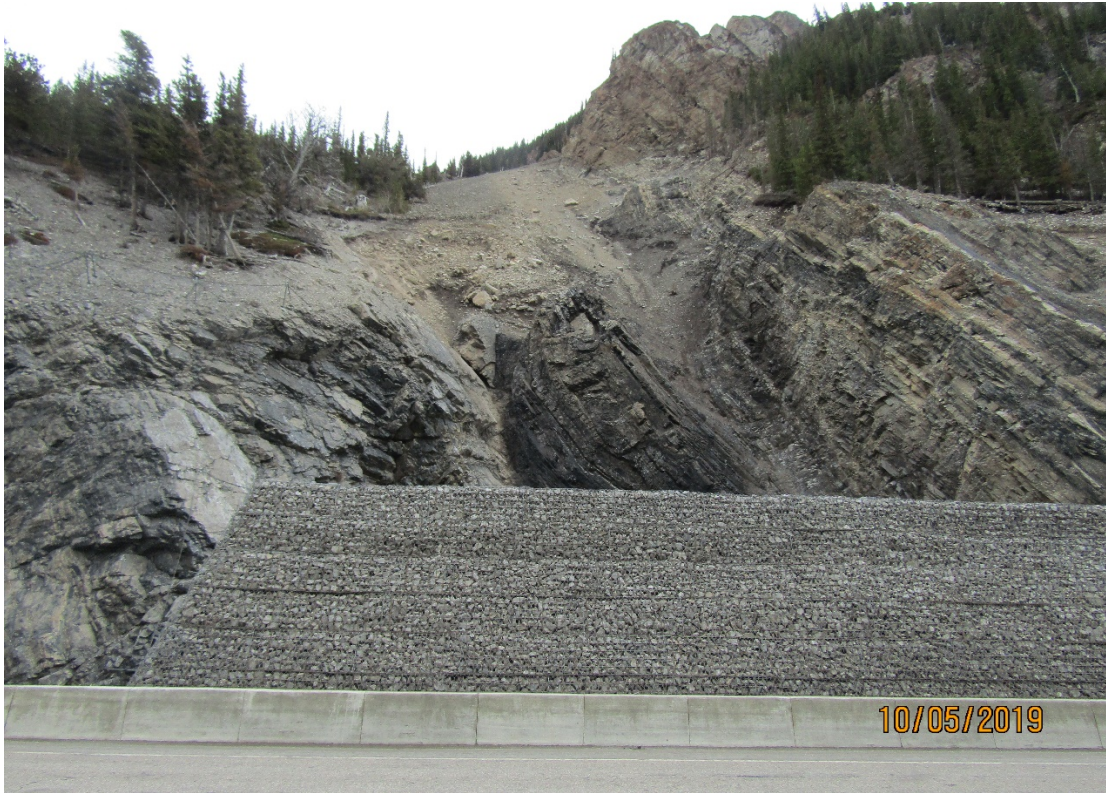
**Photo 1** Reinforced gabion barrier wall to prevent rockfall down the ravine from reaching roadway. Photo was taken facing southeast on May 10, 2019.

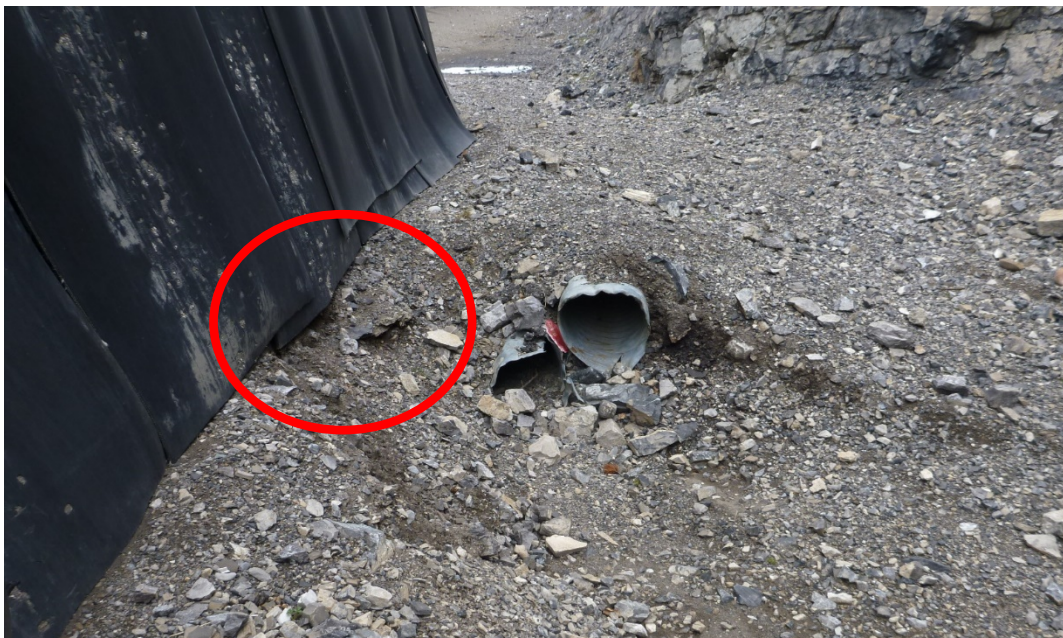
**Photo 2** Rubber mats to protect gabion wall from damage. Erosion is occurring at toe of wall (red circle) and could undermine the wall. Photo taken facing east on May 10, 2019.

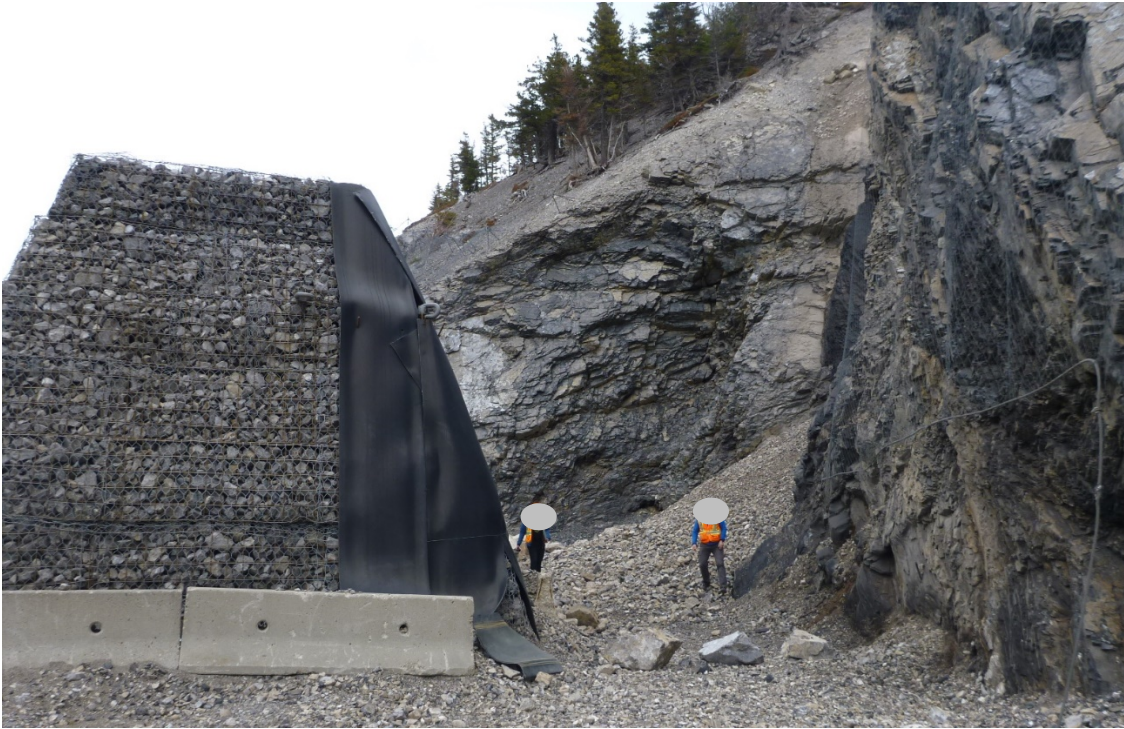
**Photo 3** Debris accumulation behind the barrier, needs cleaning. Photo was taken facing west on May 10, 2019.

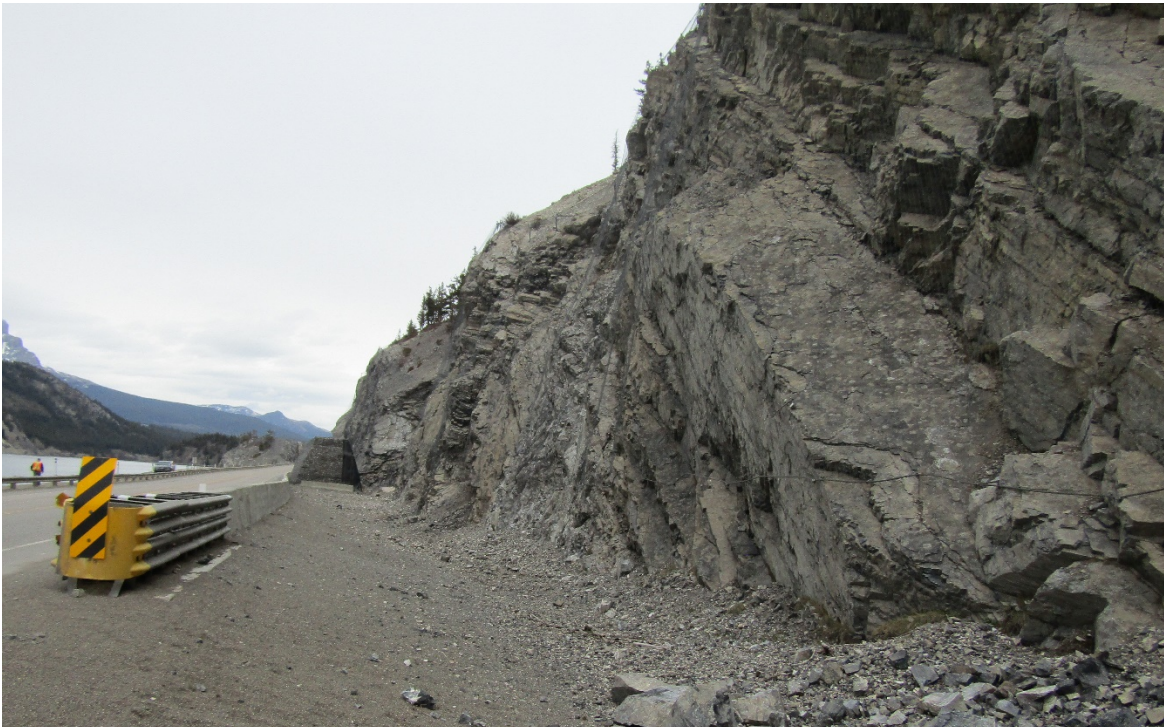
**Photo 4** Mesh covered rock slope to the southeast of the barrier. Photo was taken facing east on May 10, 2019.

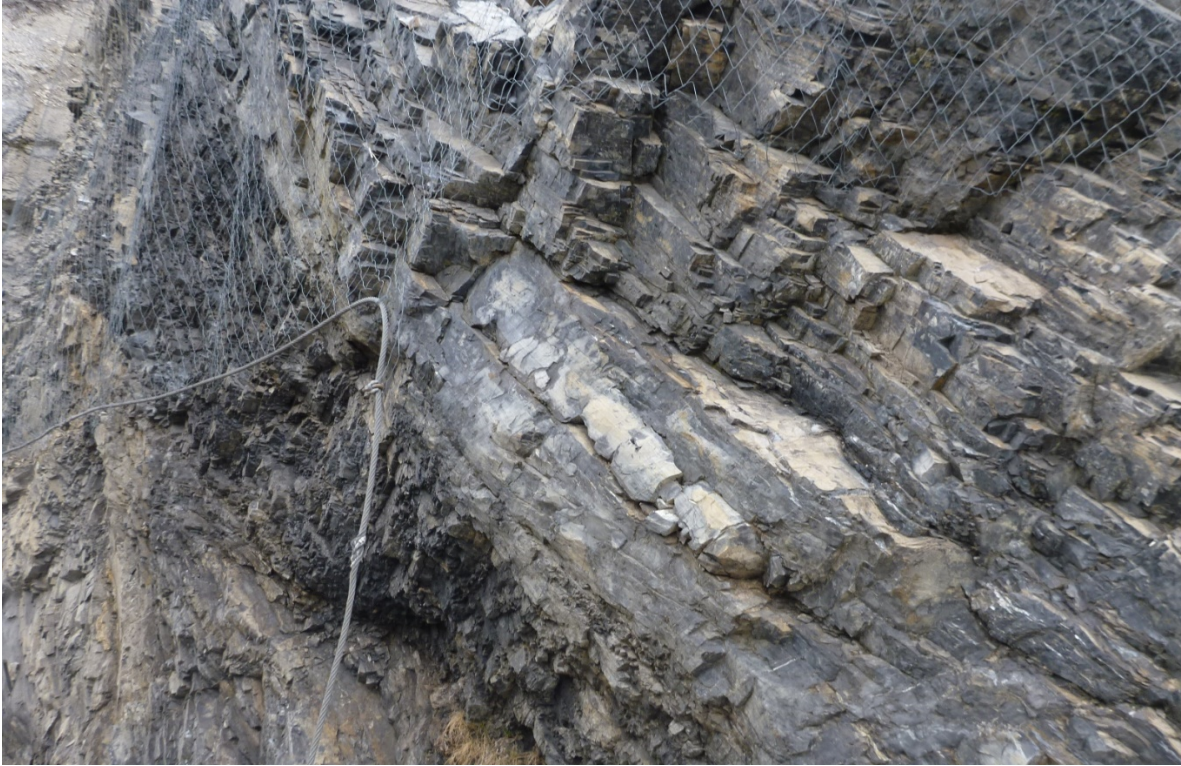
**Photo 5**      **Damaged slope mesh base cable. Photo taken May 10, 2019.**

<b>COMMENTS</b>
No significant changes. Barrier prevents rockfall in the ravine from impacting the highway. S015 site to be visited every 2 years as part of GRMP tour.
Maintain and repair barrier as needed. Rockfall debris needs to be regularly removed from behind wall. Mesh on adjacent rock slopes was placed to create safe access for contractors to access behind the wall. Rockfall debris is building up behind the barrier and should be cleaned during 2019.
The brow of the ravine slope is moving back to the west. Multiple sawed off stumps observed trapped in the mesh.
The mesh base cable has torn away from the mesh in places due to rockfall impacts. The cable has parted in one place, possibly due to a loose joint. The cable should be repaired and reattached to the mesh.

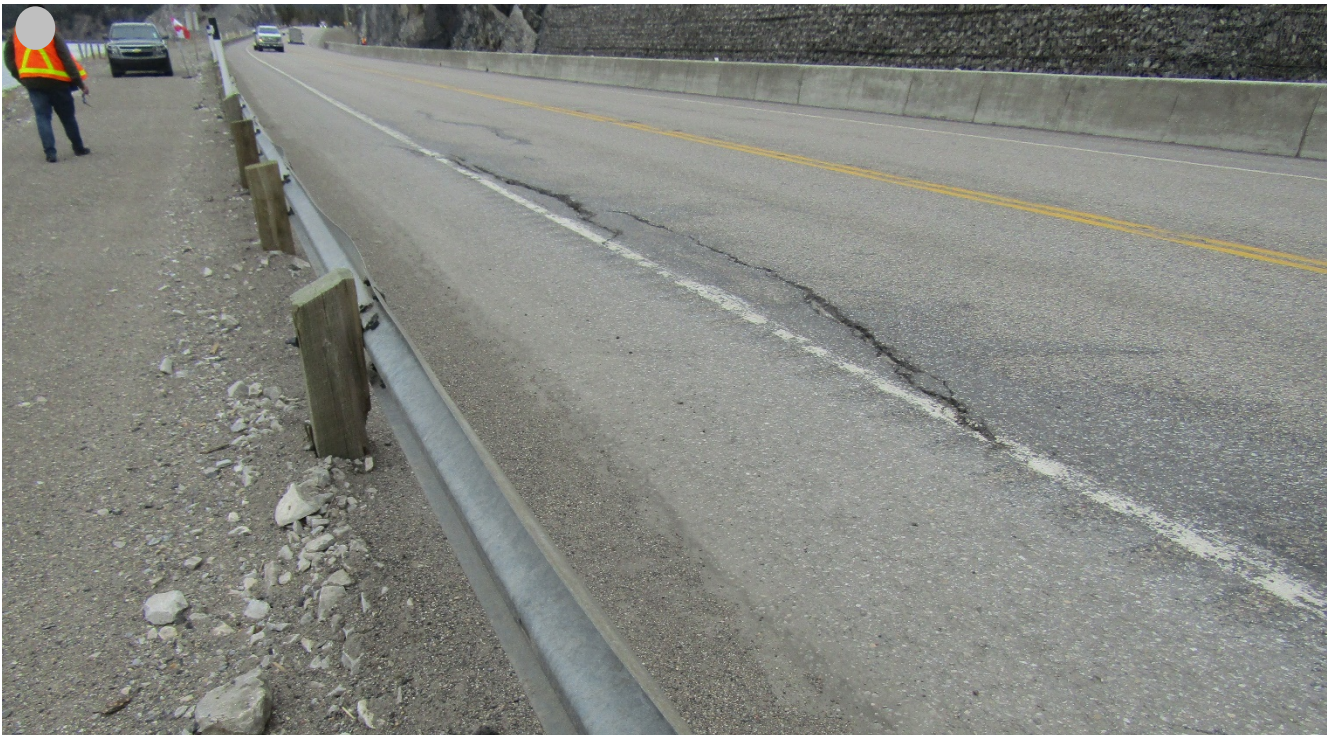
Ongoing longitudinal cracking of the pavement near Crowsnest Lake. Cracking is worse than 2017 and extends beyond the white line. Pavement is displaced approximately 30 mm vertically and cracks are open. A crack in the running lane was previously sealed.

**Photo 6**      **Pavement cracking adjacent to the lake. Photo taken facing east on May 10, 2019.**
