SITE NUMBER AND NAME: S015 Crowsnest Rockfall		HIGHWAY & KM: 3:02, 3.431	PREVIOUS INSPECTION DATE: May 10, 2019	INSPECTION DATE: May 20, 2022
LEGAL DESCRIPTION 14-05-008-05 W5M	NAD 83 COORDINATES: UTM Northing Easting 11 5499651 669776		RISK ASSESSMENT: PF: 15 CF: 2 TOTAL: 30	
AVERAGE ANNUAL DAILY TRAFFIC (AADT): 4630 (west) & 4630 (east) (Reference No. 70000005)			CONTRACTOR MAINTENANCE AREA (CMA): 26

PRIMARY SITE ISSUE: Rockfall hazard from debris falling down a ravine into the highway ditch and highway surface.

PROJECT
SOUTHERN REGION GEOHAZARD RISK MANAGEMENT PROGRAM

TITLE
Site Plan
S015 - Crowsnest Rockfall
Hwy 3:02, km 3.431

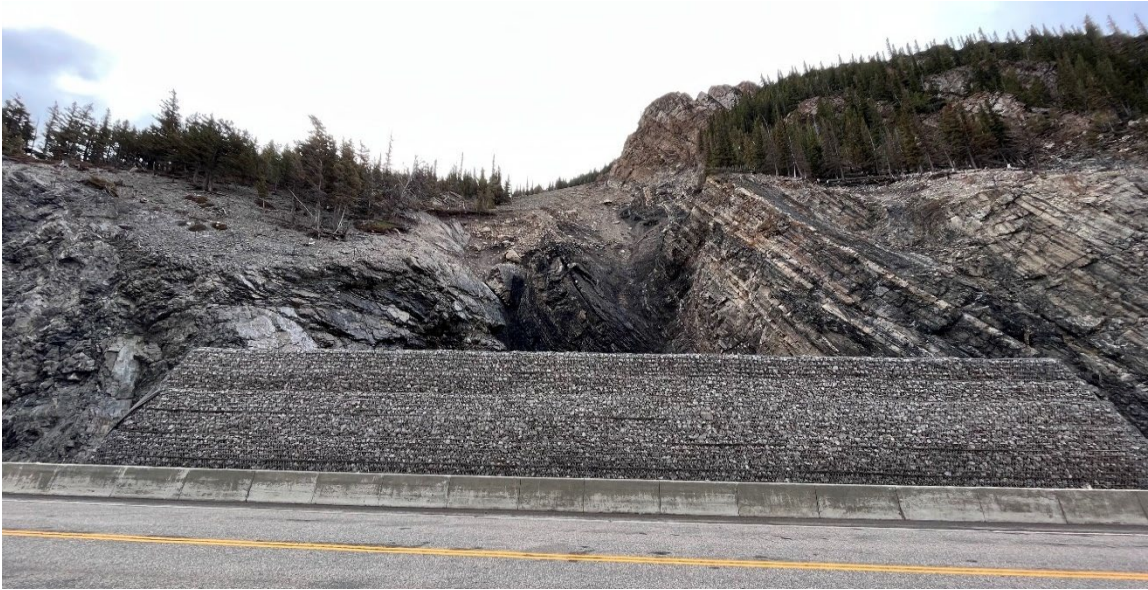
The reinforced gabion barrier prevents rockfall in the ravine from impacting the highway and appears to be performing well (Photo 1). The gabion barrier is in good condition, but multiple conveyor belts have been dislodged due to wind exposure or rockfall strikes (Photo 2 and 3).

Photo 1 Reinforced gabion barrier wall to prevent rockfall from the ravine reaching the highway. Photo was taken on May 20, 2022, facing southeast.

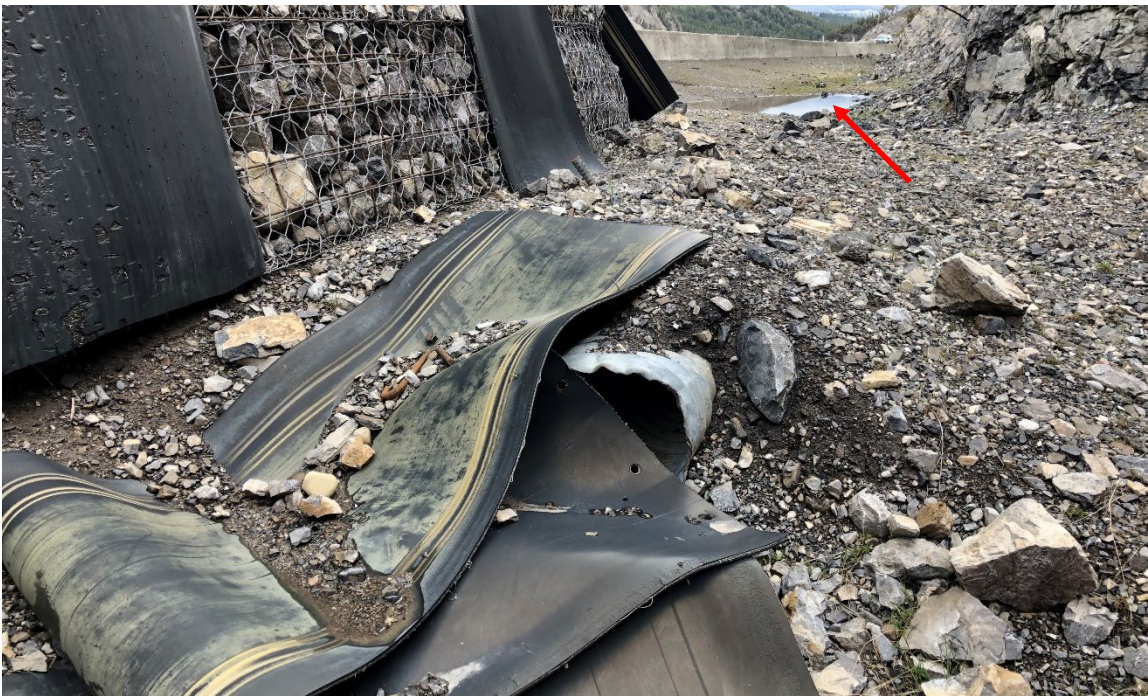
The are two culverts at the site to stop surface water runoff from undermining the northeast corner of gabion barrier. During the 2022 inspection, the culverts were blocked by fallen conveyor belts and rocks and standing water was observed northeast of the gabion barrier (WP 110) (Photo 2).

Photo 2 Rockfall material behind the gabion wall is blocking surface water drainage culverts. Standing water near the gabion wall is indicated by red arrow. Photo taken on May 20, 2022, facing northeast.

- The culverts should be cleared of any debris to allow proper drainage.
- The mesh base cable should be repaired and reattached to the mesh.
- The conveyor belts should be reattached to the gabion barrier to provide protection from rockfalls.
- The longitudinal pavement crack in the north (westbound) lane should be sealed to reduce potential infiltration.
- The site should continue to be inspected every two-years as part of the Southern Region GRMP Section B inspections.

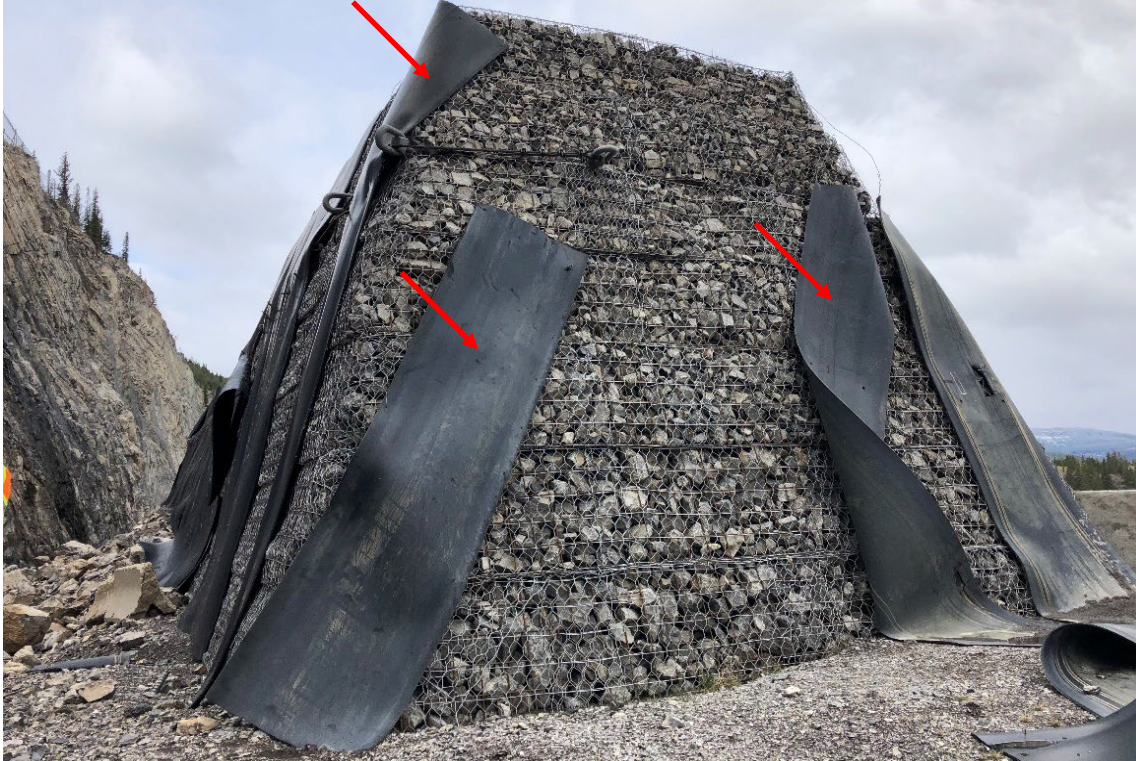
Photo 3 Rubber mats (indicated by red arrows) on south side of gabion wall have become detached and should be reinstalled to protect gabions from rockfall damage. Photo taken on May 20, 2022.

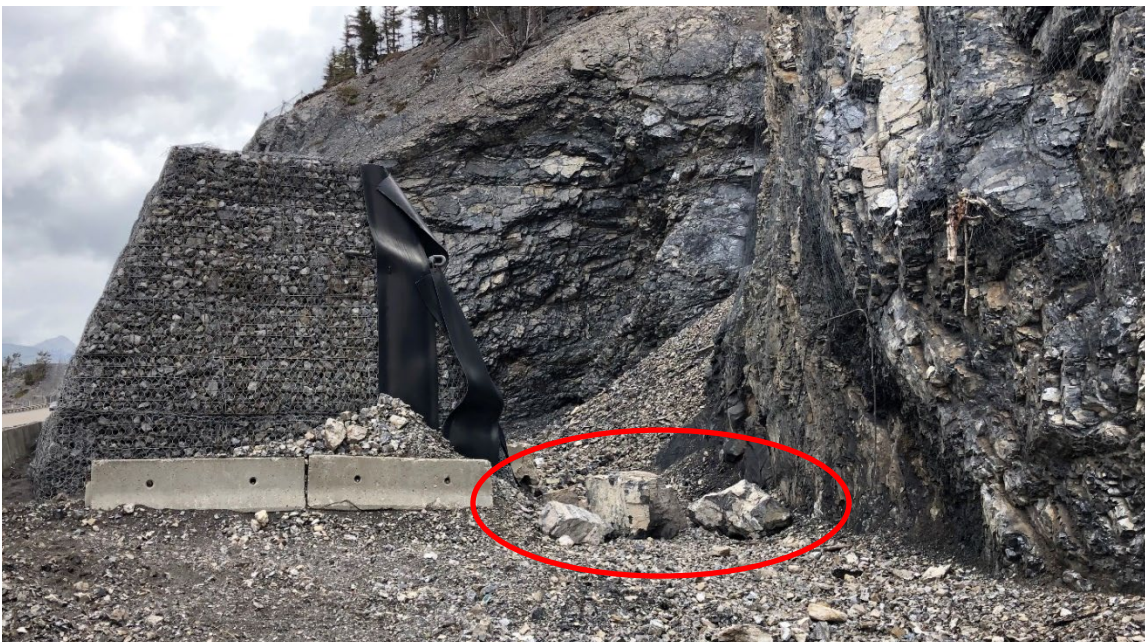
During the 2022 inspection, rockfall debris was observed building up behind the barrier (Photo 4). The debris should be removed. Mesh on adjacent rock slopes was placed to create safe access for contractors to clean out behind the wall.

Photo 4 Debris accumulation behind the barrier needs cleaning out (indicated by red circle). Photo was taken on May 20, 2022, facing northeast.

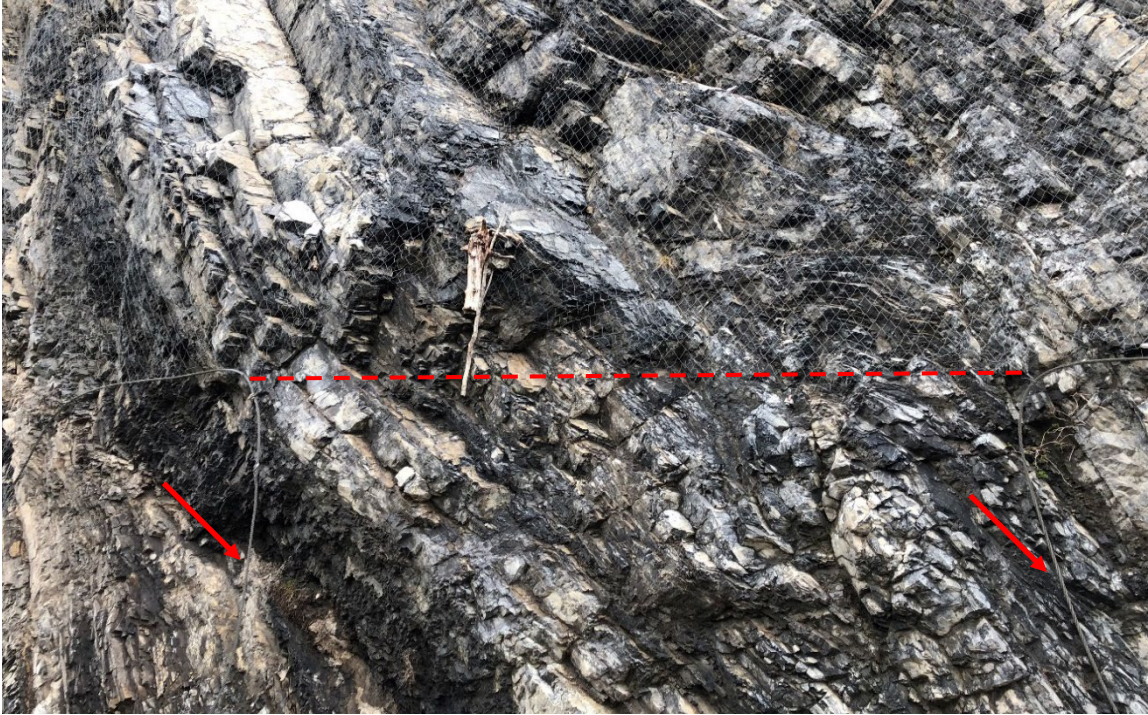
The mesh base cable has torn away from the mesh in places due to rockfall impacts (Photo 5). The cable has parted in one place, possibly due to a loose joint.

Photo 5 The base cable of the slope mesh has broken in places due to rock falls inside the mesh (loose ends indicated by red arrows). Proper location of the base a cable is indicated by red dashed line. Photo taken on May 20, 2022, facing east.

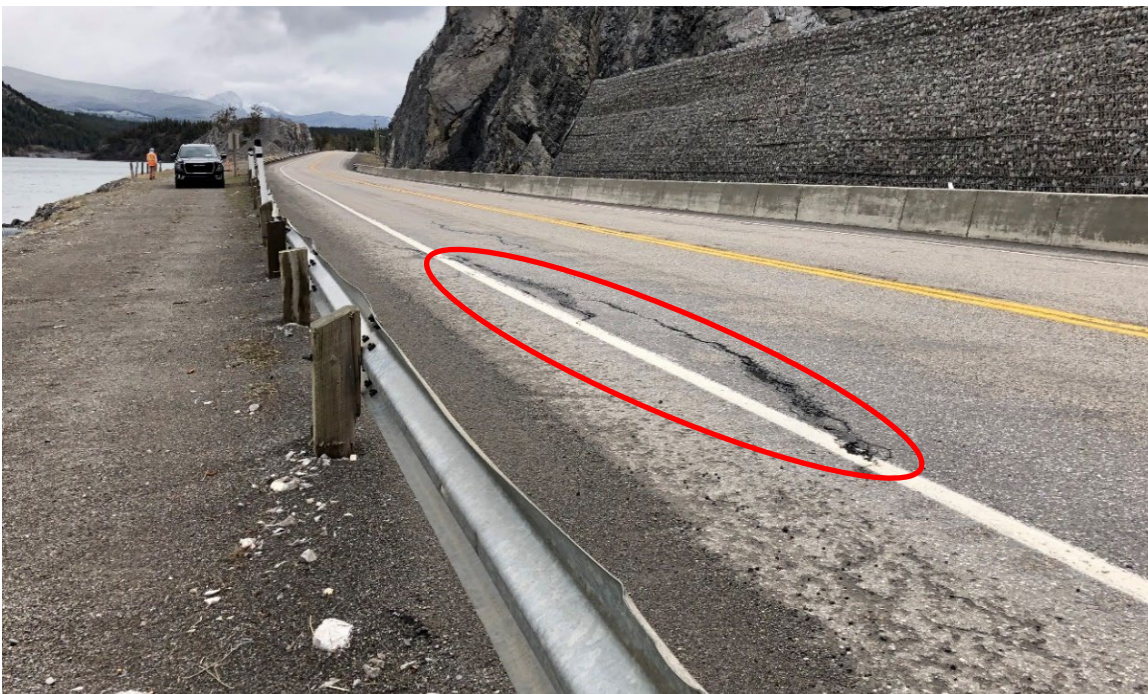
Longitudinal cracking of the pavement in the north (westbound) lane (Photo 6) has been regularly observed at the S015 site. The pavement cracking appears to be increasing in severity over time and has lengthened and widened since the 2019 inspection. The pavement has settled approximately 30 mm.

Photo 6 Longitudinal pavement cracking in the north (westbound) lane (indicated by red circle). Photo taken on May 20, 2022, facing northeast.
