SITE NUMBER AND NAME: S015 Crowsnest Rockfall		HIGHWAY & KM: 3:02, 3.431	PREVIOUS INSPECTION DATE: May 20, 2022	INSPECTION DATE: May 30, 2024
LEGAL DESCRIPTION 14-05-008-05 W5M	NAD 83 COORDINATES: UTM Northing Easting 11 5499651 669776		RISK ASSESMENT: PF: 15 CF: 4 TOTAL: 60 (Mesh) PF: 15 CF: 2 TOTAL: 30 (Gabion)	
AVERAGE ANNUAL DAILY TRAFFIC (AADT): 5880 (west), 5900 (east) (Ref. No. 70000005)			CONTRACTOR MAINTENANCE AREA (CMA): 26

PRIMARY SITE ISSUE: Rockfall hazard; debris falling down a ravine onto the highway, debris falling onto highway from the slope west of the ravine.

PROJECT
SOUTHERN REGION GEOHAZARD RISK MANAGEMENT PROGRAM

TITLE
Site Plan
S015 - Crowsnest Rockfall
Hwy 3:02, km 3.431

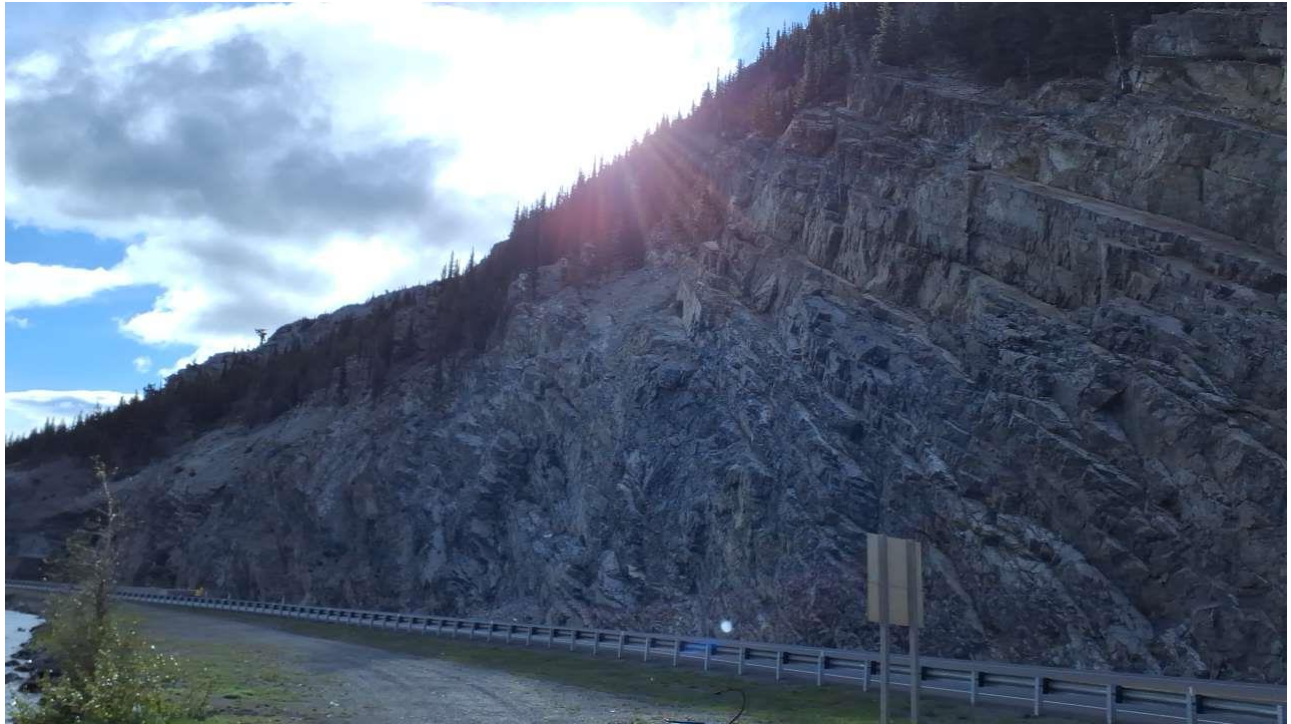
Photo 1 Rock slope with wire meshing south of Hwy 3. Photo was taken facing southeast on May 30, 2024.

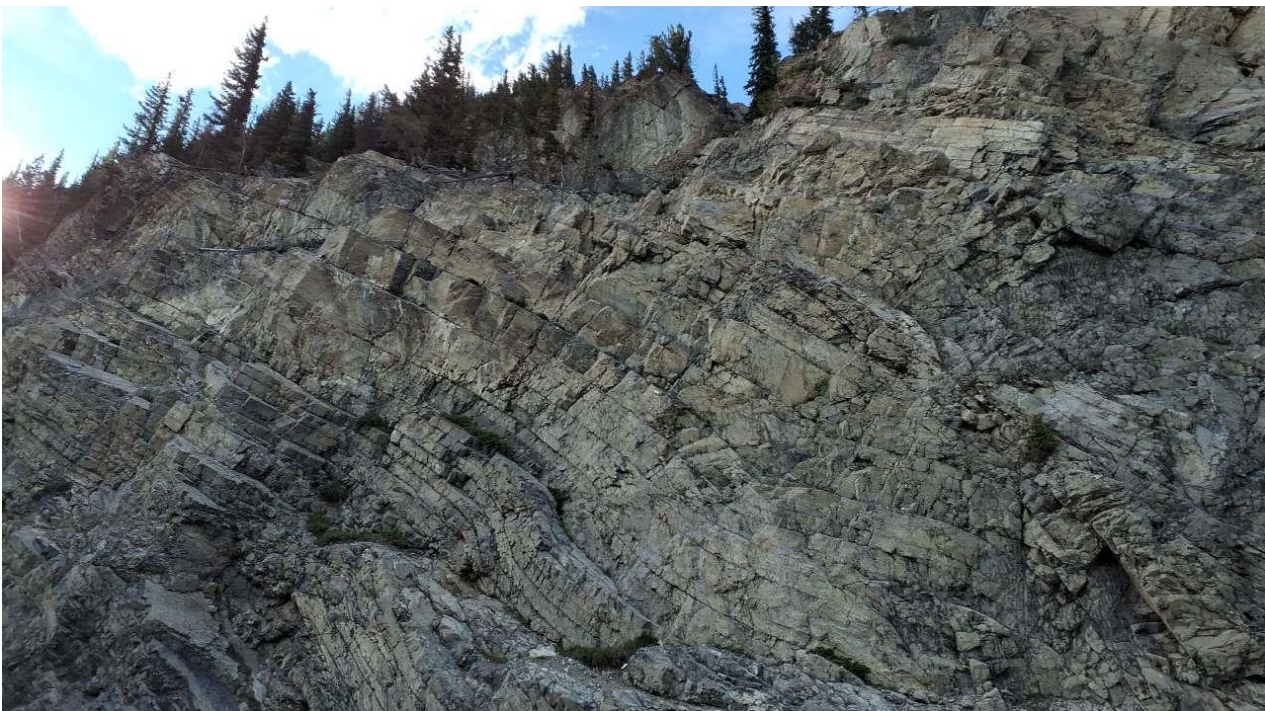
There are several potential rockfall source sites above the top of the attenuation mesh that could generate enough rockfall velocity or trajectory to bounce over the rockfall fence, avoiding the mesh, to the highway and ditch below.

Photo 2 Rock slope with wire meshing south of Hwy 3. Potential rockfall source from ravine above wire mesh. Photo was taken facing south on May 30, 2024.

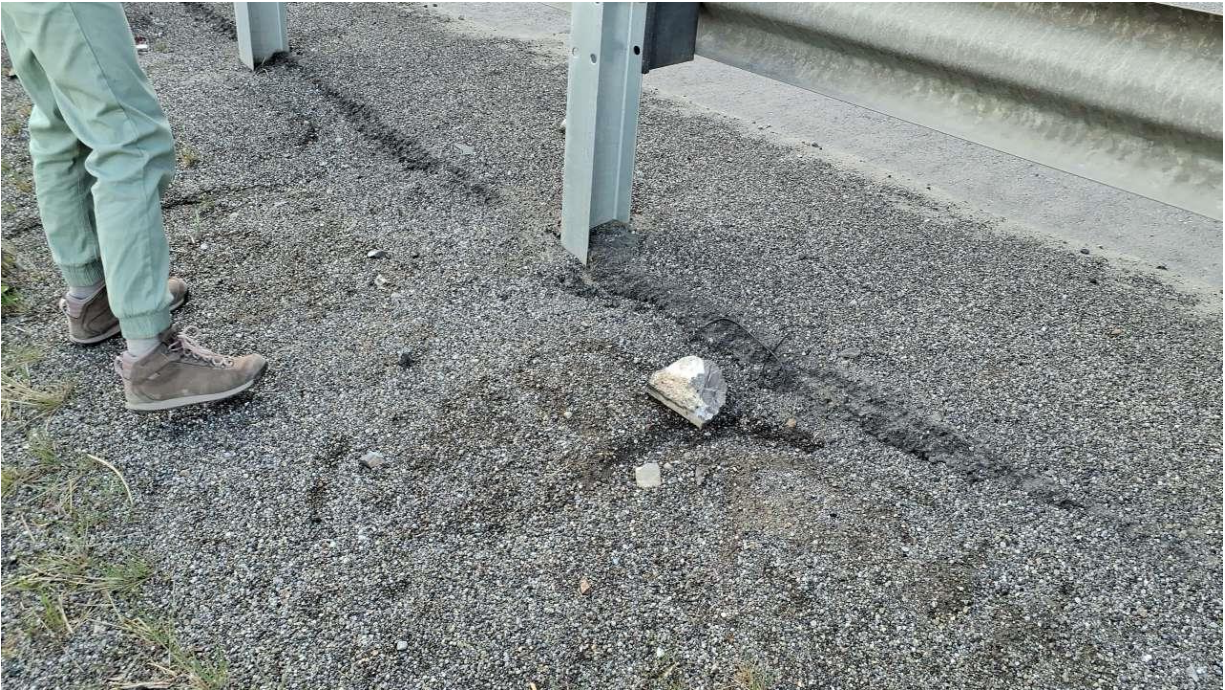
In 2023, rockfall debris (up to 250 mm in diameter) was noted by the HMC to have fallen onto and across the highway west of the ravine where the attenuation mesh is installed. During the 2024 inspection, a 150 mm diameter rockfall particle was noted on the north side of the highway, which could have fallen from the slope across the highway.

Photo 3 Rock fall debris located on north side of highway which may have travelled across the highway. Photo was taken facing southeast on May 30, 2024.

The trajectory of the larger (250 mm in diameter) particle noted by the HMC in 2023 that reached the westbound lane is not known, one of the possible trajectories could be addressed by extending the jersey barrier to the west approximately 120 m to help prevent higher energy rock fall particles discharging from the base of the attenuation mesh.

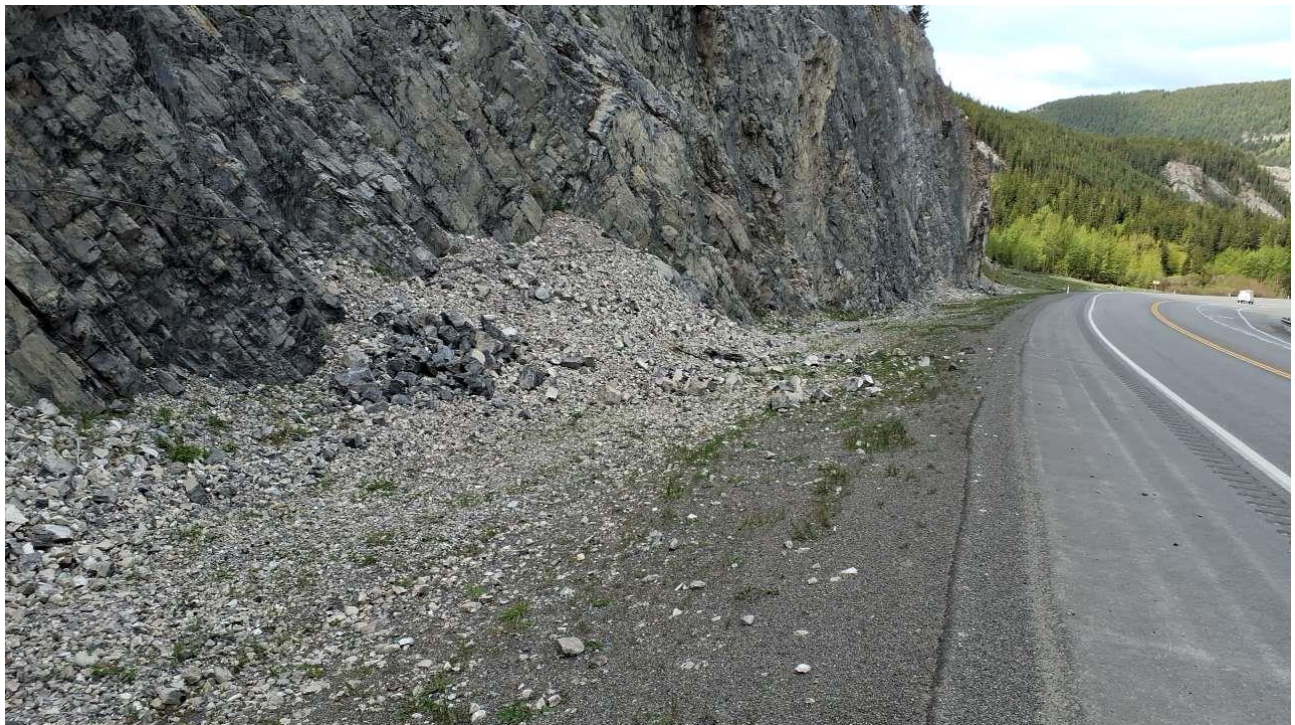
Two piles of rock debris (>2 m³ and >5 m³) were observed at the toe of the rock slope in the south ditch, west of the concrete jersey barrier. These debris piles were at the locations where the rock strikes and rock debris were observed on the highway surface.

Photo 4 Rock fall debris at the base of the wire mesh and ditch along the rock slope. Photo was taken facing west on May 30, 2024.

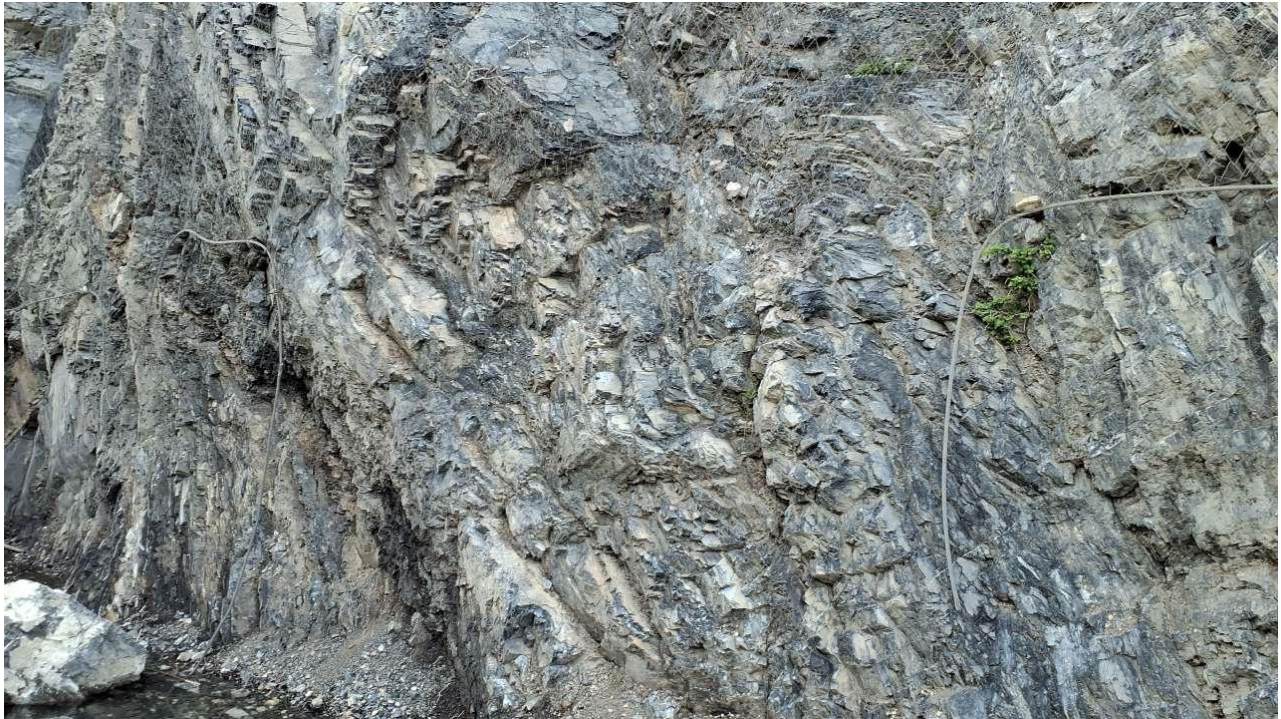
The mesh base cable has torn away from the mesh in places due to rockfall impacts. The cable has parted in one place, possibly due to a loose joint. The cable should be repaired and reattached to the mesh.

Photo 5 Cable at the base if the wire mesh separated in multiple locations. Photo was taken facing southeast on May 30, 2024.

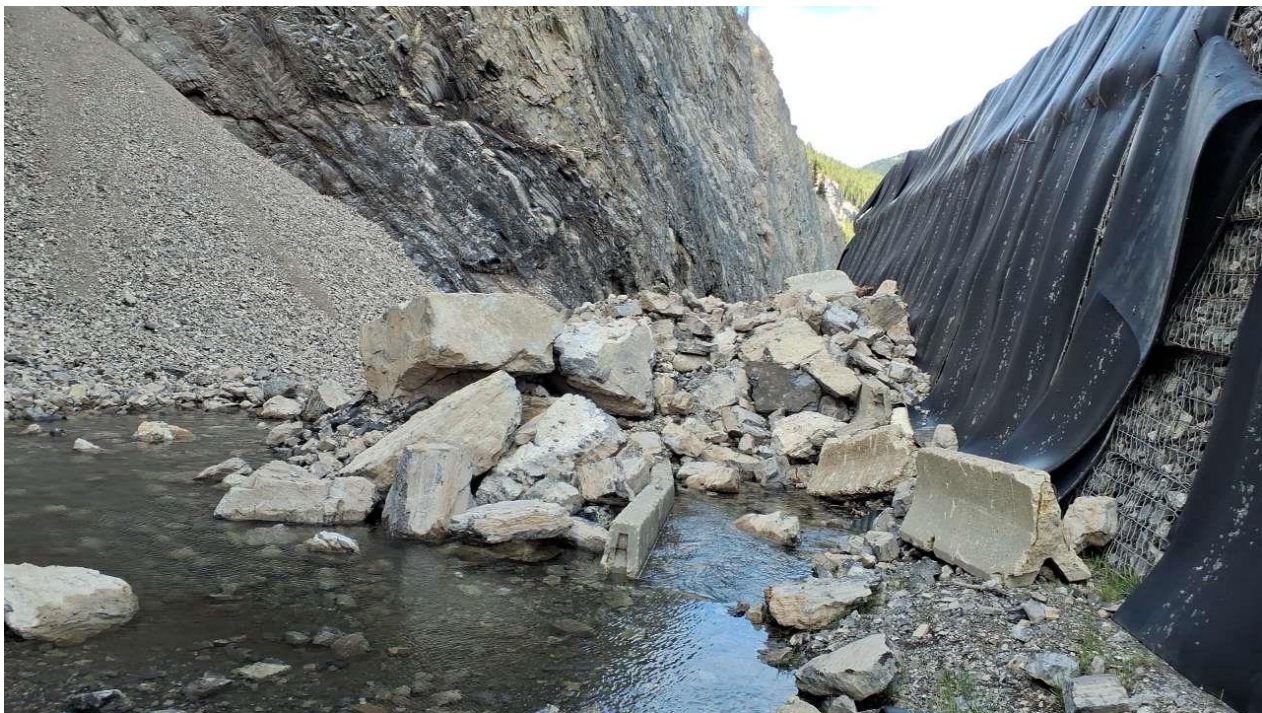
Photo 6 Debris accumulated behind gabion barrier. Photo was taken facing west on May 30, 2024.

Maintain and repair barrier as needed. Rockfall debris is building up behind the barrier and should be removed. Mesh on adjacent rock slopes was placed to create safe access for contractors to clean out behind the wall.

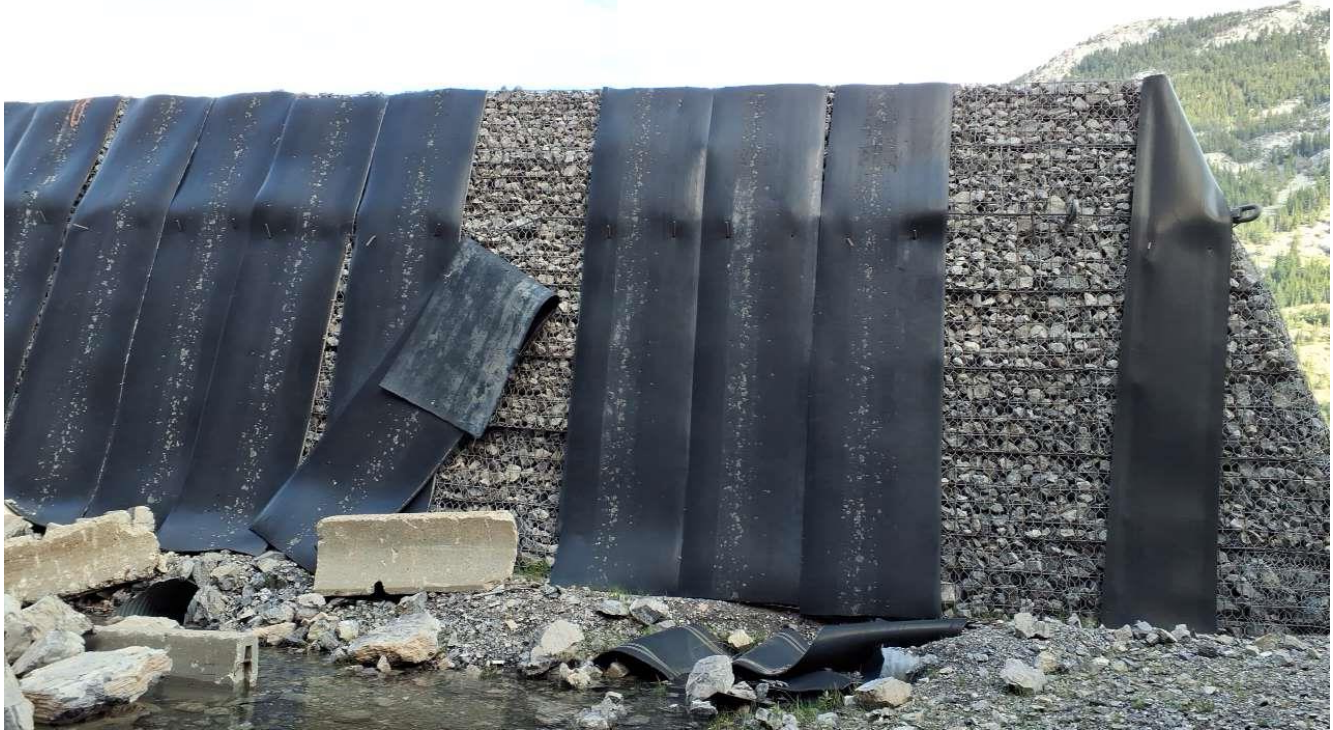
The gabion wall appears to be in good condition. Multiple conveyor belts have been dislodged due to wind or rock strikes. The belts should be reattached to the back of the gabion wall for protection.

Photo 7 Rubber mats on south side of gabion wall have become detached and should be reinstalled to protect gabions from rockfall damage. Photo taken facing north on May 30, 2024.
