September 2, 2016

Alberta Transportation  
2<sup>nd</sup> Floor, Willowglen Business Park  
803 Manning Road NW  
Calgary, Alberta  
T2E 7M8

**CON0017609 Southern Region GRMP - Call-Out Reports**  
**S047 - Hwy 3:02 Coleman Bin Wall (km 13.283)**  
**S048 - Hwy 3:04 Castle Back Slopes (km 23.567)**

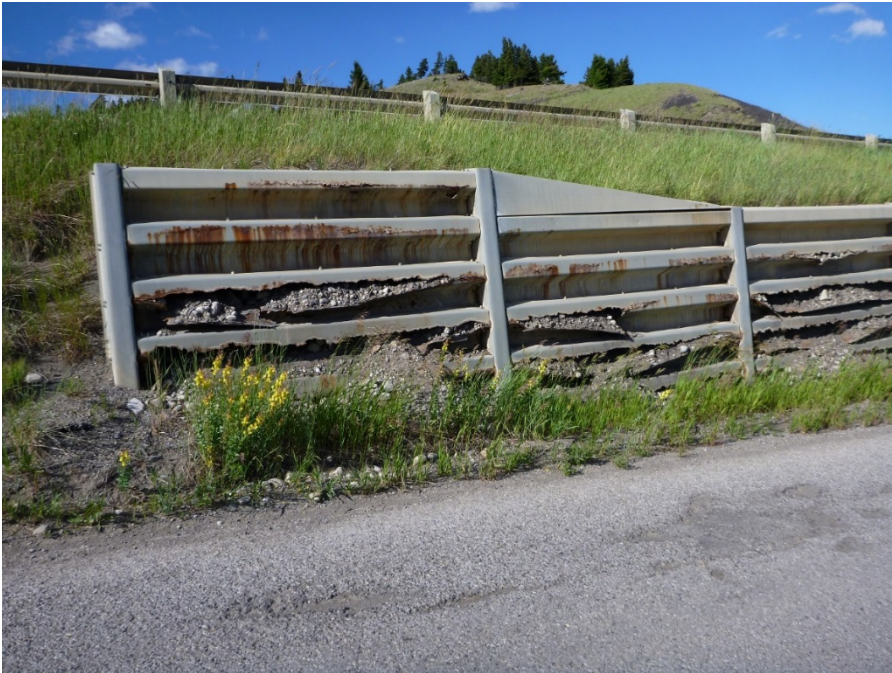
- 11 sections (approximately 35 m) of the binwall structure have experienced corrosion visible from 19 Avenue. Granular fill material has started coming out of the eight western most bin walls (Photo 1). Rust stains are present on the remaining 3 bin walls showing evidence of corrosion.

- In general, there appeared to be no visible sign of global instability of the binwalls, aside from the rupture and loss of backfill materials in 8 binwalls.

The call-out inspection can only assess the external condition of the bin wall. The condition of the buried structural members is unknown. However, corrosion of the buried structural elements should be expected.

The observation of corrosion being located only on the binwall segments located adjacent to a valley suggest that groundwater seepage may be more corrosive and aggressive near the valley. The reasons for this are not clear; however, the cause of the corrosion failure of the wall could include, but not be limited to:

- drainage from abandoned mine workings or piles of slack coal upslope of the binwalls could be acidic; and
- the soil backfill placed in the binwalls could have variable geochemical properties which would result in varying degrees of corrosion potential.

There is potential for brittle failure of the retaining wall caused by a collapse failure of buried and corroded structural elements in tension. In the absence of any observations that could refute this and given the proximity of 19 Avenue to the toe of the wall, repairs should be implemented immediately. Failure of the wall will impact the Hwy 3 embankment slope above the binwall and could lead to retrogression of the backscarp to the edge of the pavement or into the eastbound lane.

**Photo 1 Corroded and failing Bin Wall. Photo was taken facing northeast on June 15, 2016.**

A jersey barrier should be installed in front of the failing sections of the wall with signage installed indicating a speed reduction, narrow lane and hazard indication. The rate of backfill loss through the voids and short term failure of the binwalls could be reduced by placement of temporary steel plating over the face of the walls braced with concrete jersey barricades and/or granular fill placed at the toe of the binwalls. The cost of this work should be between \$10,000 and \$20,000. However, the drilling investigation described in section 6.2.2 should be completed first.

The extent of repair required cannot be assessed at this time. Based on the degree of deterioration visible from 19 Avenue, it appears that the corroded sections of the binwall need to be replaced. However, the extent of corrosion of buried structural elements is unknown. While adjacent, apparently good condition binwalls can be exposed to have their buried structural elements exposed and assessed, it will not be possible to completely assess the condition of all buried elements of the binwall without excavating the entire wall. Therefore, AT the following options:

- partial or complete binwall removal, depending on conditions of exposure of buried structural elements, with replacement with a reinforced earth retaining wall system; and
- rehabilitate the wall in situ without removal of the bin walls with:
  - ◆ corrosion protected tied back pre-cast or cast-in-place concrete panels placed over the front of the binwalls; and
  - ◆ A tied back driven steel h-pile and timber lagging retaining wall.

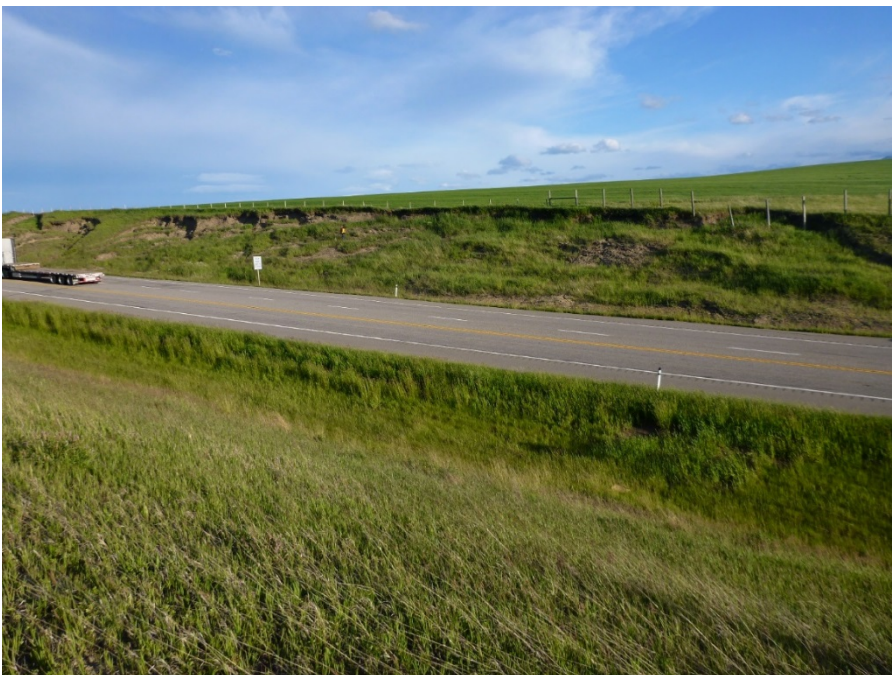
- An approximately 200 m length of the 8 m high back slope has failed on the north facing south slope (Photos 2, 3, 4, and 5). The slope on the south side is approximately 3H:1V. The failed slope is sporadically vegetated as a result of the failure and sloughing. The south-facing north slope has not failed.

- The slide appears to be a result of surface water and possibly groundwater drainage toward and out of the south or north-facing slope. The north-facing south slope has a larger catchment area to the southeast draining towards it. By contrast, regional surface water drainage appears to be draining away from the crest of the south-facing slope.

It appears that the root cause of the back slope failure of the south slope is primarily related to surface runoff with an unknown contribution from regional groundwater seepage. The south slope gets less sunlight than the slope on the north side of Highway 3 because it is oriented facing north, and therefore there is less evapotranspiration occurring on the south slope which will support wetter conditions. Review of the imagery presented in Figure 1 indicates a lighter color on the north slope which indicates drier conditions. The zones of failure on the south slope are also lighter colored which indicates that the failed materials may dry out due to loss of grass cover or disrupted surface drainage.

**Photo 2 Looking south at the north-facing failing back slope. The photo was taken on June 15, 2016.**

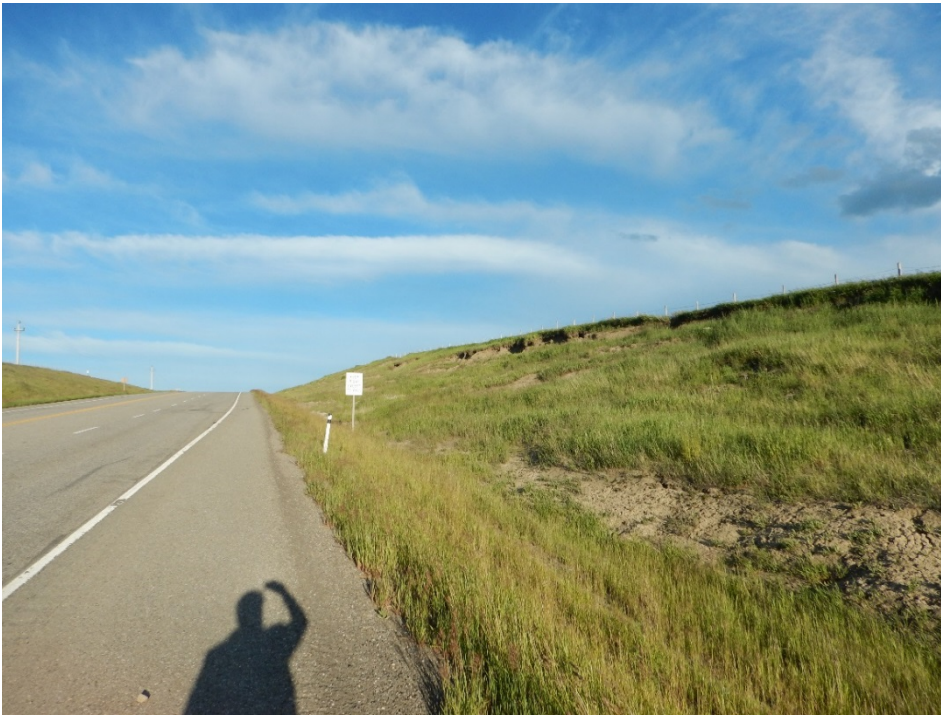
**Photo 3** Looking east at the failing back slope. The photo was taken on June 15, 2016.

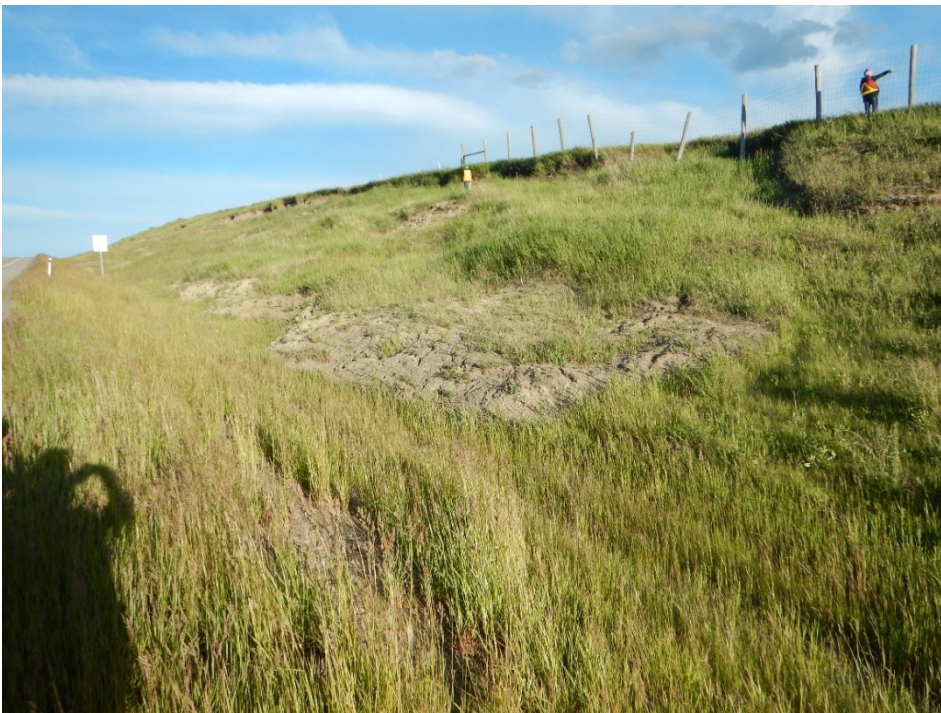
- The failed back slope has undermined a fence line beside the adjacent field over a length of approximately 10 m (Photos 4, 6, and 7). Four fence posts have been undermined by the slope failure. Other than the four fence posts that have been undermined, in general, the fence line appears to be relatively straight along the crest of the slope (Photo 10).

**Photo 4** Looking southeast at the failing back slope. The photo was taken on June 15, 2016.

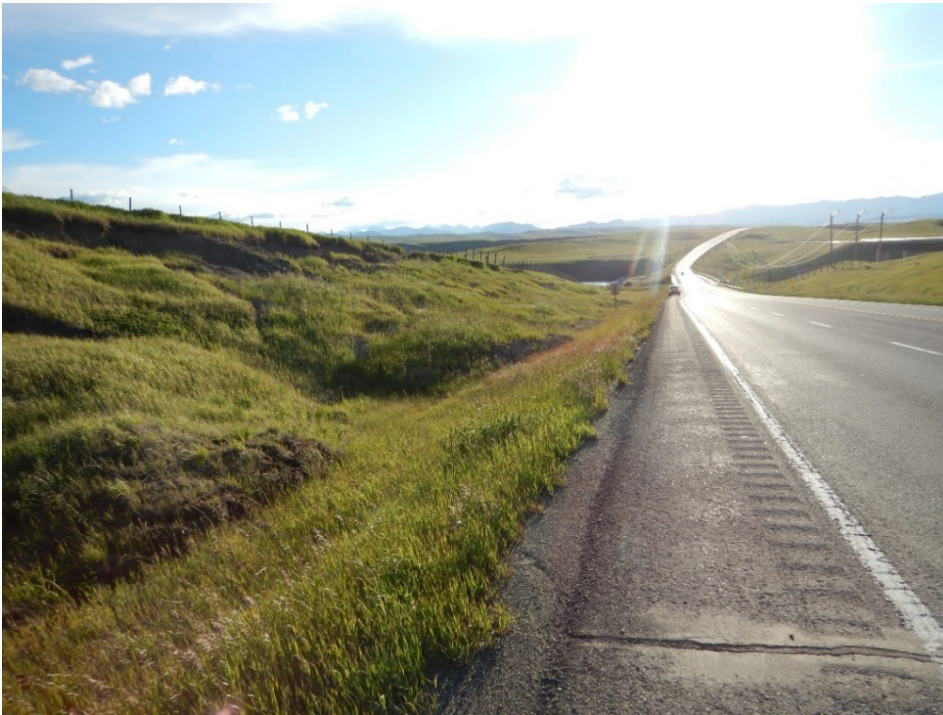
- The zone of accumulation at the toe of the slide has extended into the ditch and has caused some partial ditch blockage and some erosion (Photo 5).
- The sloughing has resulted in a near vertical slope at the crest of the slope near the fence (Photos 8 and 9).

**Photo 5** Looking west at the failing back slope. The photo was taken on June 15, 2016.

For the short term, the ditch should be re-graded to allow for positive surface water drainage. This will require removal of slide toe materials from the ditch. The amount of slide material should be limited to the minimum required to re-establish drainage without initiating additional slope movements. The cost of this work is estimated to be between \$5,000 and \$10,000.

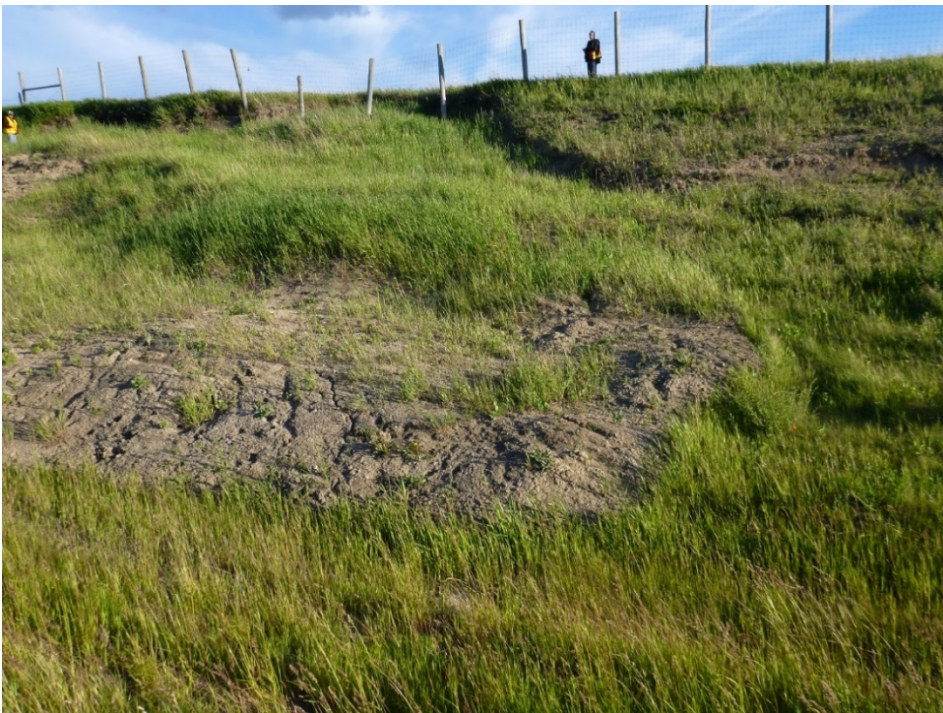
**Photo 6** A closer look at the failing back slope. The fence has failed as a result of the failing slope. The photo was taken on June 15, 2016.

The long term solution for this site should include establishing a crest ditch to intercept surface water drainage and divert it downslope in an armoured channel. The area where the slide has retrogressed behind the fence line should either be re-established with fill or have the fence line relocated. The entire failed back slope area should be hydro-seeded to re-establish grass cover.

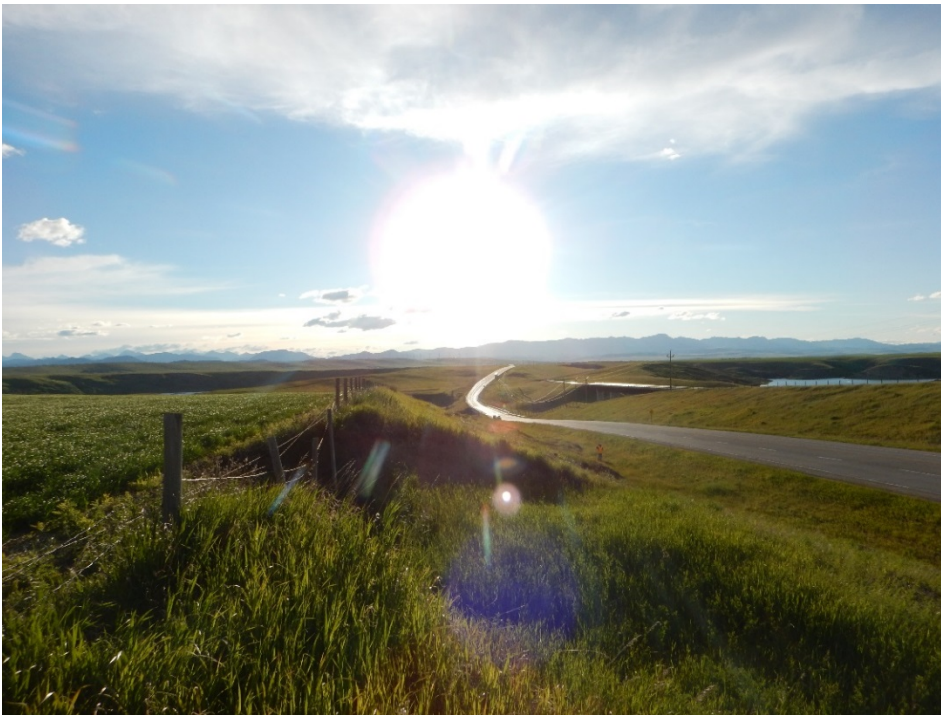
**Photo 7** Fence posts that have failed and sloughed as a result of the failing back slope. The photo was taken on June 15, 2016.

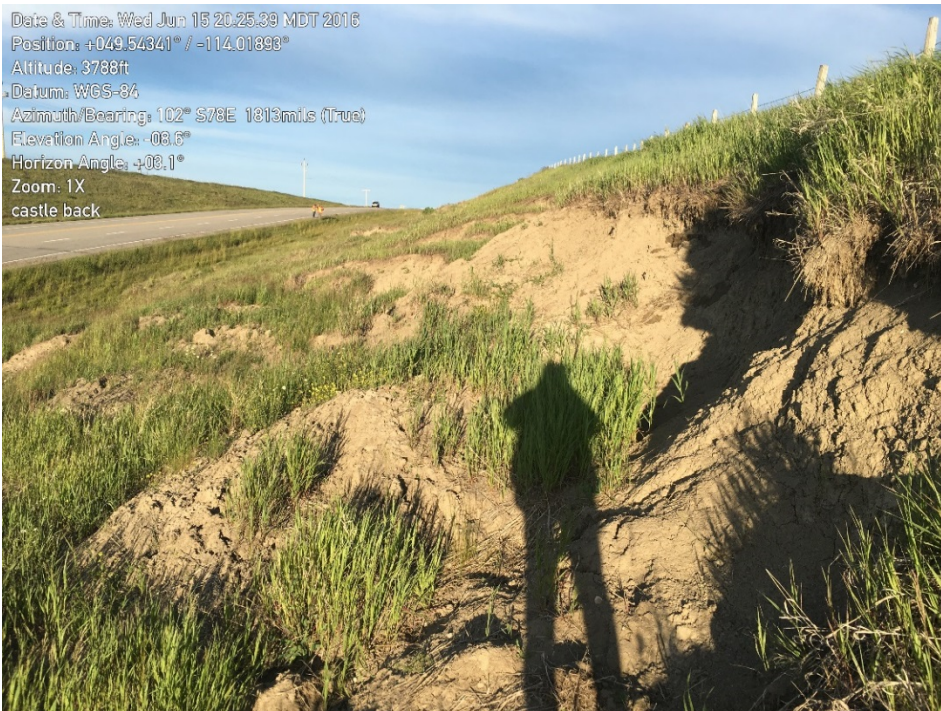
**Photo 8** Looking east at the failing back slope approximately 200 m on the south side. Rills on the slope were present. Photo taken on June 15, 2016.

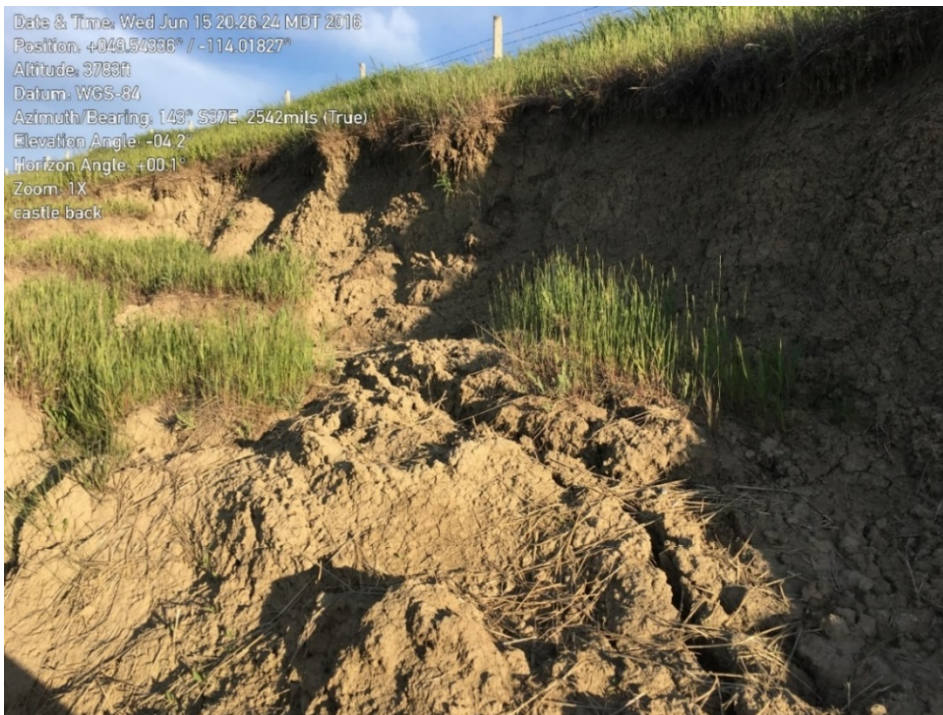
- Some minor erosion and rills can be seen on the failed slope material (Photo 9).

**Photo 9** Entire back slope is moving and eroding due to a water runoff from the field. Photo taken on June 15, 2016.

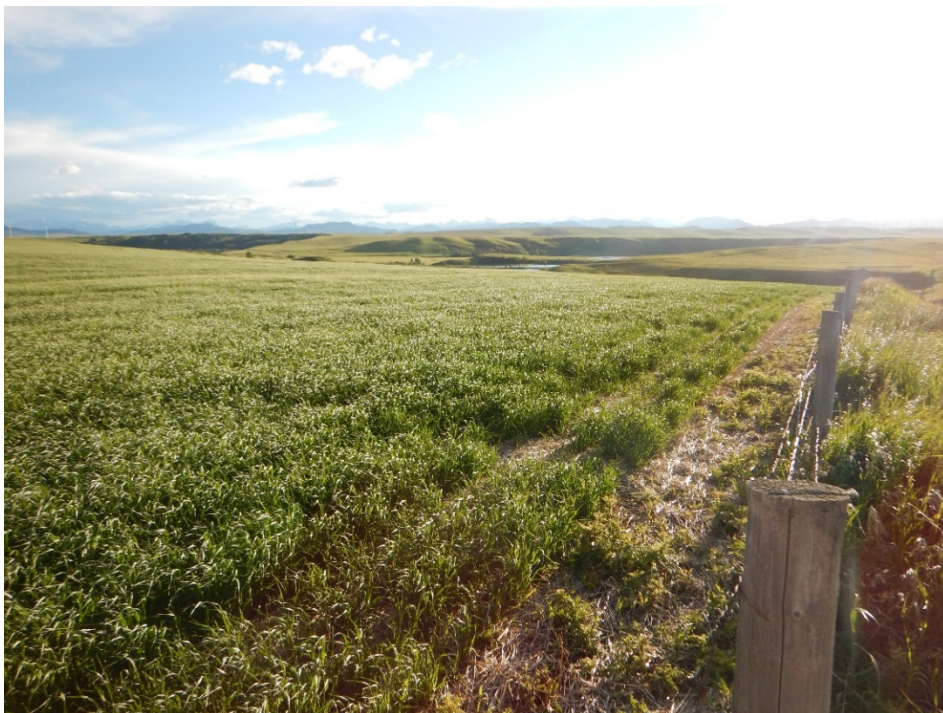
**Photo 10** Looking west at the slope and drainage grade in the field adjacent to the south side (crest) of the slope. The photo was taken on June 15, 2016.
