| SITE NUMBER AND NAME:<br><b>S048 Castle Back Slopes</b> | | HIGHWAY & KM:<br>3:04, 23.567 | PREVIOUS INSPECTION DATE:<br>May 2, 2018 | INSPECTION DATE:<br><b>June 9, 2020</b> |

| PRIMARY SITE ISSUE: Multiple slope failures on the south bank of the highway into the ditch extending up to 4 m onto private land. The slope failures are coalescing to form larger backslope failure areas and toe rolls are blocking the ditch. | |

| PROJECT<br>SOUTHERN REGION GEOHAZARD RISK MANAGEMENT PROGRAM | | |
| TITLE<br>Site Plan<br>S048 - Castle Back Slopes<br>Hwy 3:04, km 23.567 | | |

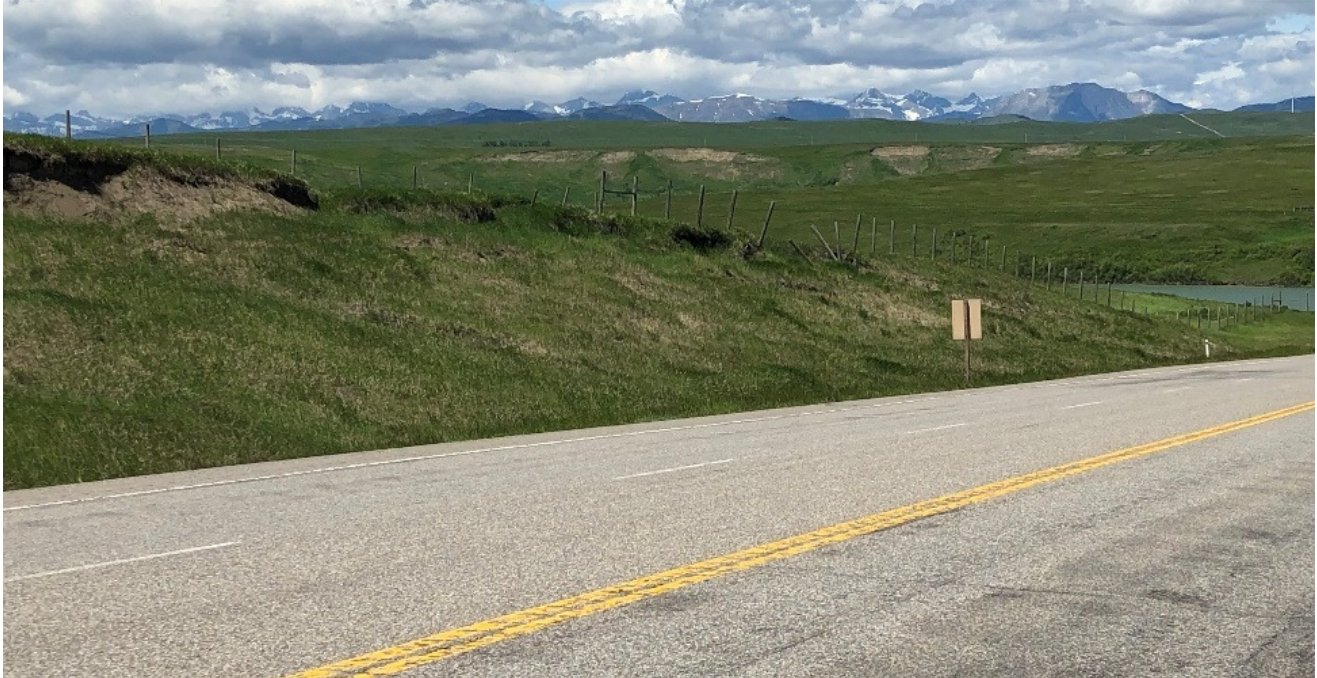
| The exposed back scarp was up to 1.8 m high. Tension cracking near the crest indicates ongoing slope movement and slide retrogression. |

**Photo 1** Looking south at the north-facing failing back slope. The photo was taken on June 9, 2020.

- Flatten the slope to 4H:1V or 5H:1V, which would require moving the fence line back on the slope crest. A preliminary design should be prepared to assess slope flattening and the area of land required should be assessed. KCB could prepare the preliminary design without investigation, with AT putting the investigation costs into land purchase. AT land agents should contact owner of the land at the crest of the backslope and start discussions on land procurement.
- Material excavated during slope flattening could be stockpiled in low area to the southwest of the site, levelling the area for possible future use by the farmer. The stockpile/fill placement should consider the potential for destabilizing the Oldman River slope near the Hwy 3 bridge.

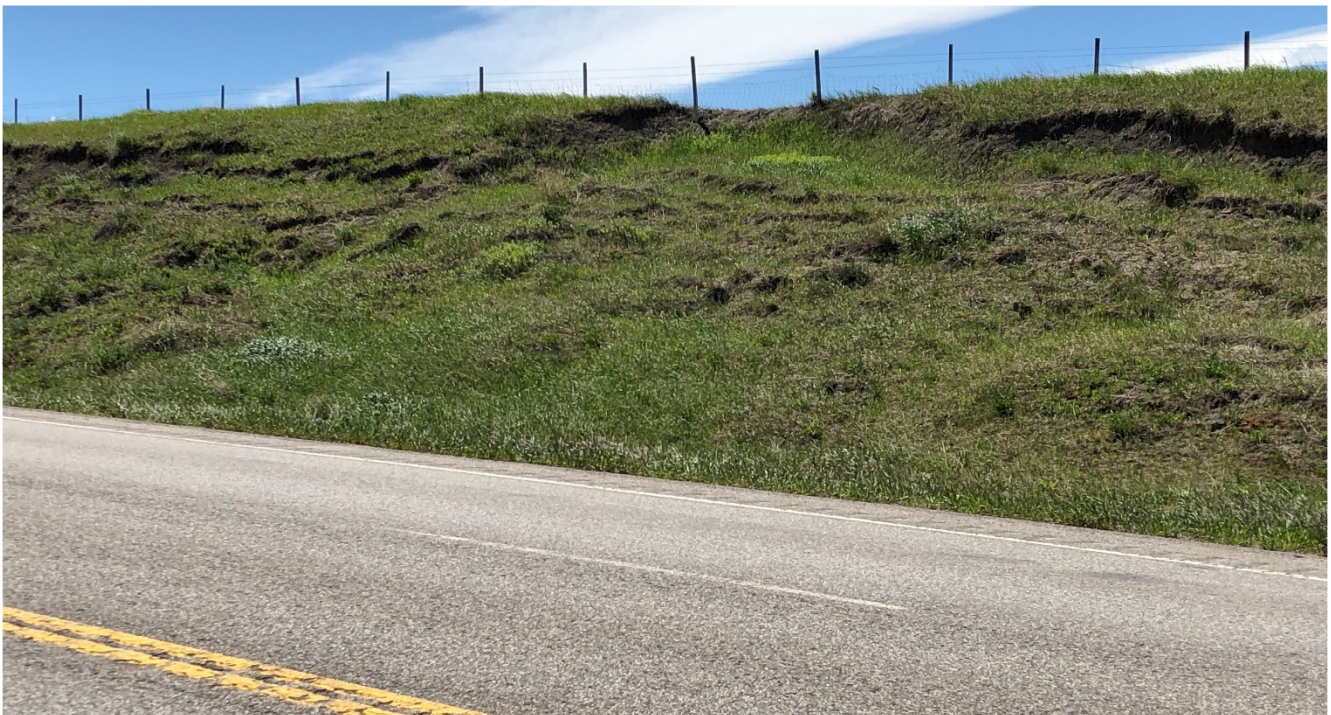
**Photo 2** Looking south at the north-facing failing back slope. The photo was taken on June 9, 2020.

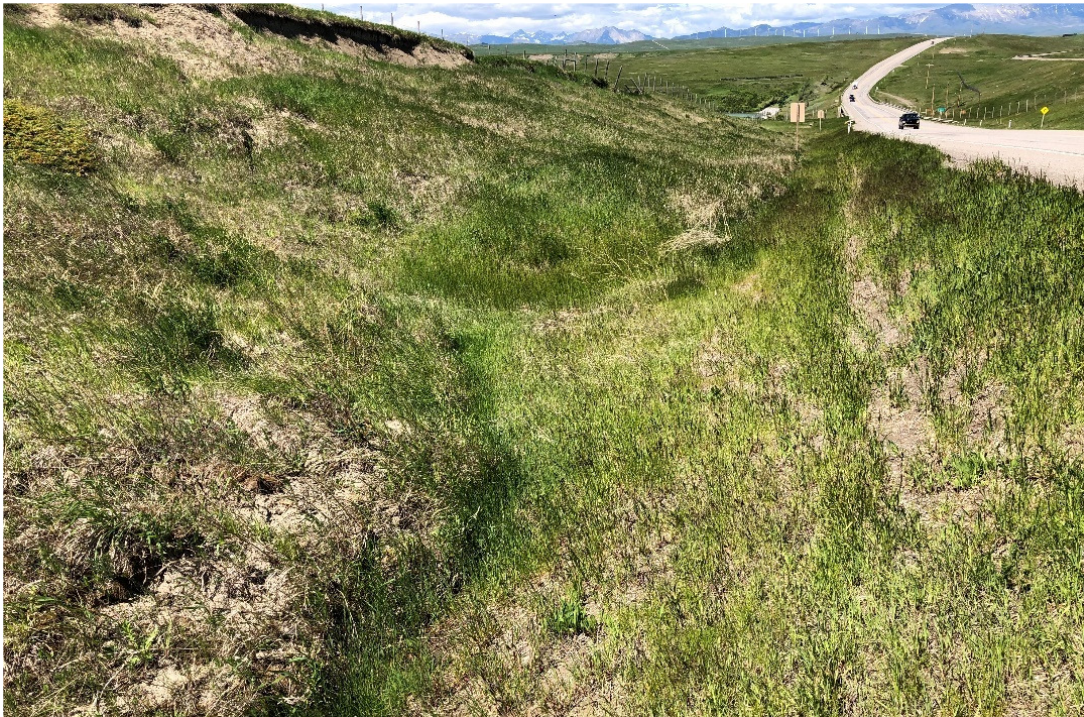
| Failure zones are coalescing and the zone of accumulation at the toe of the slide is blocking the ditch over the length of the failure. Areas of ponded water were noted along the length of the ditch. |

**Photo 3** Toe rolls coalescing and blocking the ditch. The photo was taken facing west on June 9, 2020.

- The drainage ditch should be regraded to allow for positive surface water drainage, this will require the removal of the slide toe materials from the ditch. Materials removed should be kept to the minimum required to re-establish drainage without initiating additional slope movements.

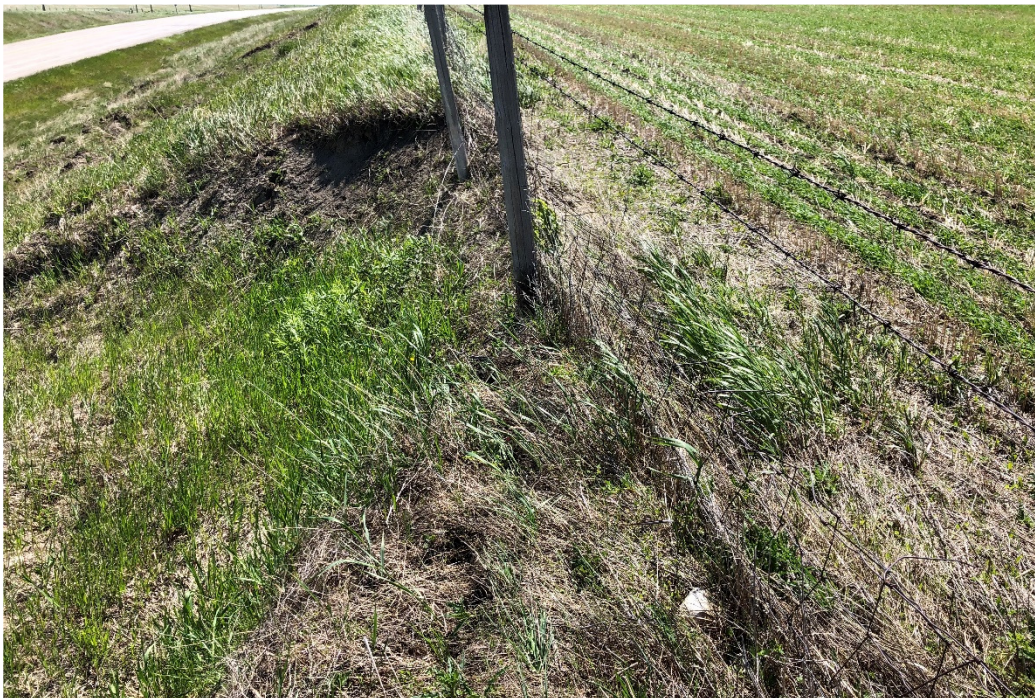
| Barbed wire fence at the crest of the slope to private farmland is being undermined by the slope failures at 4 separate locations. Other sections of fence appear relatively straight along the crest of the slope. |

**Photo 4** Fence being undermined in several locations by slope failure. Photo taken facing east on June 9, 2020.

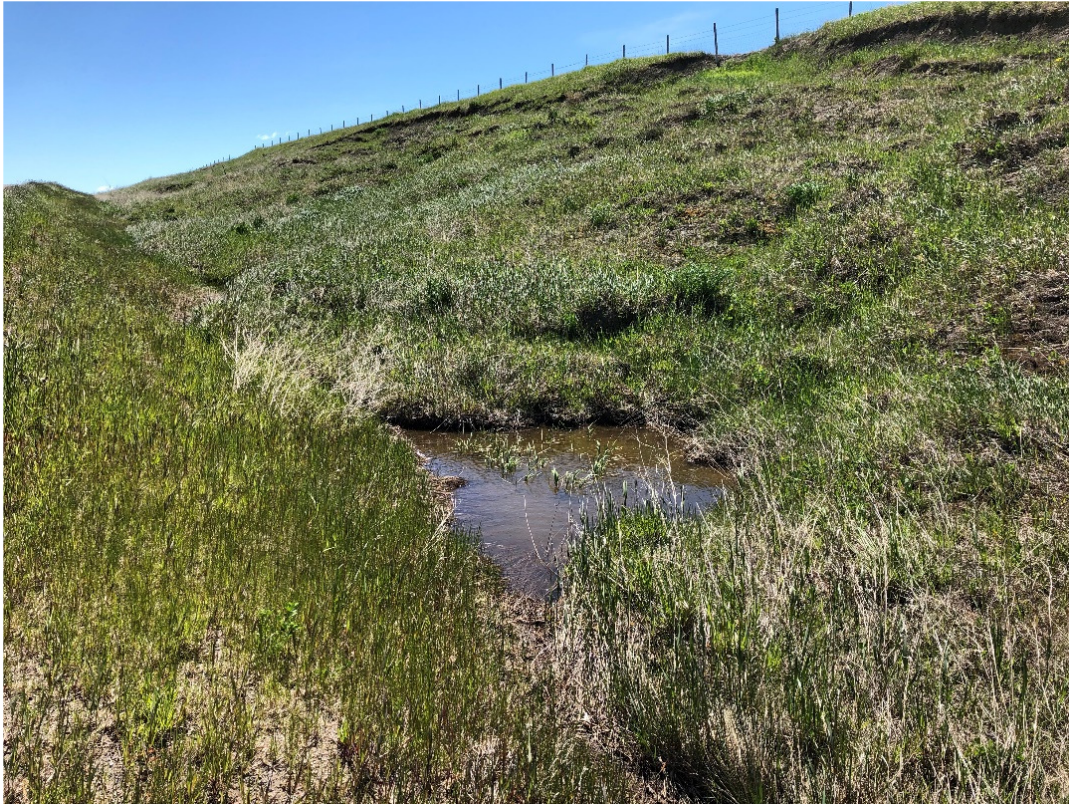
**Photo 5** Toe rolls blocking ditch at several locations. Photo taken facing east on June 9, 2020.
