SITE NUMBER AND NAME: S048 Castle Back Slope Failures		HIGHWAY & KM: 3:04, 23.708	PREVIOUS INSPECTION DATE: June 9, 2020	INSPECTION DATE: July 8, 2021
LEGAL DESCRIPTION: 15/06-12-007-01 W5M	NAD 83 COORDINATES: UTM Northing Easting 11 5492157 715695		RISK ASSESMENT: PF: 9 CF: 3 TOTAL: 27	
AVERAGE ANNUAL DAILY TRAFFIC (AADT): 3,860 (west), 4,140 (east), (Ref. No. 78050)			CONTRACTOR MAINTENANCE AREA (CMA): 26

PROJECT SOUTHERN REGION GEOHAZARD RISK MANAGEMENT PROGRAM		
TITLE Site Plan S048 - Castle Back Slope Failures Hwy 3:04, km 23.708		
SCALE 1:1,700	PROJECT No. A05116A03	FIG No. 1

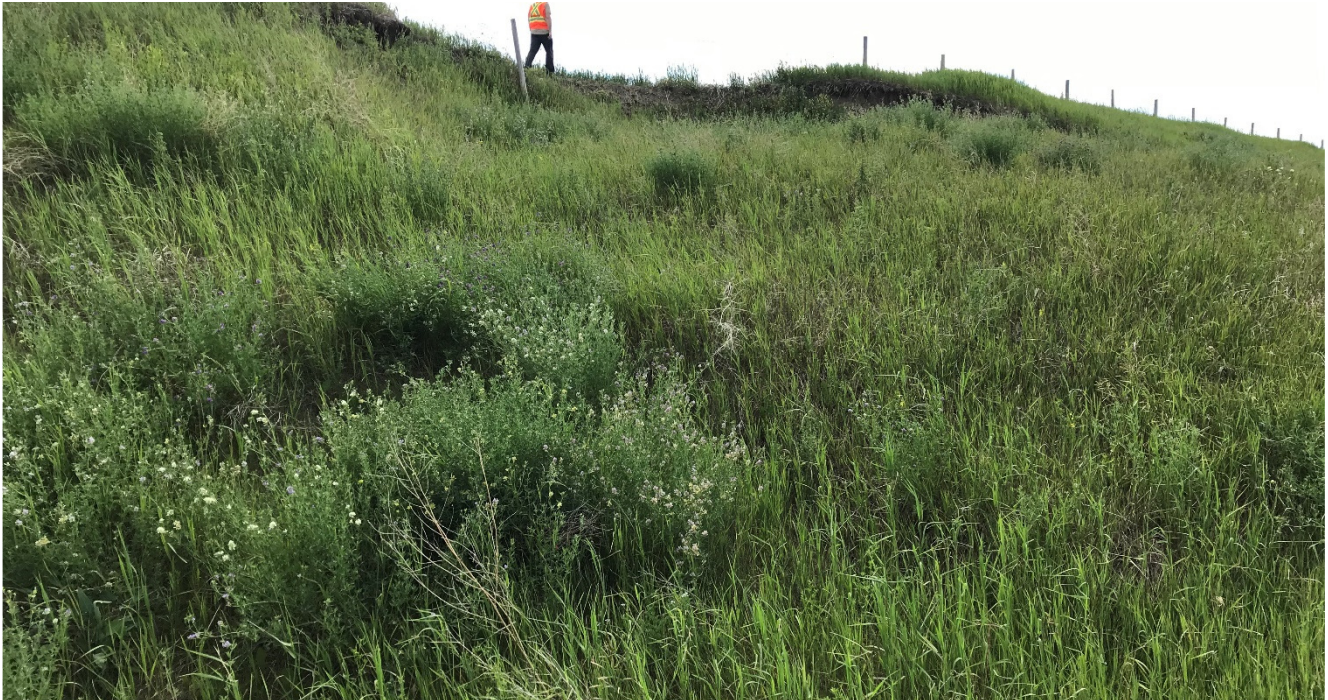
During the 2021 inspection, the lateral extents of the slope failure appeared similar to 2020. In the slide zones, the exposed back scarp is up to 1.8 m high. Tension cracking near the crest indicates ongoing slope movement and slide retrogression. Failure zones are coalescing.

Photo 1 Looking south at the north-facing failing back slope. Photo taken on July 8, 2021.

- Flatten the slope to 4H:1V or 5H:1V, which would require moving the fence line back on the slope crest. A preliminary design should be prepared to assess slope flattening and the area of land required should be assessed. KCB could prepare the preliminary design without investigation, with AT putting the investigation costs into land purchase. AT land agents should contact the owner of the land at the crest of the backslope and start discussions on land procurement.
- Material excavated during slope flattening could be stockpiled in low area to the southwest of the site, levelling the area for possible future use by the farmer. The stockpile/fill placement should consider the potential for destabilizing the Oldman River slope near the Hwy 3 bridge.

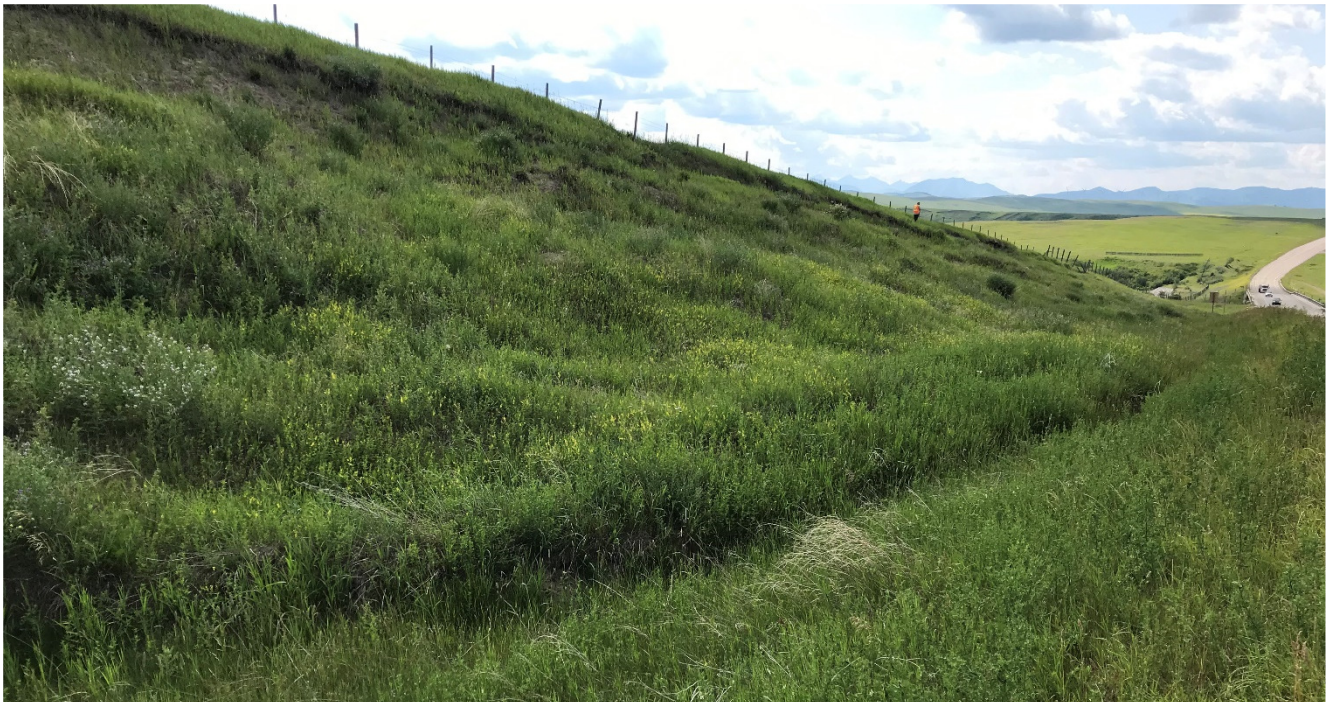
Zones of accumulation at the toe of the slide are blocking the ditch over the length of the failure. Areas of ponded water were noted along the length of the ditch.

Photo 2 Toe rolls coalescing and blocking the ditch. Photo was taken facing west on July 8, 2021.

- The drainage ditch should be regraded to allow for positive surface water drainage, this will require the removal of the slide toe materials from the ditch. Materials removed should be kept to the minimum required to re-establish drainage without initiating additional slope movements.

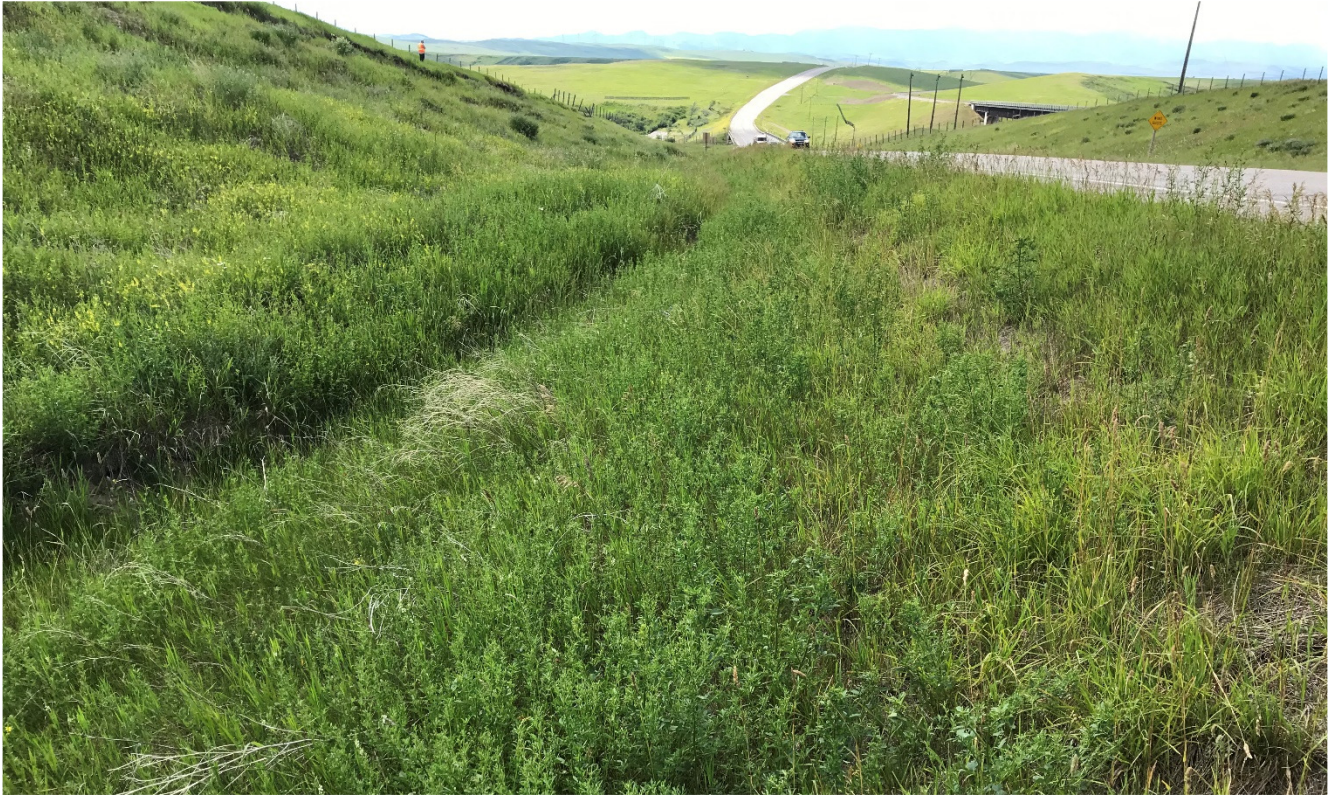
Photo 3 Toe rolls blocking the ditch. Photo was taken facing west on July 8, 2021.
