SITE NUMBER AND NAME: S048 Castle Back Slope Failures		HIGHWAY & KM: 3:04, 23.708	PREVIOUS INSPECTION DATE: June 8, 2021	INSPECTION DATE: May 8, 2023
LEGAL DESCRIPTION: 15/06-12-007-01 W5M	NAD 83 COORDINATES: UTM Northing Easting 11 5492157 715695		RISK ASSESMENT: PF: 9 CF: 3 TOTAL: 27	
AVERAGE ANNUAL DAILY TRAFFIC (AADT): 4,100 (west), 4,340 (east), (Ref. No. 78050)			CONTRACTOR MAINTENANCE AREA (CMA): 26

PROJECT SOUTHERN REGION GEOHAZARD RISK MANAGEMENT PROGRAM		
TITLE Site Plan S048 - Castle Back Slope Failures Hwy 3:04, km 23.708		
SCALE 1:2,500	PROJECT No. A05116A03	FIG No. 1

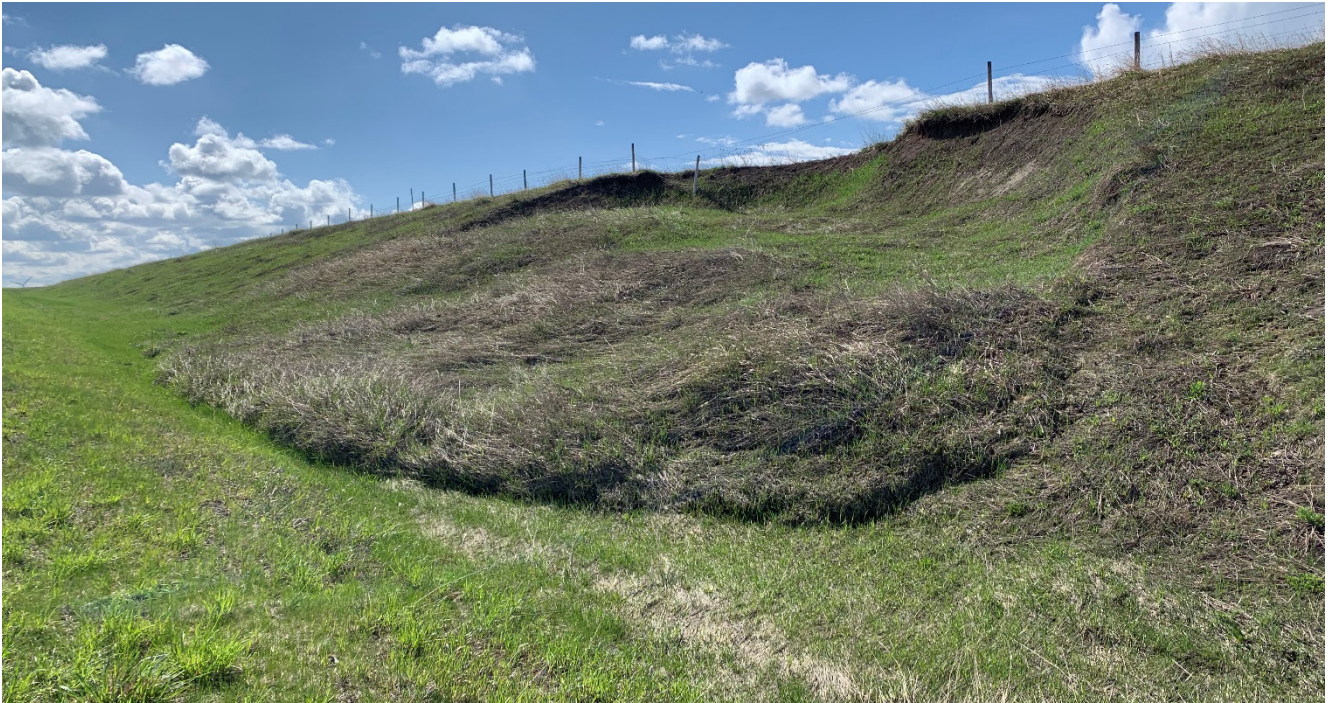
Zones of accumulation at the toe of the slide are blocking the ditch over the length of the failure. Areas of ponded water were noted along the length of the ditch.

Photo 1 Toe rolls from formerly separate slope failure zones coalescing and blocking the ditch. Photo was taken facing southeast on May 10, 2023.

- The drainage ditch should be regraded to allow for positive surface water drainage, this will require the removal of the slide toe materials from the ditch. Materials removed should be kept to the minimum required to re-establish drainage without initiating additional slope movements.

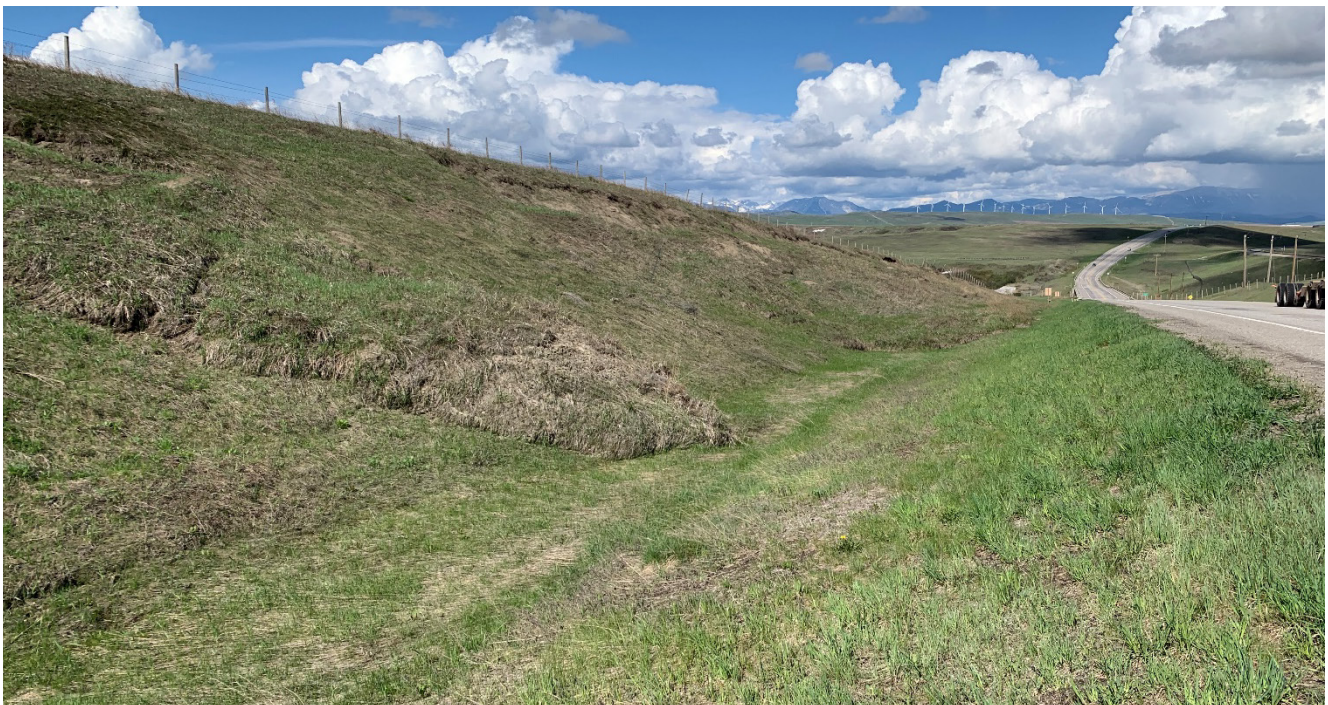
Photo 2 Toe rolls coalescing and blocking the ditch. Photo was taken facing west on May 10, 2023.

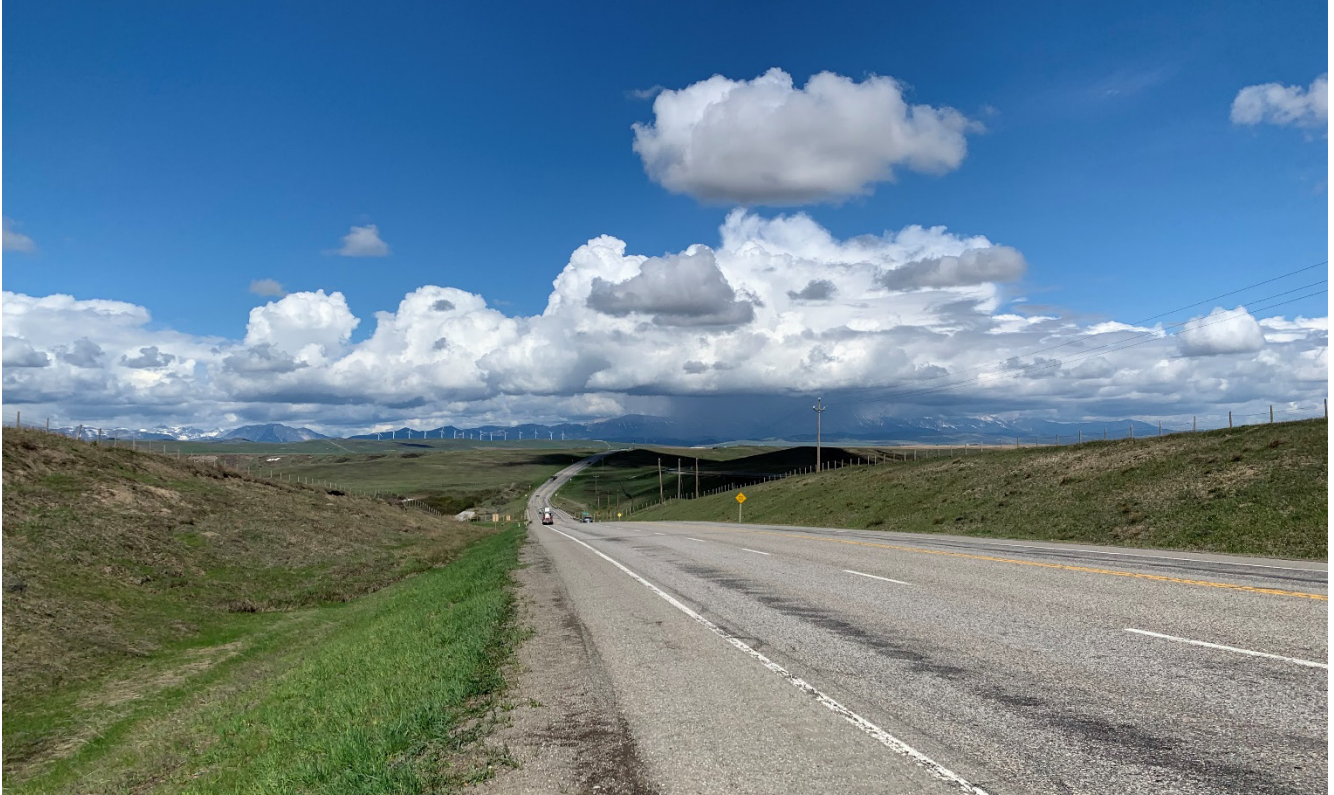
COMMENTS
During the 2023 inspection, the lateral extents of the slope failure appeared similar to 2021. In the slide zones, the near vertical upper back scarp is up to 1.8 m high. Tension cracking near the crest indicates ongoing slope movement and slide retrogression. Failure zones are coalescing, and will eventually result in one long failure zone after which further retrogression into private land may occur.
Slide zones are located over approximately 200 m length on the south side of the highway. Slides appear to be a result of groundwater and precipitation leading to saturation of the slope south of the highway. The north-facing aspect of the slide will decrease evapo-transpiration from the slope surface and promote a longer duration of snow cover in the spring. The highest stable slope is approximately 5.5 m, located at the east end of the north facing backslope.
The field located at the top of the slope failure is mostly graded towards the river and crop furrows are parallel to the fence line meaning that surface runoff is likely to drain away from the highway.

Photo 3 Slope on the south side of the road. Photo was taken facing west on May 10, 2023.

- Flatten the slope to 4H:1V or 5H:1V, which would require moving the fence line back on the slope crest. A preliminary design should be prepared to assess slope flattening and the area of land required should be assessed. KCB could prepare the preliminary design without investigation, with AT putting the investigation costs into land purchase. AT land agents should contact the owner of the land at the crest of the backslope and start discussions on land procurement.
- Material excavated during slope flattening could be stockpiled in low area to the southwest of the site, levelling the area for possible future use by the farmer. The stockpile/fill placement should consider the potential for destabilizing the Oldman River slope near the Hwy 3 bridge.
