SITE NUMBER AND NAME: S039-I & -II Brocket Slides		HIGHWAY & KM: 3:06, 12.952 & 13.062	PREVIOUS INSPECTION DATE: June 9, 2020	INSPECTION DATE: July 8, 2021
LEGAL DESCRIPTION: 09/10-07-007-28 W4M	NAD 83 COORDINATES: UTM Northing Easting 12 5491976 298990		RISK ASSESSMENT: PF: 11 CF: 3 TOTAL: 33 (Site I)	
AVERAGE ANNUAL DAILY TRAFFIC (AADT): 4,700 (west), 4,780 (east), (Ref. No. 84050)			CONTRACTOR MAINTENANCE AREA (CMA): 24

PRIMARY SITE ISSUE: Natural slope landslide encroaching on west lane of highway.

PROJECT SOUTHERN REGION GEOHAZARD RISK MANAGEMENT PROGRAM		
TITLE Site Plan S039 - Brocket Slides Hwy 3:06; km 12.952		
SCALE 1:3,000	PROJECT No. A05116A03	FIG No. 1

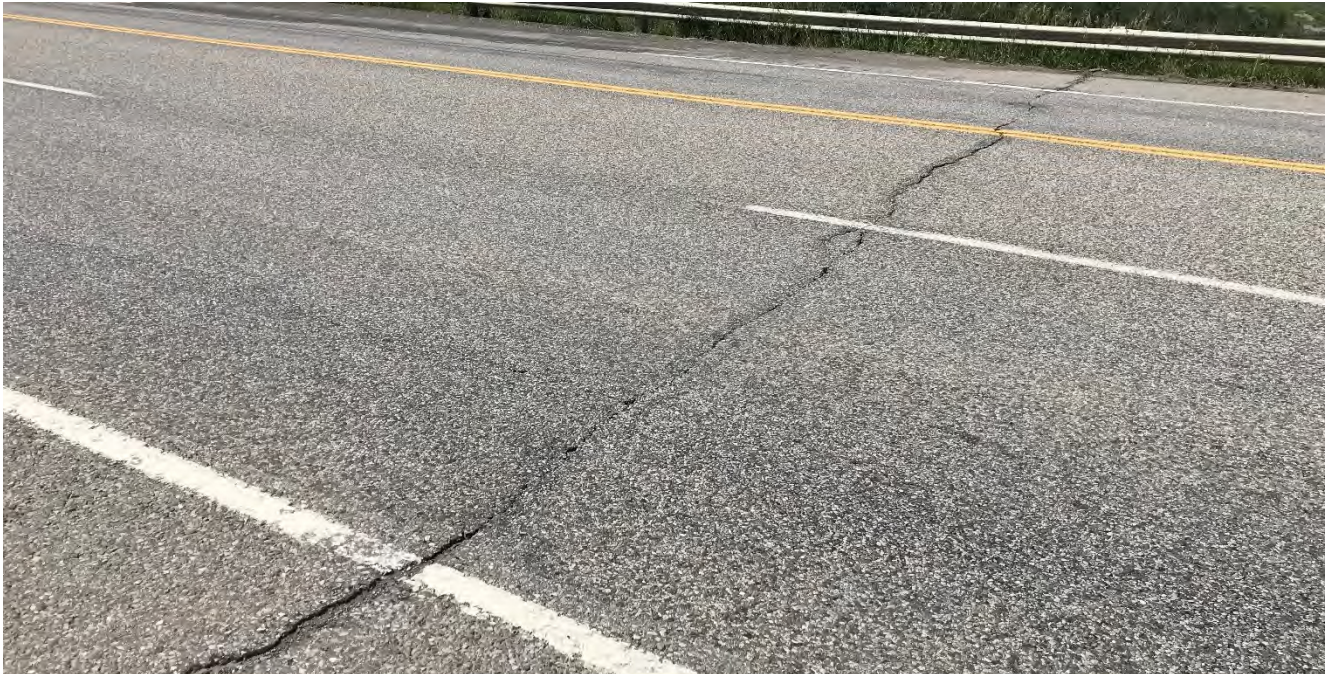
Photo 1 **Site I – Transverse pavement cracking east of the slide. Photo was taken facing south on July 8, 2021.**

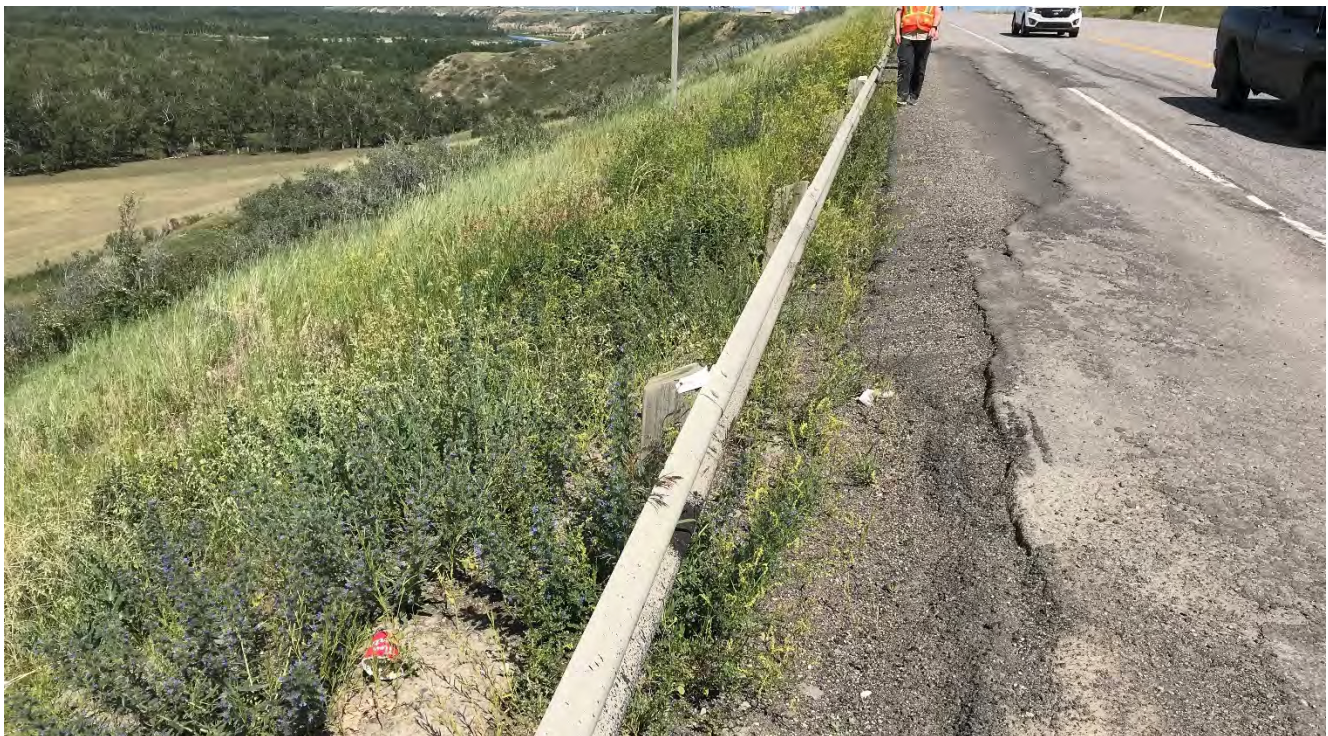
Slide movements have impacted the highway. The cracks are a several inches wide and deep, and partially collapsed. The 2017 asphalt patching has cracked.

Cracking of highway surface indicates that retrogression of head scarp into the highway lanes will continue. Water flow off the highway is eroding the placed gravel. Ongoing need for patching and asphalt curb repair.

Photo 2 **Site I - Head scarp impacting the highway. The 2017 patching has cracked and settled. Photo was taken facing east on July 8, 2021.**

In the short-term, the asphalt curb at Site I should be reestablished to limit pavement drainage onto the slide zone. The curb may need to be protected from snowplows by HTCB.

Design of remedial measures and preparation of tender documents for Site I has been completed by KCB. The repair solution includes soil nails and surface mesh to stabilize the highway embankment. Construction is slated for 2022

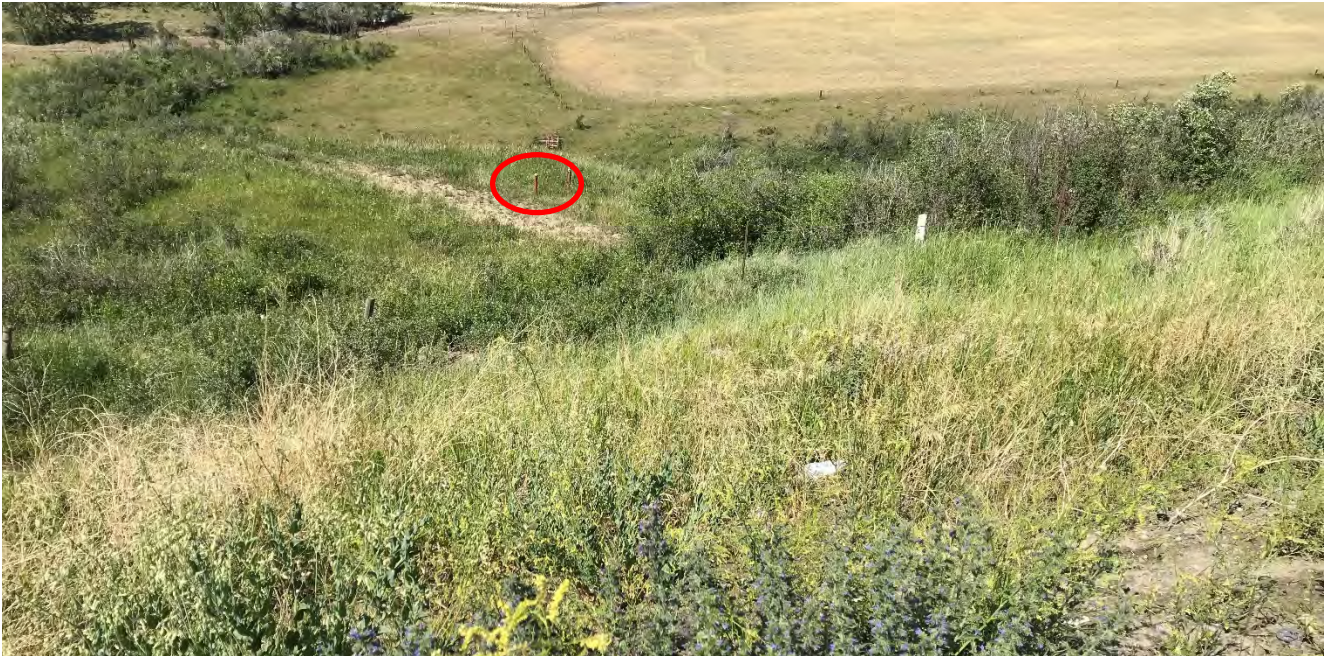
Bench in slide mass is located approximately mid-slope and appears to be the location of the failure plane just above the elevation of bedrock outcrops on natural slopes on the flanks of the slide zone, with the slide mass falling to the toe of the natural slope.

Photo 3 **Site I - Instrumentation installed on a bench constructed mid slope in the middle of the slide area (red circle). Photo was taken facing northwest on July 8, 2021.**
