SITE NUMBER AND NAME: S039-I Brocket Slides		HIGHWAY & KM: 3:06, 12.952	PREVIOUS INSPECTION DATE: July 8, 2021	INSPECTION DATE: May 19, 2021
LEGAL DESCRIPTION: 09/10-07-007-28 W4M	NAD 83 COORDINATES: UTM Northing Easting 12 5491976 298990		RISK ASSESSMENT: PF: 11 CF: 3 TOTAL: 33	
AVERAGE ANNUAL DAILY TRAFFIC (AADT): 4,700 (west) & 4,780 (east) (Reference No. 84050)			CONTRACTOR MAINTENANCE AREA (CMA): 26

PRIMARY SITE ISSUE: Natural slope landslide encroaching on west lane of highway.

PROJECT SOUTHERN REGION GEOHAZARD RISK MANAGEMENT PROGRAM		
TITLE Site Plan S039 - Brocket Slides Hwy 3:06, km 12.952		
SCALE 1:3,000	PROJECT No. A05116A03	FIG No. 1

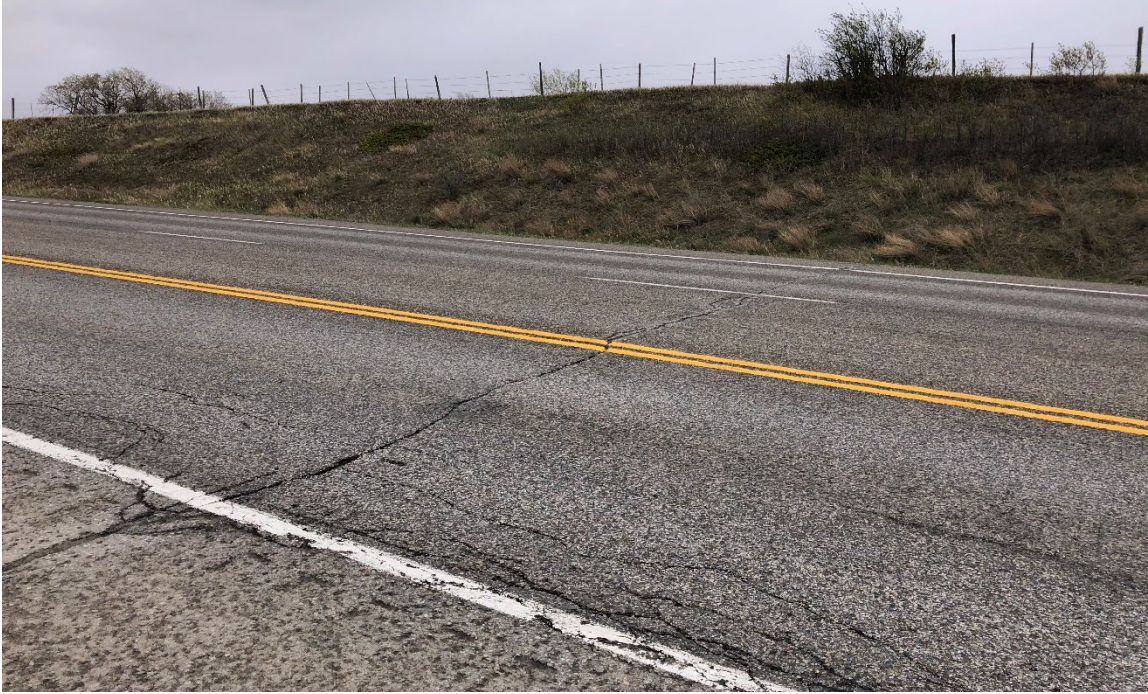
- There were no significant changes observed in the slide zone during the 2022 inspection.
- A previously observed transverse pavement crack across both lanes is located east of the slide and doesn't appear to have changed since the 2021 inspection (Photo 1).
- Between the 2021 and 2022 inspections, the pavement cracking increased in width from approximately 10 mm to 20 mm (Photo 2). The pavement cracks were up to 10 mm deep.

Photo 1 Transverse pavement cracking across both lanes east of the slide. Photo taken May 19, 2022, facing south.

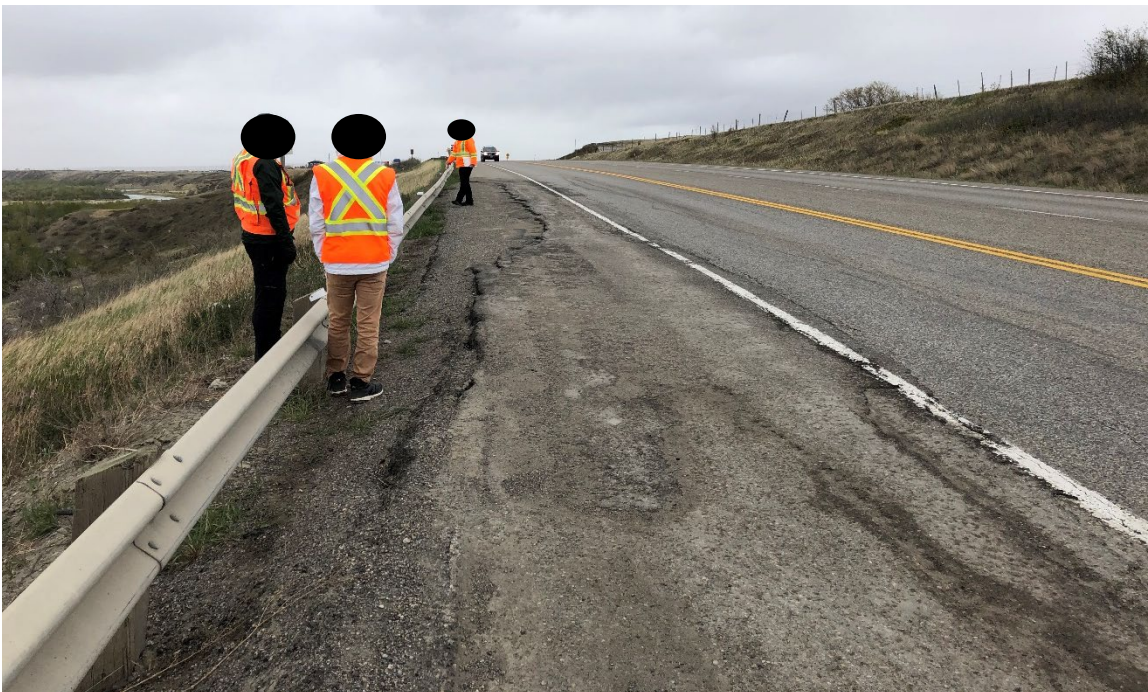
Photo 2 Slide movement is impacting the highway surface and has deformed (cracked and settled) the 2017 pavement patch. Photo taken May 19, 2022 facing east.

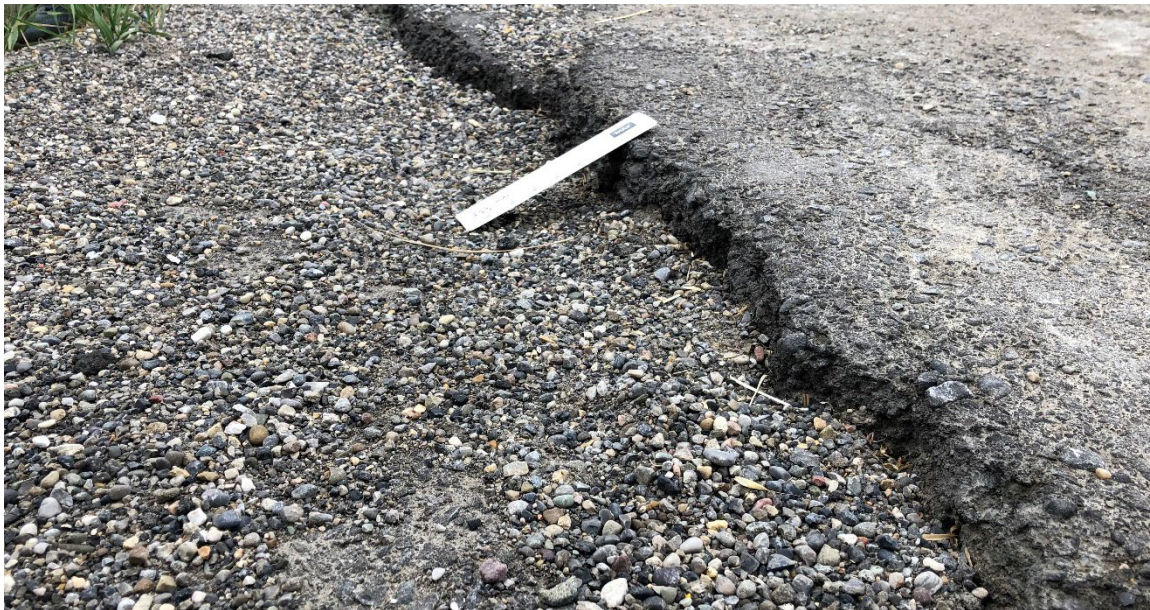
- Between 2017 and 2022, the pavement has settled appropriately 50 mm (Photo 3 and 4).
- Cracking of highway surface indicates that retrogression of head scarp will continue into the highway.

Photo 3 The pavement in the north (westbound) shoulder has settled up to 50 mm due to ongoing slope movement. Photo taken May 19, 2022, facing east.

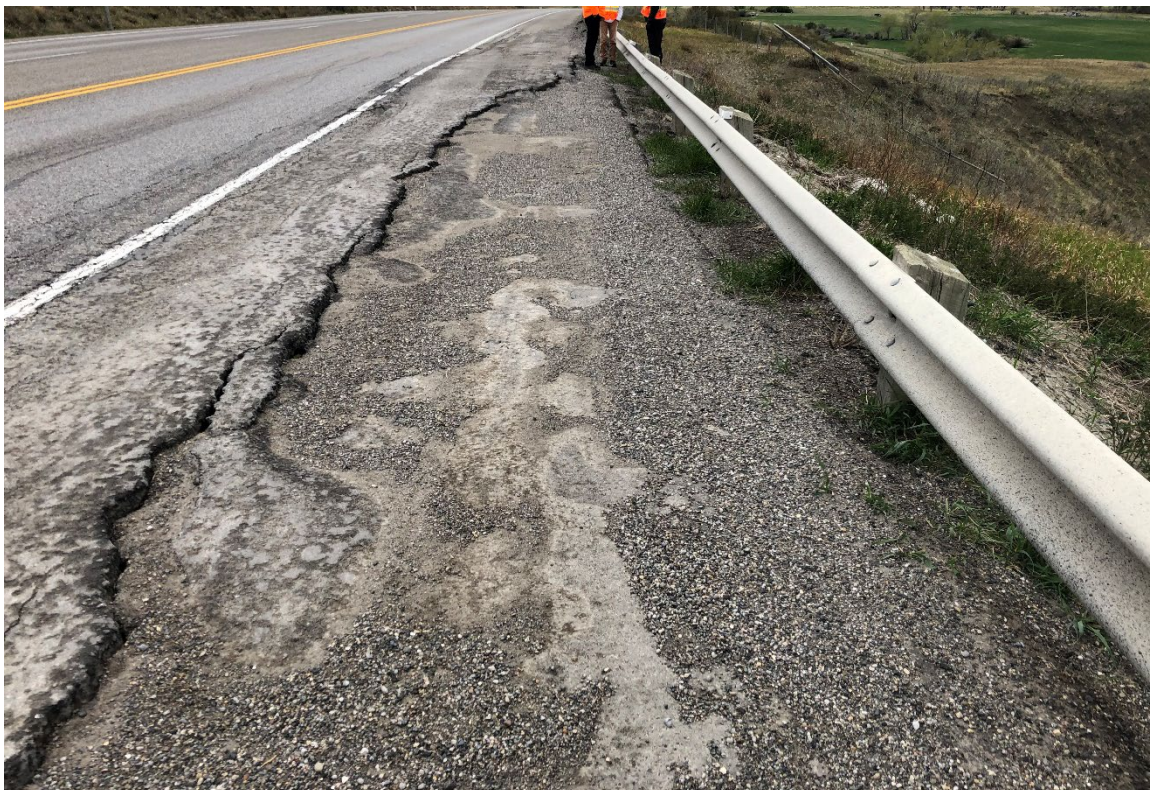
Photo 4 Pavement cracking and settlement in the 2017 pavement patch. Photo taken May 19, 2022, facing west.
