November 29, 2024

Alberta Transportation and Economic Corridors
2nd Floor, 803 Manning Road N.E.
Calgary, Alberta
T2E 7M8

**CON0022161 Southern Region GRMP Instrumentation Monitoring
Site S039-I; H03:06, km 12.952 West Bocket Slide
Section C – 2024 Fall Readings**

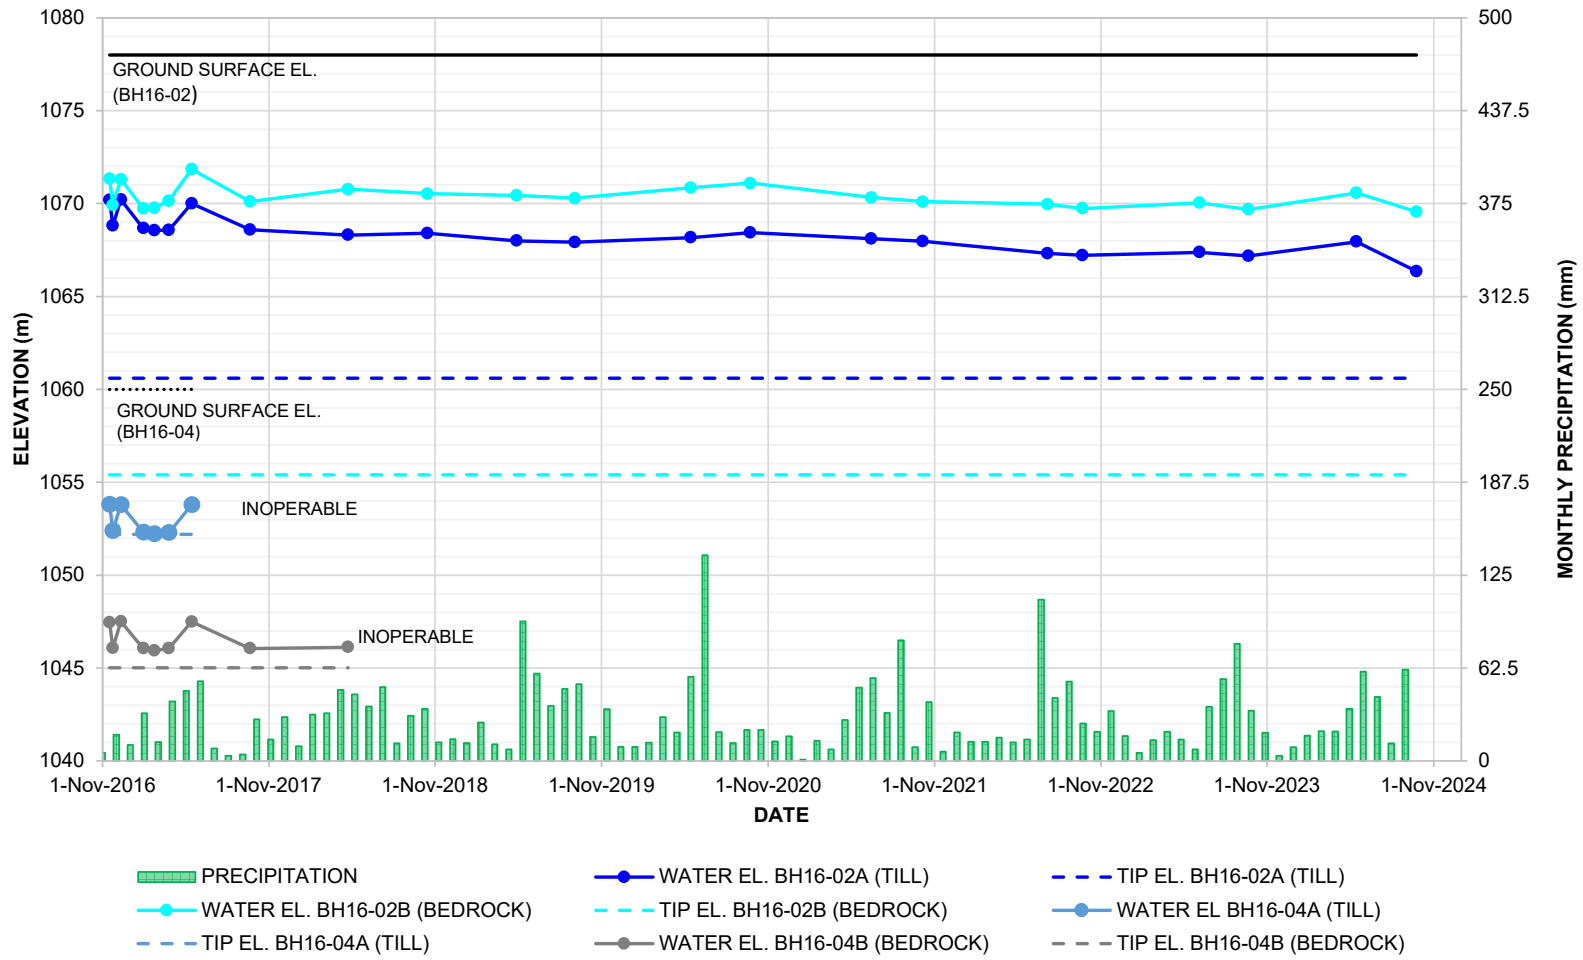
TITLE
 Piezometer Data
 S039 - West Bocket Slide
 Hwy 03:06 km 12.952

Since fall 2017, water levels recorded in the two VWPs installed in BH16-02A (clay till) and BH16-02B (bedrock) have been relatively steady (up to ± 1.0 m). Water level readings completed in fall 2024 decreased by 1.5 m and 1.0 m in BH16-02A and BH16-02B, respectively, compared to the spring 2024 readings. At the time of writing this report, rainfall data was only available up to the end of August 2024.

Observed ground water noted on the slope at the eastern extent of the repair slope during the spring 2023 Section B inspection in May 2023 did not correspond with the water levels recorded in the VWPs read in June 2023. During the September 2024 instrument reading there were no wet areas located on the slope. There could be perched water tables within the slope in more permeable seams as noted by Thurber in 1998 “the surficial soils in the area comprise a sequence of medium to high plastic glaciolacustrine silty clays, with occasional lenses or discontinuous beds of sands and gravels. Underlying these surficial soils is a stiff to hard clay till, which overlies clay shale bedrock”. Data loggers should be installed on the VWPs to get more information on how ground water levels fluctuate in relation to snow melt and precipitation events.

Data logger should be installed on the functioning VWP's upslope of the repair section to monitor groundwater fluctuations throughout the year.

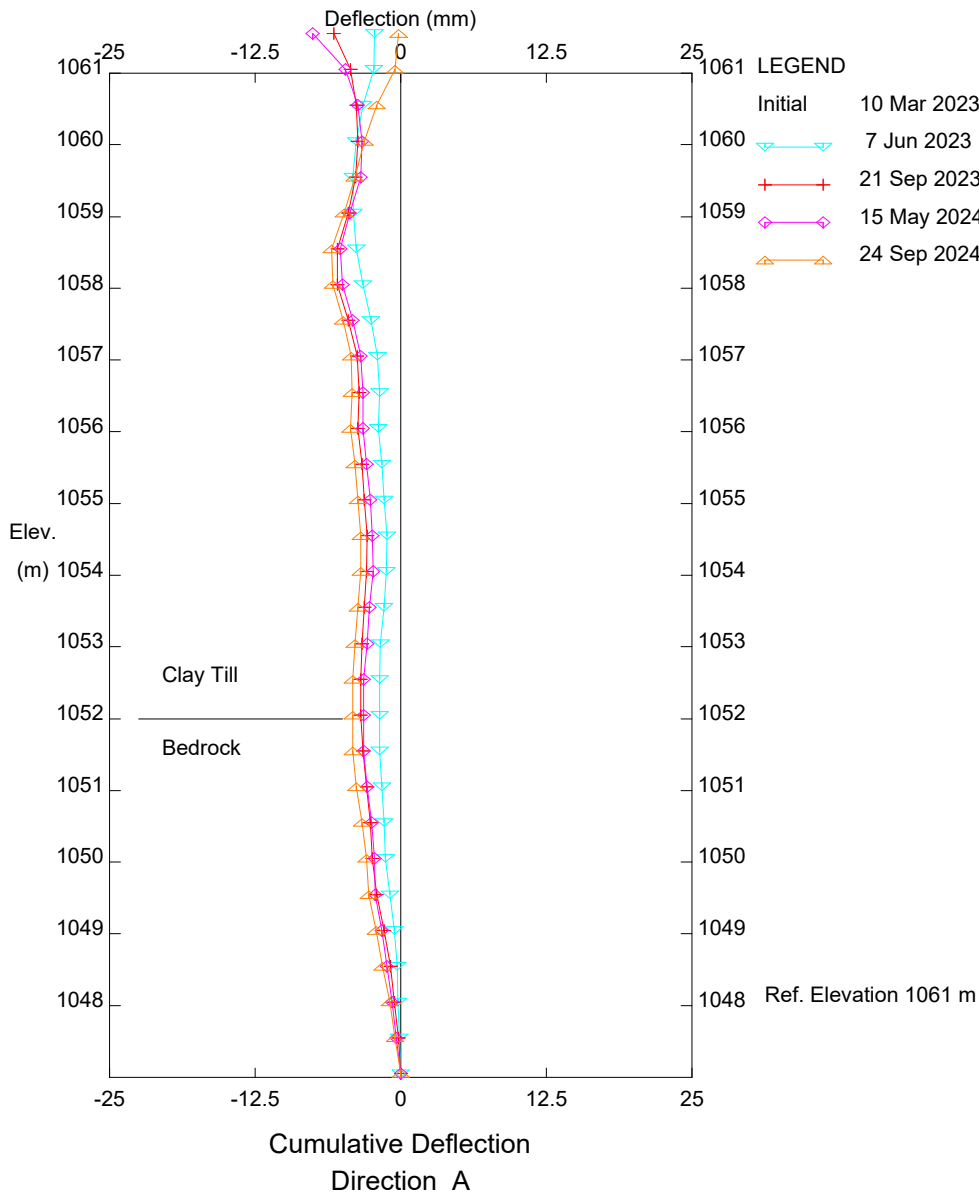
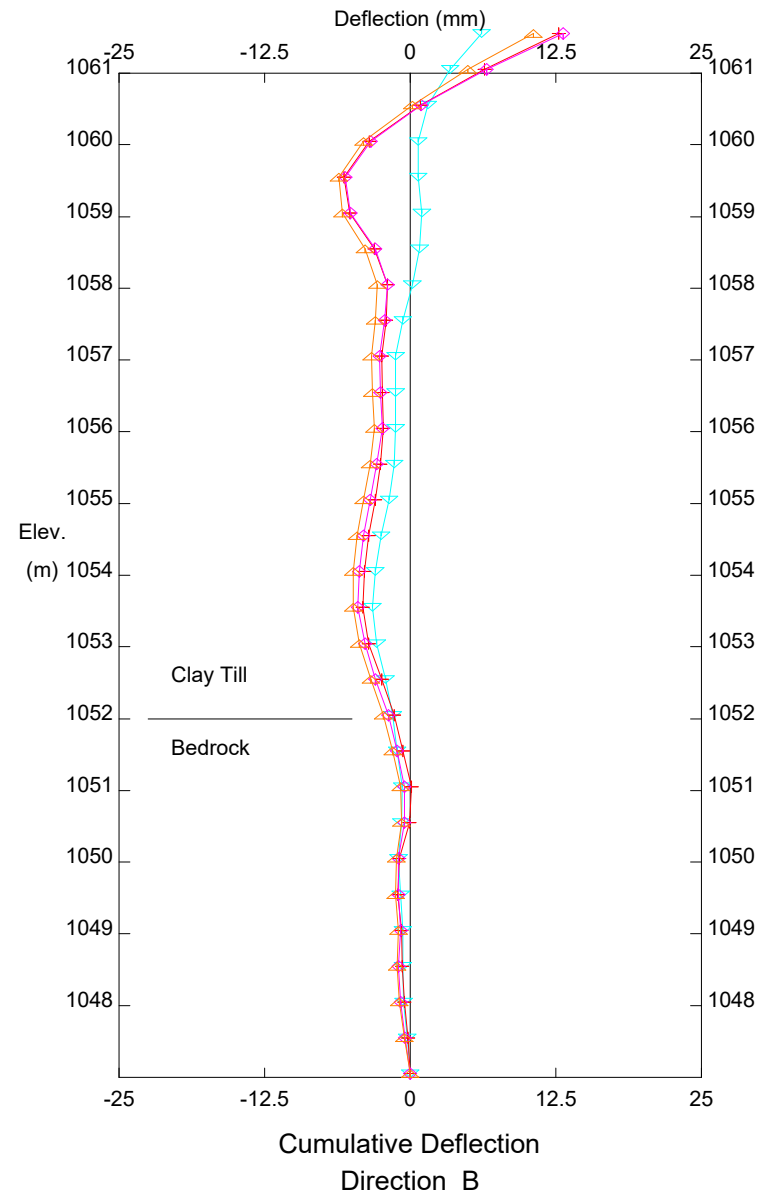
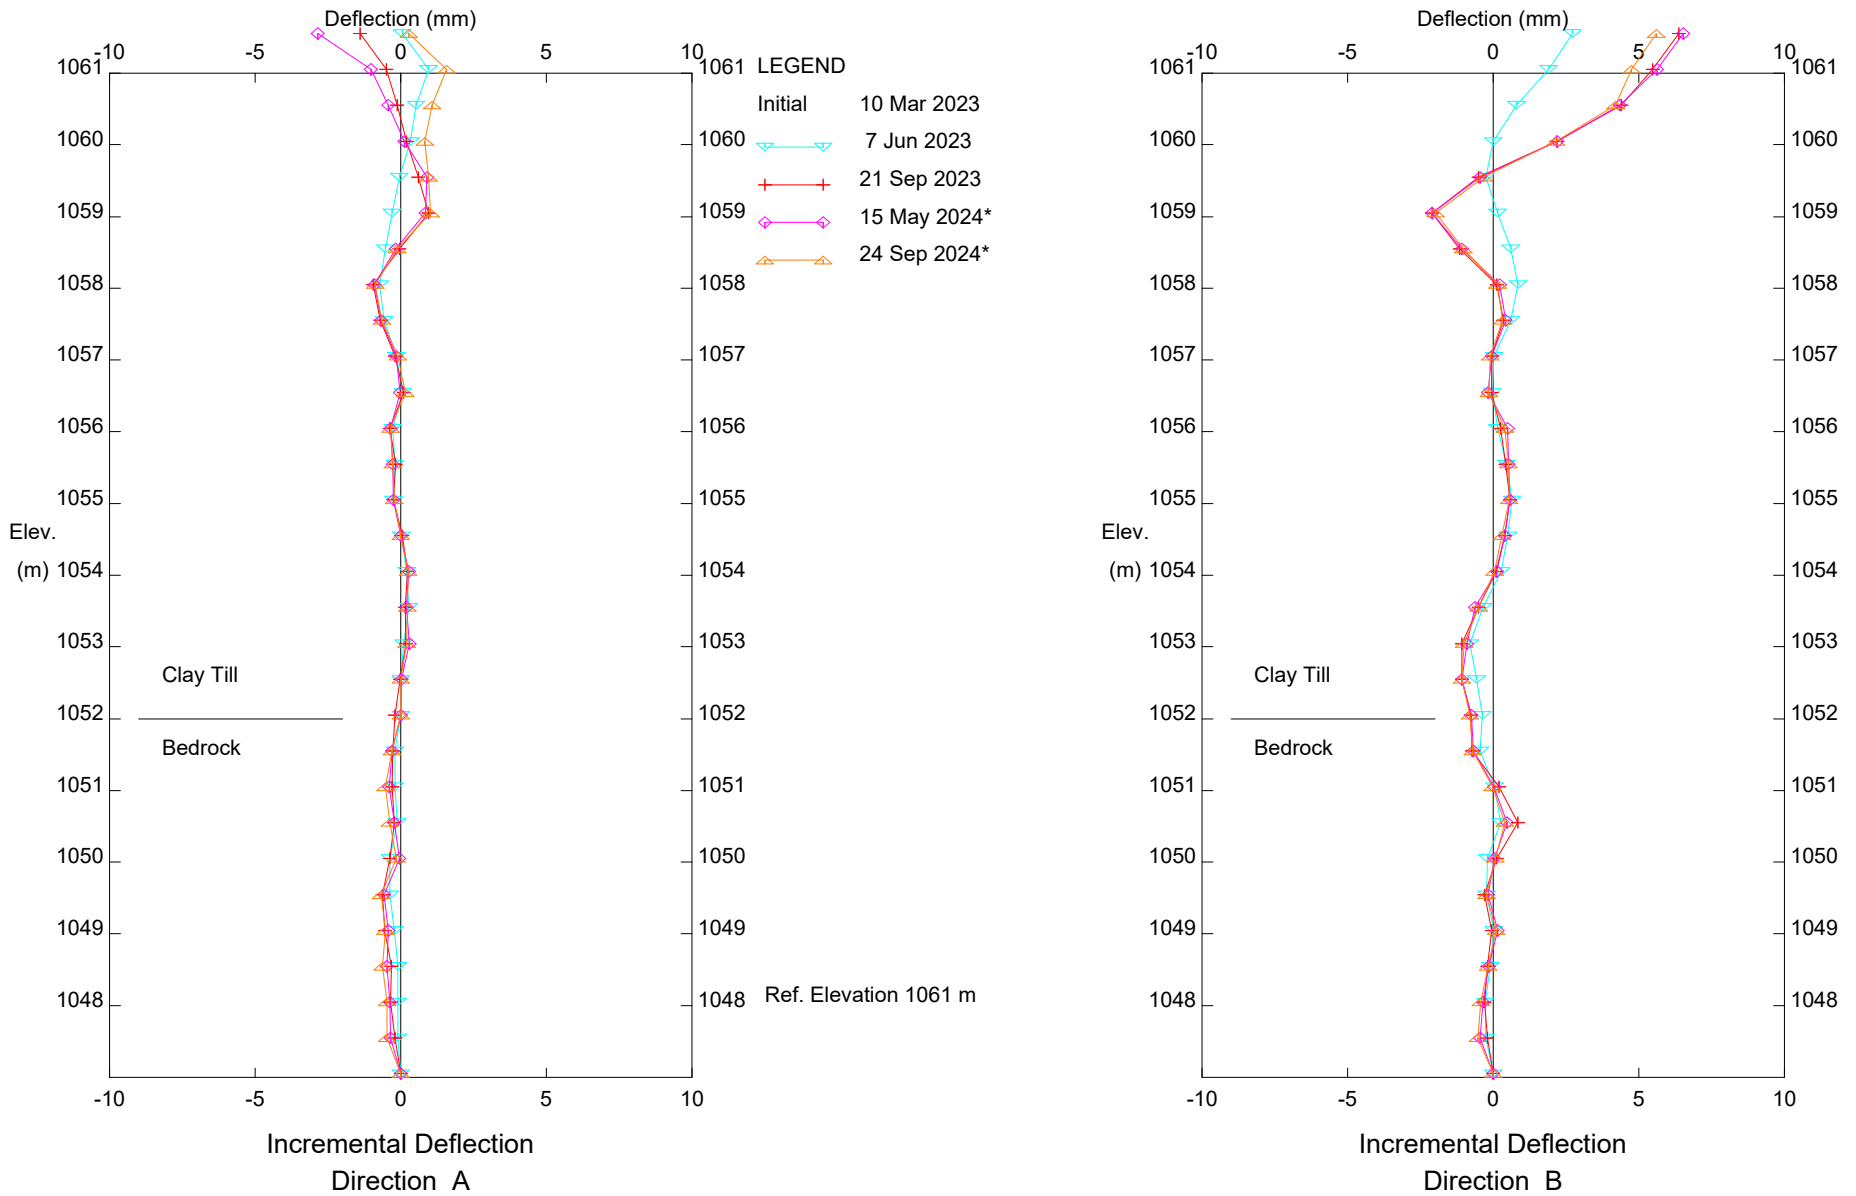
S039; H03:06, West Brocket Slide, Inclinometer SI 23-01

The SI data obtained in the three new SIs is relatively noisy (despite good data quality) compared to the existing SI (SI16-03) and is difficult to interpret. It is unclear if the noise is due to installation issues (e.g., casing kinked or titled). For example, SI23-01 is tilted approximately 0.8 m over its 14 m depth and SI23-03 is tilted approximately 1 m over its 21 m depth. More data is needed to interpret the data and movement zones.

More data is needed to assess movement zones and trends in the newly installed SIs (SI23-01 and SI23-02) located at the base of the repair area. SI23-01 measured movement in the upper 3 m below ground level, with the majority of the movement in the B-direction. SI23-02 measured distributed movement between depths of approximately 9 m to 11 m below ground level. Based on the installation records, this movement is in the upper bedrock, however the data is difficult to interpret, despite good data quality.

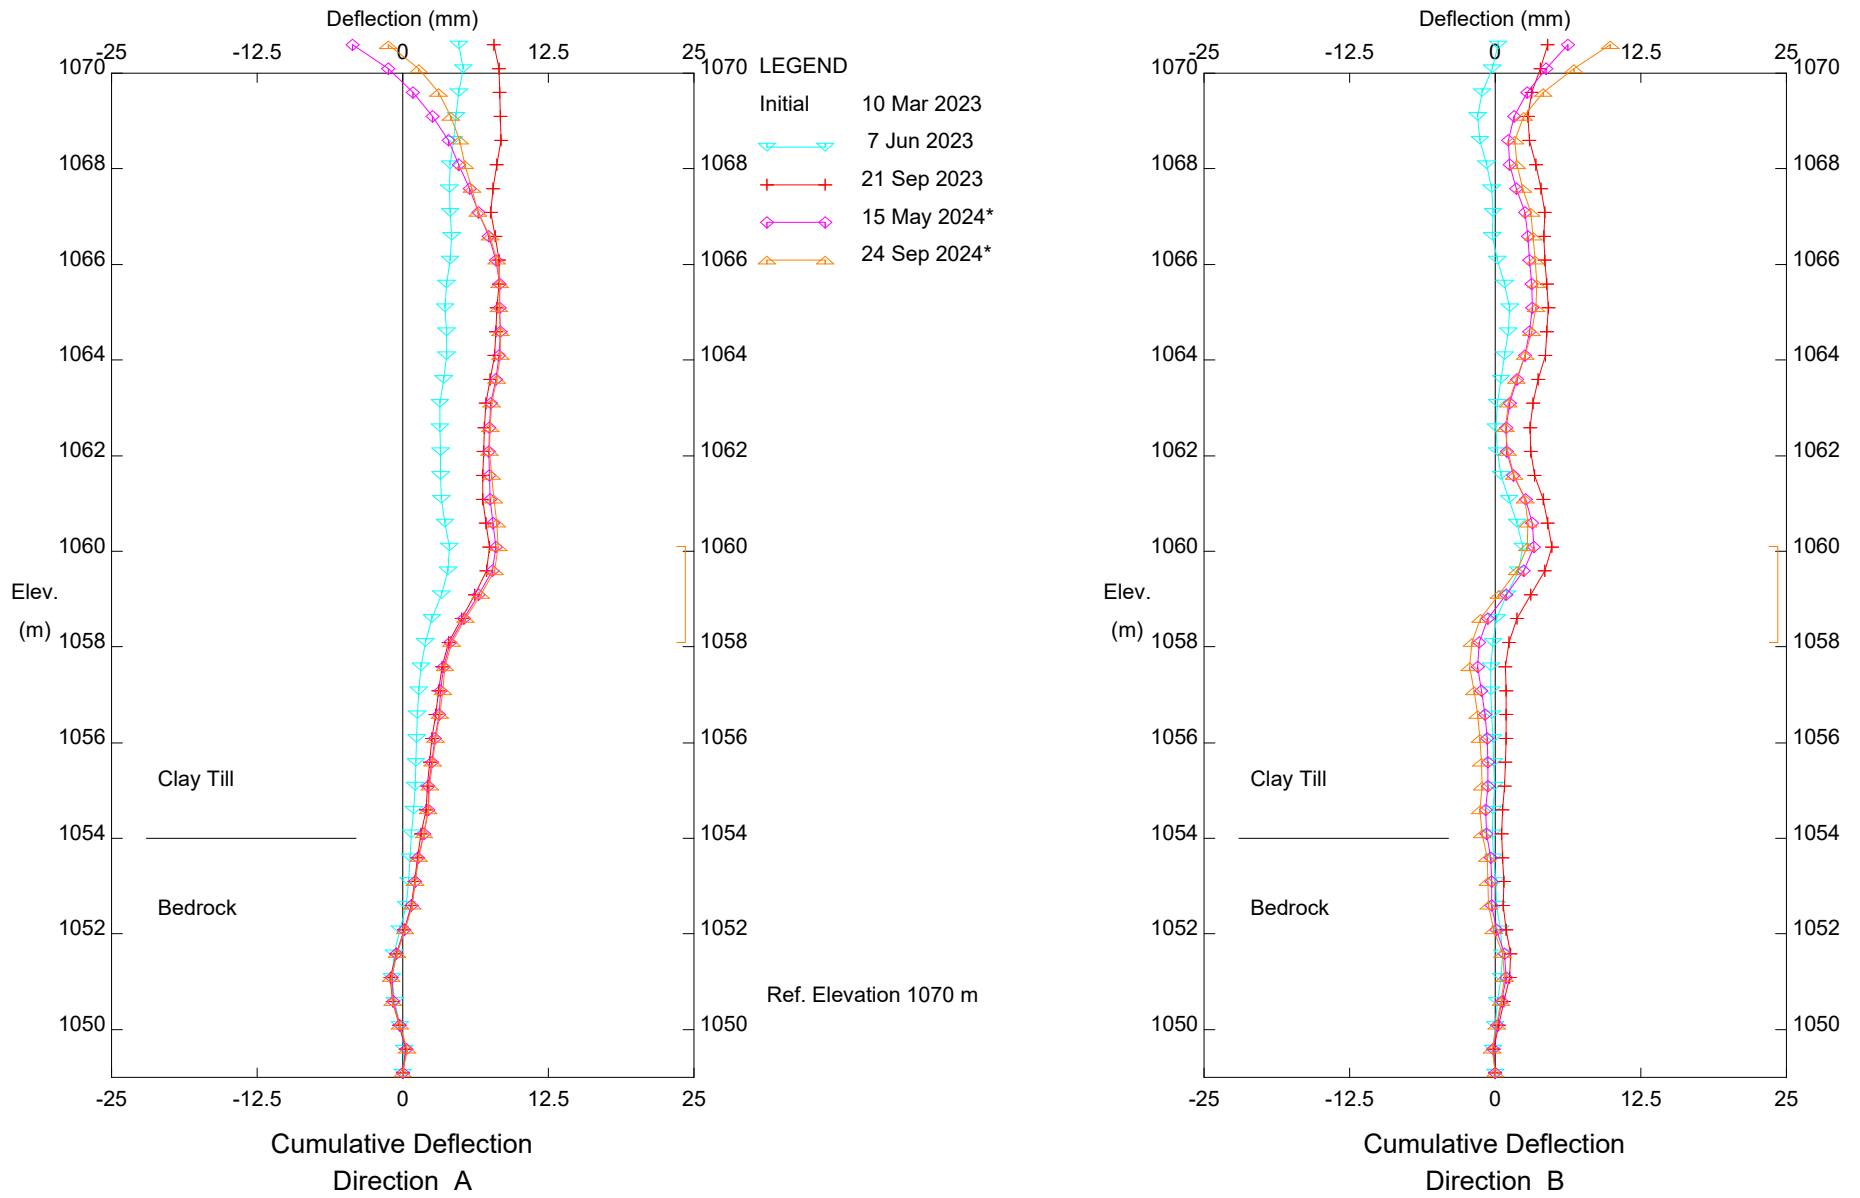
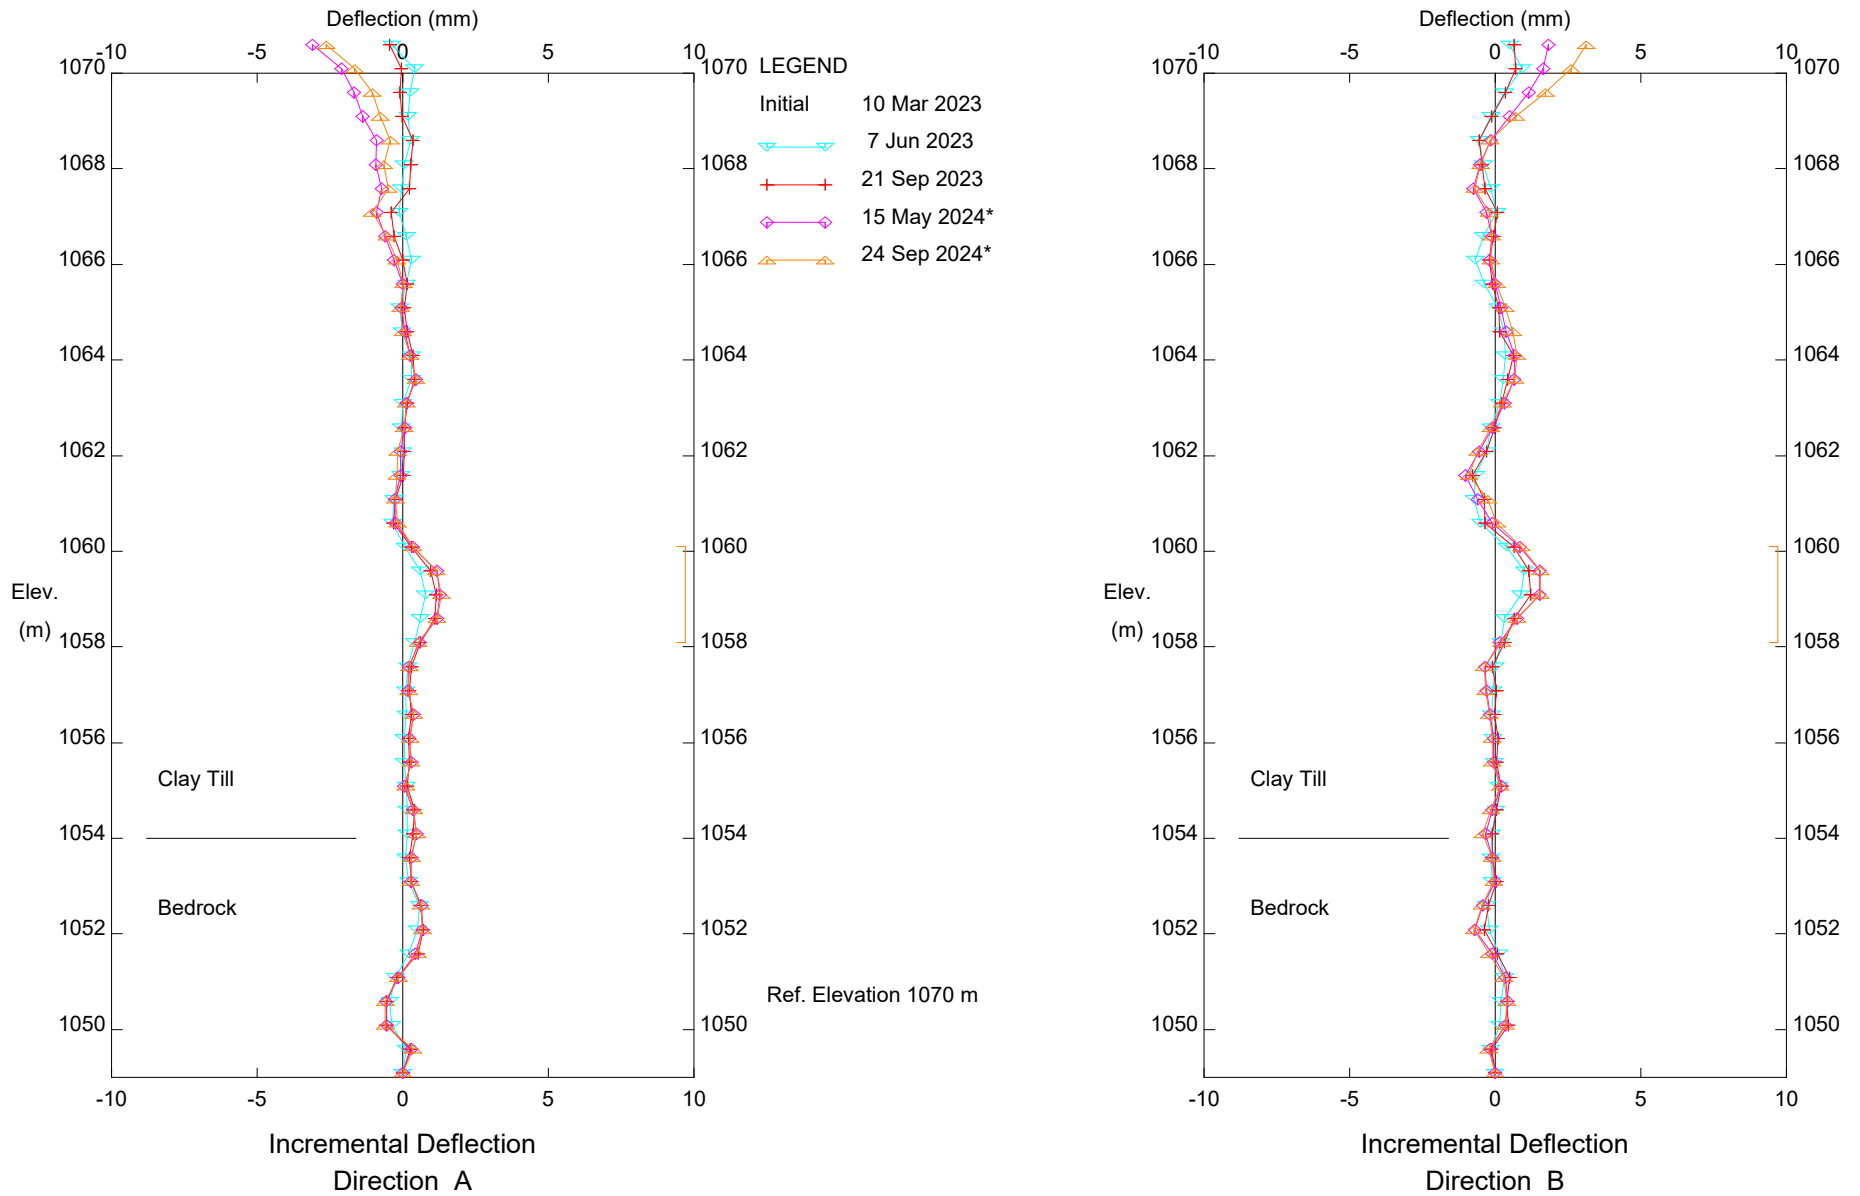
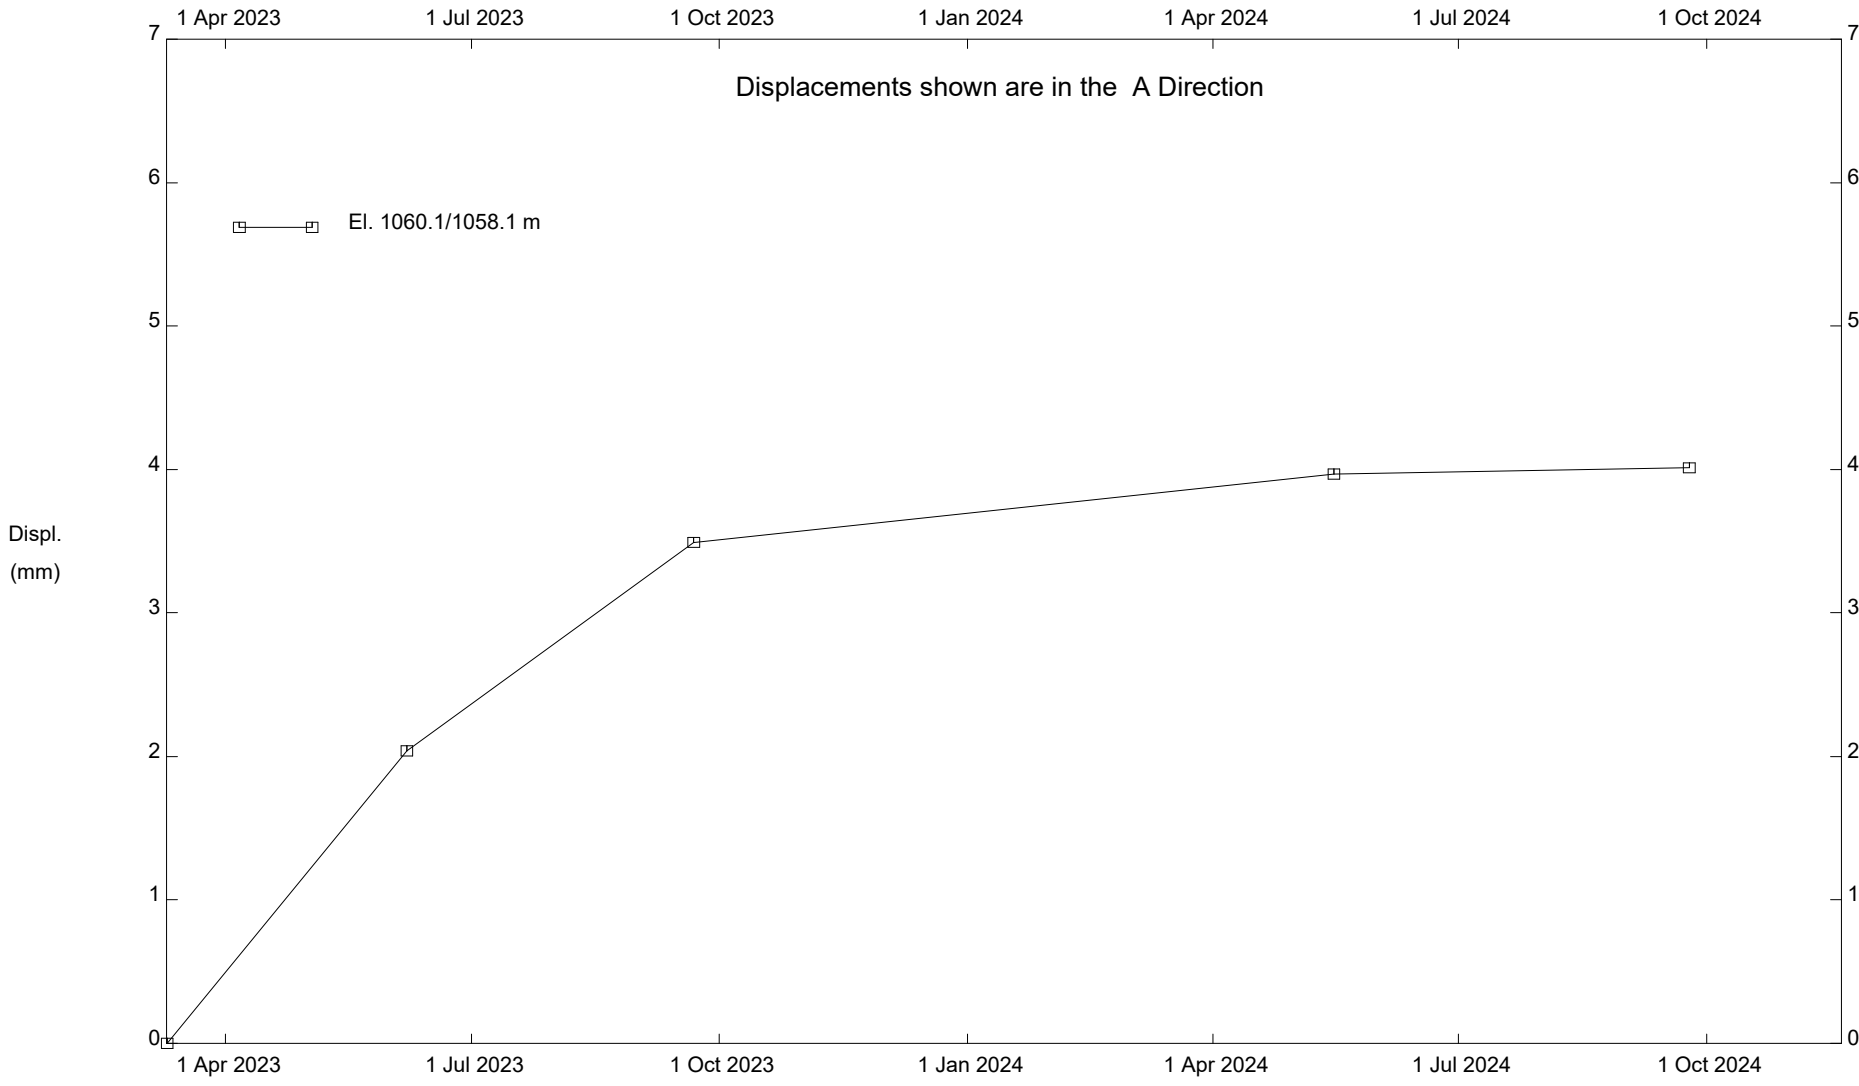
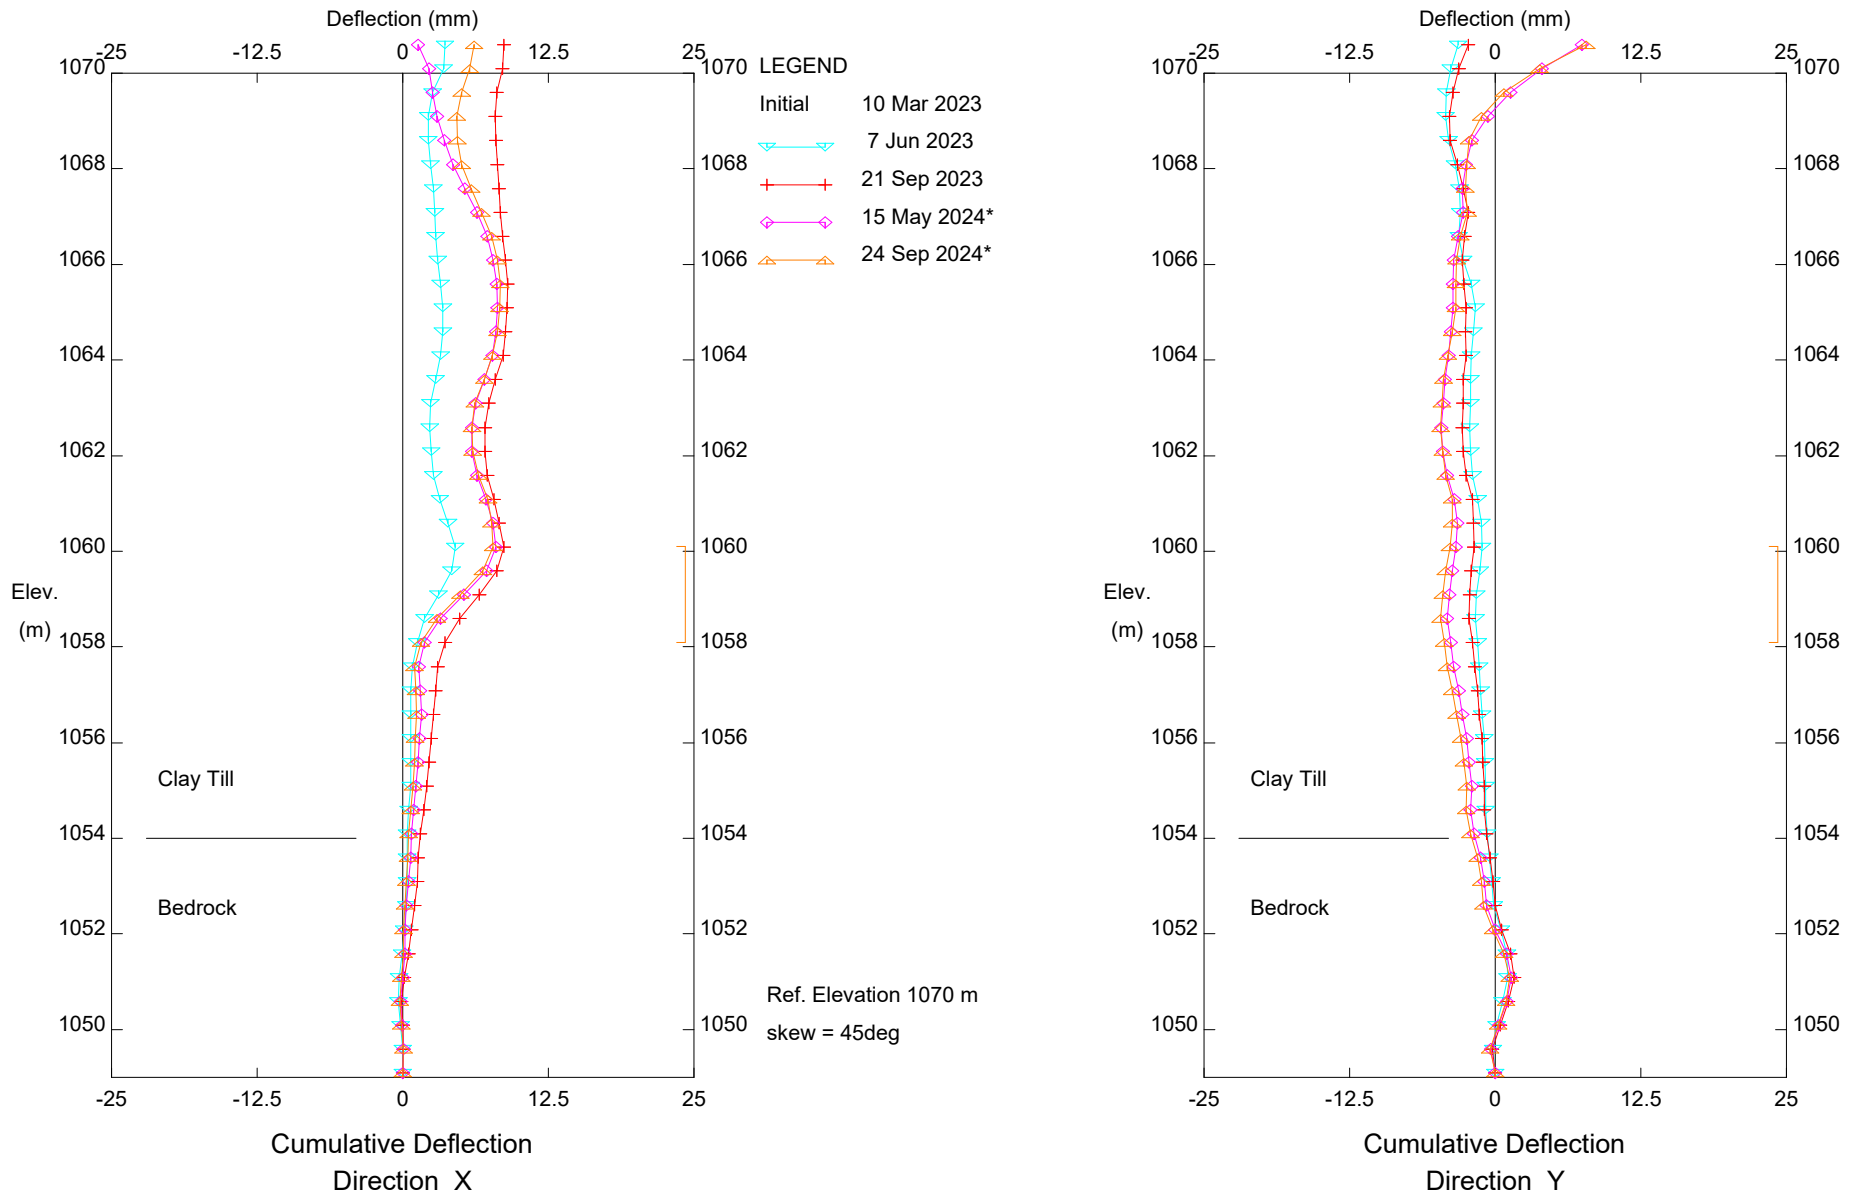
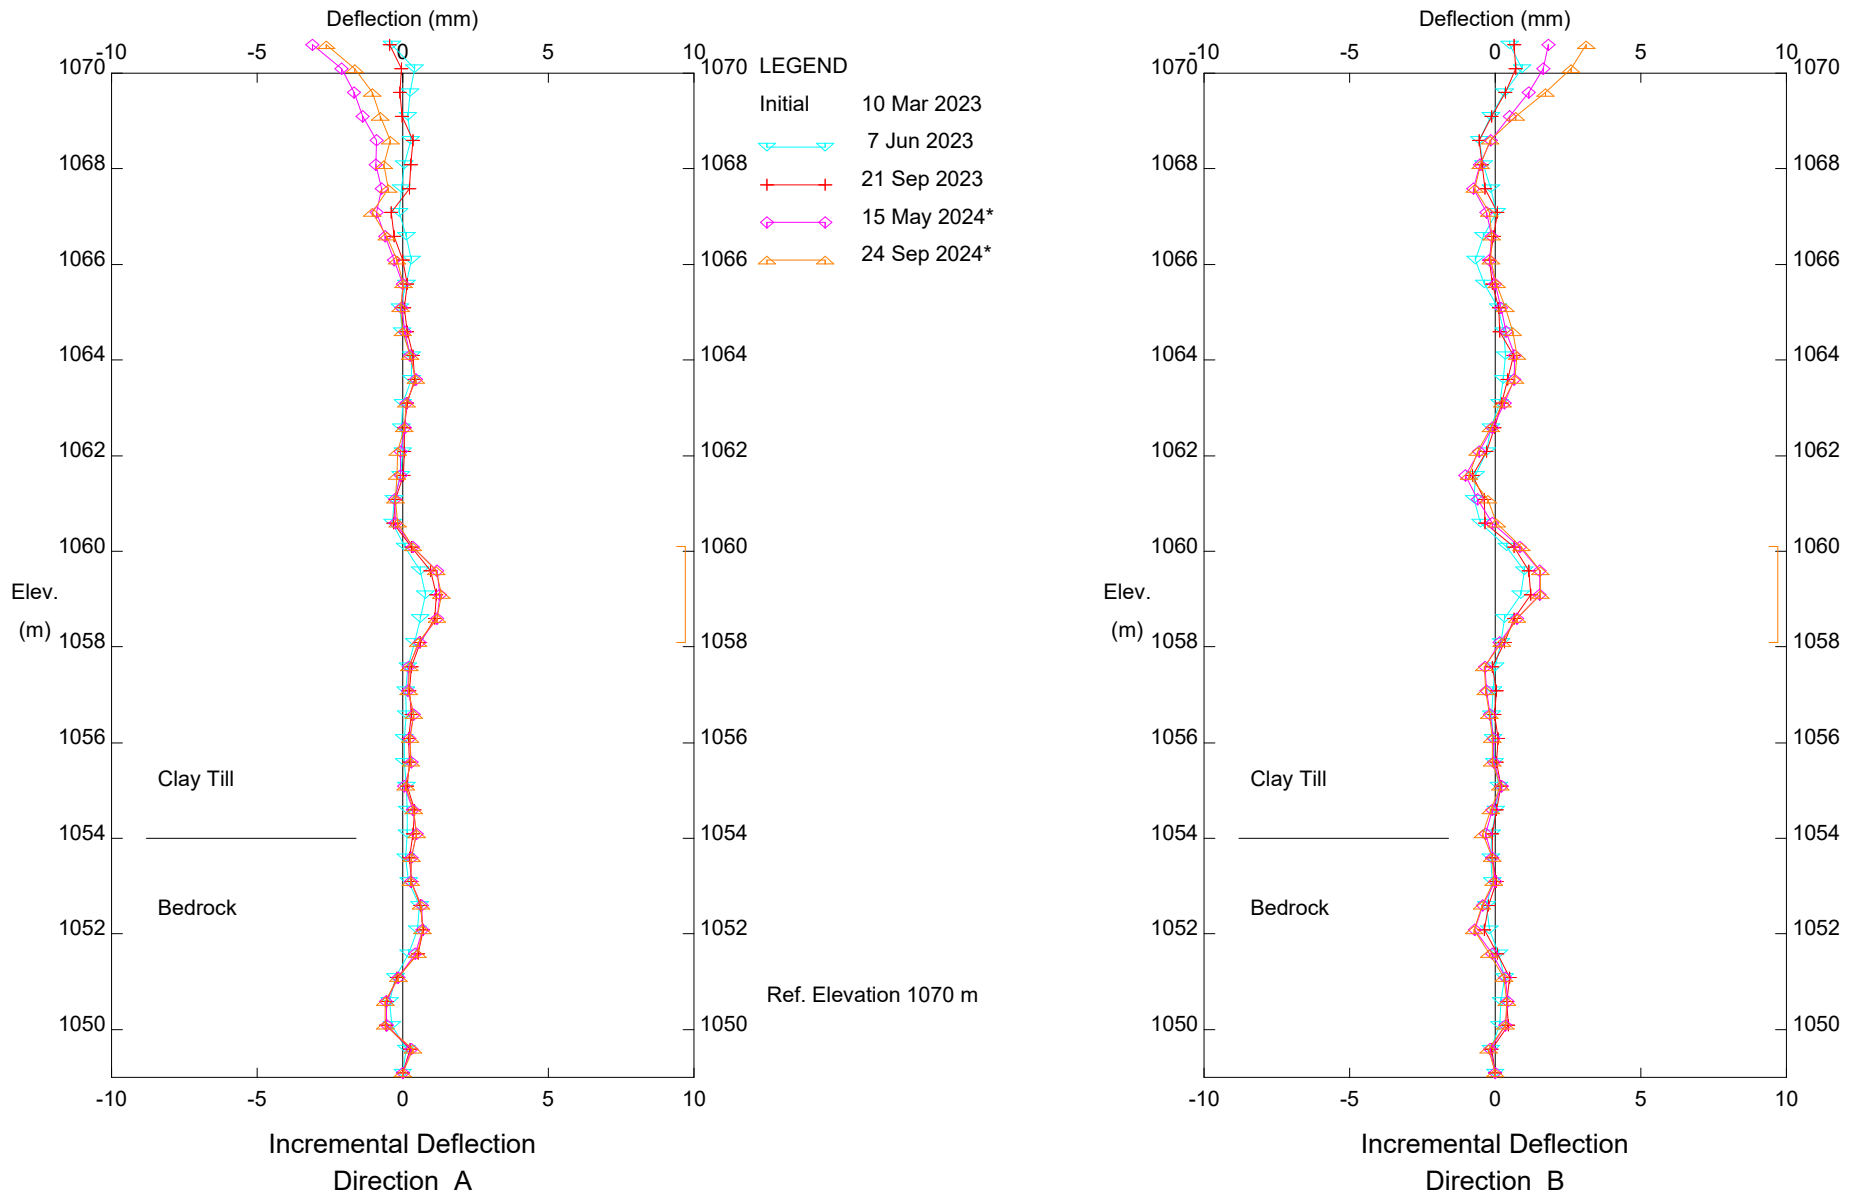
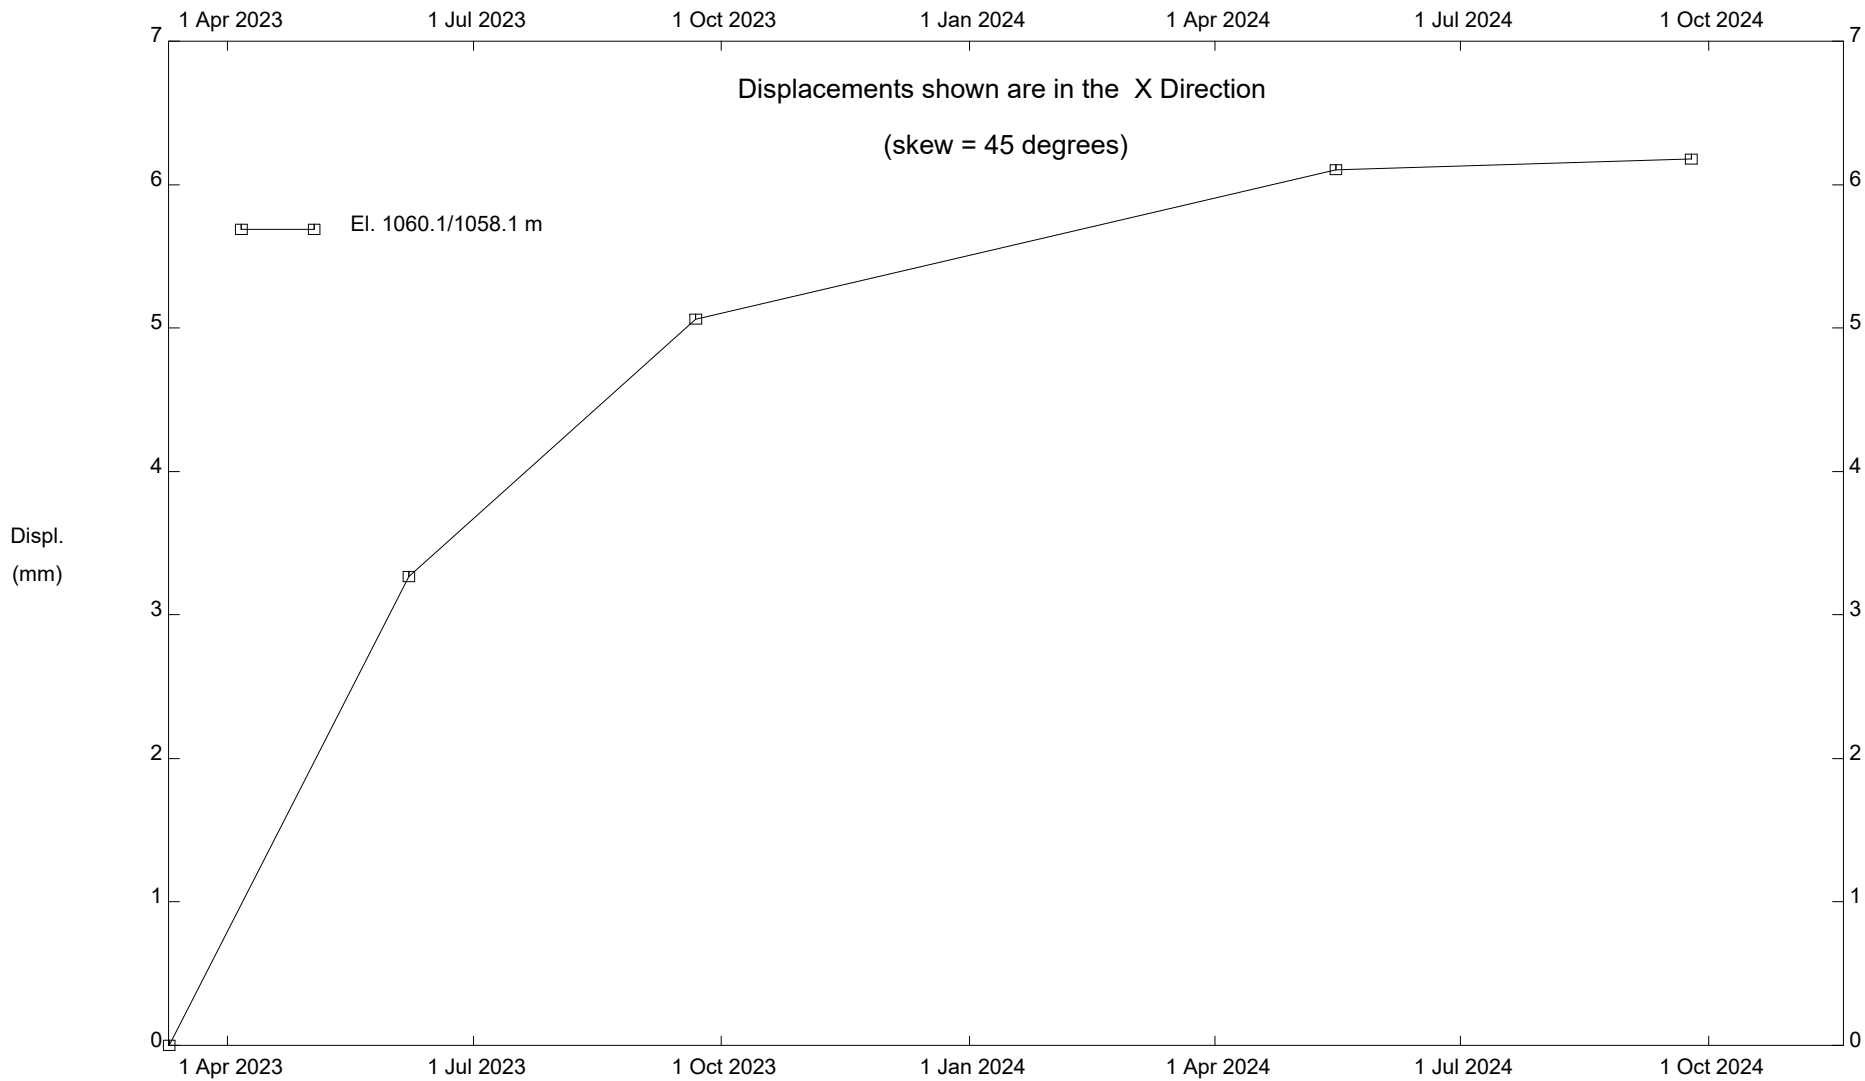
S039 West Brocket Slide, Inclinator SI 23-03

SI23-03 is located on the west flank of the slide near the crest of the slope. A possible zone of distributed movement has been recorded in SI23-03 between an approximate depth of 10 m and 12 m below ground surface (approximately El. 1062 m to El. 1057 m) in the clay till.

SI23-03 (located west of slide mass) measured distributed movement between depths of approximately 10 m to 12 m below ground level at a skew angle of 45 degrees (northeast) from down slope (perpendicular to the highway). Movement at similar depths was previously measured in SI16-01 (replaced by SI23-03) prior to it being damaged. This elevation is approximately the same as the bench at the base of the slope. More data is required to assess movement zones and trends.
