November 29, 2024

Alberta Transportation and Economic Corridors
2nd Floor, 803 Manning Road N.E.
Calgary, Alberta
T2E 7M8

**CON0022161 Southern Region GRMP Instrumentation Monitoring
Site S039-I; H03:06, km 12.952 West Bocket Slide
Section C – 2024 Fall Readings**

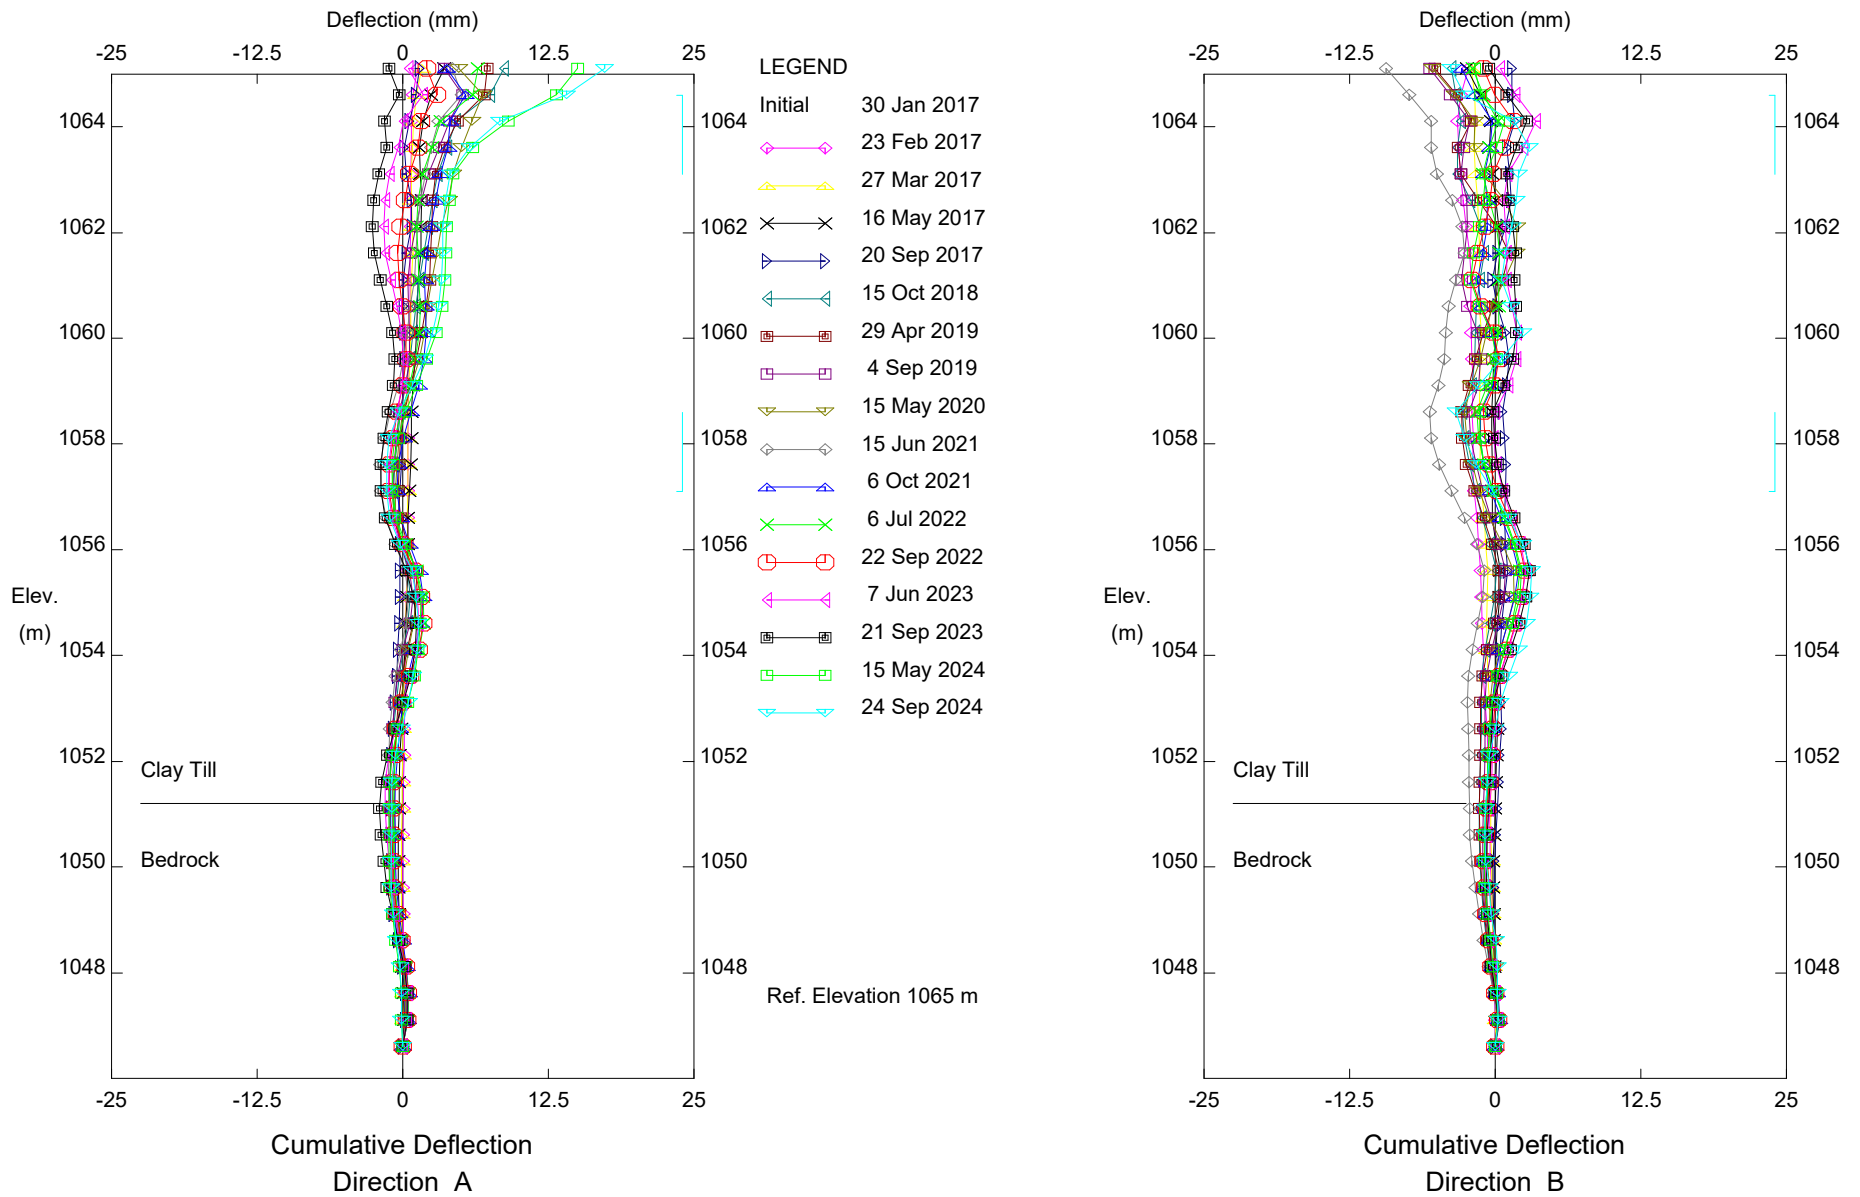
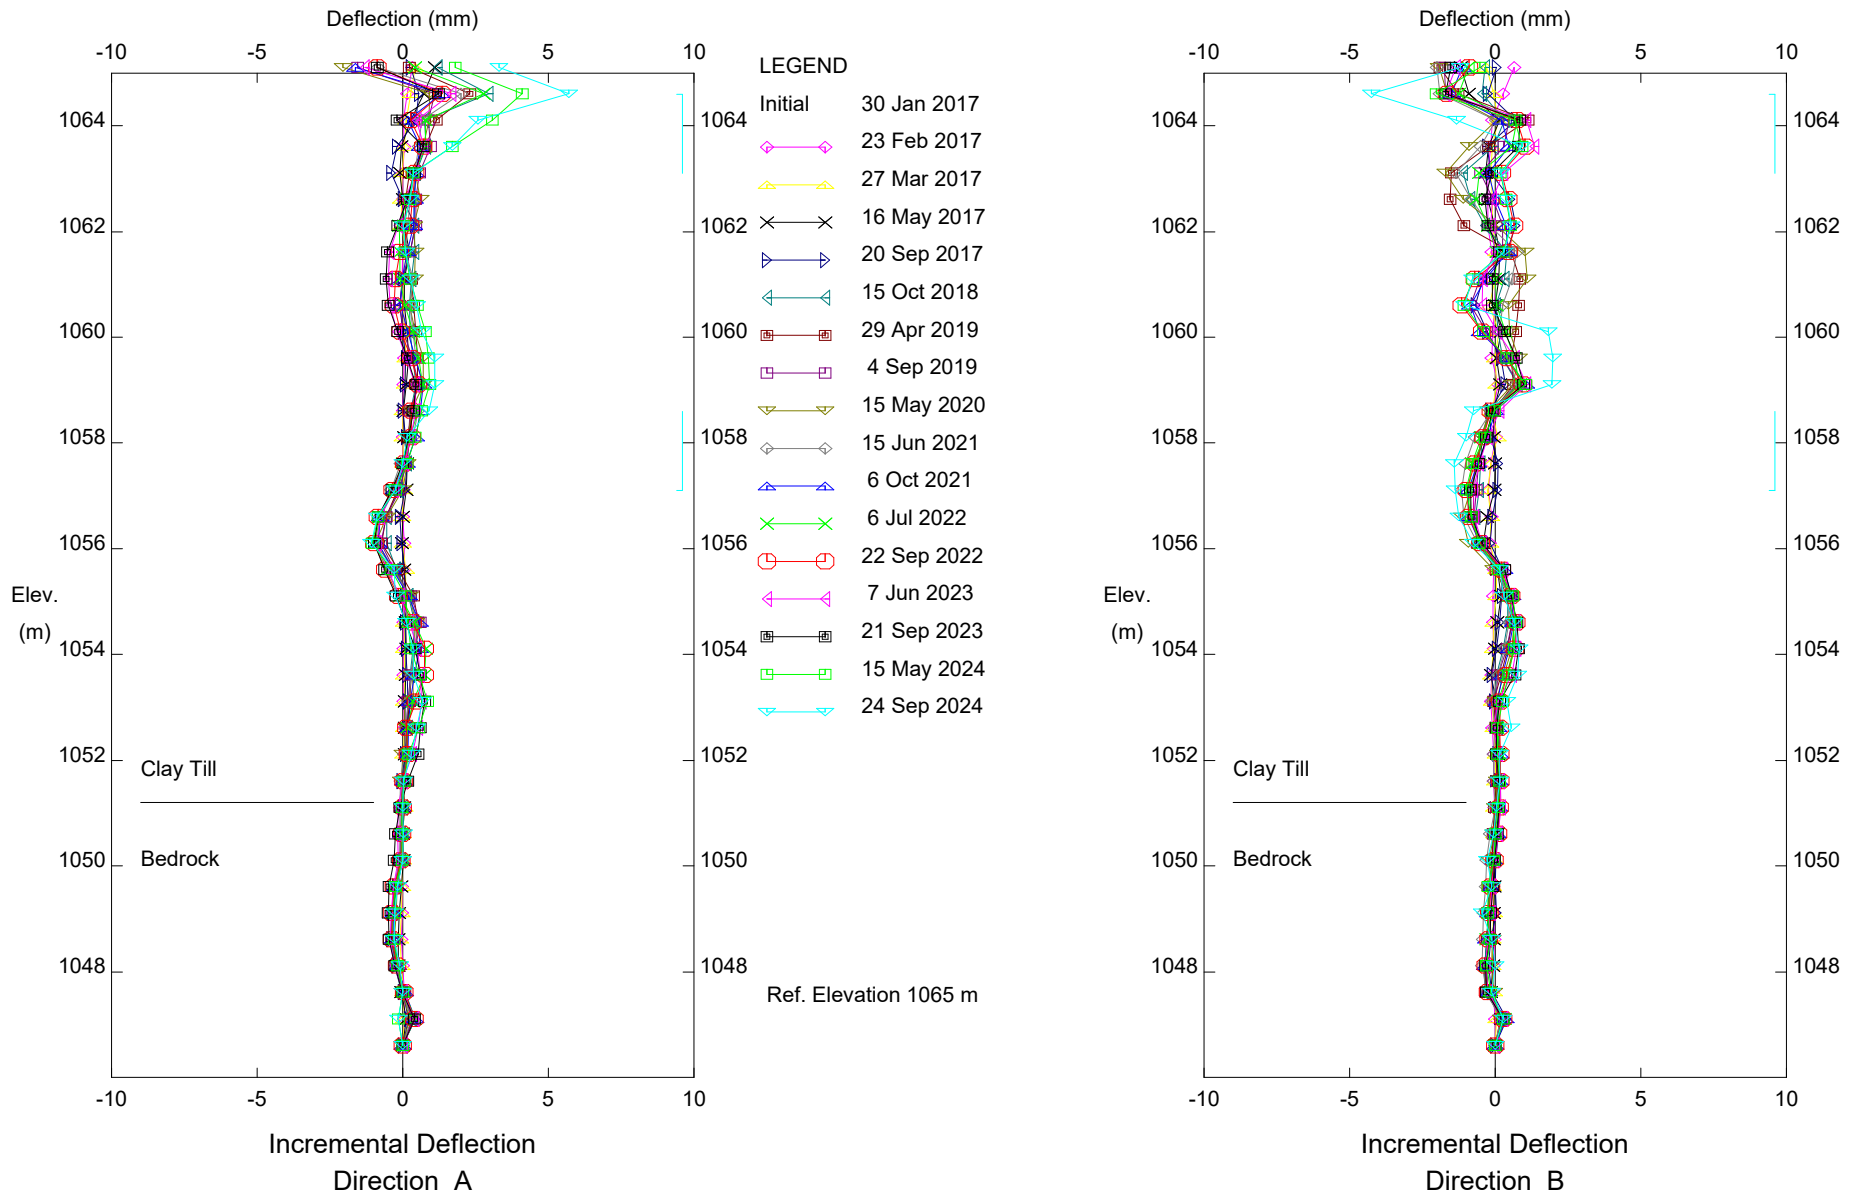
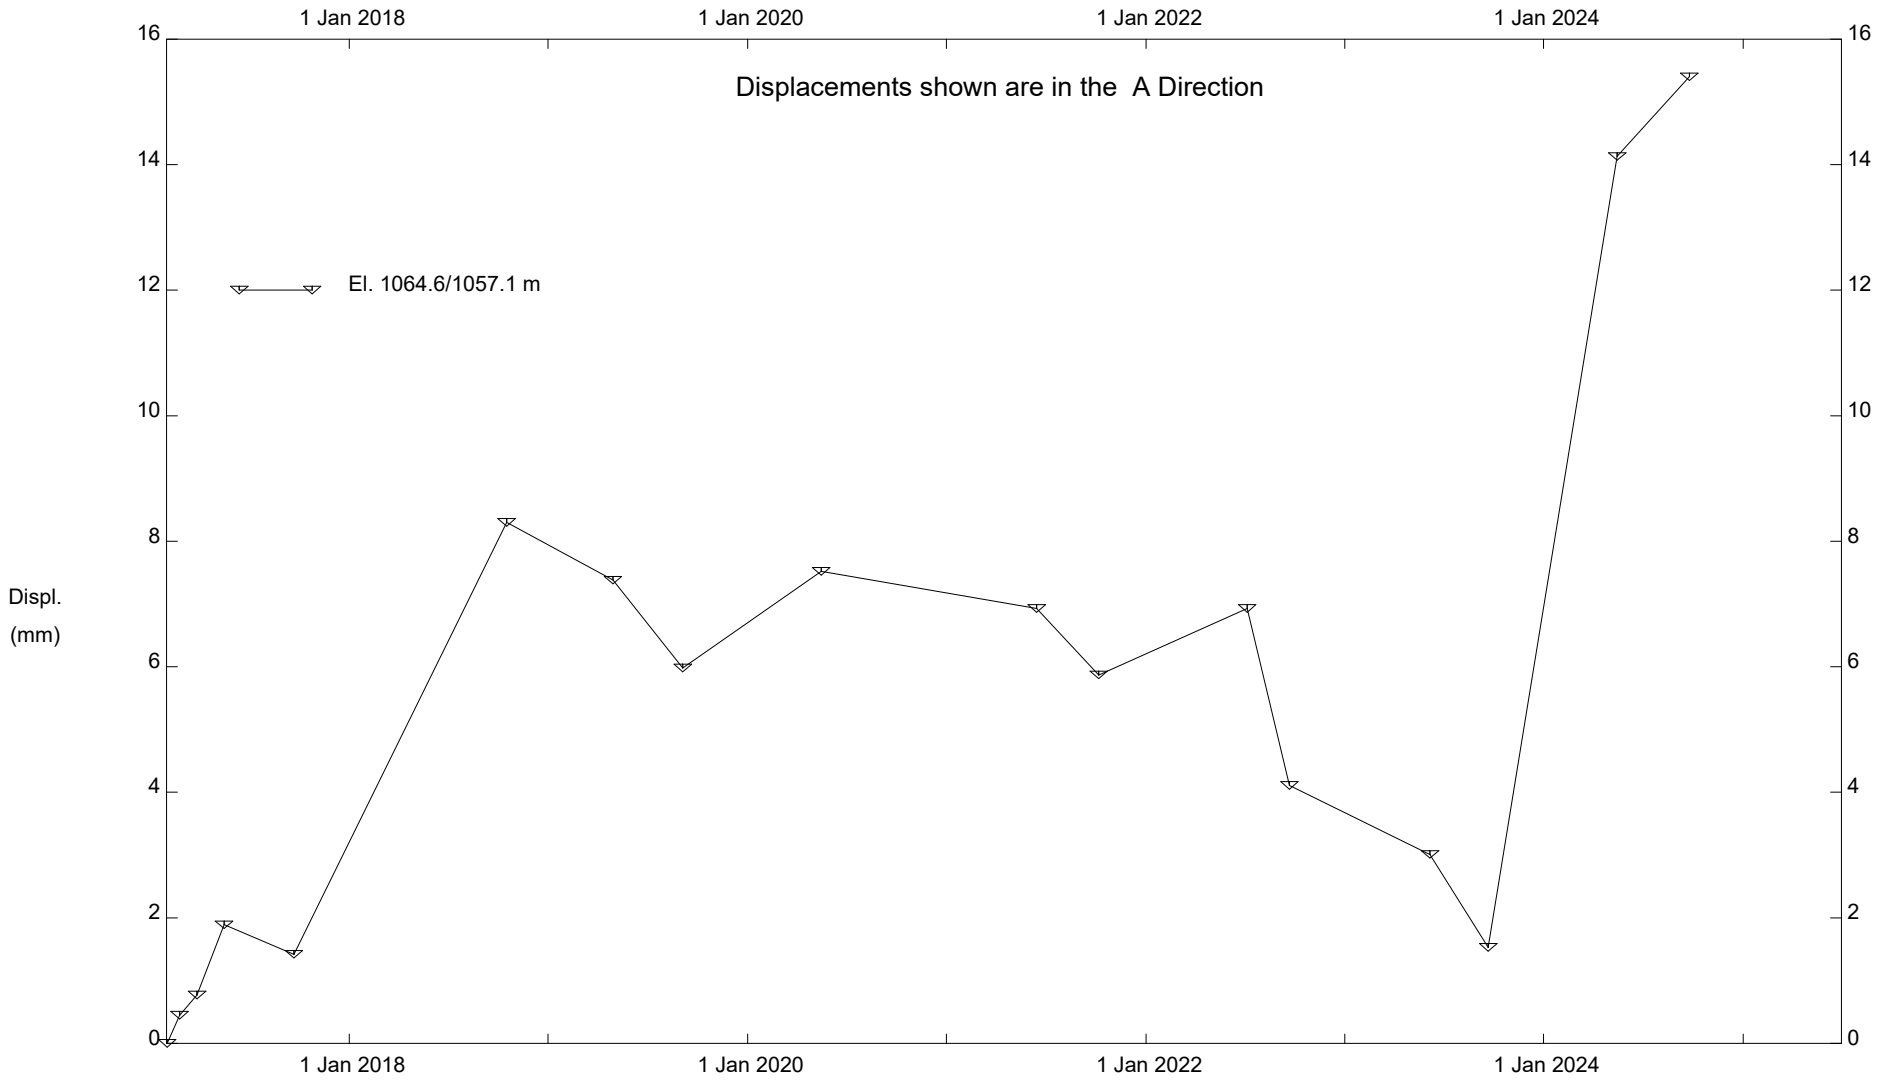
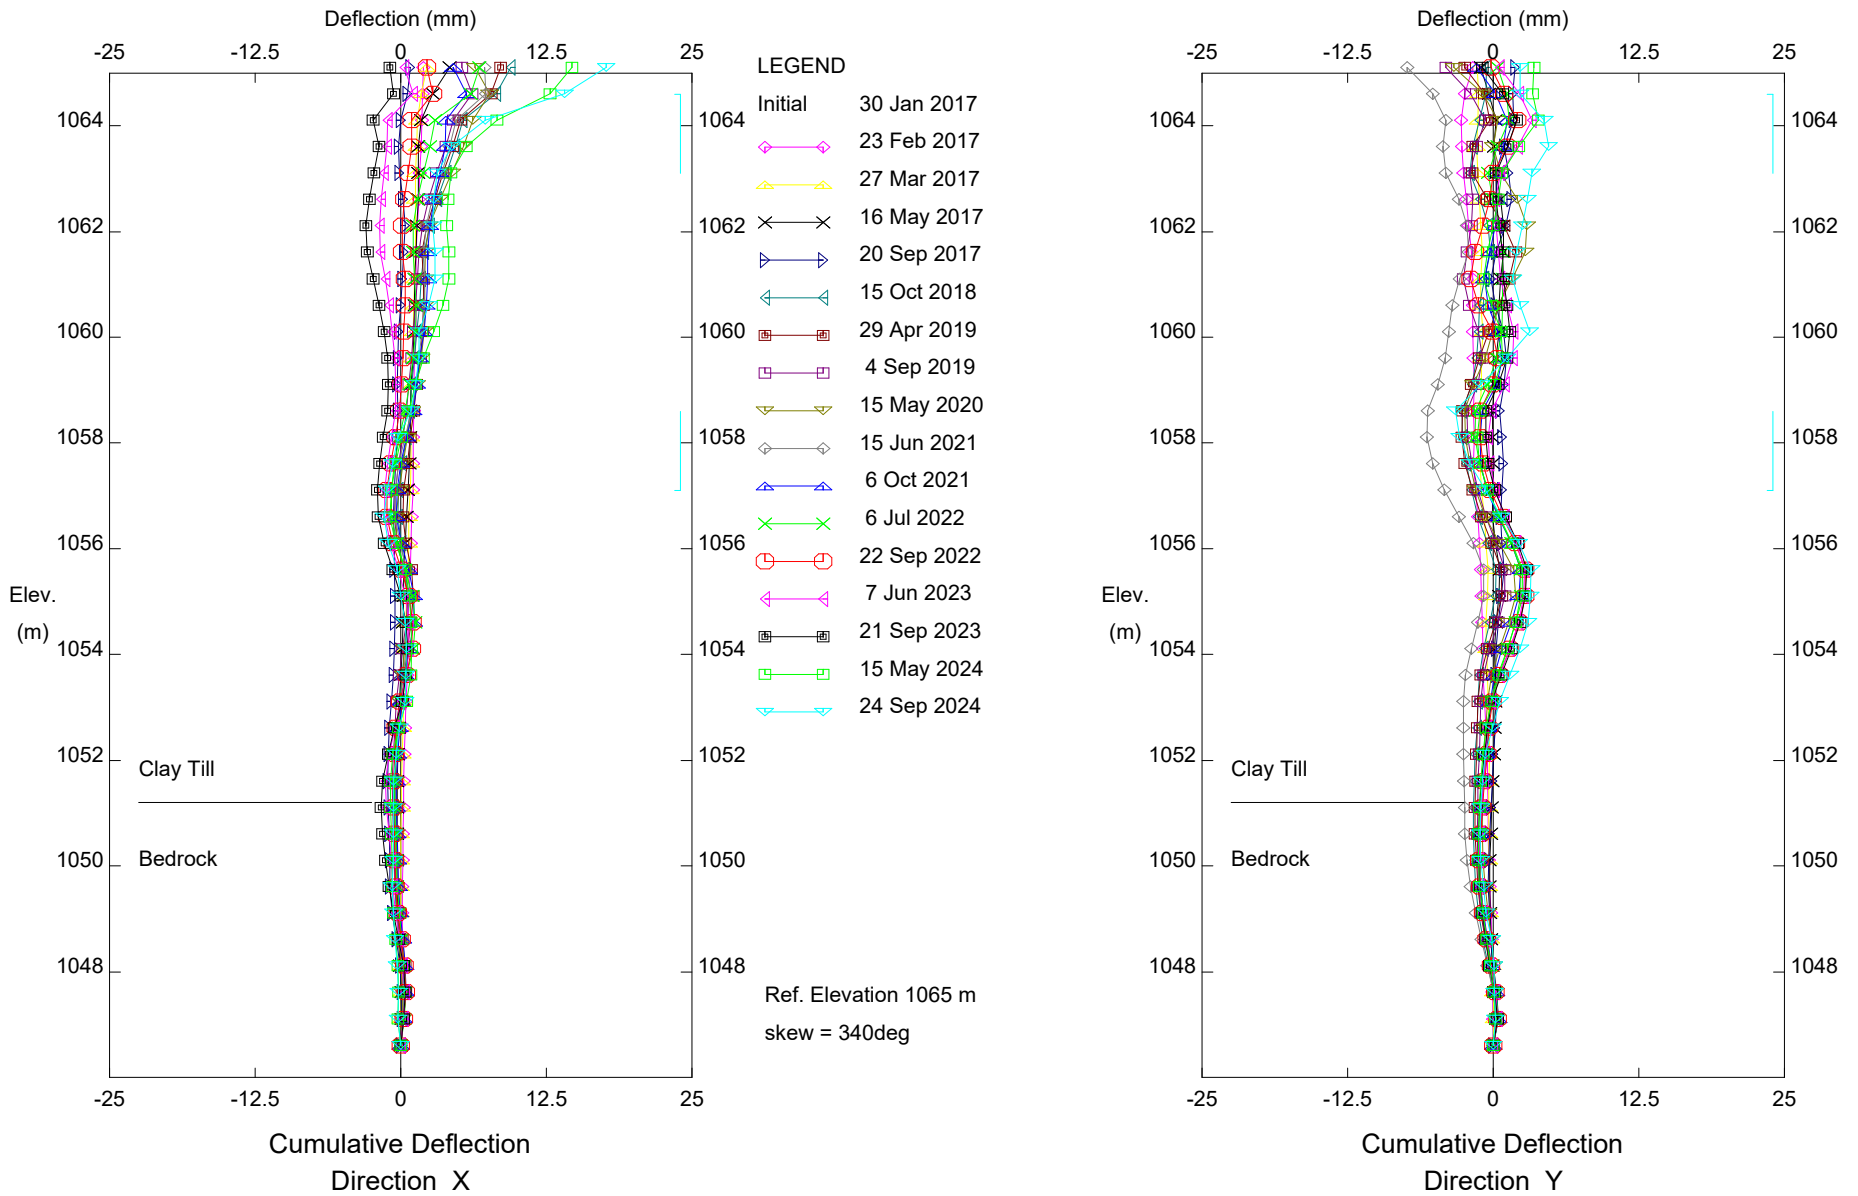
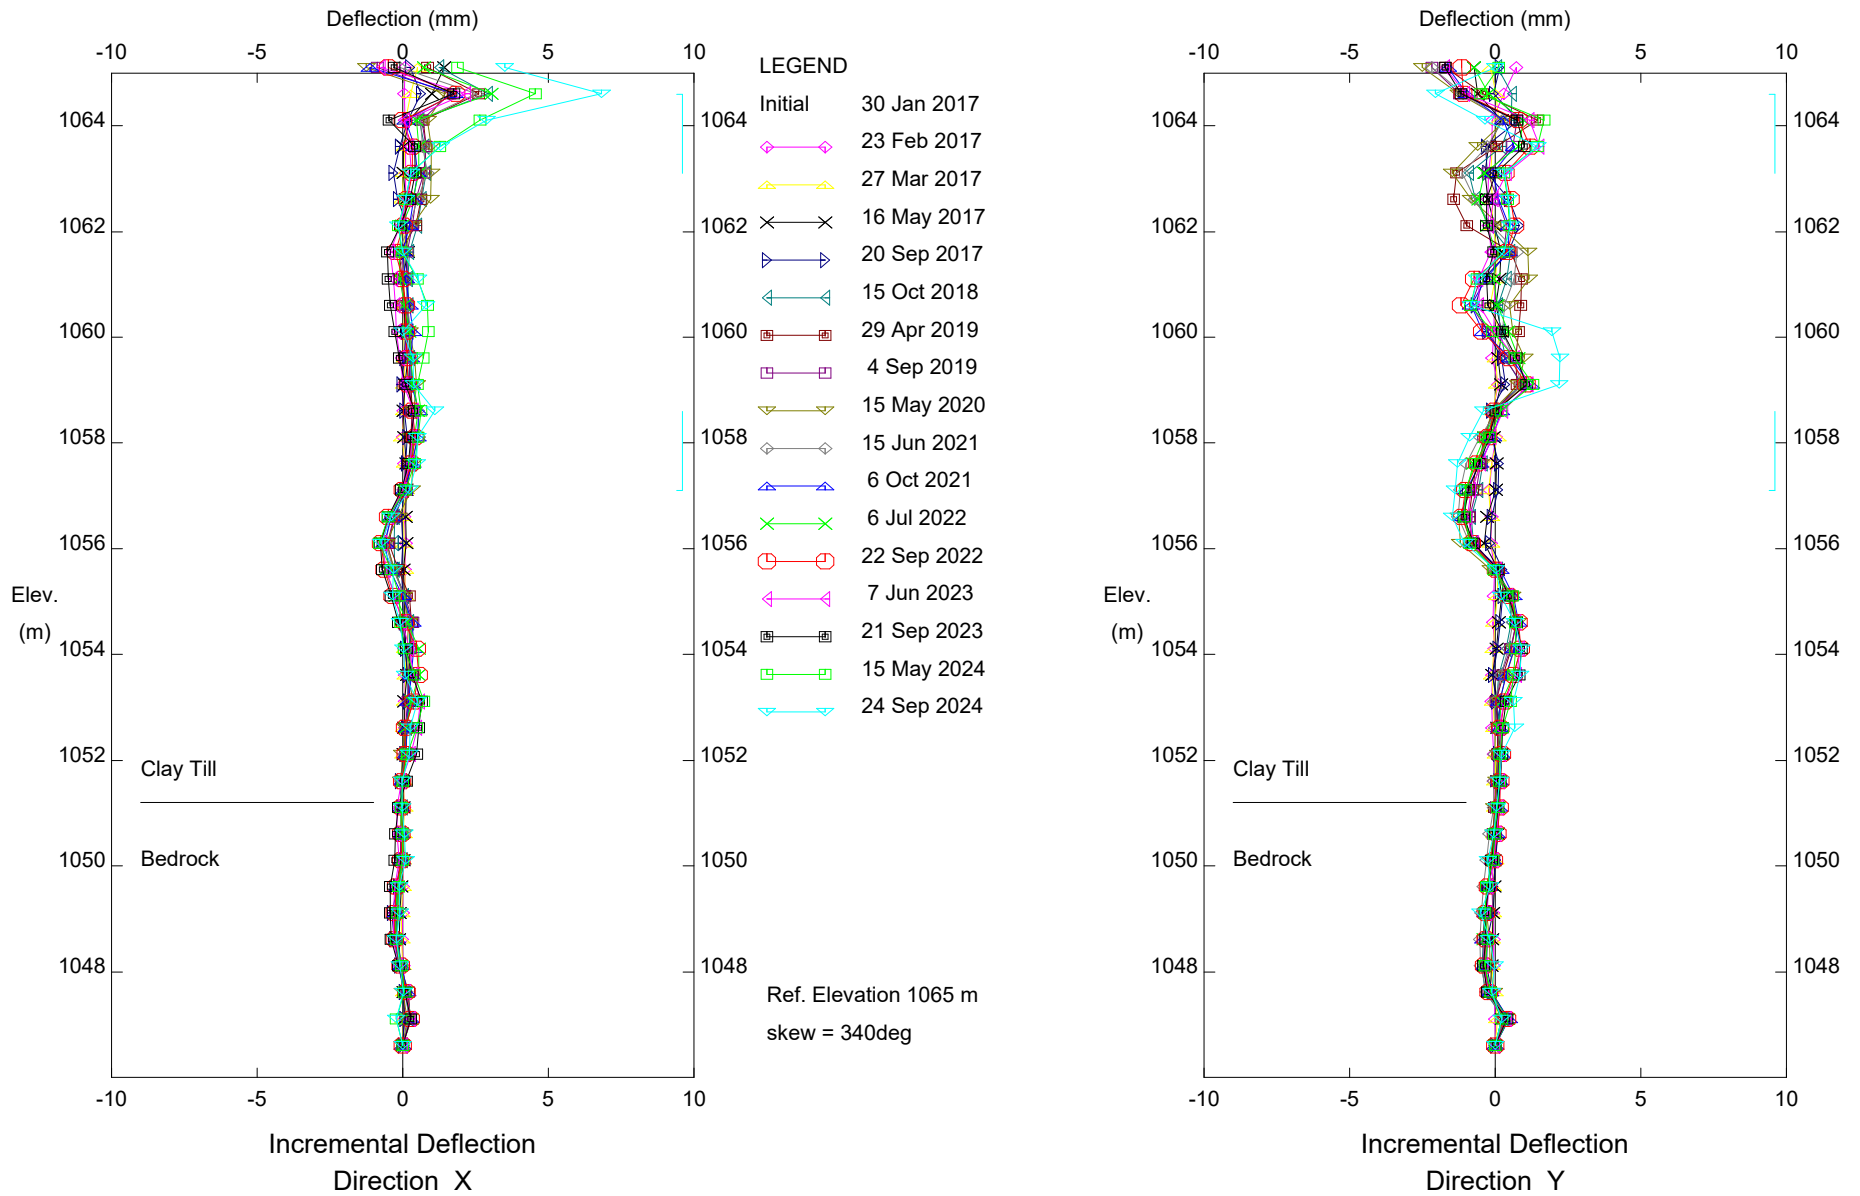
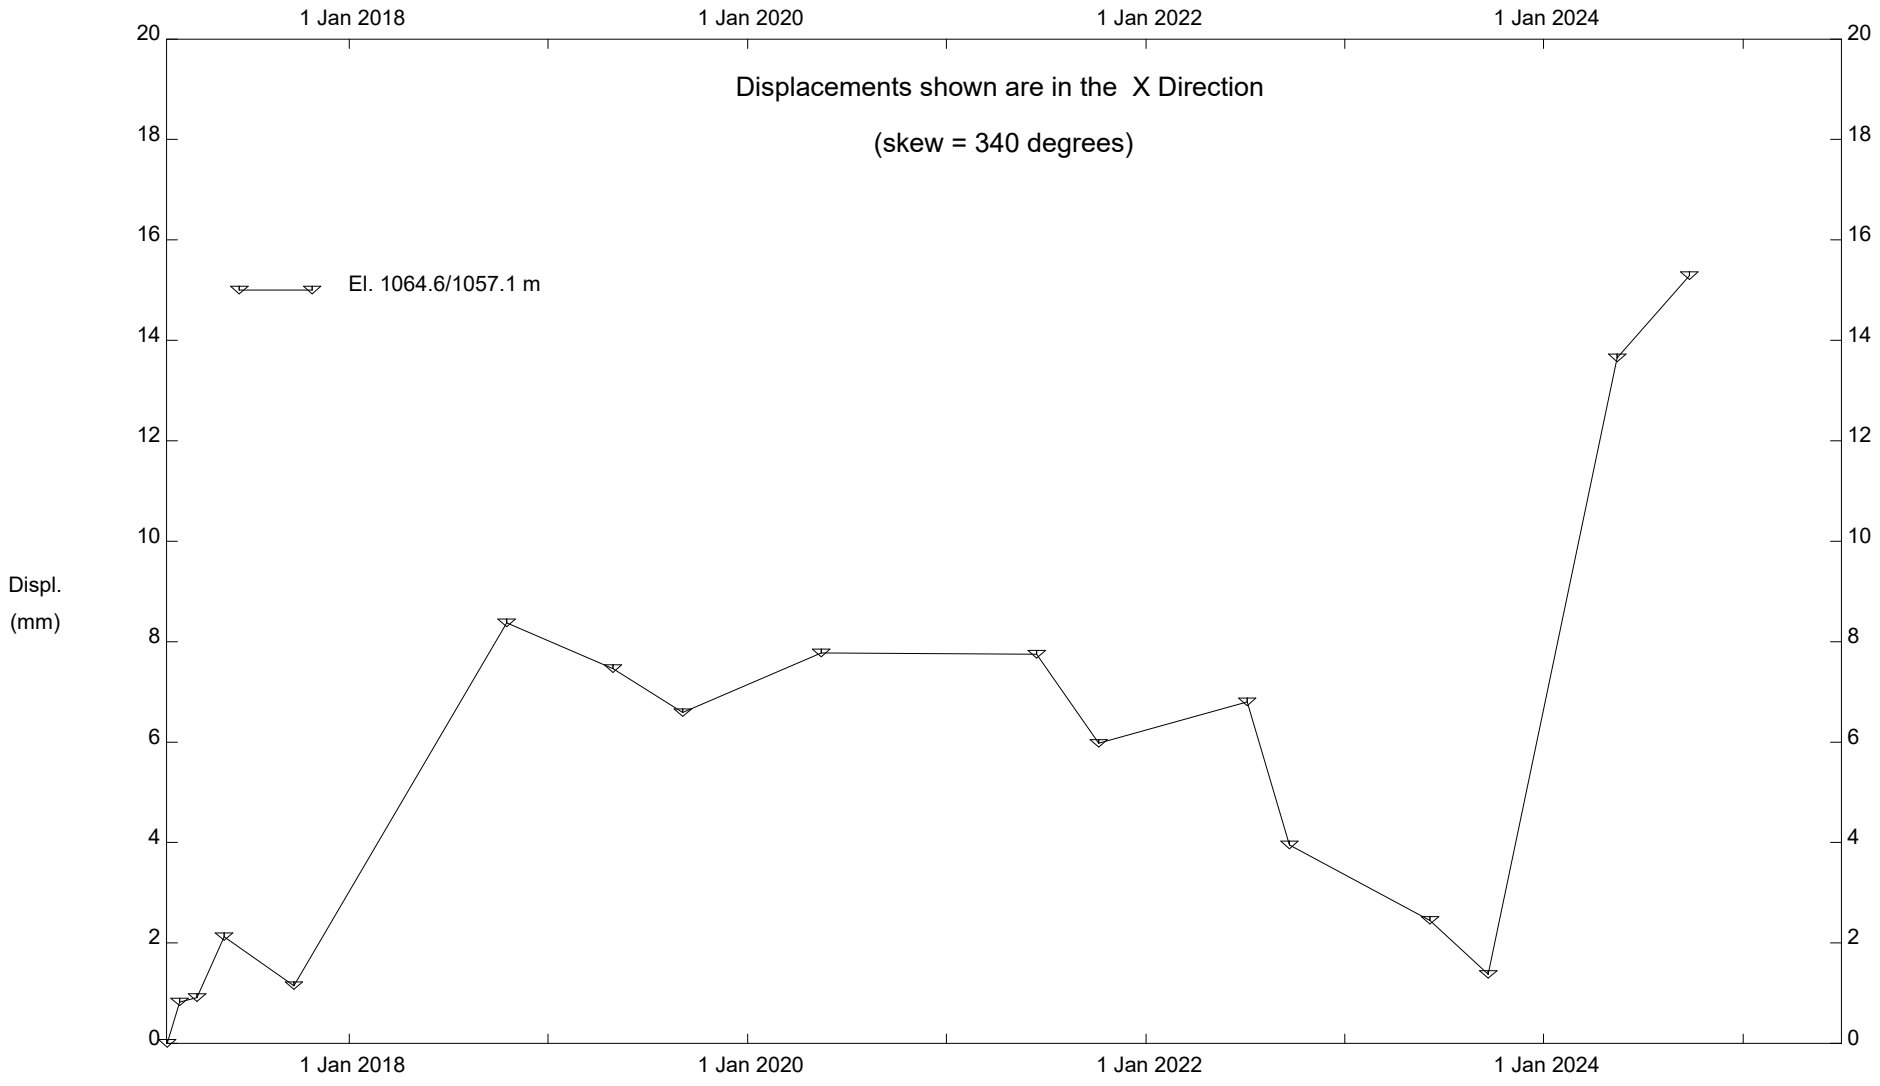
S039; H03:06, West Brocket Slide, Inclinometer SI16-03
 Alberta Transportation

SI16-03 is located on the east flank of the slide near the mid slope. Distributed movement (less than 10 mm) has been recorded in SI16-03 from ground surface to an approximate depth of 8 m below ground surface (approximately El. 1057 m) in the clay till.

Most of the movement recorded in SI16-03 (located east of the slide mass) occurred immediately after installation and could be due to post installation SI casing flexure. Since late-2018, the rate of movement recorded in SI16-03 has been slow (less than 5 mm/year). The spring 2024 reading measured approximately 9 mm of movement in the top 1.5 m of the SI which could indicate the slide is expanding laterally to the east. Additional readings are needed to interpret this data and determine if this is a long term movement trend.
