July 10, 2024

Alberta Transportation and Economic Corridors
2nd Floor, 803 Manning Road N.E.
Calgary, Alberta
T2E 7M8

**CON0022161 Southern Region GRMP Instrumentation Monitoring
Site S039-I; H03:06, km 12.952 West Bocket Slide
Section C – 2024 Spring Readings**

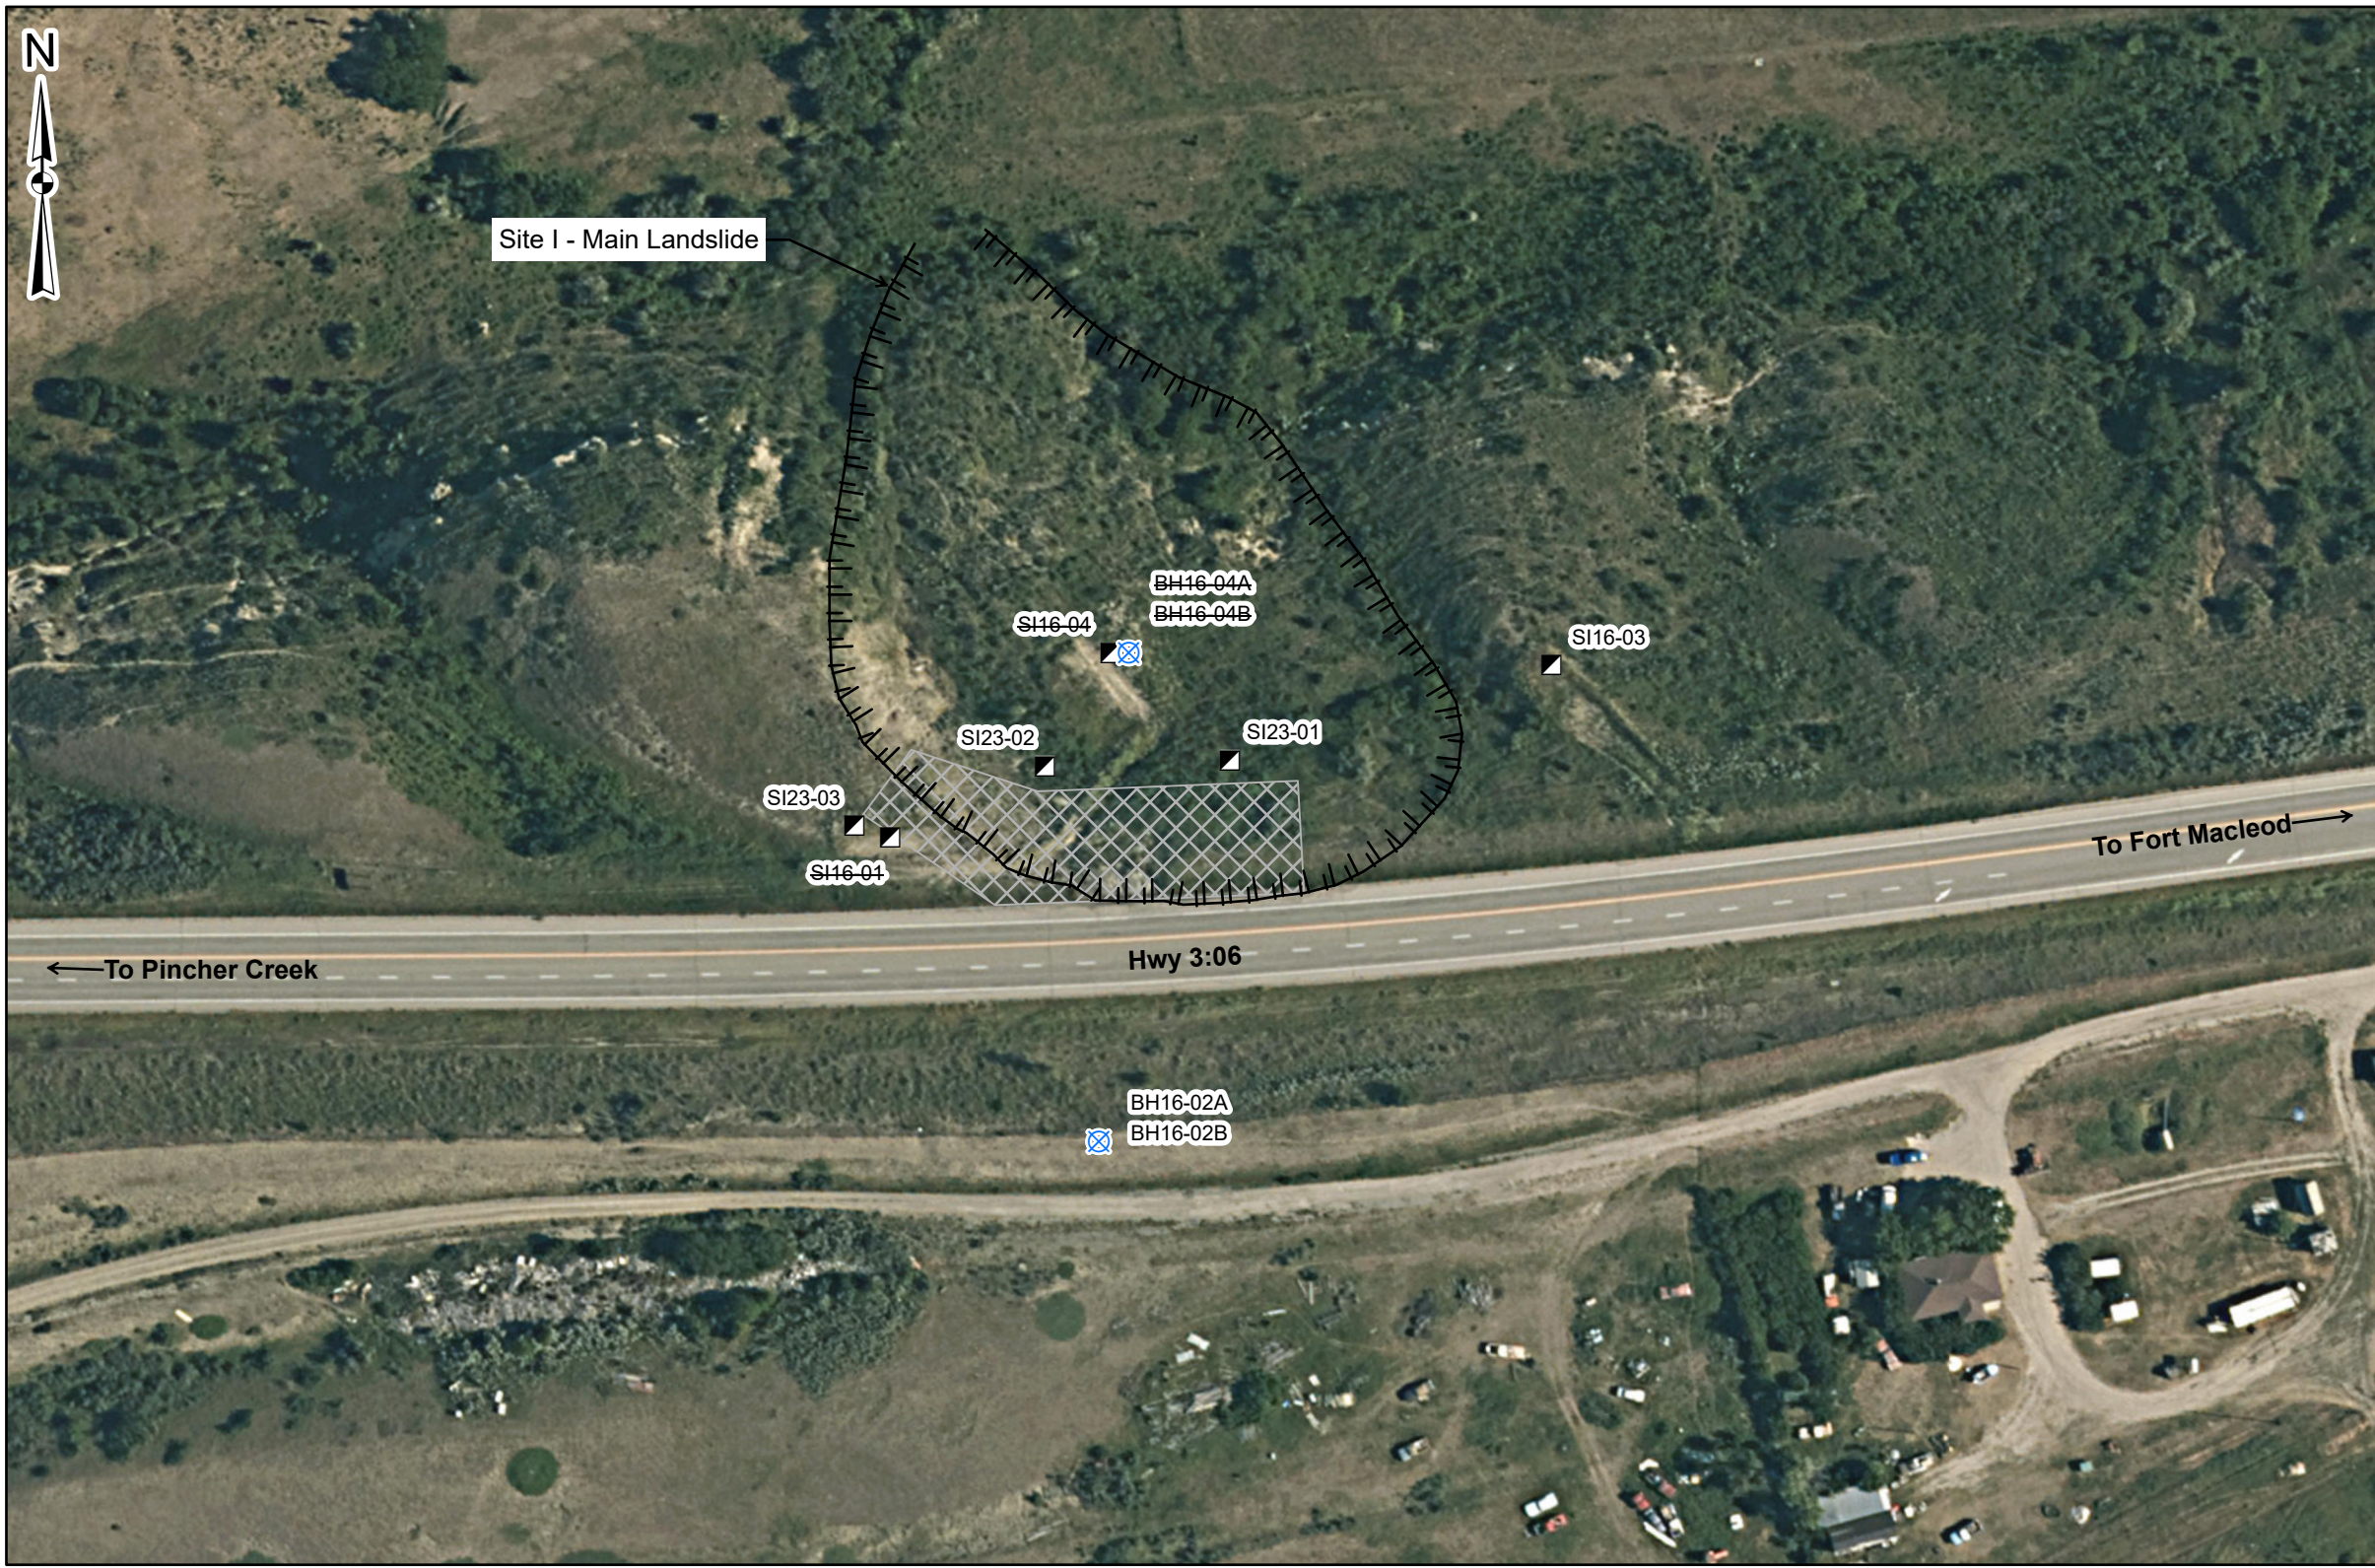
PROJECT SOUTHERN REGION GEOHAZARD RISK MANAGEMENT PROGRAM		
TITLE Site Plan S039 - Brocket Slides Hwy 3.06, km 12.952		
SCALE 1:1,250	PROJECT No. A05116A03	FIG No. 1

The geohazard at the S039 site consists of a range of instabilities over a total length of approximately 600 m along Hwy 03:06. Two subsites have been identified: S039-I at the west end of the site and S039-II at the east end of the site. Instrumentation is only installed at the S039-I site.

Since completion of the repair, a wet zone on the upper $\frac{3}{4}$ mark of the east limit of the anchored backscarp slope was first observed during the May 2023 Section B inspection. This wet zone was not observed or encountered during the 2017 drilling investigation, during any Section B inspections, nor during construction. A small, shallow zone of movement developed in 2023 approximately 30 m by 6 m at the east extent of the repair. During the spring 2024 Section B inspection additional slope movement and sloughing was observed across the repair slope. Instrumentation is not in place to monitor the performance of the anchored back slope nor the zone of movement associated with an isolated wet area on the upper east part of the anchored slope.

Surveys (ground-based LiDAR or UAV photogrammetry) should be done to complete change detection analysis to monitor movement on the repair slope as there is no instrumentation currently installed.

Additional repair work is required on the slope due to the ongoing sloughing and slope movement. A proposal was submitted to TEC in July 2024 to evaluate additional repair options.

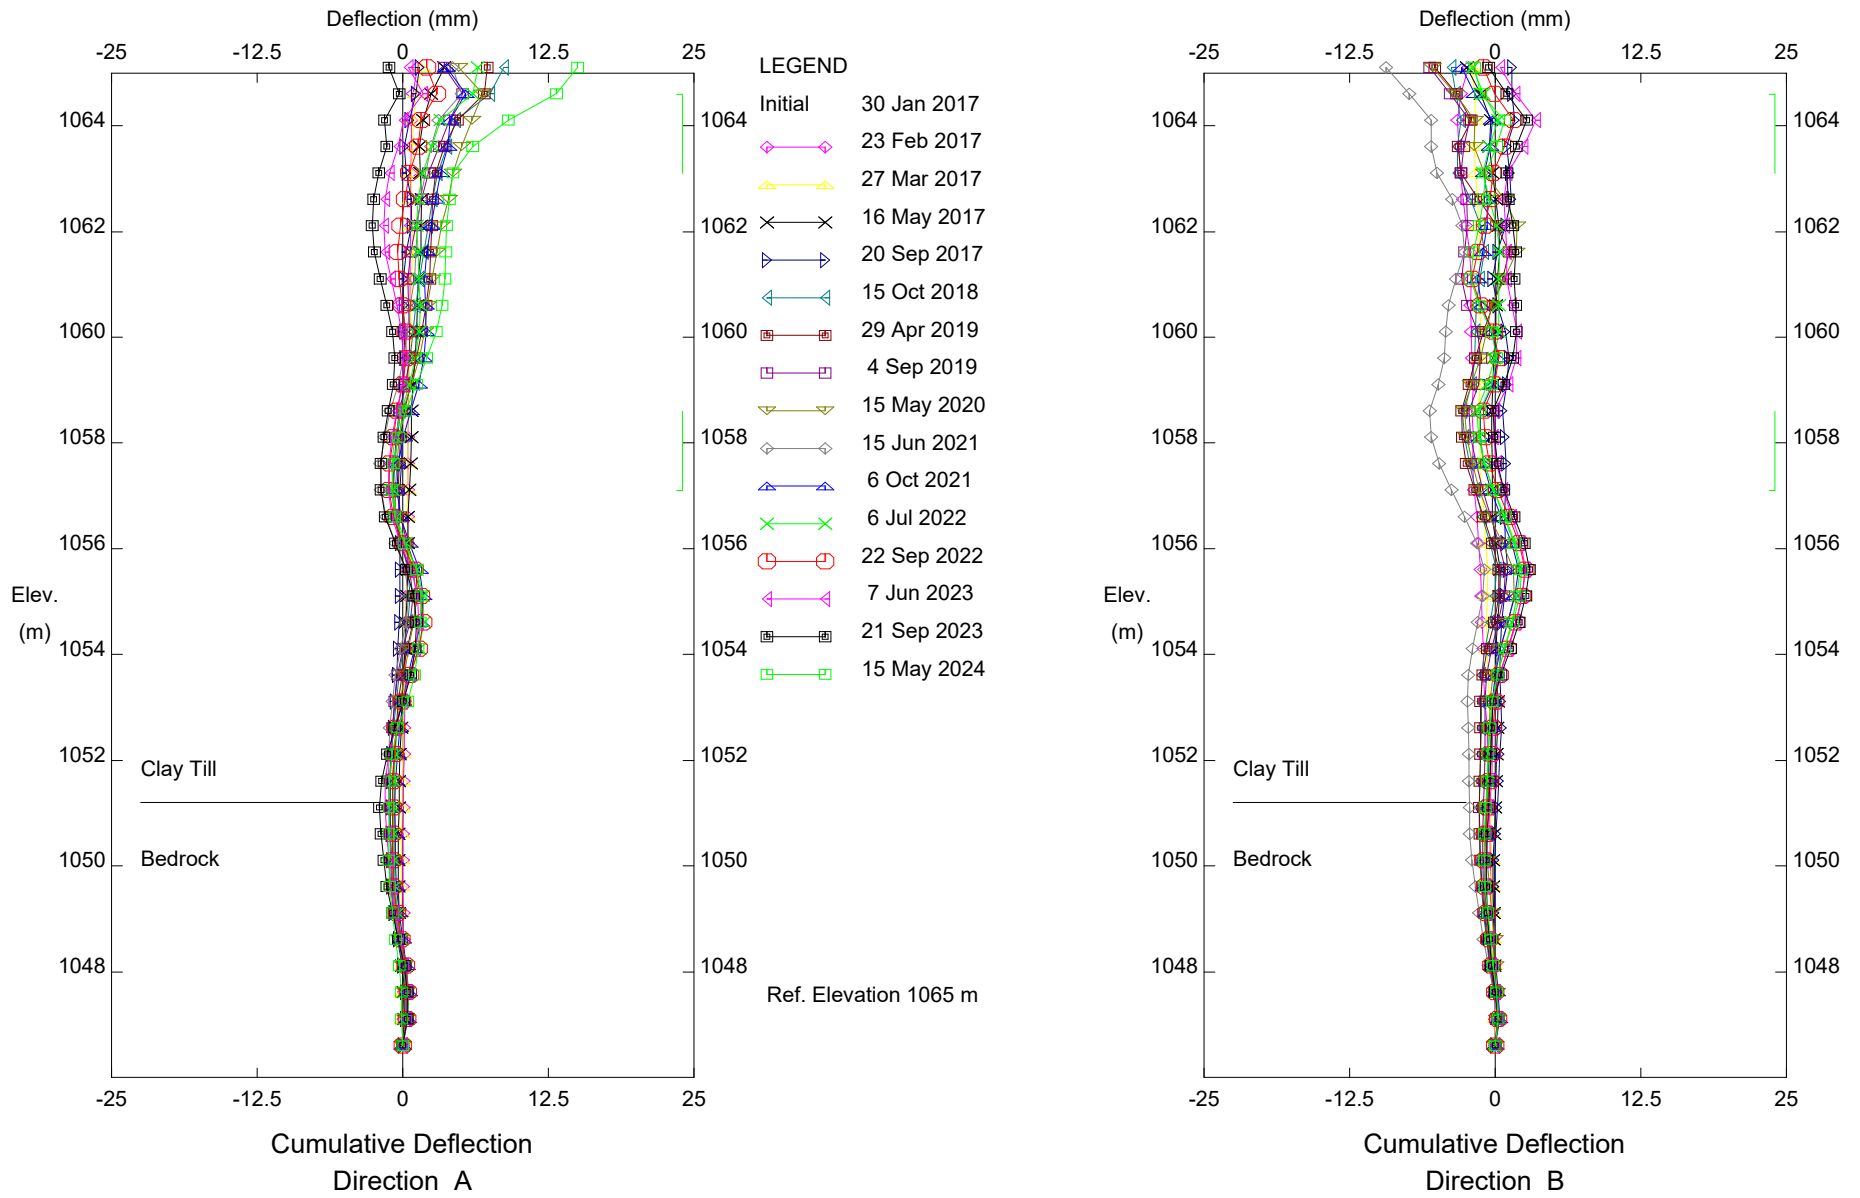
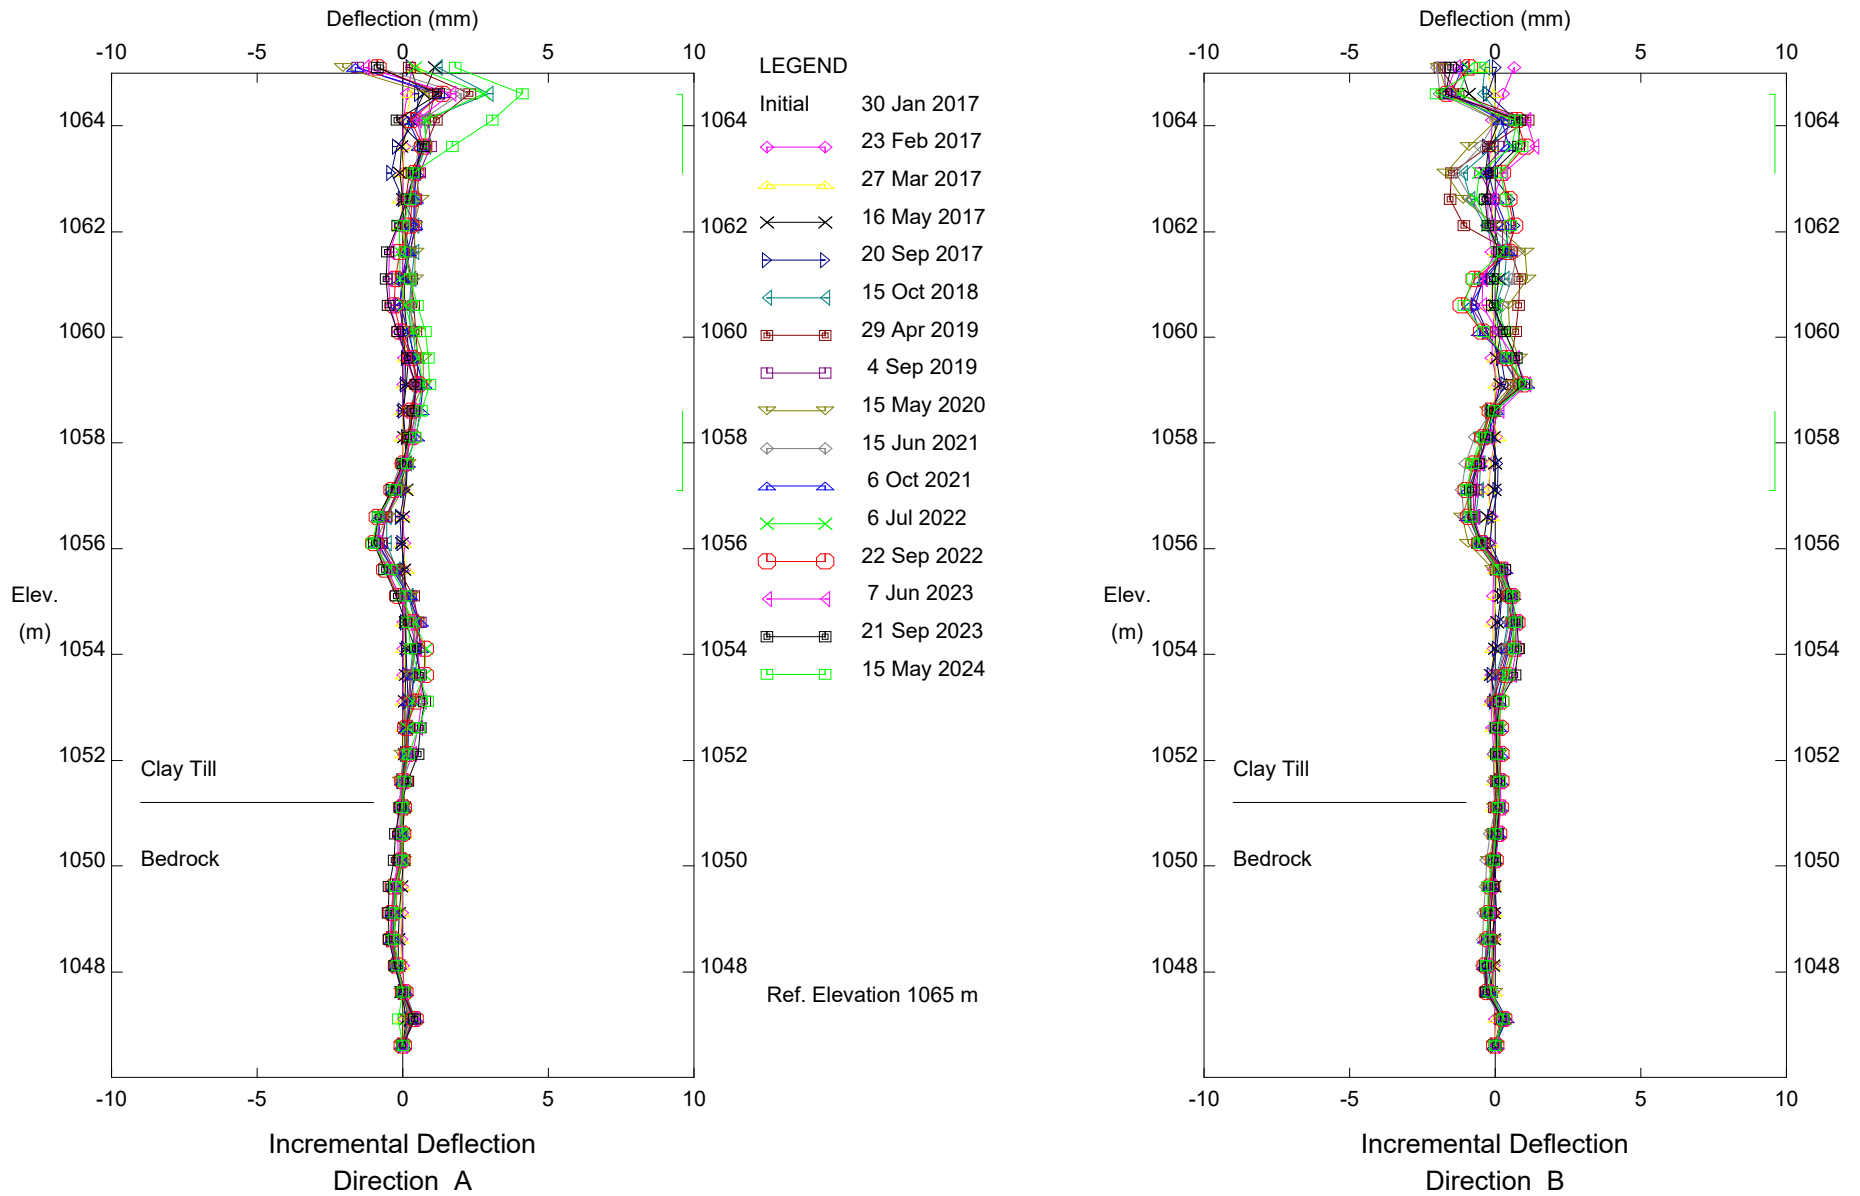
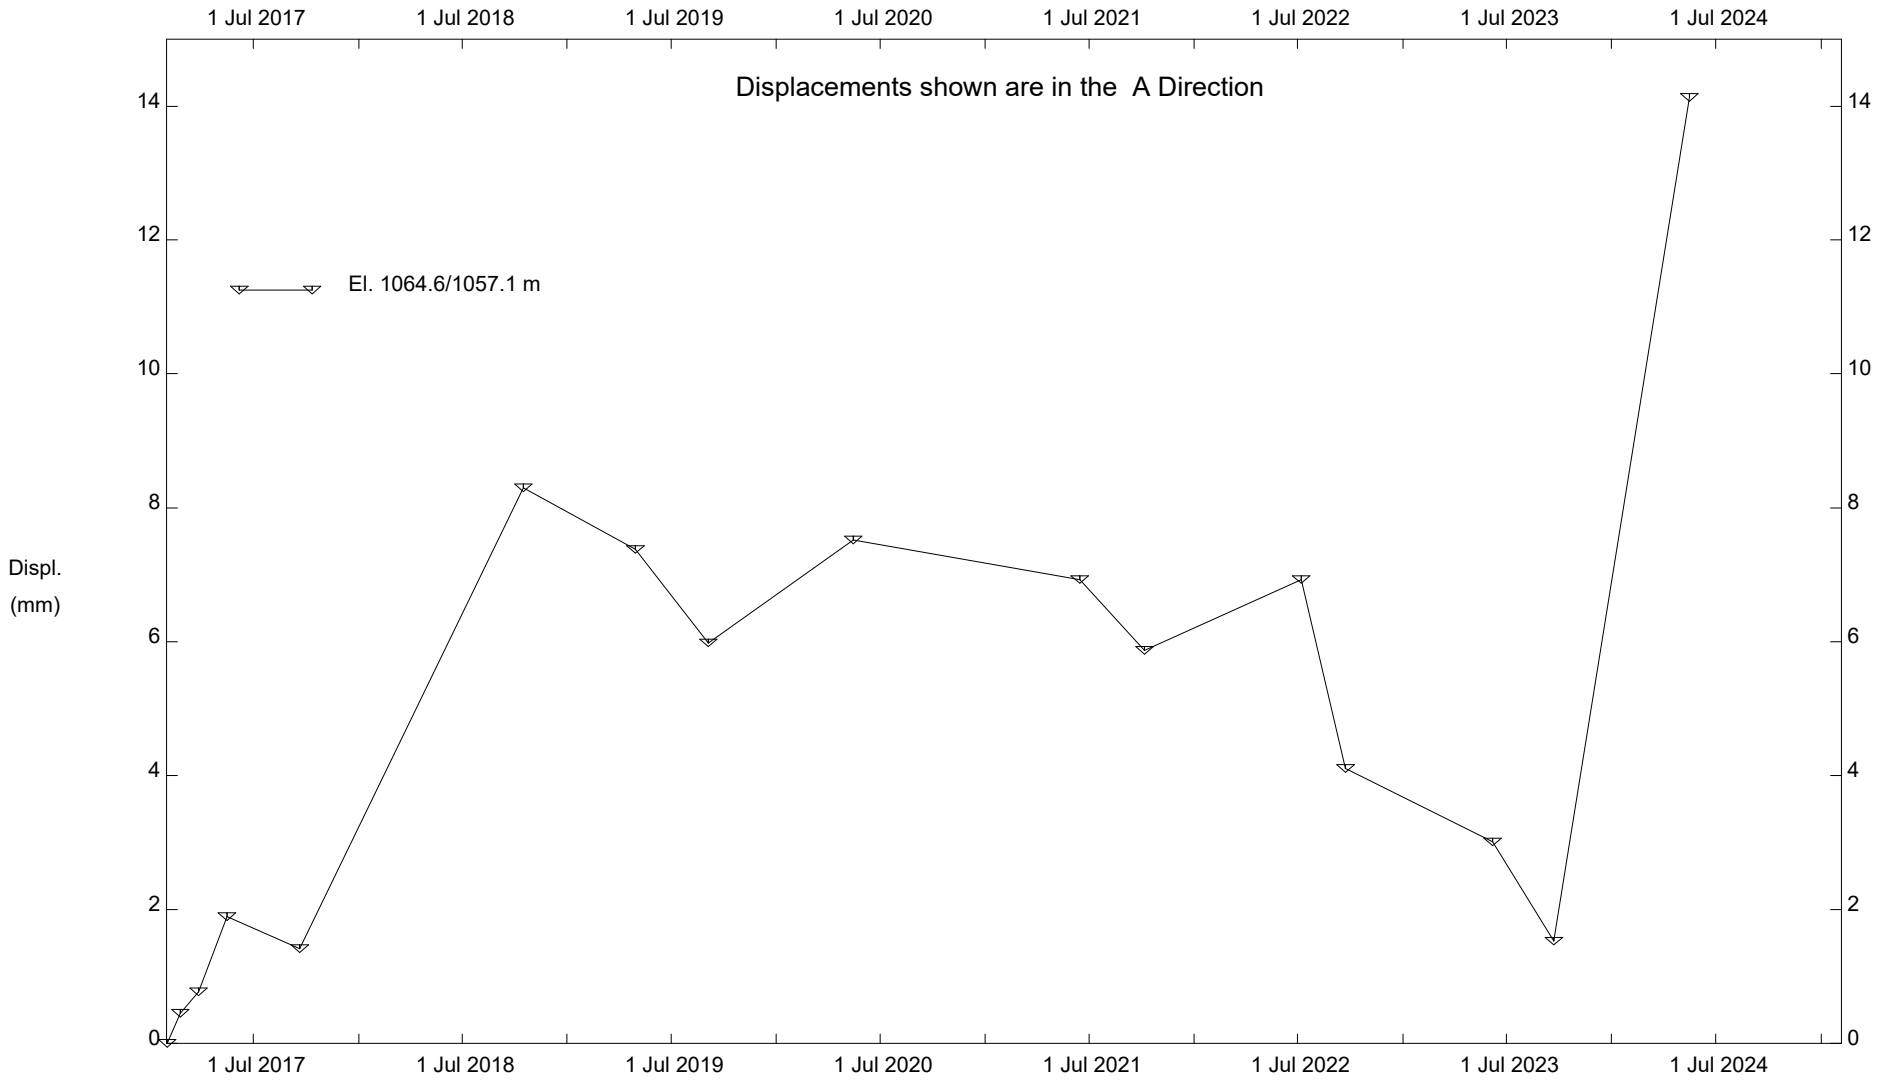
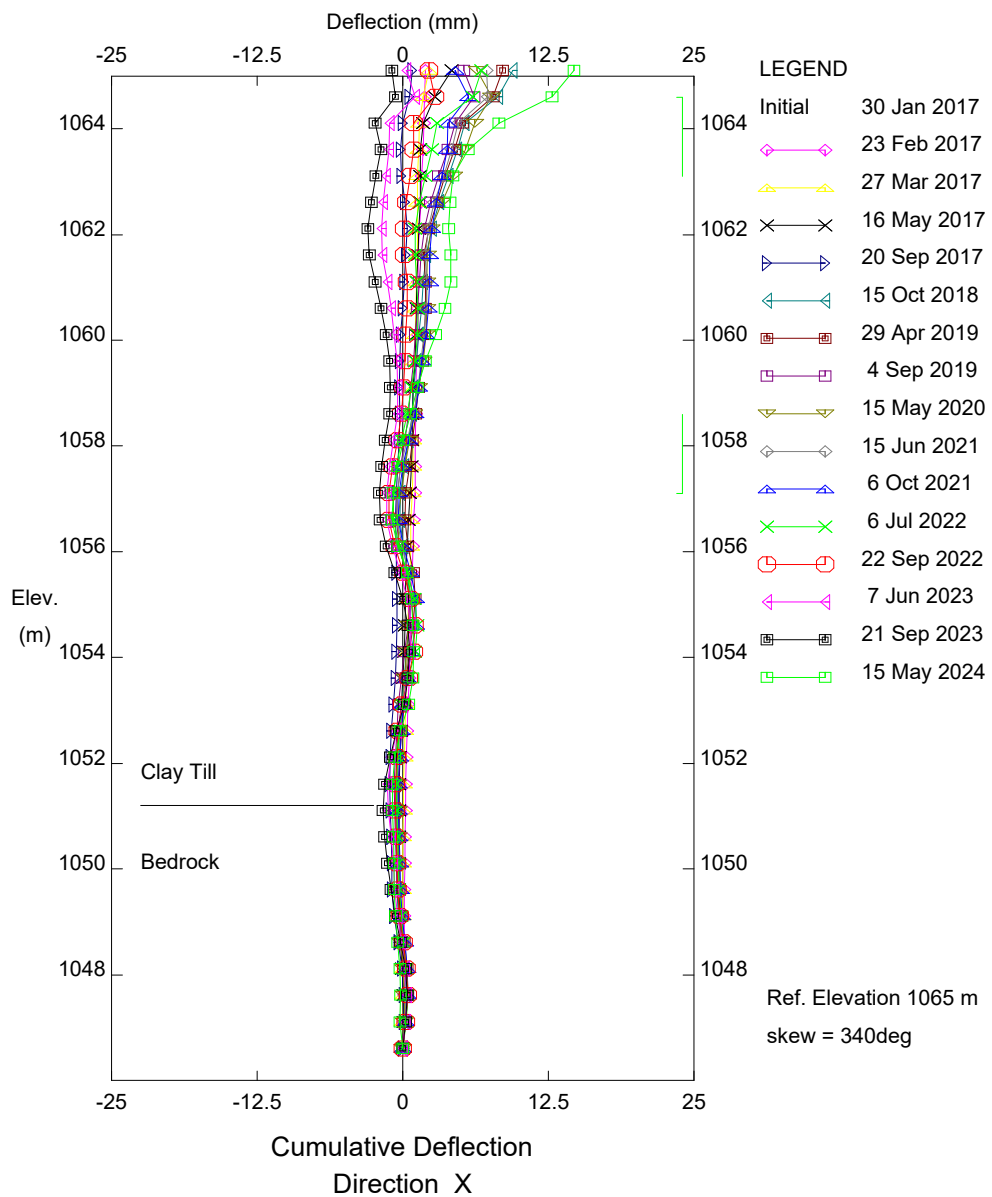
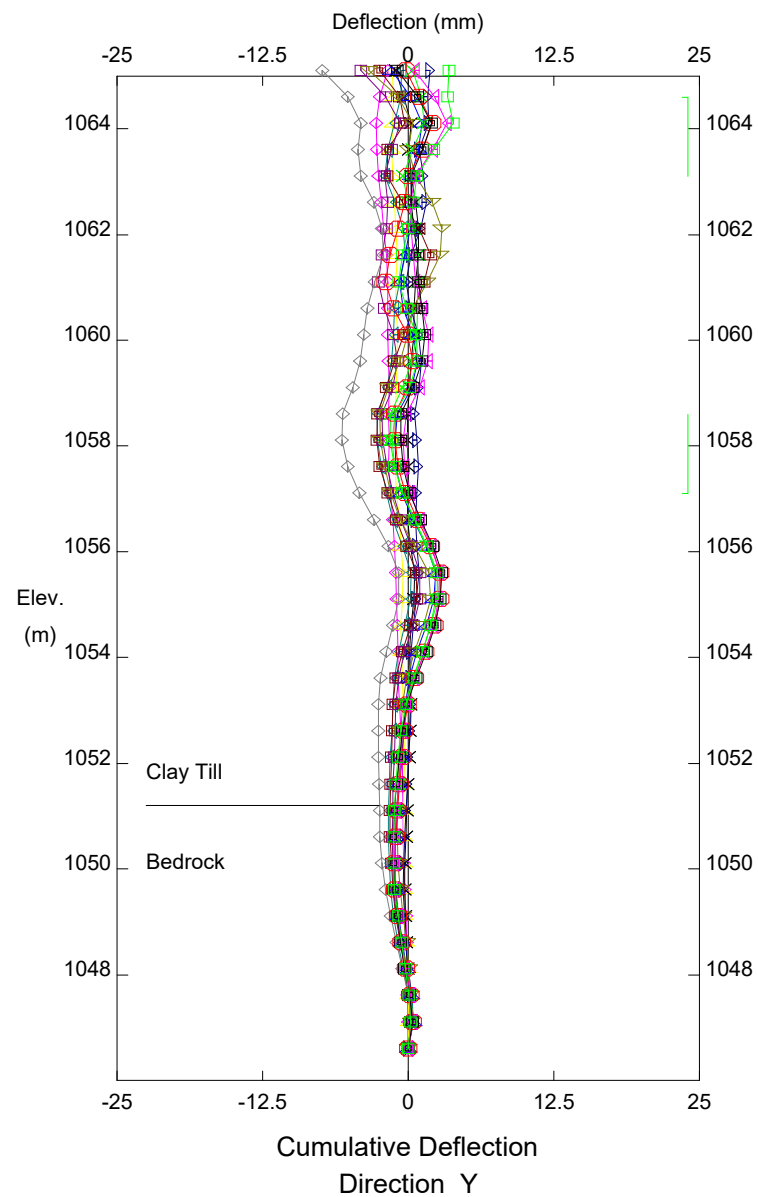
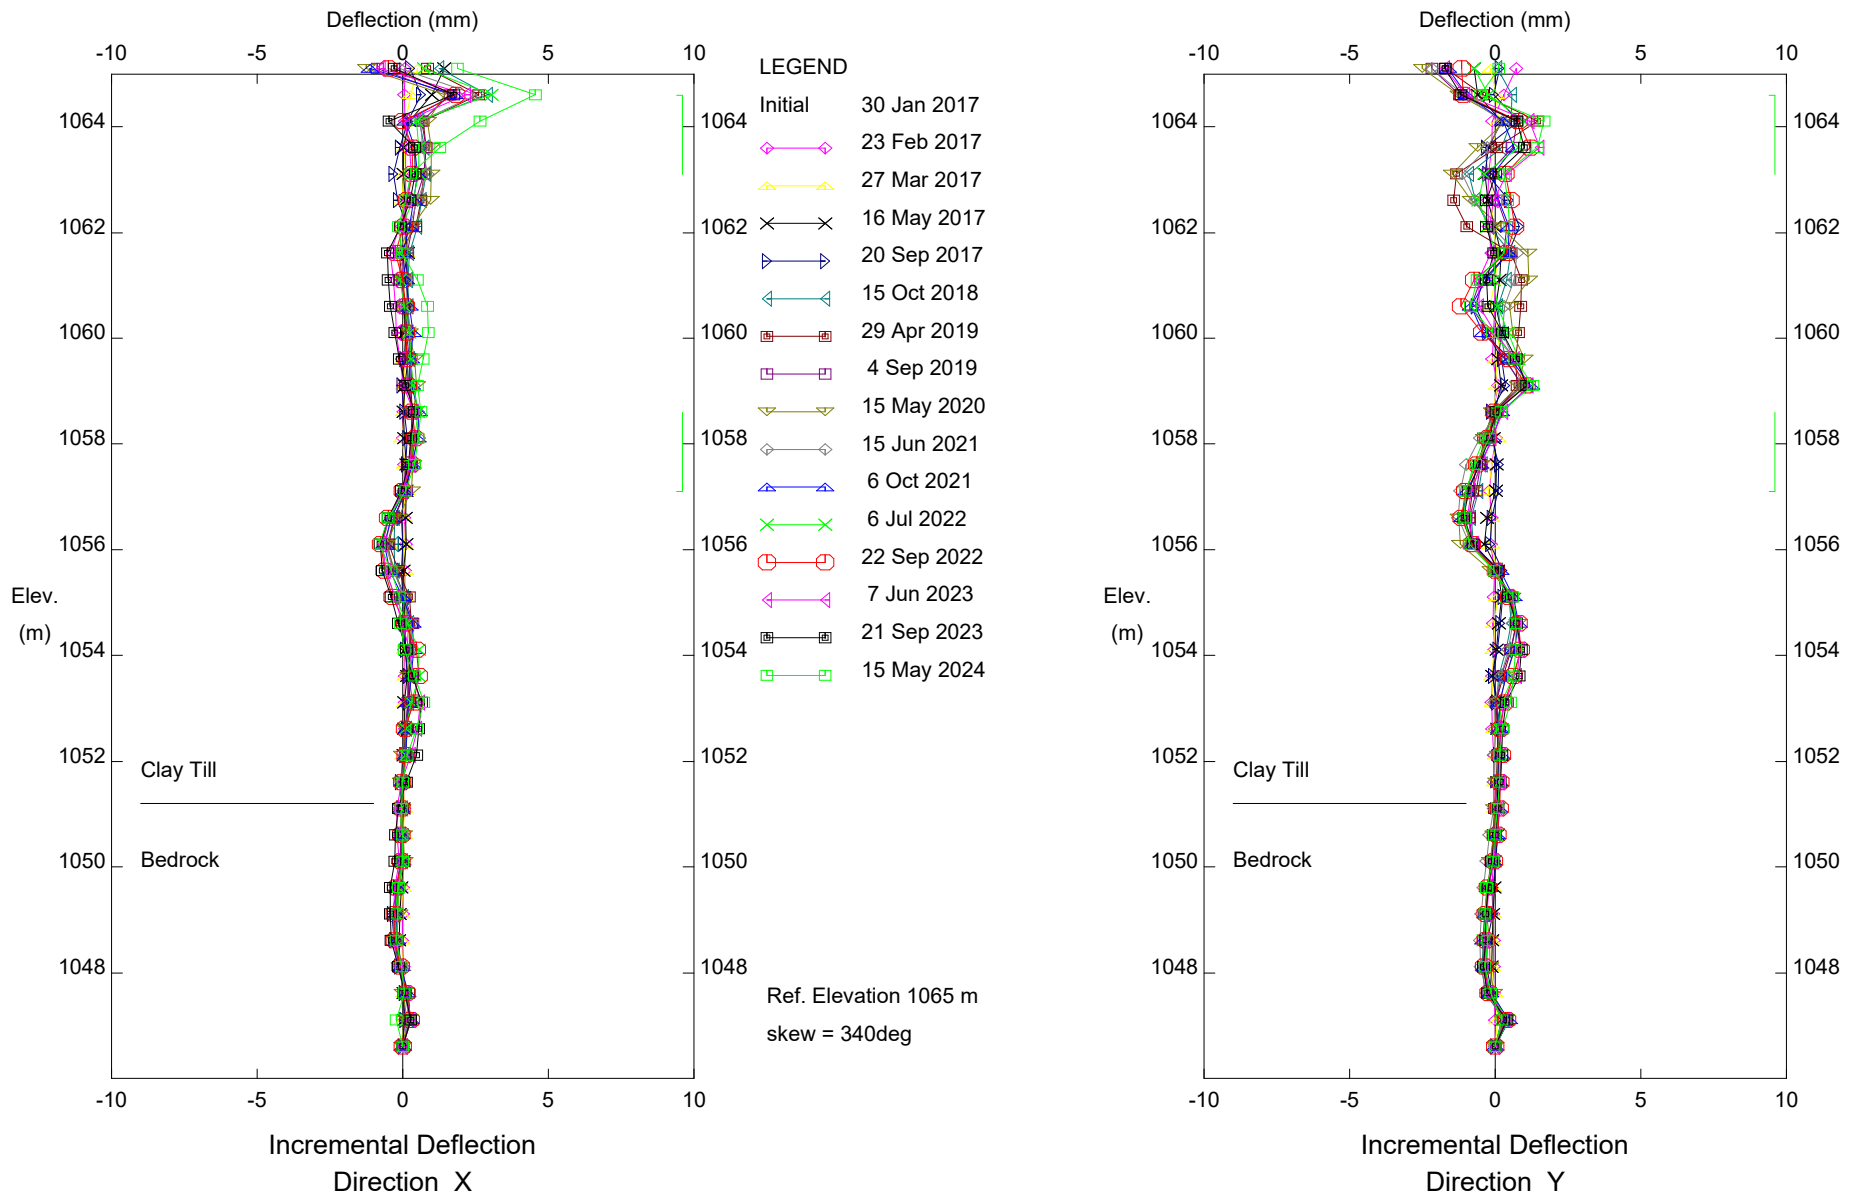
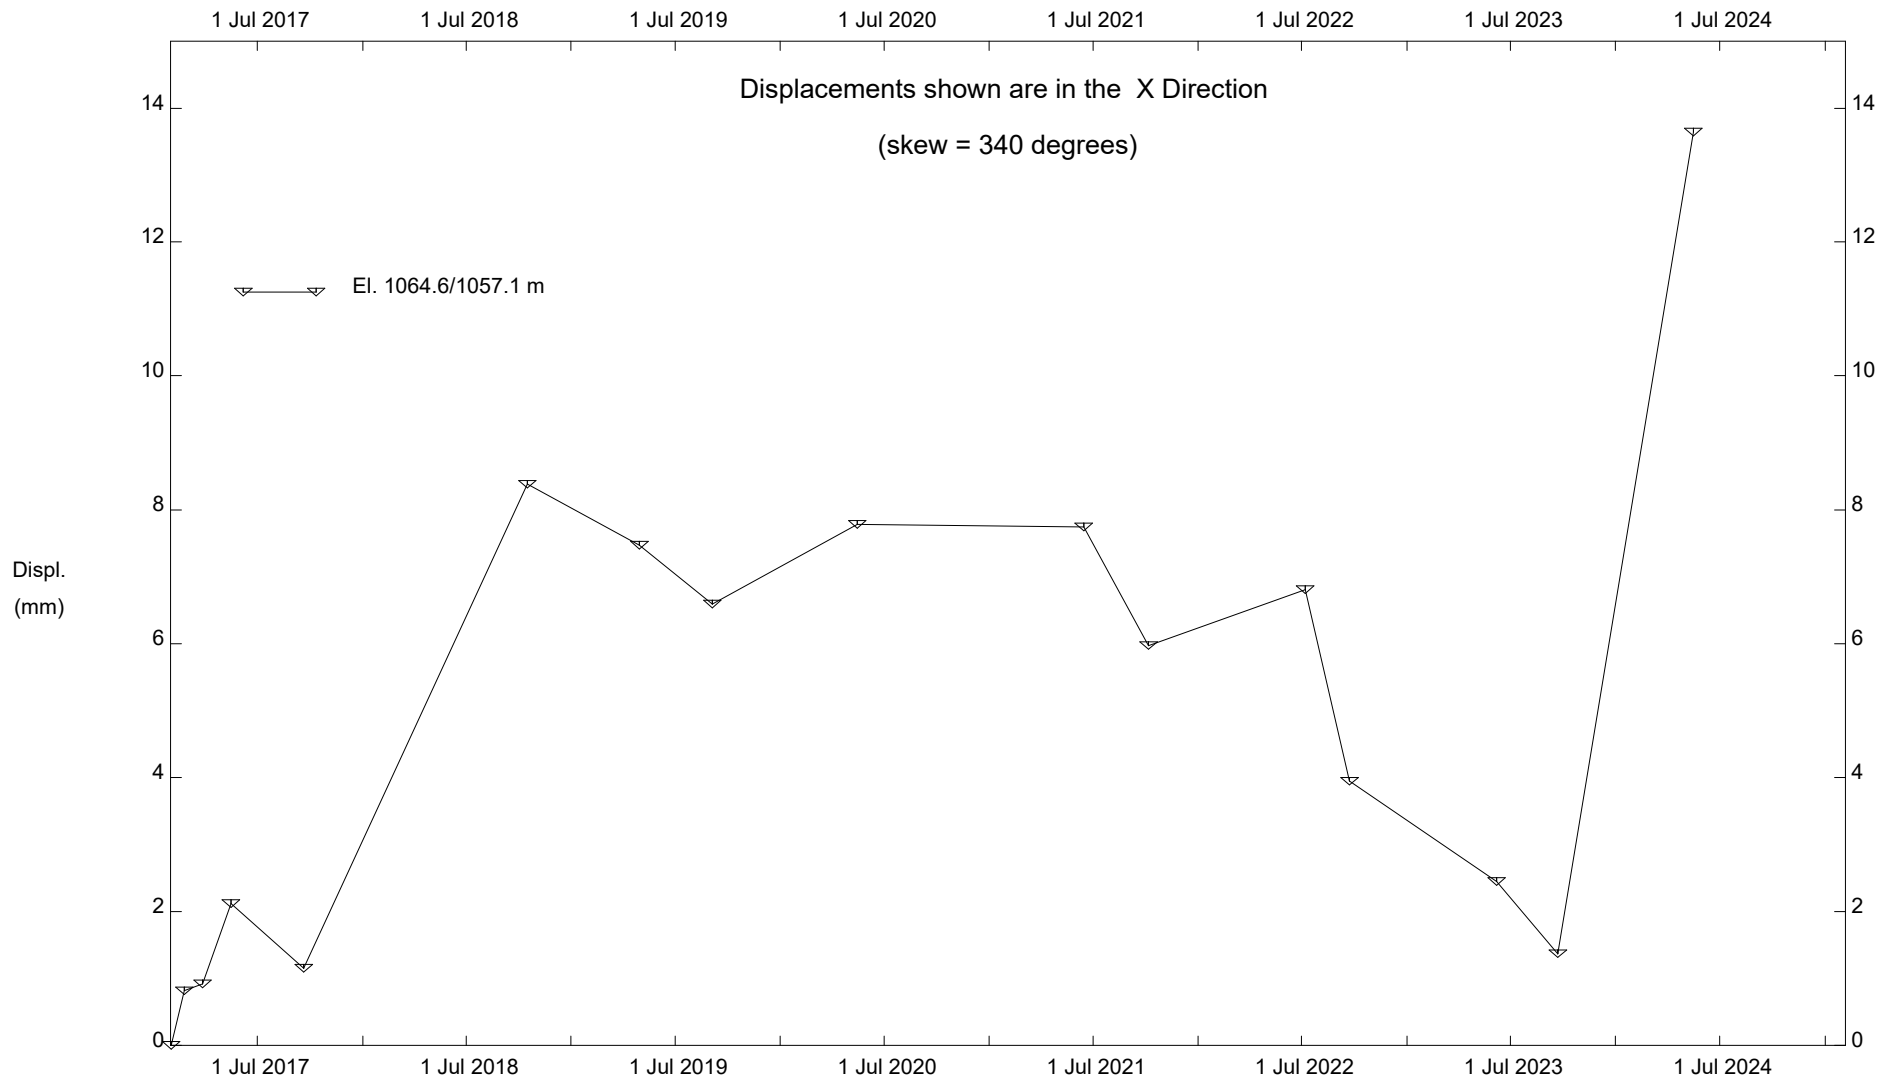
S039; H03:06, West Brocket Slide, Inclinometer SI16-03
 Alberta Transportation

SI16-03 is located on the east flank of the slide near the mid slope. Distributed movement (less than 10 mm) has been recorded in SI16-03 from ground surface to an approximate depth of 8 m below ground surface (approximately El. 1057 m) in the clay till.

Most of the movement recorded in SI16-03 (located east of the slide mass) occurred immediately after installation and could be due to post installation SI casing flexure. Since late-2018, the rate of movement recorded in SI16-03 has been slow (less than 5 mm/year). The spring 2024 reading measured approximately 9 mm of movement in the top 1.5 m of the SI which could indicate the slide is expanding laterally to the east. Additional readings are needed to interpret this data and determine if this is a long term movement trend.

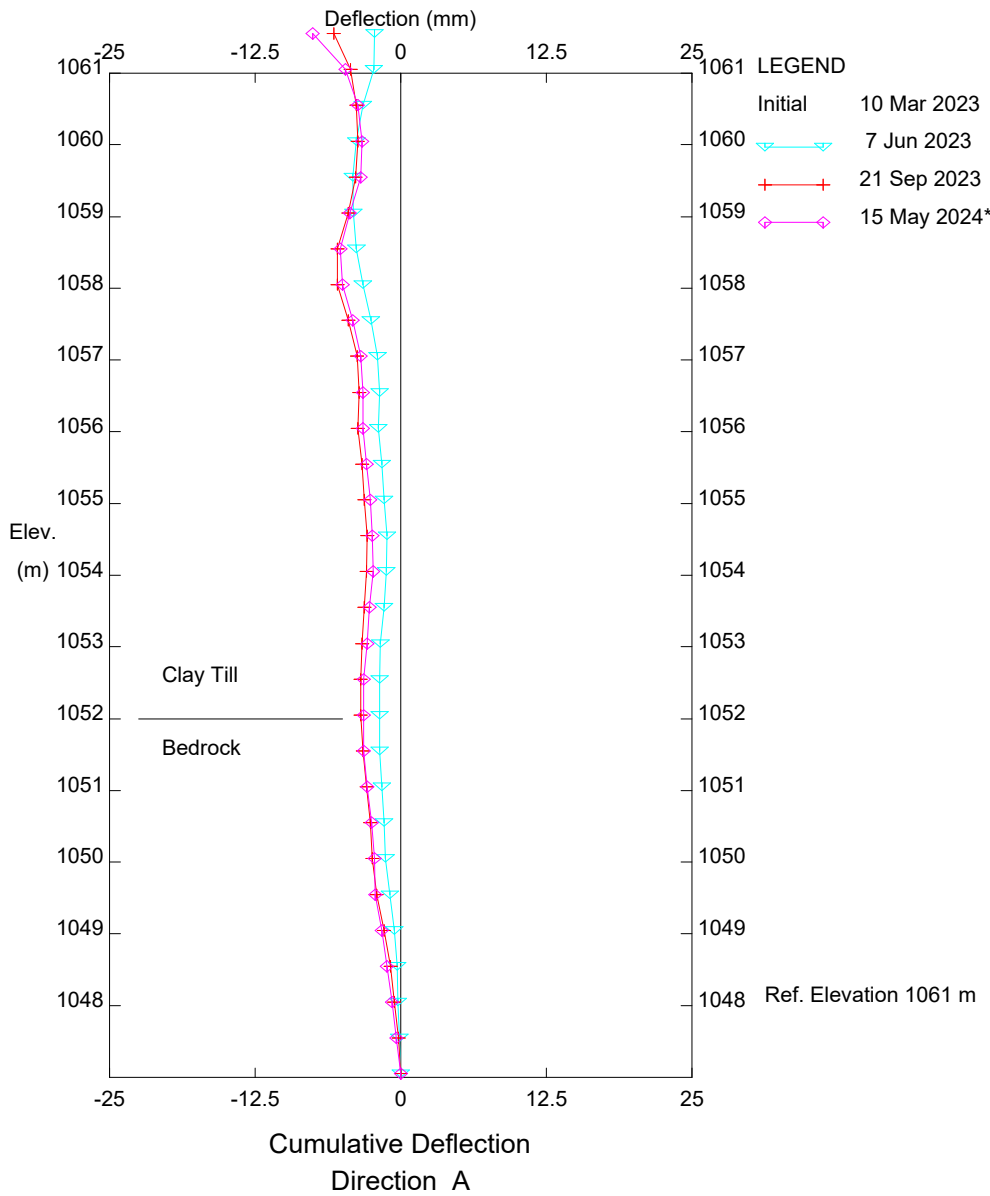
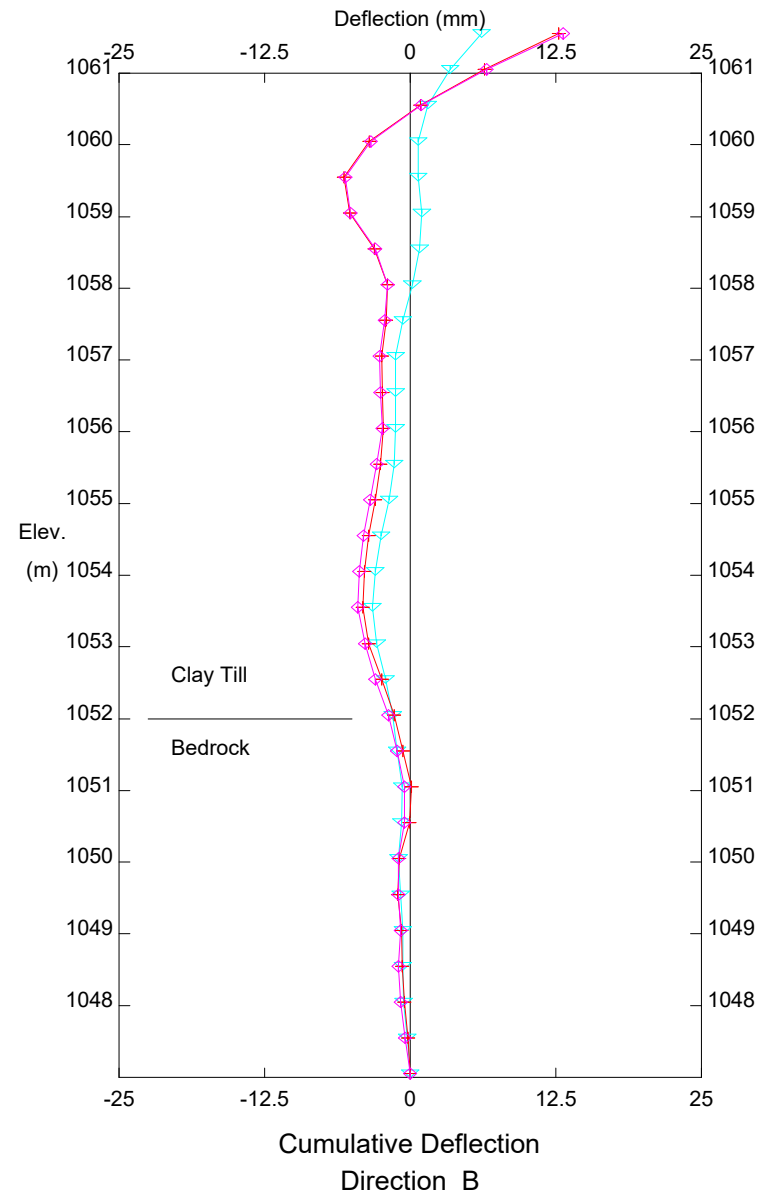
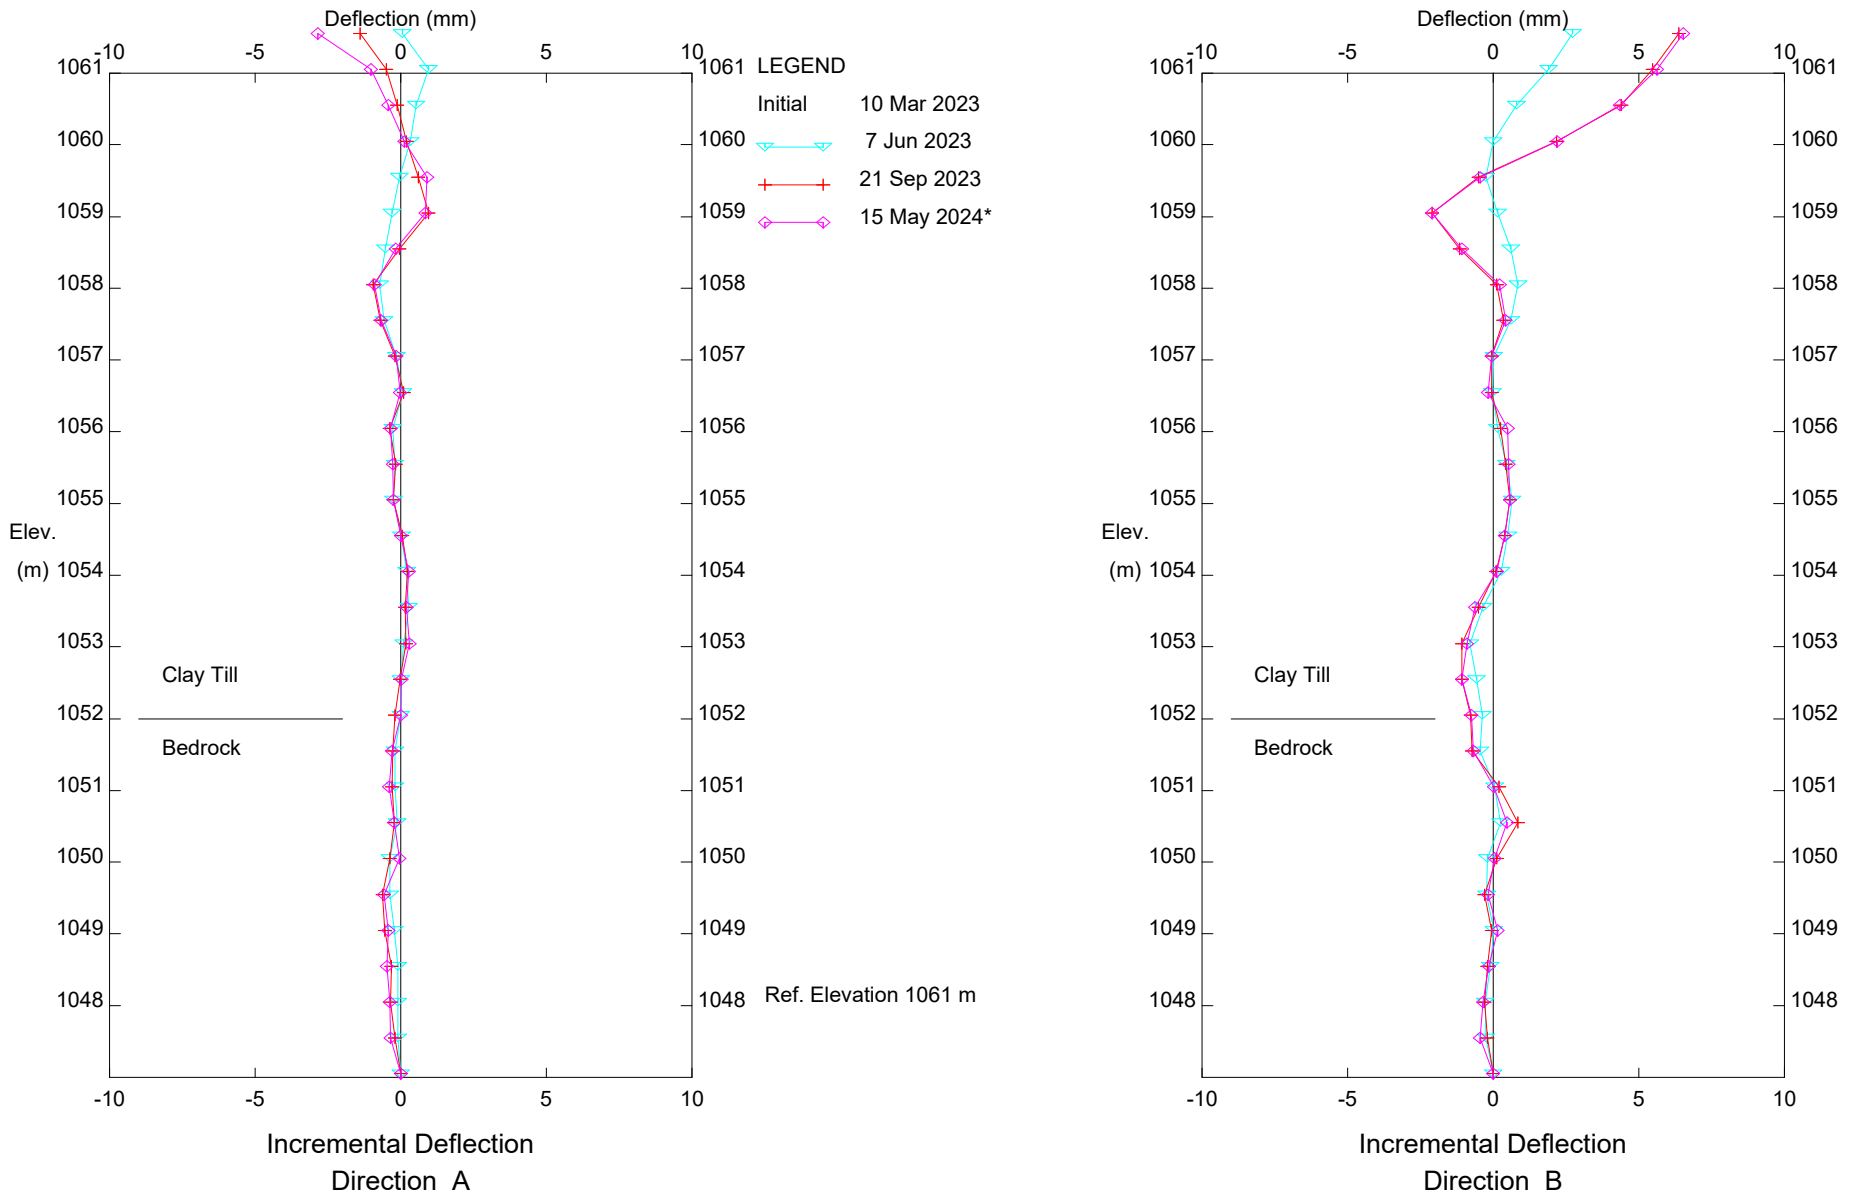
S039; H03:06, West Brocket Slide, Inclinometer SI 23-01

The SI data obtained in the three new SIs is relatively noisy (despite good data quality) compared to the existing SI (SI16-03) and is difficult to interpret, especially for SI23-02. It is unclear if the noise is due to installation issues (e.g., casing kinked or titled). For example, SI23-01 is tilted approximately 0.8 m over its 14 m depth and SI23-03 is tilted approximately 1 m over its 21 m depth. More data is needed to interpret the data and movement zones.

More data is needed to interpret the movement zones in SI23-01 and SI23-02, located at the base of the repair slope.
