July 10, 2024

Alberta Transportation and Economic Corridors
2nd Floor, 803 Manning Road N.E.
Calgary, Alberta
T2E 7M8

**CON0022161 Southern Region GRMP Instrumentation Monitoring
Site S039-I; H03:06, km 12.952 West Bocket Slide
Section C – 2024 Spring Readings**

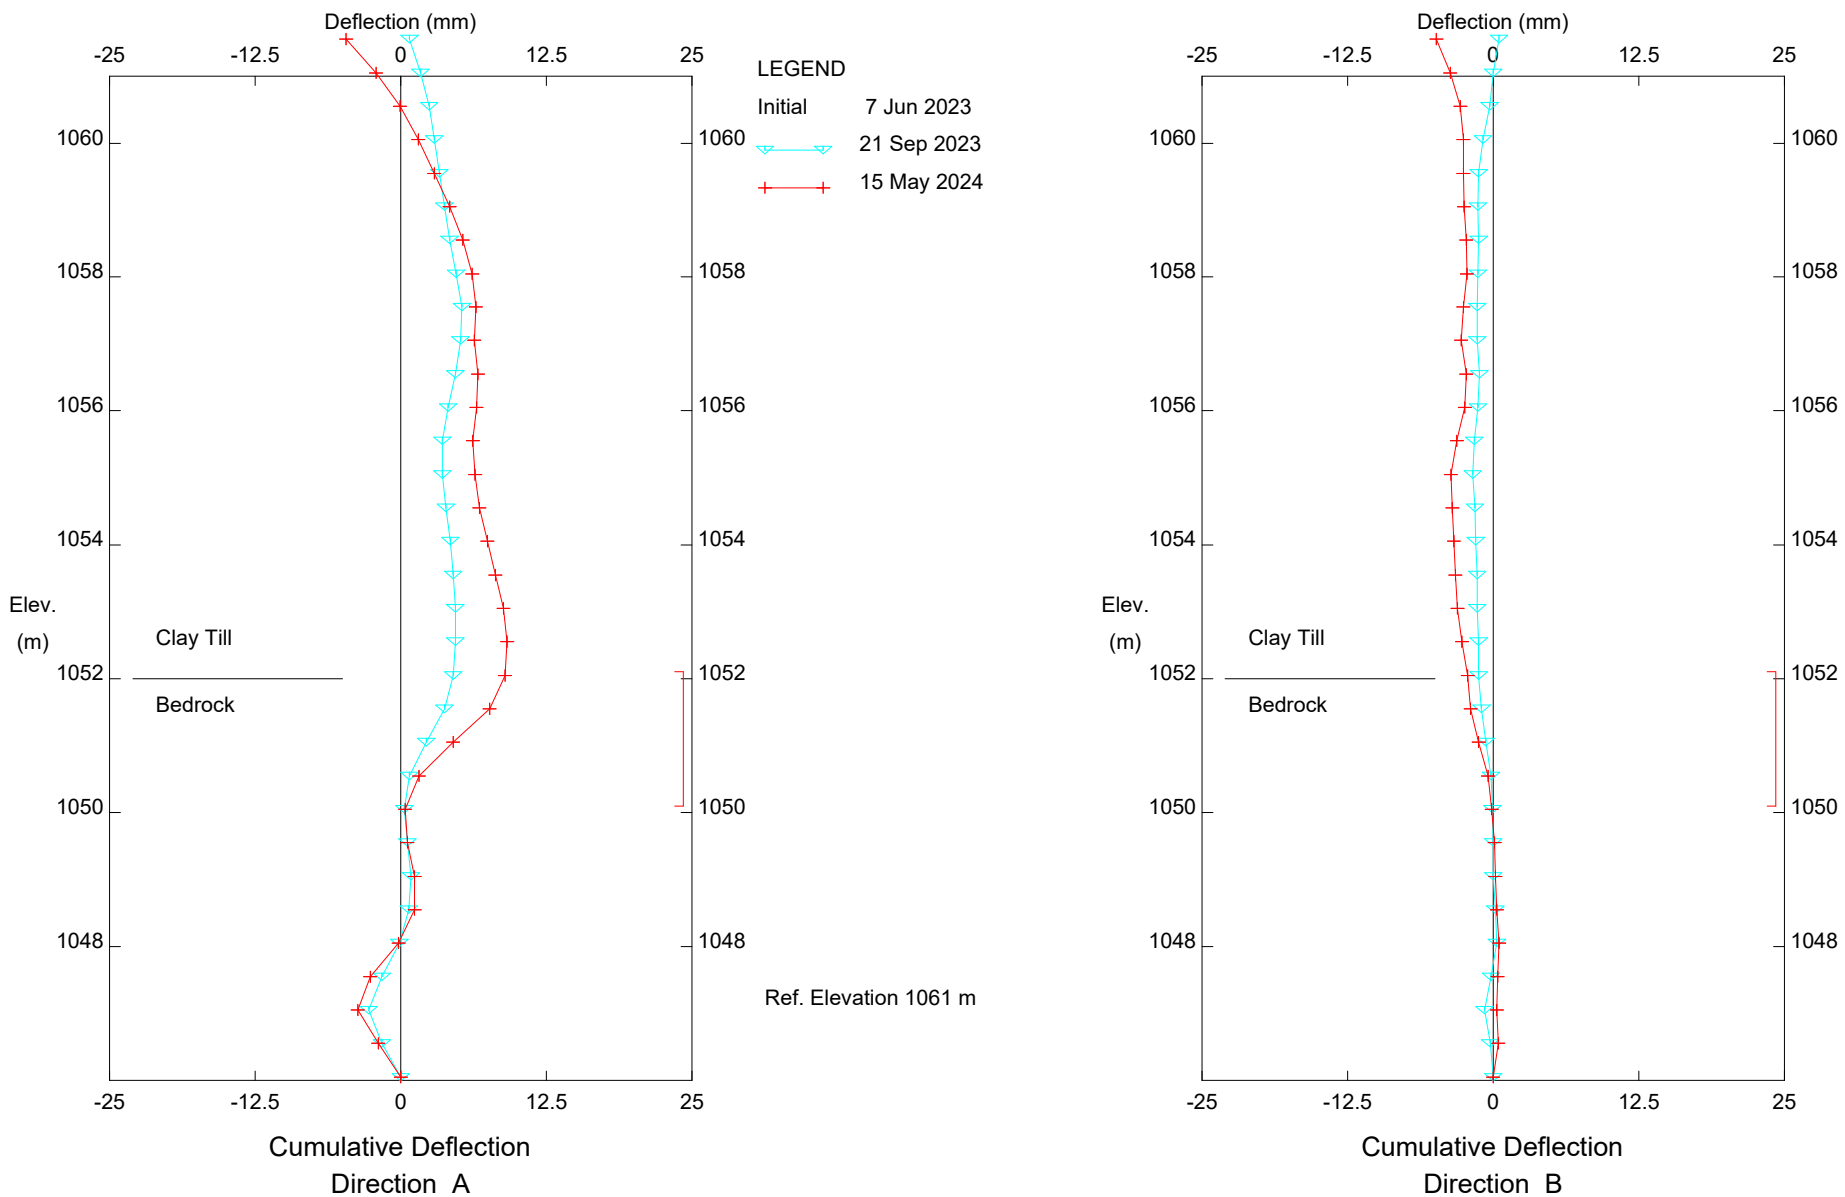
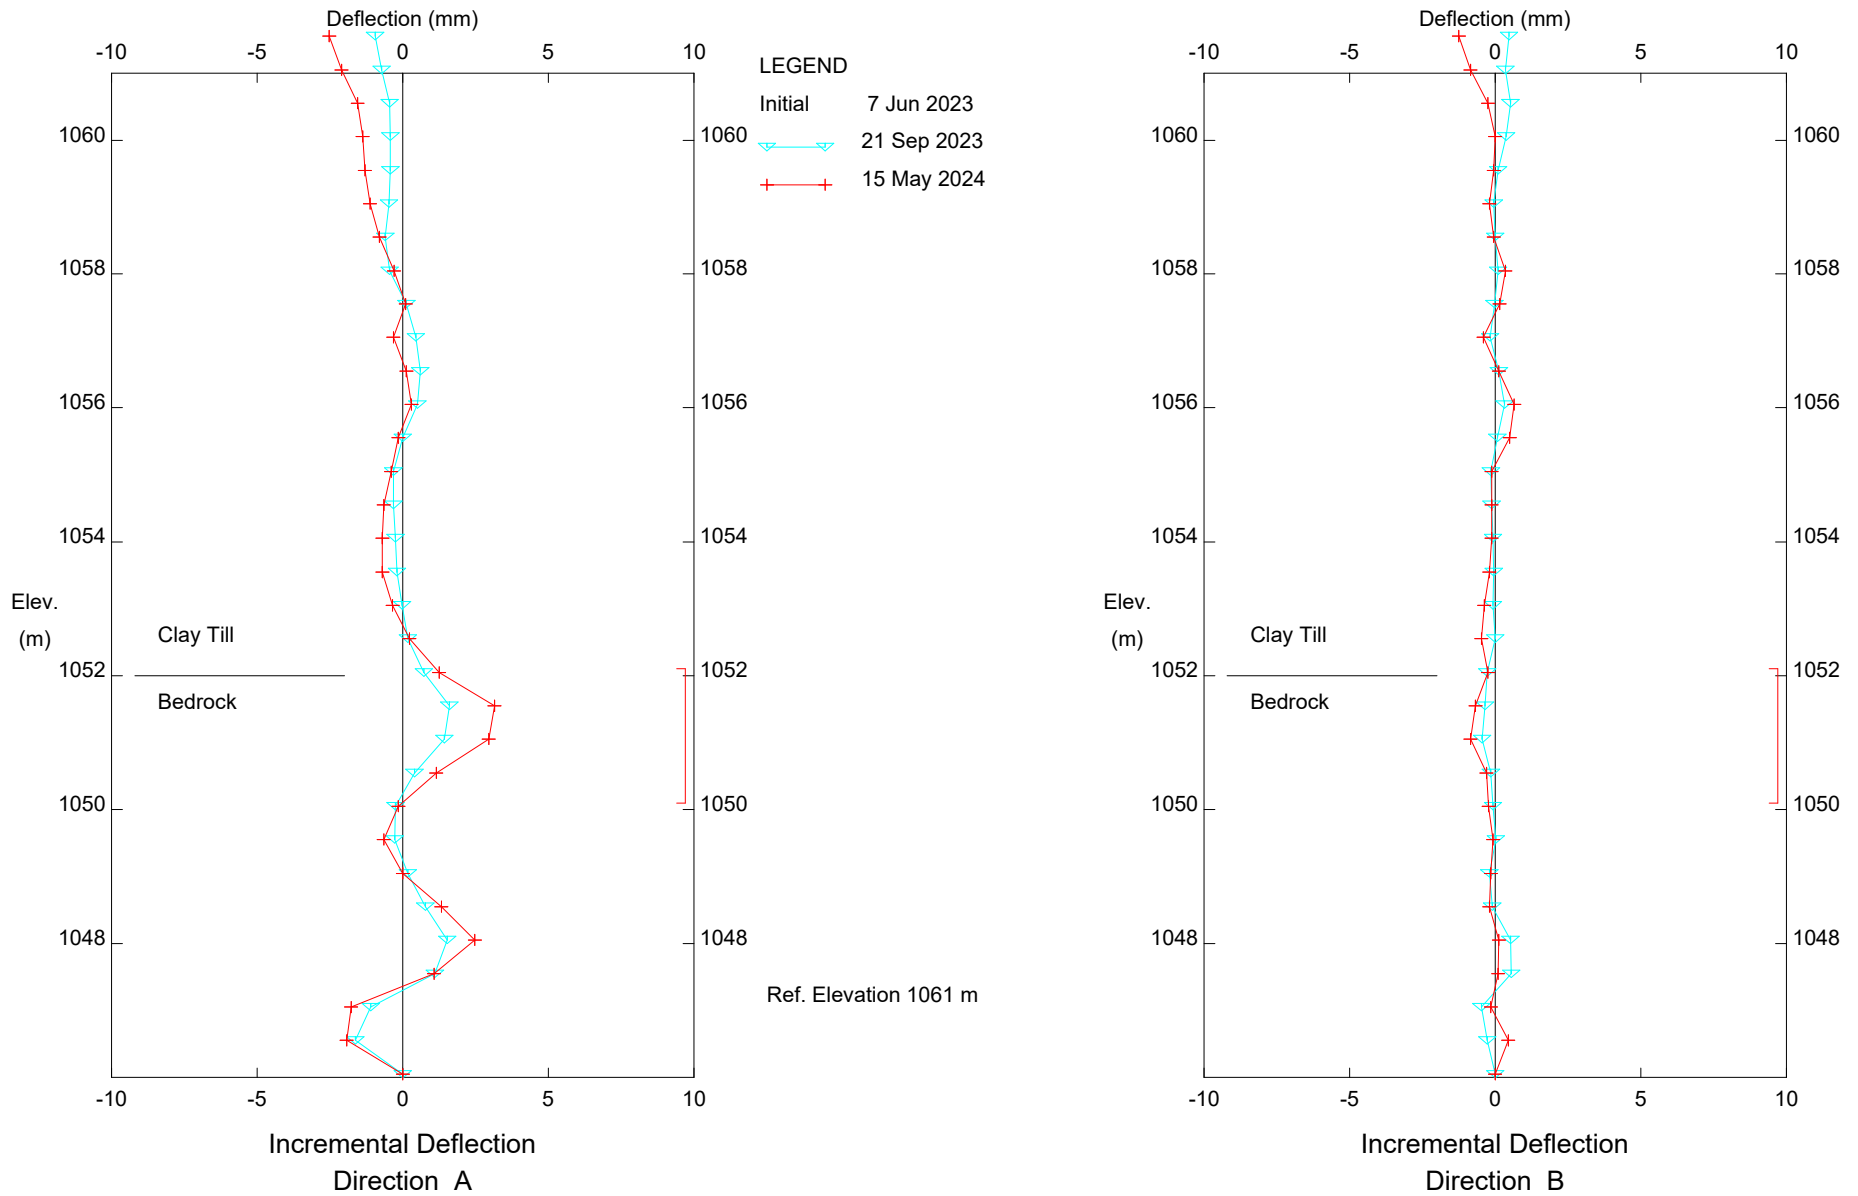
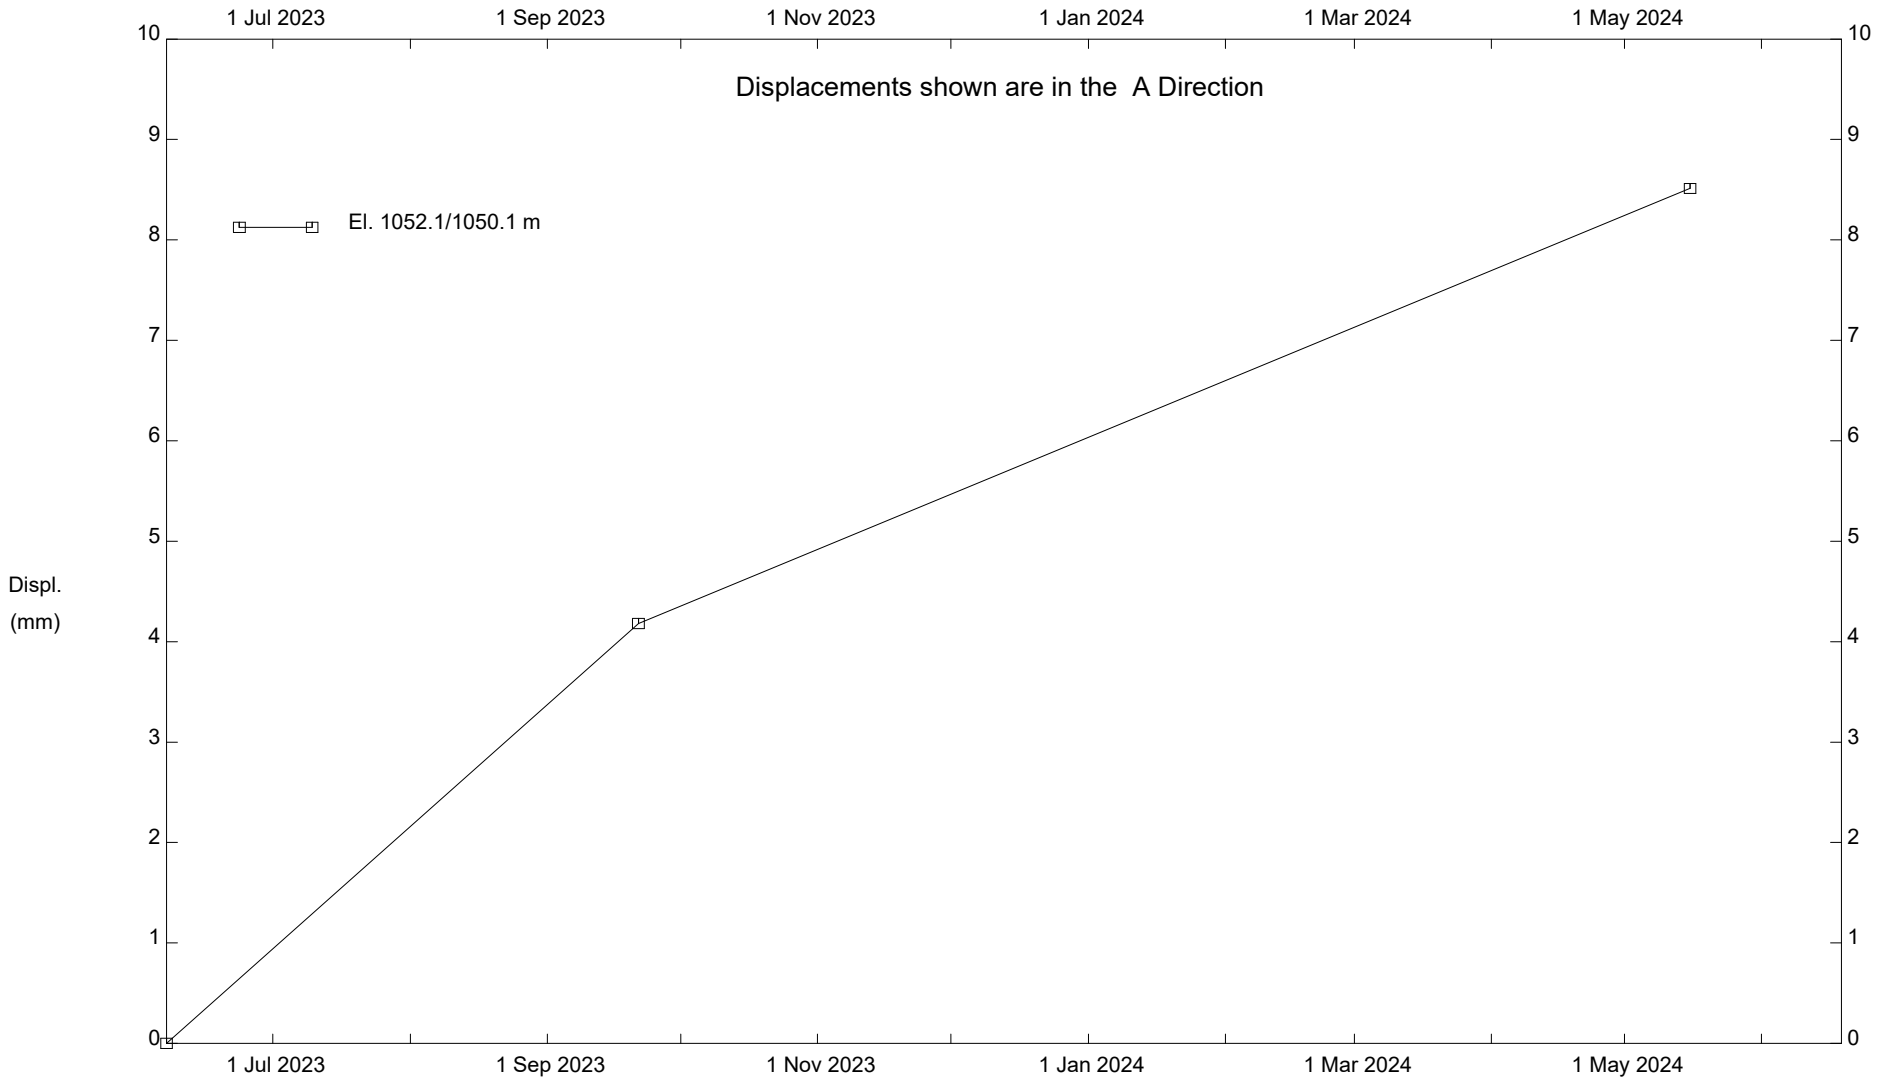
S039; H03:06, West Brocket Slide, Inclinator SI23-02
 Alberta Transportation

More data is needed to assess movement zones and trends in the newly installed SIs (SI23-01 and SI23-02) located at the base of the repair area. SI23-02 measured distributed movement between depths of approximately 9 m to 11 m below ground level. Based on the installation records, this movement is in the upper bedrock, however the data is difficult to interpret, despite good data quality.

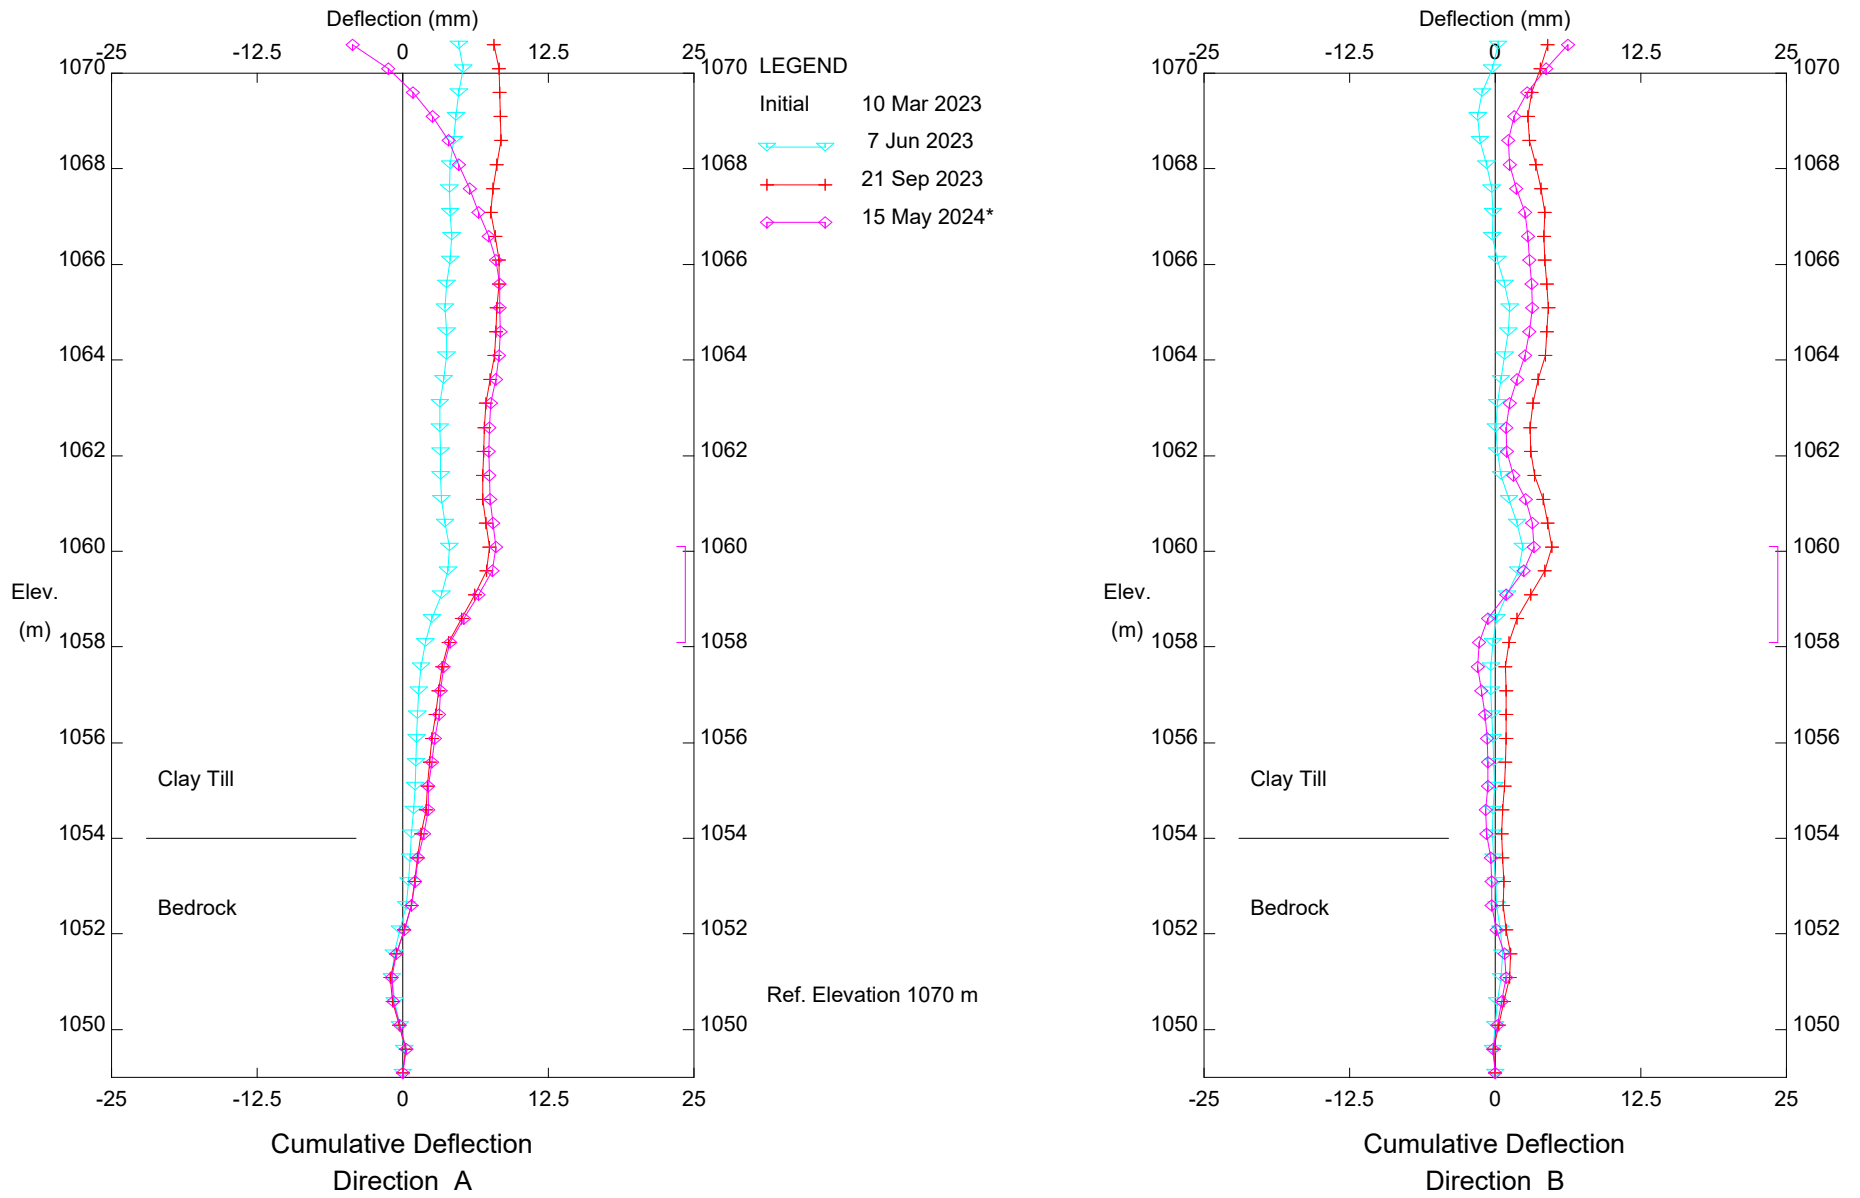
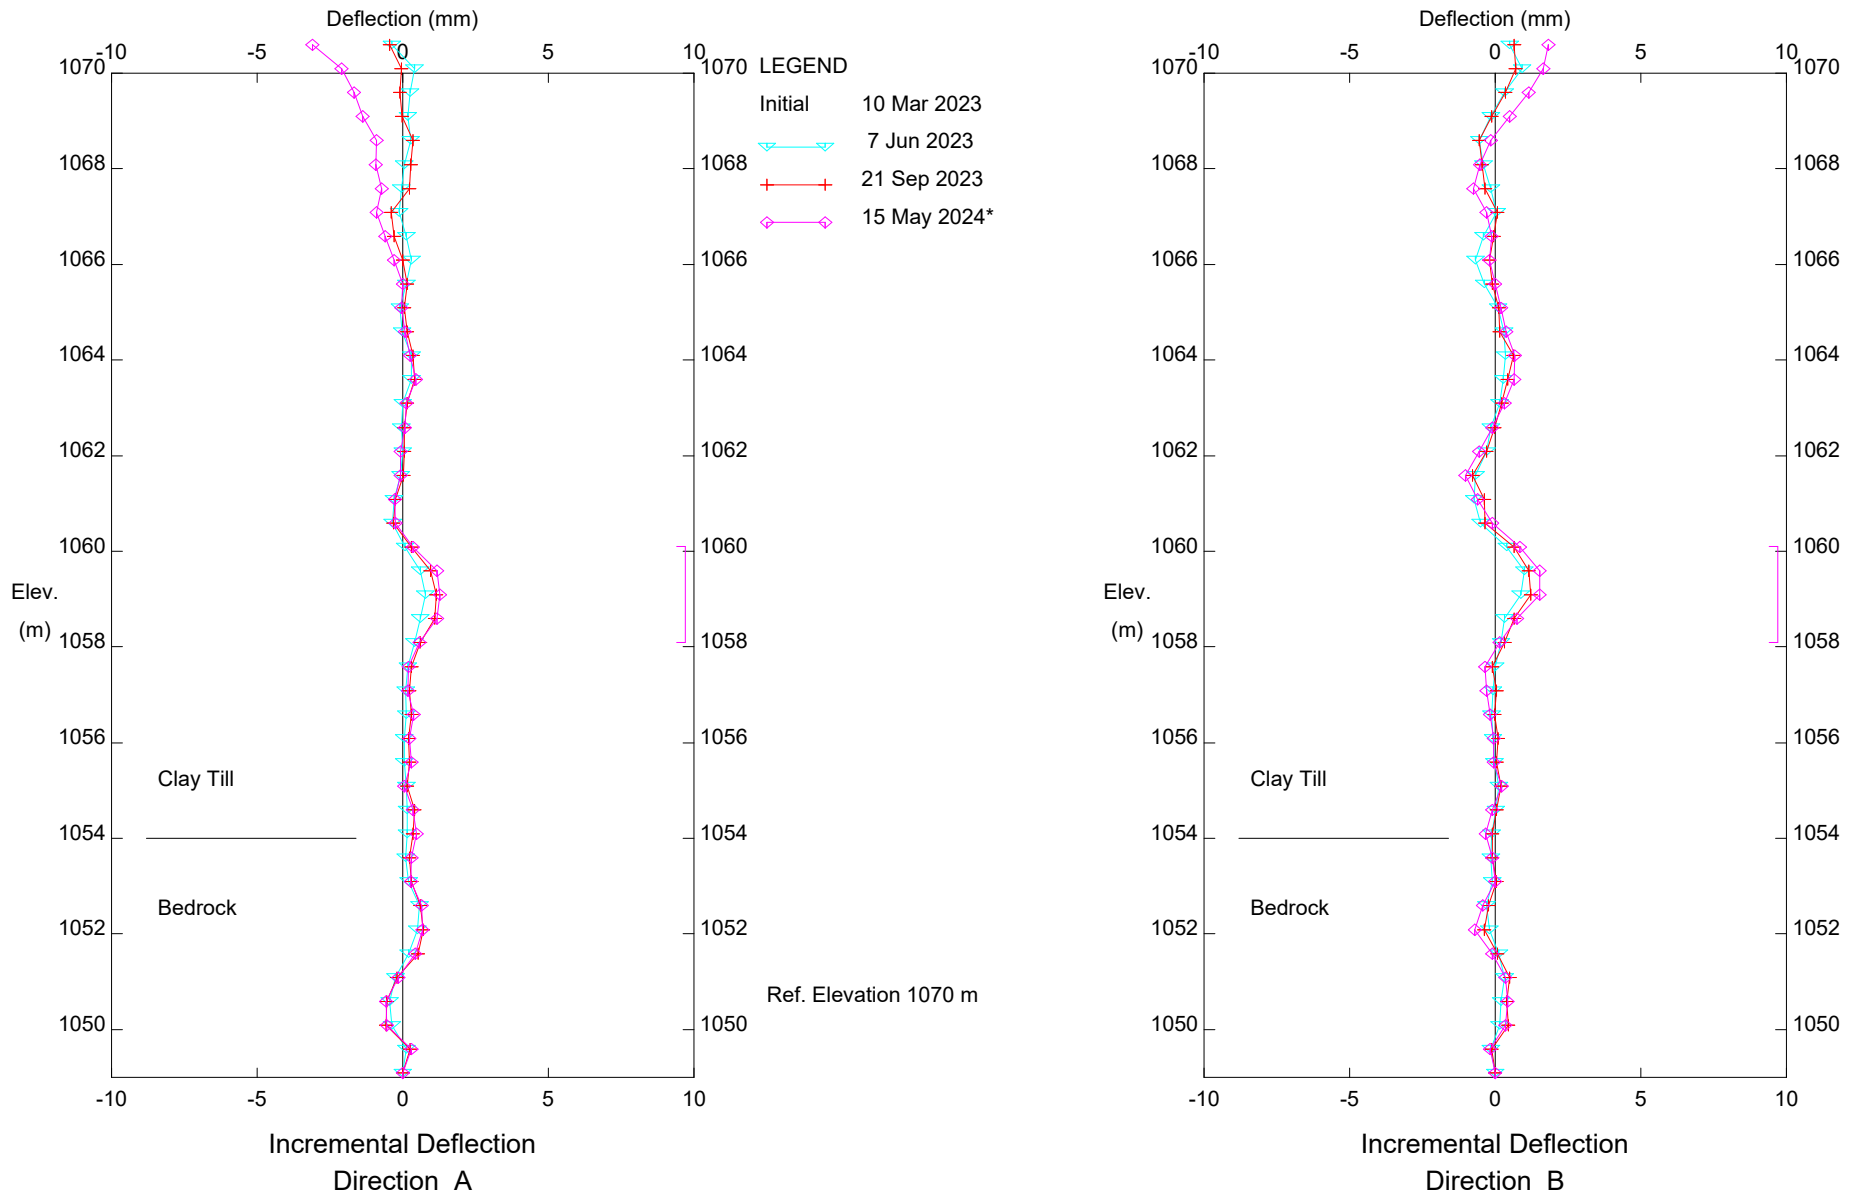
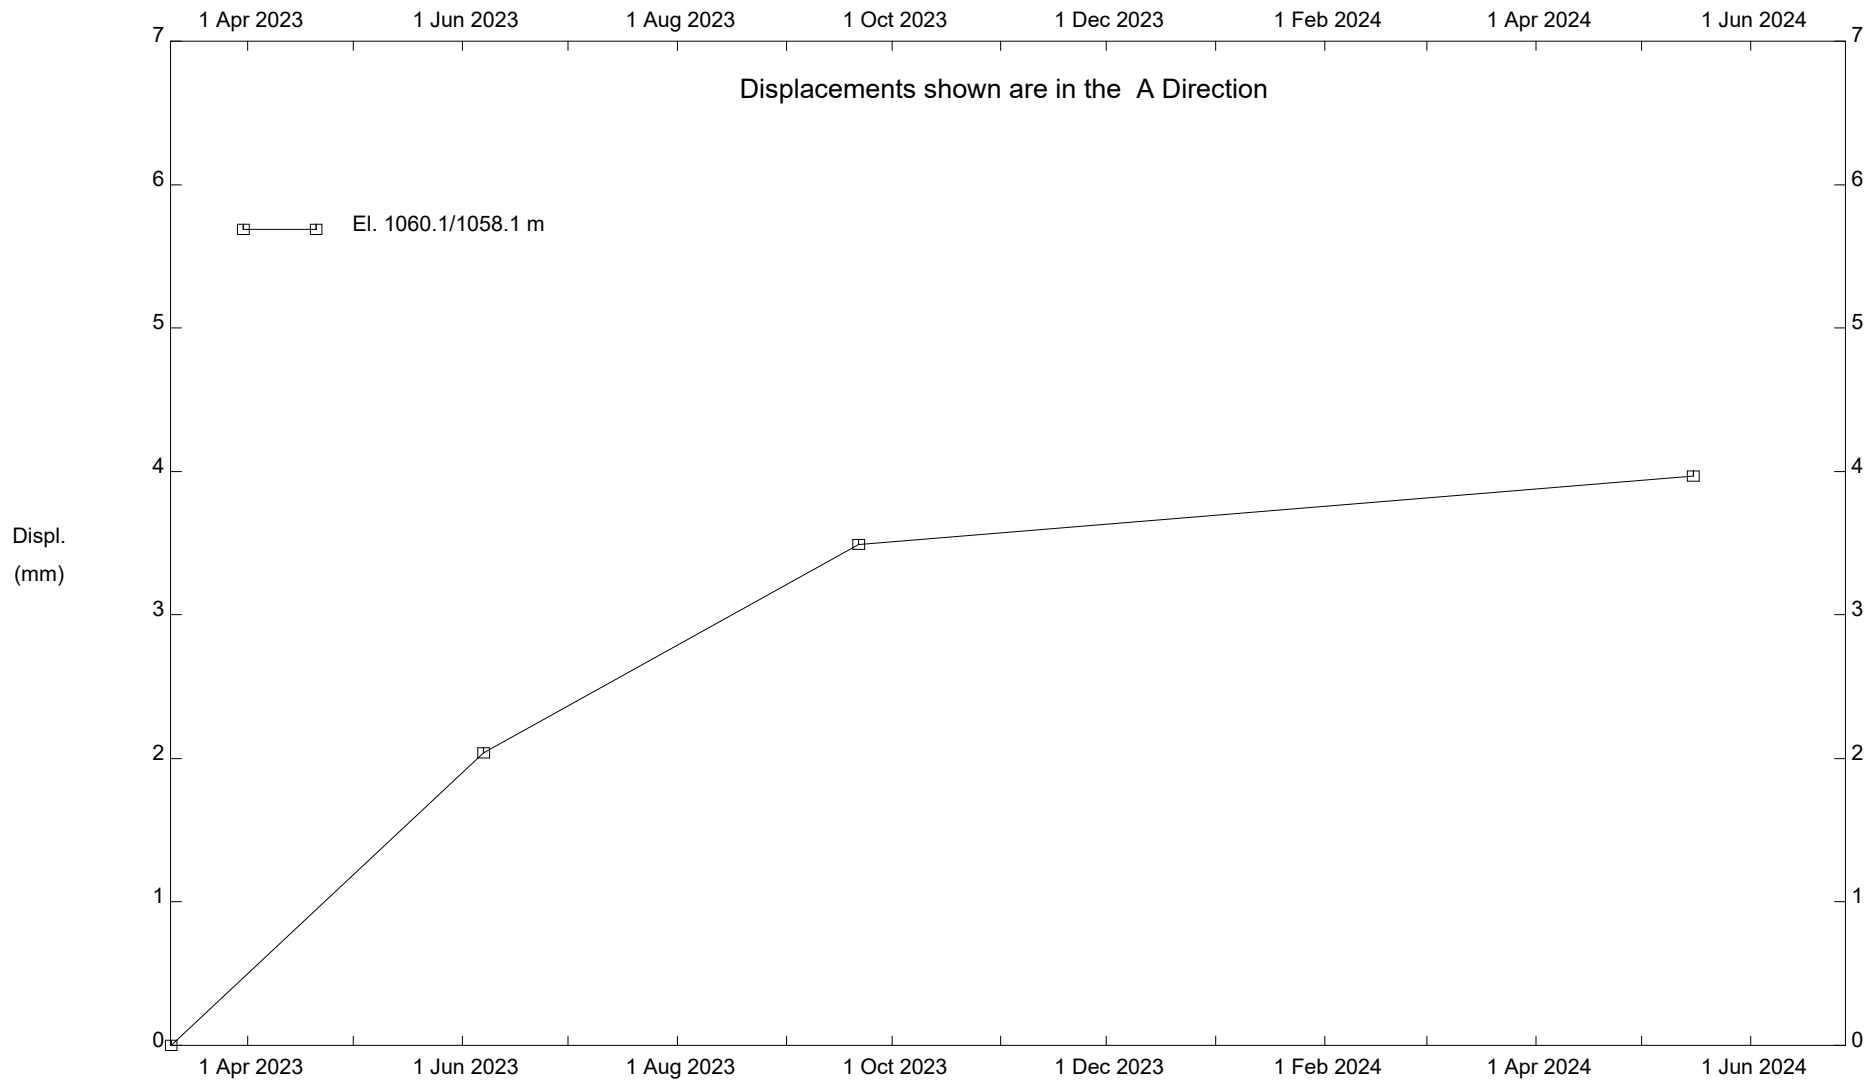
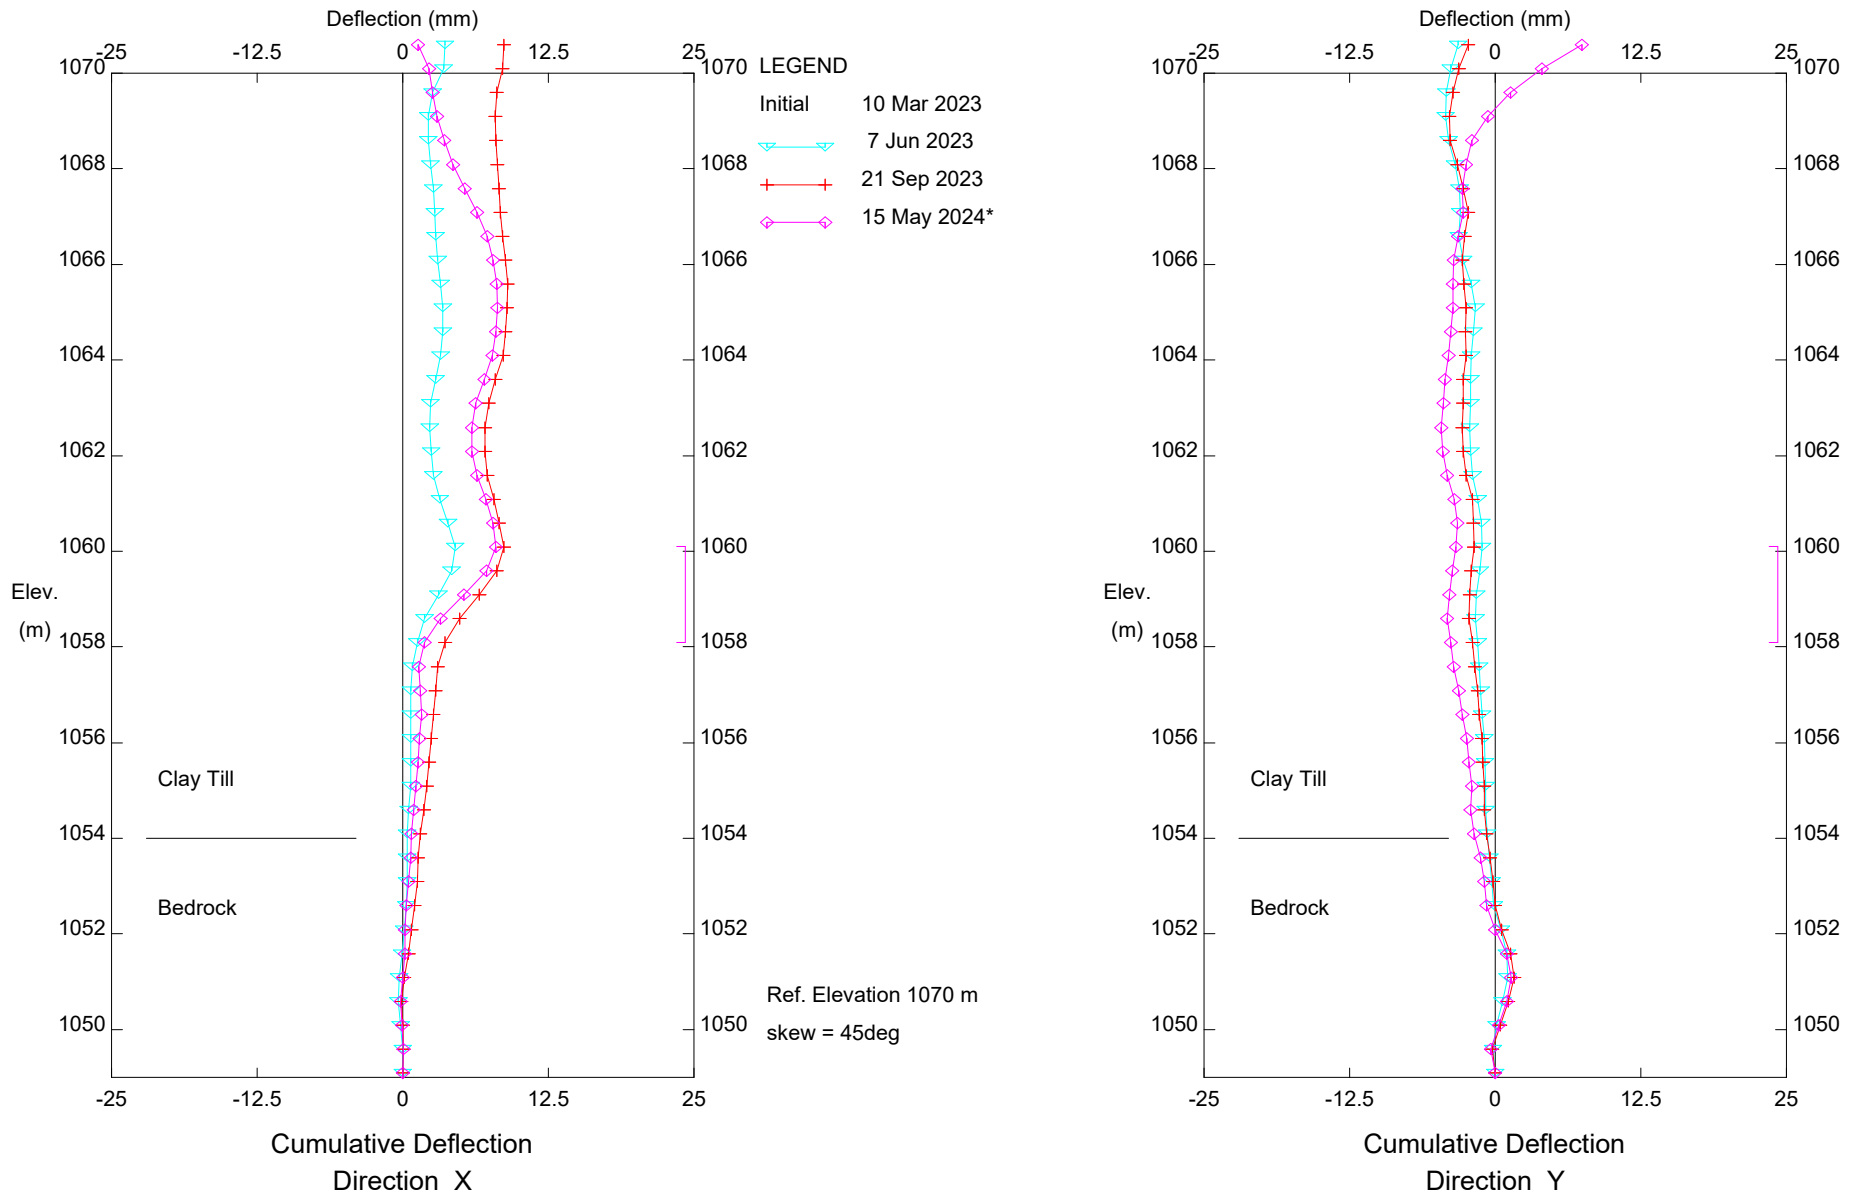
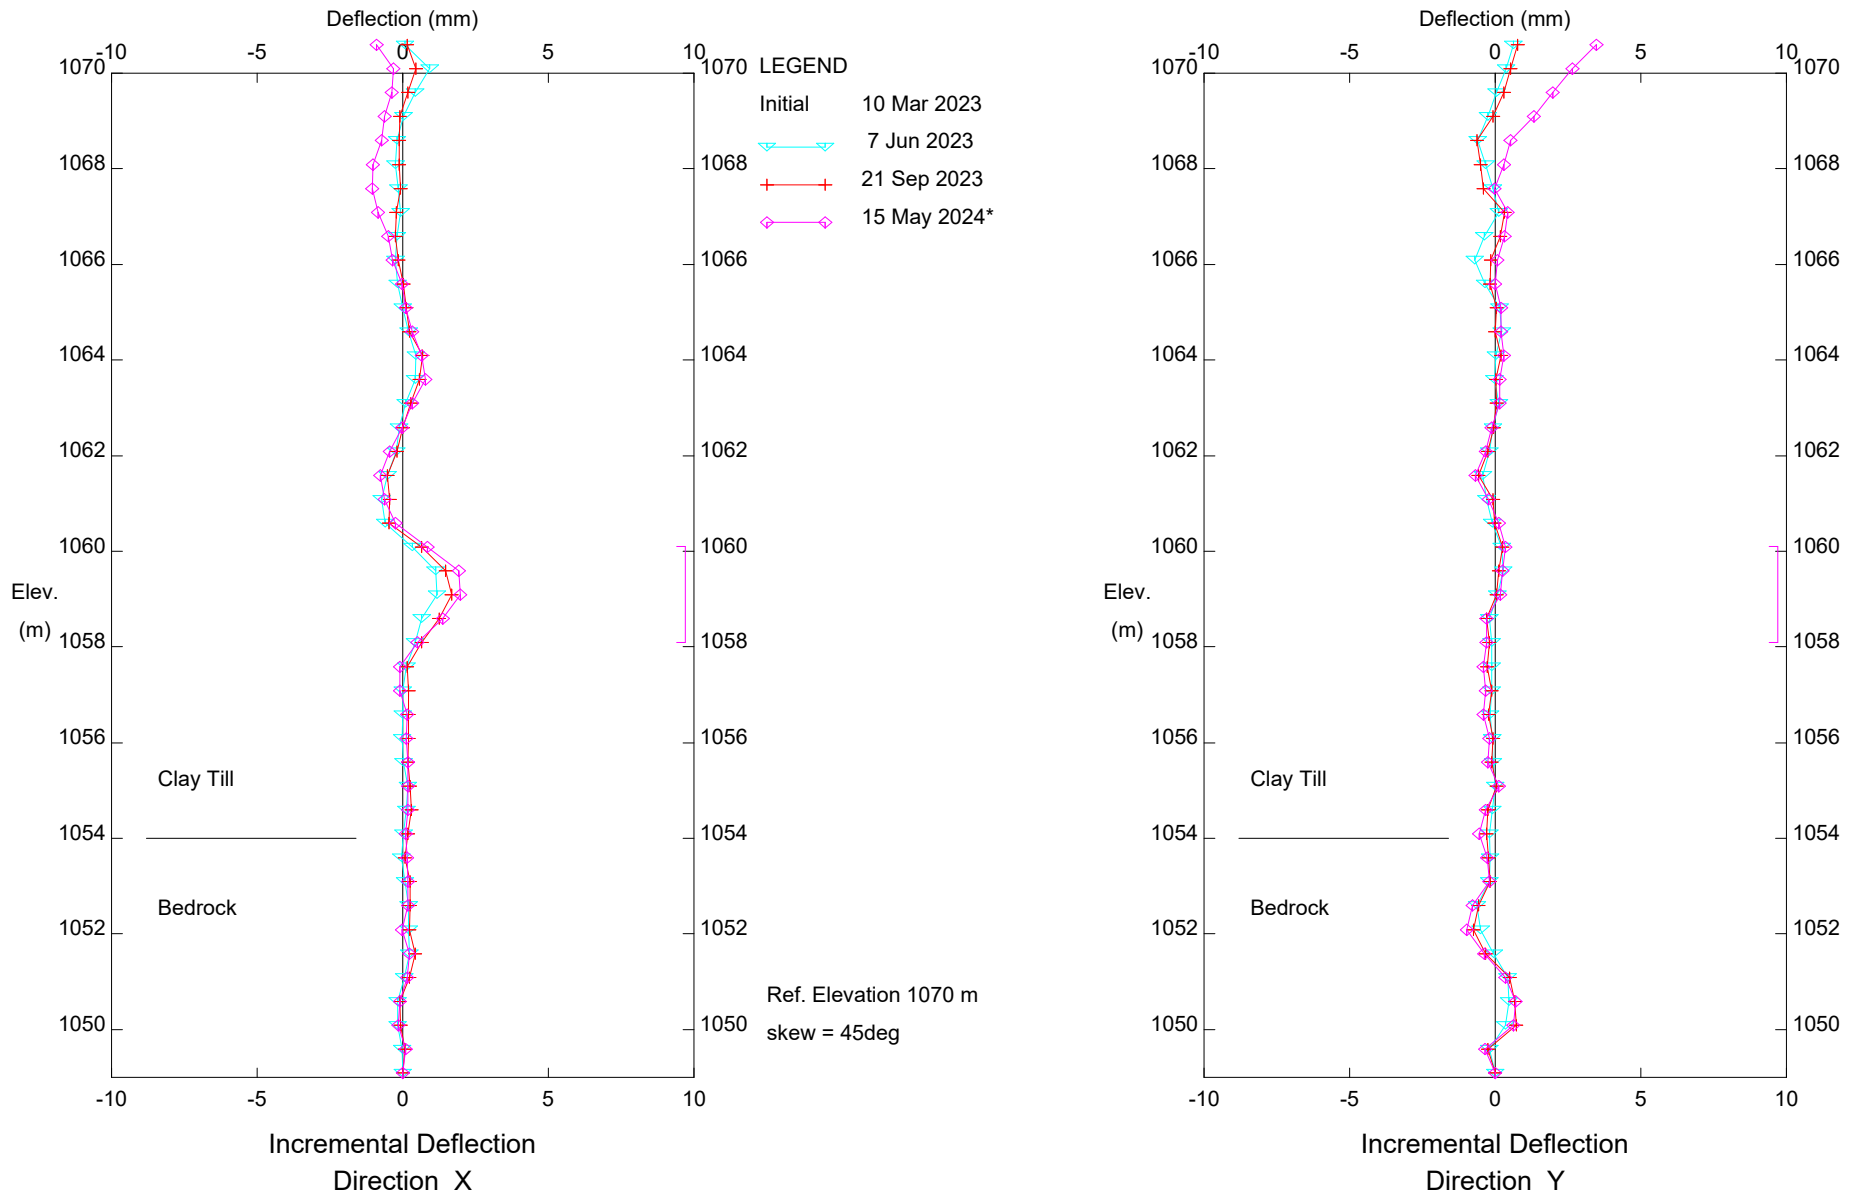
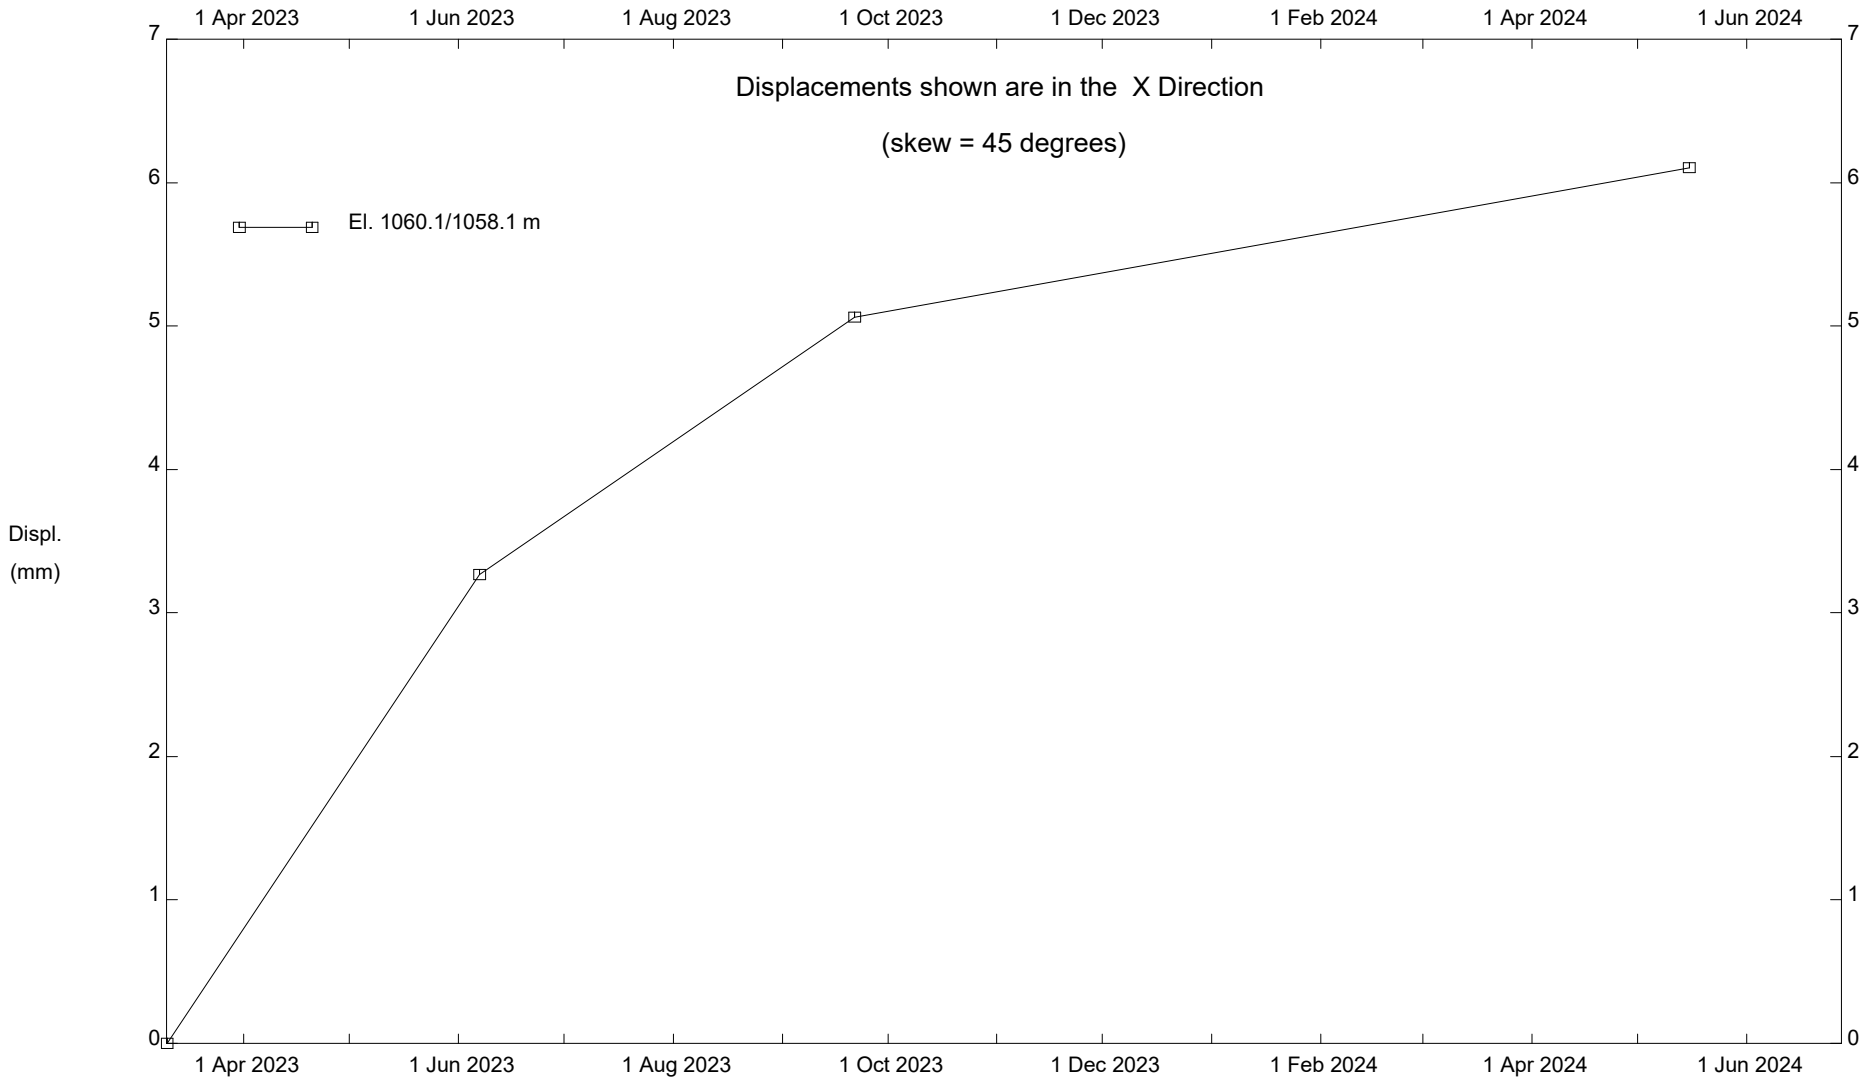
S039 West Brocket Slide, Inclinometer SI 23-03

SI23-03 is located on the west flank of the slide near the crest of the slope. A possible zone of distributed movement has been recorded in SI23-03 between an approximate depth of 10 m and 12 m below ground surface (approximately El. 1062 m to El. 1057 m) in the clay till.

SI23-03 (located west of slide mass) measured distributed movement between depths of approximately 10 m to 12 m below ground level at a skew angle of 45 degrees (northeast) from down slope (perpendicular to the highway). Movement at similar depths was previously measured in SI16-01 (replaced by SI23-03) prior to it being damaged. This elevation is approximately the same as the bench at the base of the slope. More data is required to assess movement zones and trends.

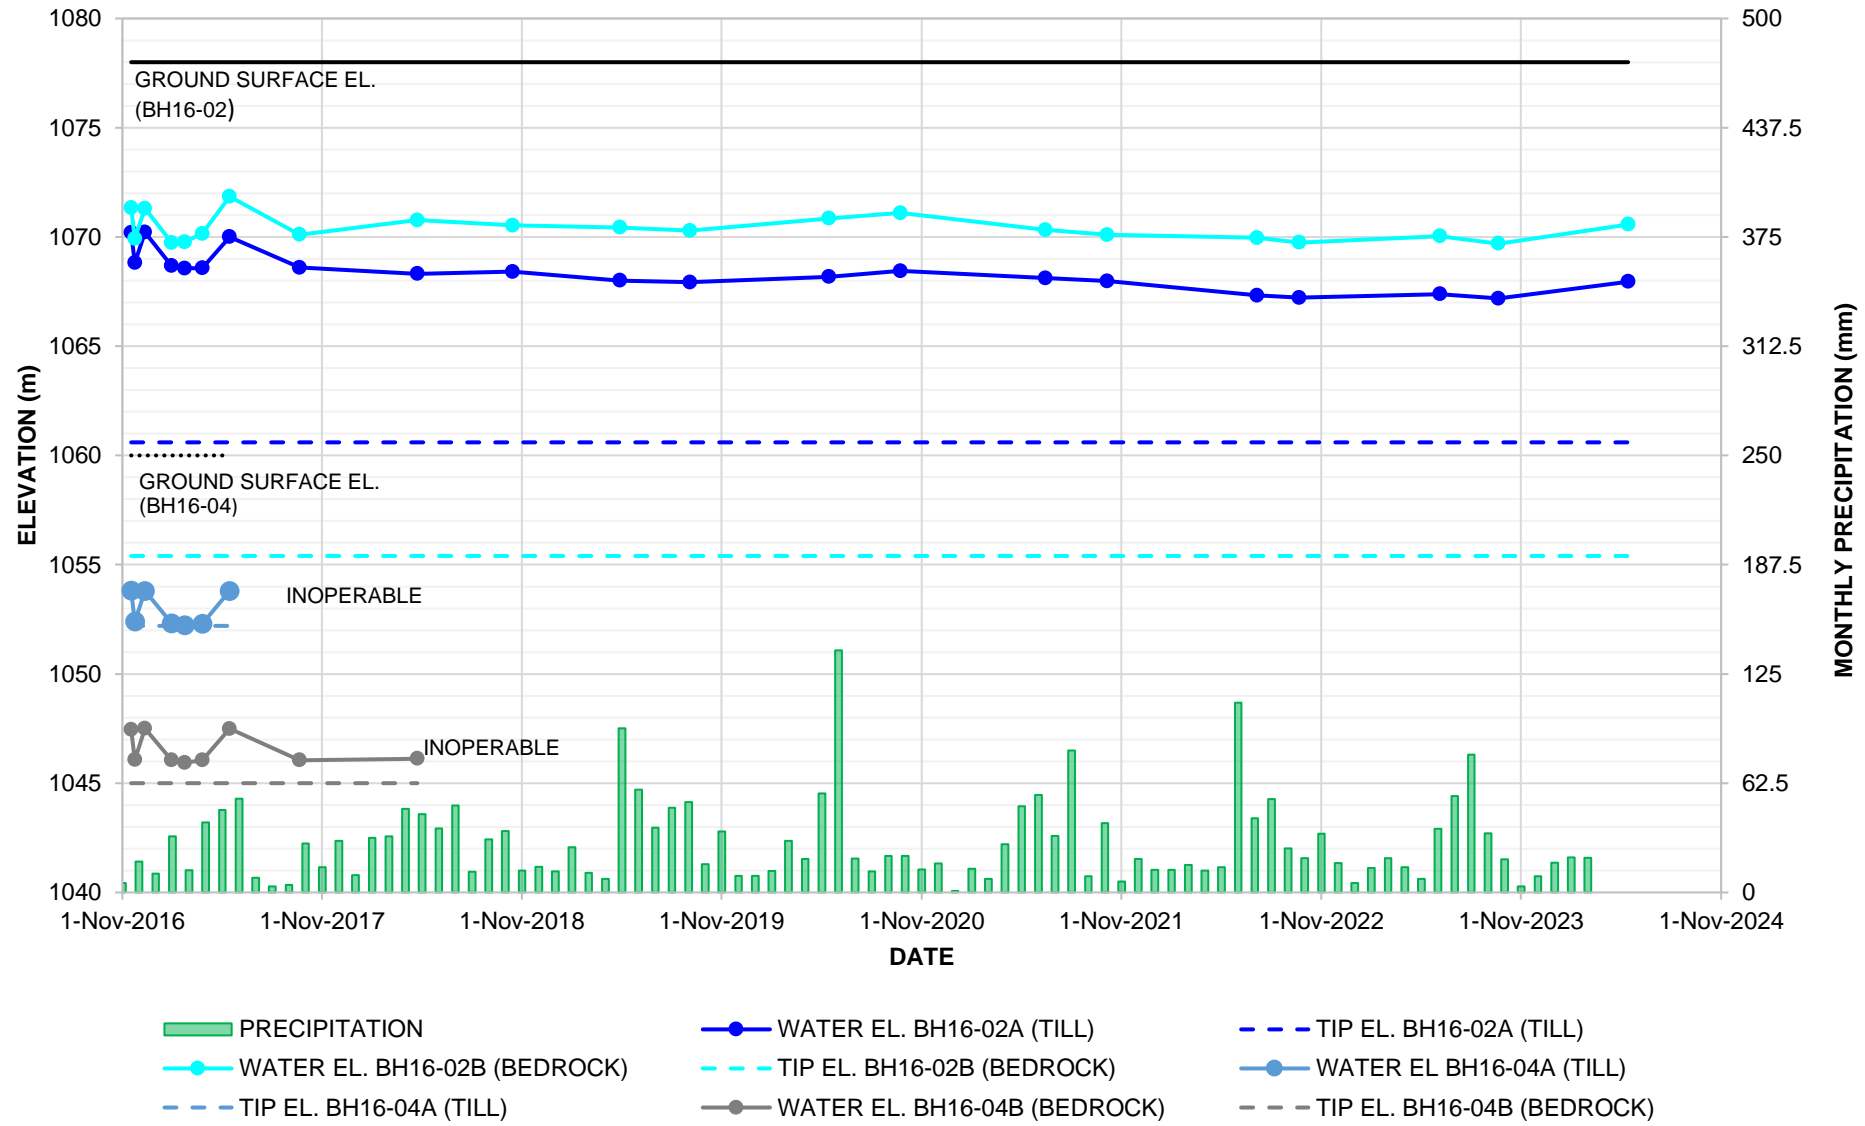
PROJECT		
SOUTHERN REGION GEOHAZARD RISK MANAGEMENT PROGRAM		
TITLE		
Piezometer Data S039 - West Brocket Slide Hwy 03:06 km 12.952		
SCALE	PROJECT No.	FIG No.
	A05116A03

Since fall 2017, water levels recorded in the two VWP's installed in BH16-02A (clay till) and BH16-02B (bedrock) have been relatively steady (up to ± 1.0 m). Water level readings completed in spring 2024 increased by 0.7 m and 0.9 m in BH16-02A and BH16-02B, respectively, compared to the fall 2023 readings. This increase could be due to increased precipitation in spring 2024 compared with previous years. At the time of writing this report, rainfall data was only available up to the end of March 2024.

Observed ground water noted on the slope at the eastern extent of the repair slope during the spring 2023 Section B inspection in May 2023 did not correspond with the water levels recorded in the VWP's read in June 2023. During the May 2024 instrument reading there was no wet areas located on the slope. There could be perched water tables within the slope in more permeable seams as noted by Thurber in 1998 "the surficial soils in the area comprise a sequence of medium to high plastic glaciolacustrine silty clays, with occasional lenses or discontinuous beds of sands and gravels. Underlying these surficial soils is a stiff to hard clay till, which overlies clay shale bedrock". Data loggers should be installed on the VWP's to get more information on how ground water levels fluctuate in relation to snow melt and precipitation events.

Data logger should be installed on the functioning VWPs upslope of the repair section to monitor groundwater fluctuations throughout the year.
