SITE NUMBER AND NAME: S039-I Brocket Slides		HIGHWAY & KM: 3:06, 12.952	PREVIOUS INSPECTION DATE: May 19, 2022	INSPECTION DATE: May 29, 2024
LEGAL DESCRIPTION: 09/10-07-007-28 W4M	NAD 83 COORDINATES: UTM Northing Easting 12 5491976 298990		RISK ASSESMENT: PF: 13 CF: 3 TOTAL: 39	
AVERAGE ANNUAL DAILY TRAFFIC (AADT): 5240 (west) & 5260 (east) (Reference No. 84050)			CONTRACTOR MAINTENANCE AREA (CMA): 26

PRIMARY SITE ISSUE: Natural slope landslide encroaching on west lane of highway.

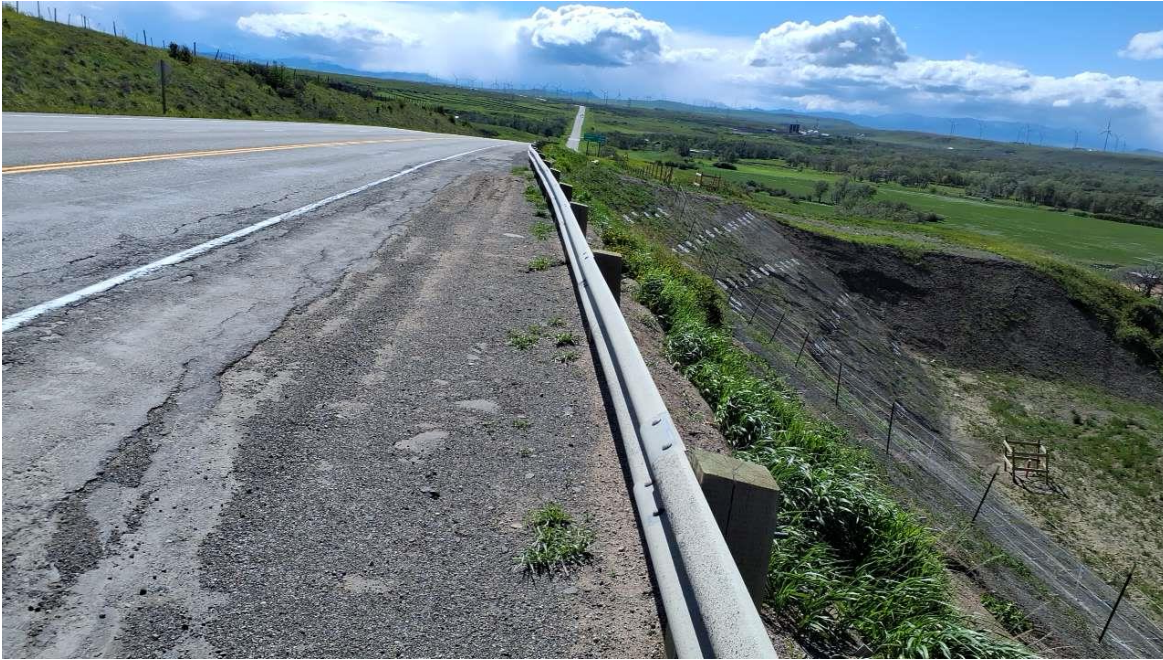
Photo 1 Transverse pavement cracking across both lanes east of the slide. Photo taken May 29, 2024, facing west.

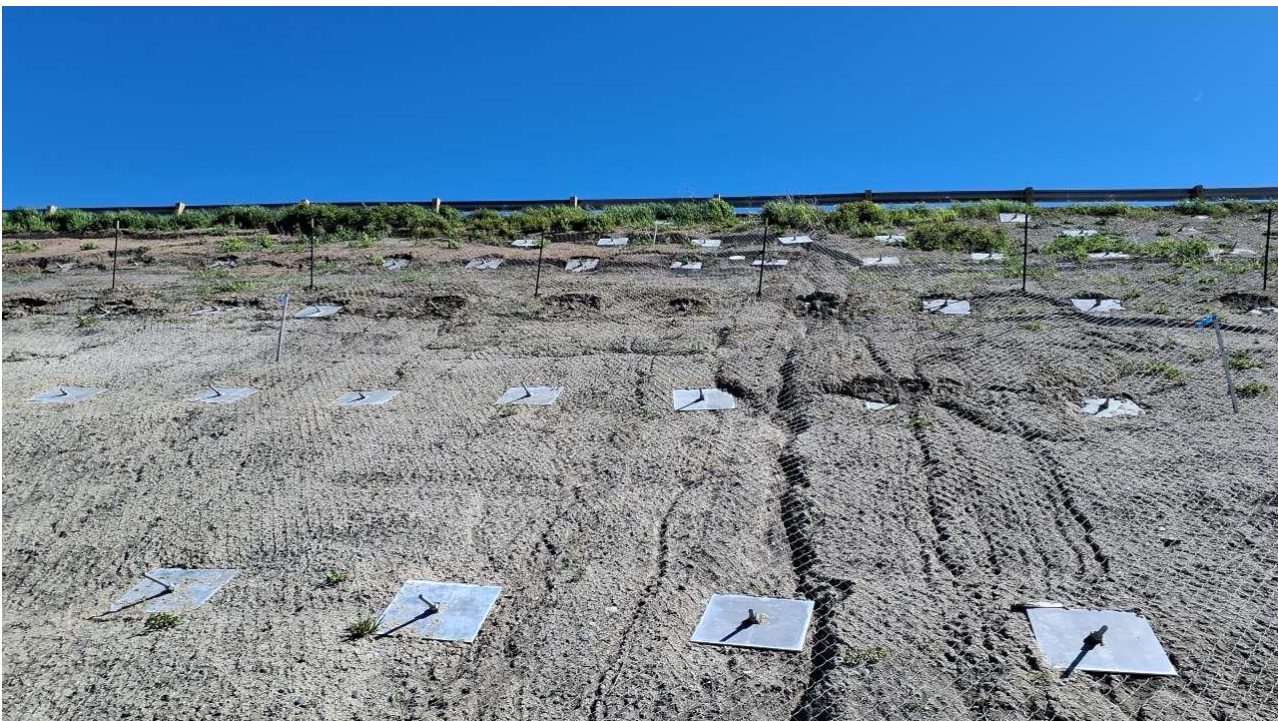
In June 2023 it was noted that movement had occurred at the east end of the repair slope, with the development of a tension crack near the crest of the slope. The contractor was requested to go back to site to fill in the tension crack with fine grained granular material to help limit the amount of water that could flow into the crack. Additionally, large rills and small gullies were observed to be forming on the slope surface due to water flowing over the edge of the pavement.

Photo 2 Erosion rilling from highway runoff down the slope. Photo taken on May 29, 2024 looking south.

- Assess what options could be implemented to help with the ongoing movement and erosion observed on the slope. As originally specified in the tender, a hydraulic erosion control product was to be installed as part of the construction project. To install a hydraulic erosion control product on the slope, the voids caused by slope movement would need to be filled in so there would be intimate contact between the hydraulic erosion control product and the soil. This could be completed by using a blown-on mulch product with a tackifier. The existing wire mesh could be left in place and a new hydraulic erosion control product (which would include a wire mesh and erosion control blanket) installed on the slope. The hydraulic erosion control product would need to be anchored to the slope so that it is able to hold back any material from sloughing or eroding beneath due to ground water in the slope.

- Assess the material on the slope for salinity and if it is suitable for growing vegetation as no vegetation has started to grow on the slope since hydroseeding

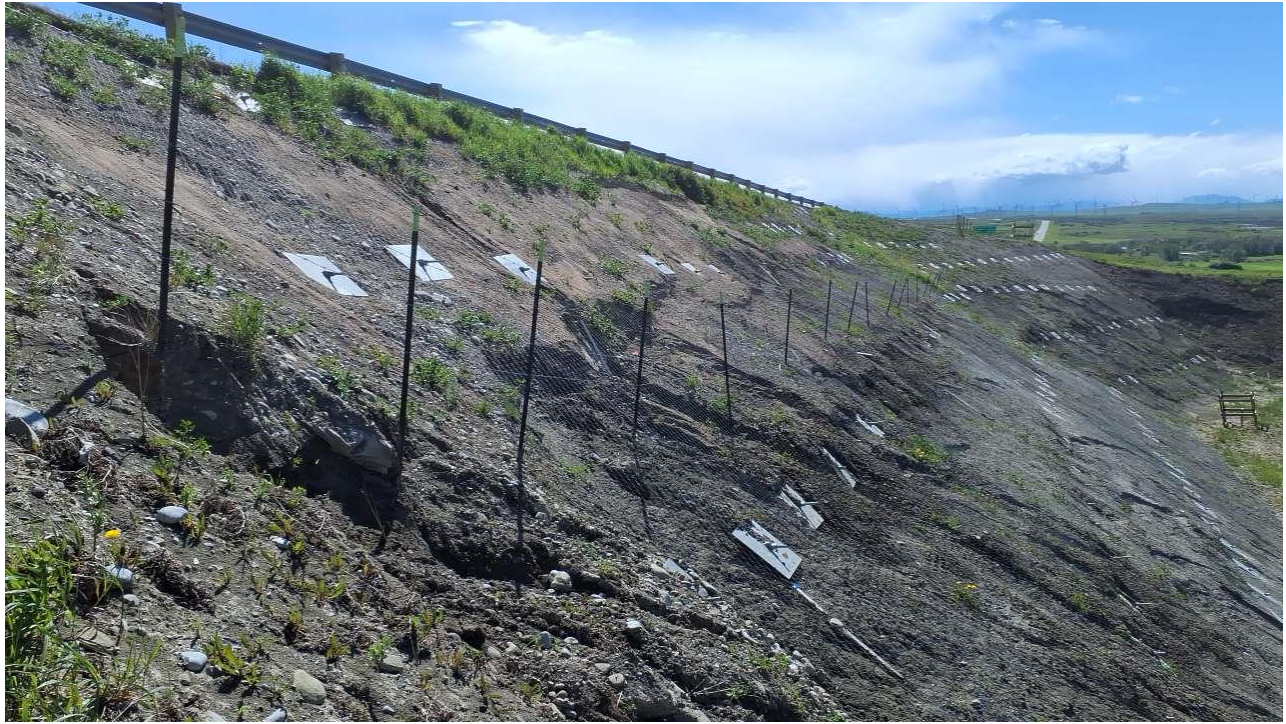
During the site visits in 2024, additional slope movement was observed across most of the repair area. The soil nails were observed to be taking load from the slope movement, but it was observed that in several locations the

Photo 3 Soil nails installed with anchor plates. Slope movement, cracking and sloughing of the slope. Photo taken facing west on May 29, 2024.

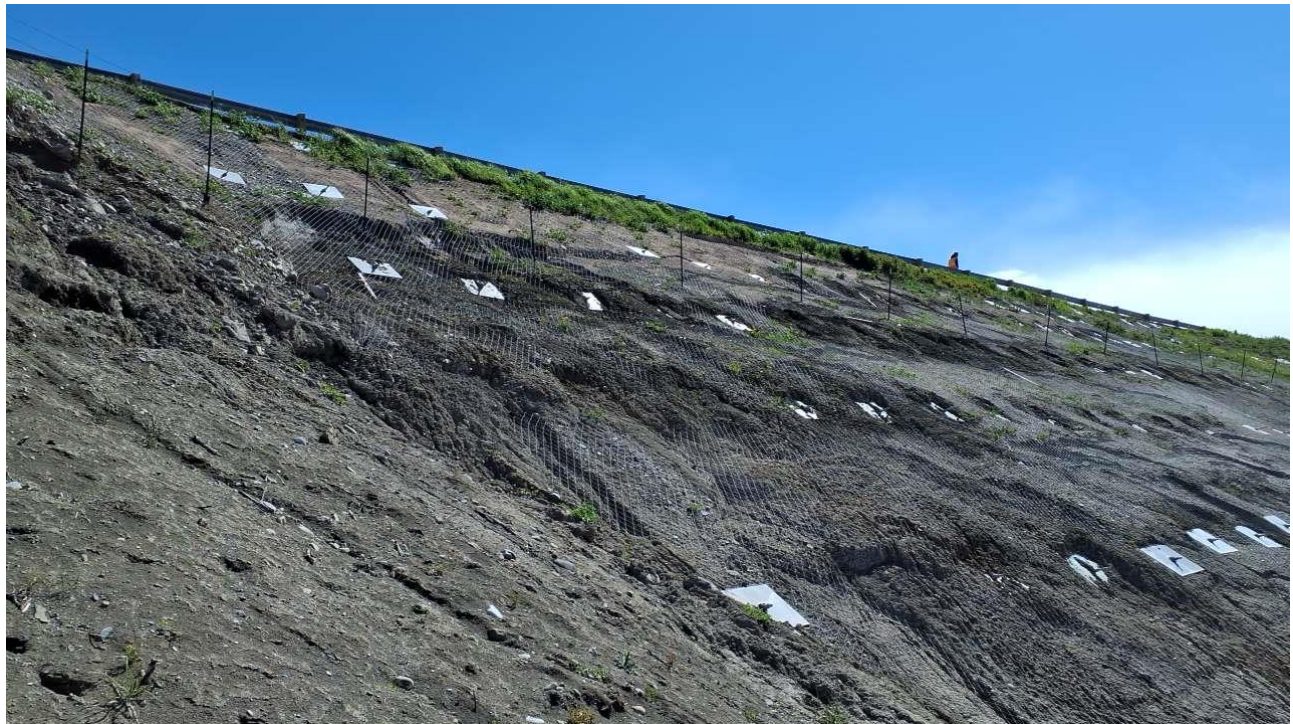
material on the slope was moving (or flowing) around the anchor plates. The material on the slope is not acting as it was assumed in the repair design as it was assumed the material was cohesive based on the site investigation completed. More importantly, the observation of the soil deforming around and above the anchor plates at slope surface indicates the soil is acting like a plastic, not a solid. The design work completed by KCB for the soil nail design was based on the soil acting like a solid upon completion of the repair.

The surface mesh installed as part of the construction did not meet the mesh requirements stated in the tender but was accepted as part of a RFI after contract award. The mesh installed does not include an erosion control element and is only a wire mesh that is more suitable for bedrock slopes. Due to this, material on the slope can move through the mesh and will not be held in place. Due to the lack of erosion control material in the mesh (a design requirement), the slope is relatively unprotected which will challenge initial vegetation growth after seeding, leading to a higher chance of erosion occurring which has been the case so far. The site was hydroseeded in June 2023. The seed has not taken and there is little to no growth on the slope which is contributing to erosion and sloughing. Rilling on the slope surface has resulted in a limited number of anchor plates having soil removed from beneath them which will impact the ability of the soil nails to resist destabilizing forces within the slope.

Photo 4 Slope movement. Material moving around soil nail anchor plates. Photo taken facing south on May 29, 2024.

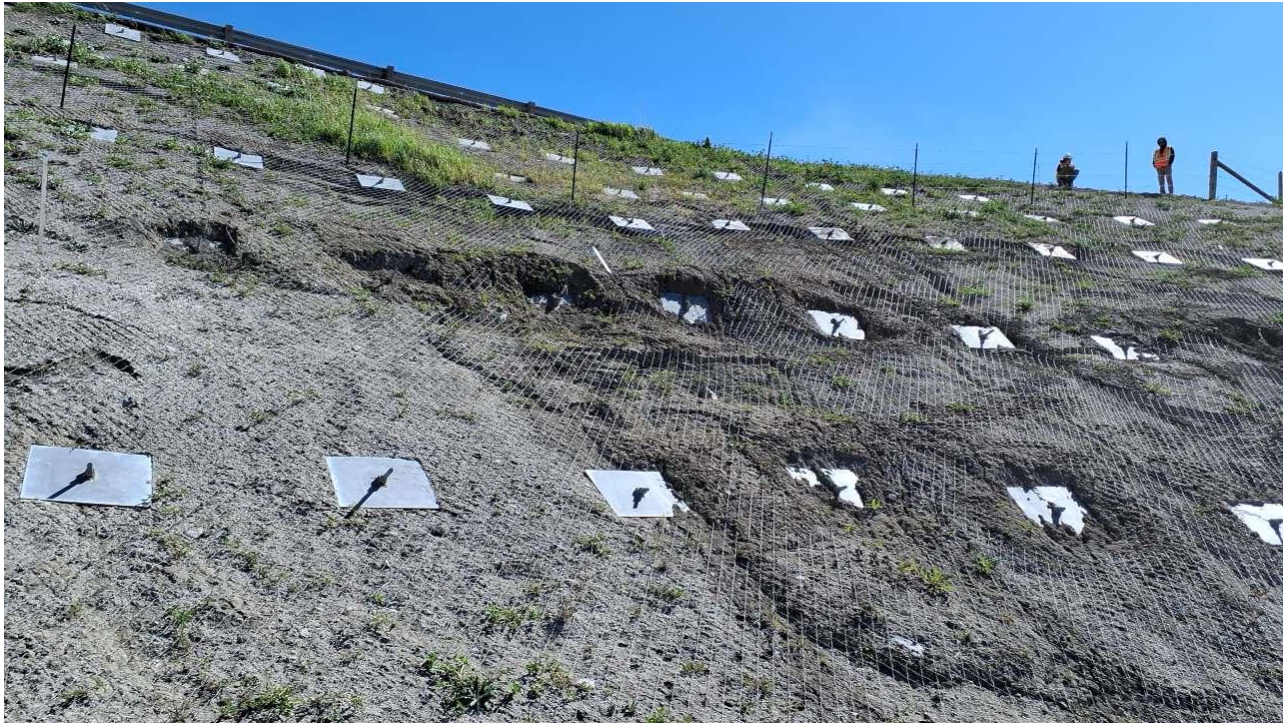
Photo 5 Slope movement. Material moving around soil nail anchor plates. Photo taken facing south on May 29, 2024.

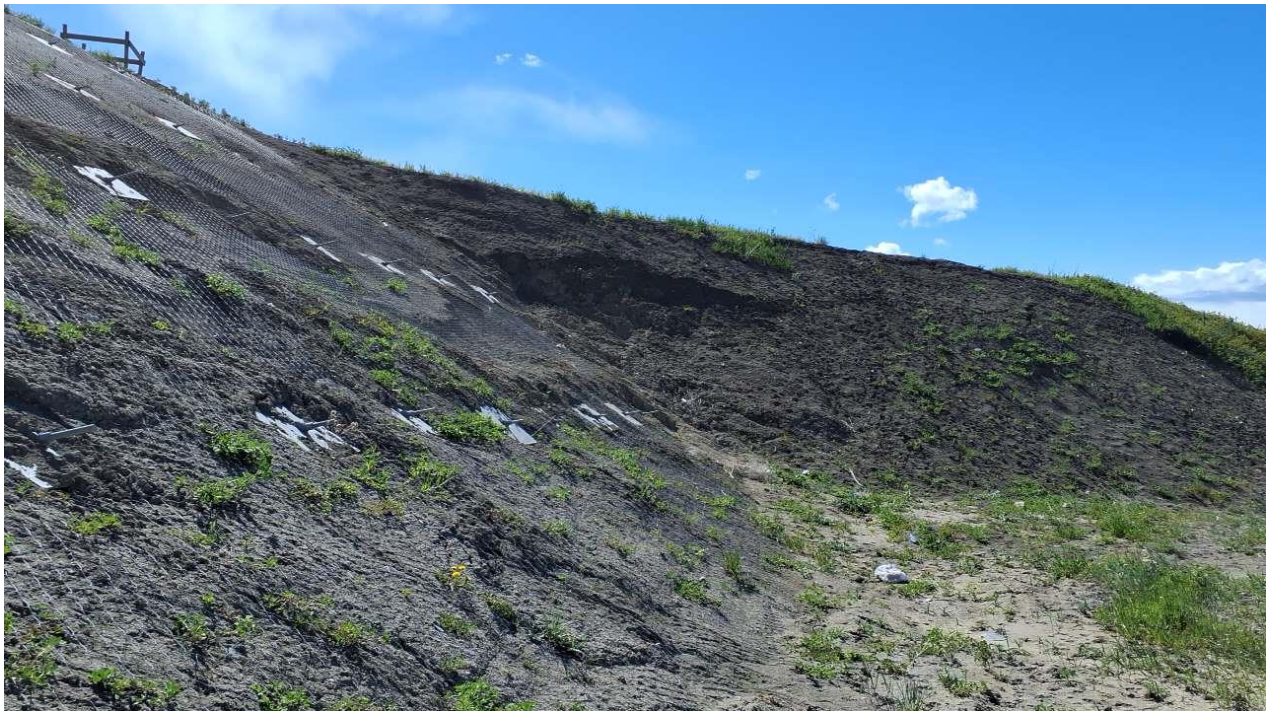
Photo 6 Slope movement on west flank of repair slope. Photo taken facing northeast on May 29, 2024.
