March 1, 2021

Alberta Transportation
2nd Floor, 803 Manning Road NE
Calgary, Alberta
T2E 7M8

Southern Region Geohazard Risk Management Plan
S063 Hwy 3:09, km 1.38 Call-Out Report

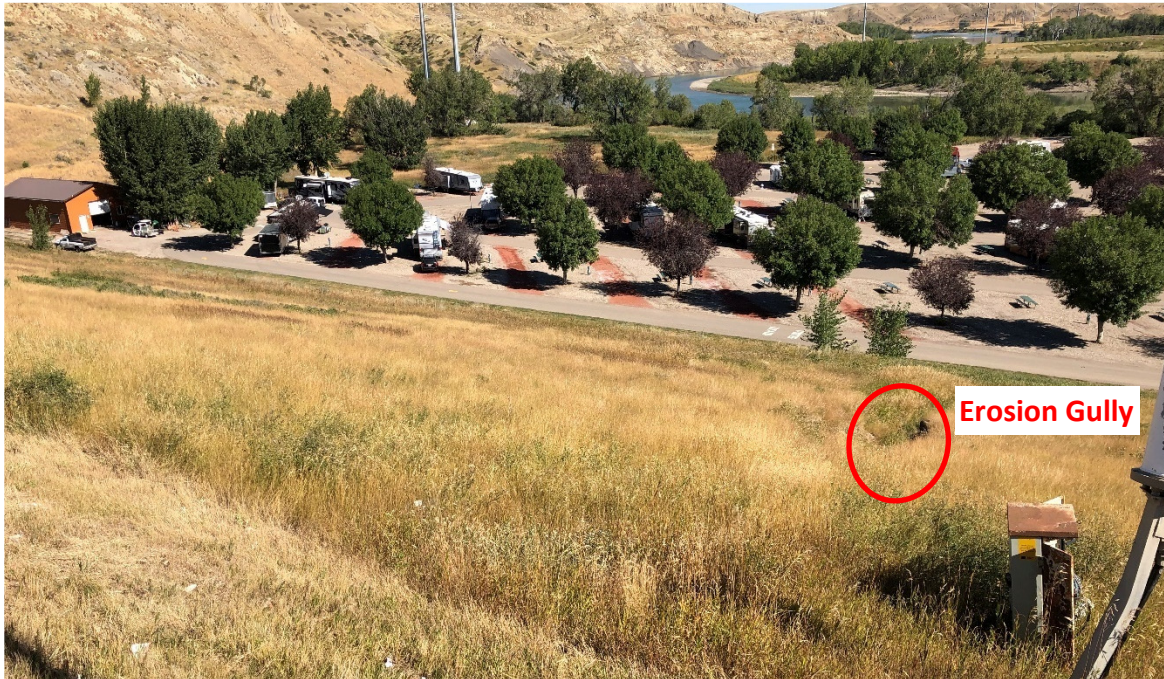
Photo 1 View from crest of highway embankment looking downslope towards the RV Park and river. Photo taken facing northeast on September 9, 2020.

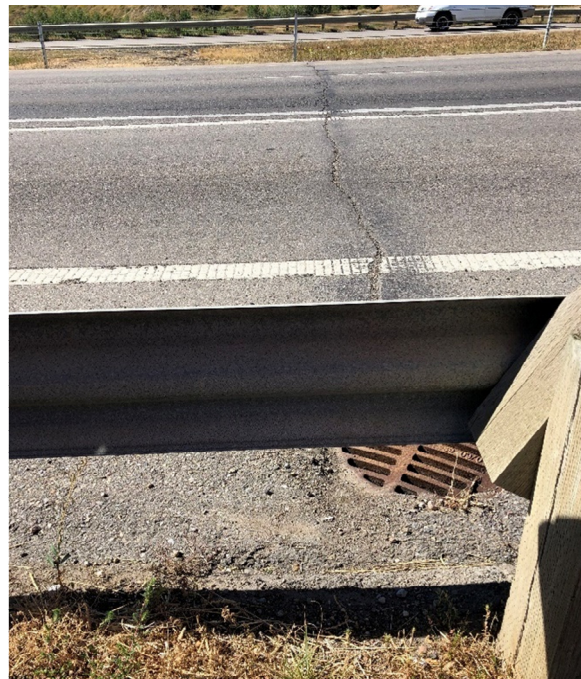
- The highway pavement appeared to be in good condition with no evidence of cracking, dislocation, or slope instability. Transverse cracking was noted on the highway surface and appears to be located over highway surface drainage pipes and inlet grates.

Photo 2 Crack in pavement surface over highway drainage. Photo taken facing southwest on September 9, 2020.

- Hydrovac the pavement drains and collector vaults, to remove accumulated debris and improve highway surface drainage;
- Carry out a CCTV camera survey to determine the material type and condition of the highway surface water drainage system; and
- Complete a topographic and hydrotechnical evaluation for highway runoff and RV Park surface drainage. Upgrade the surface drainage channel to the Oldman River to reduce the potential for overland flooding. Include sediment retention structures where necessary.

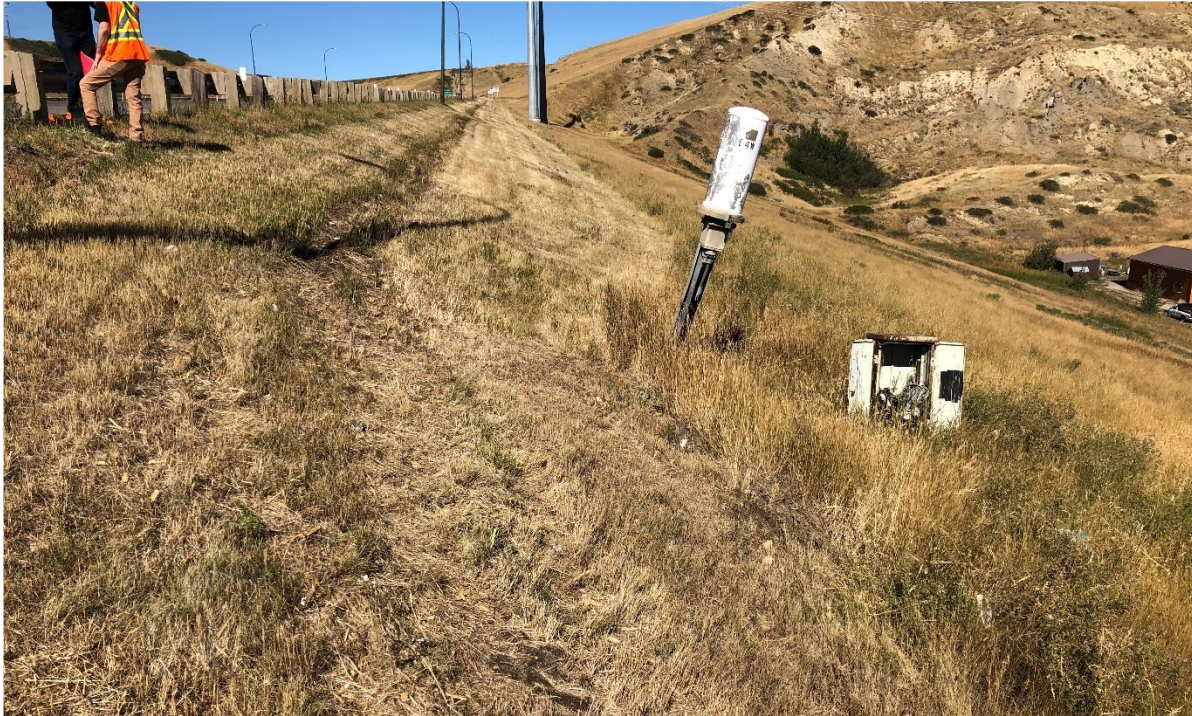
Photo 3 Crest of highway embankment looking northwest. Photo taken September 9, 2020.

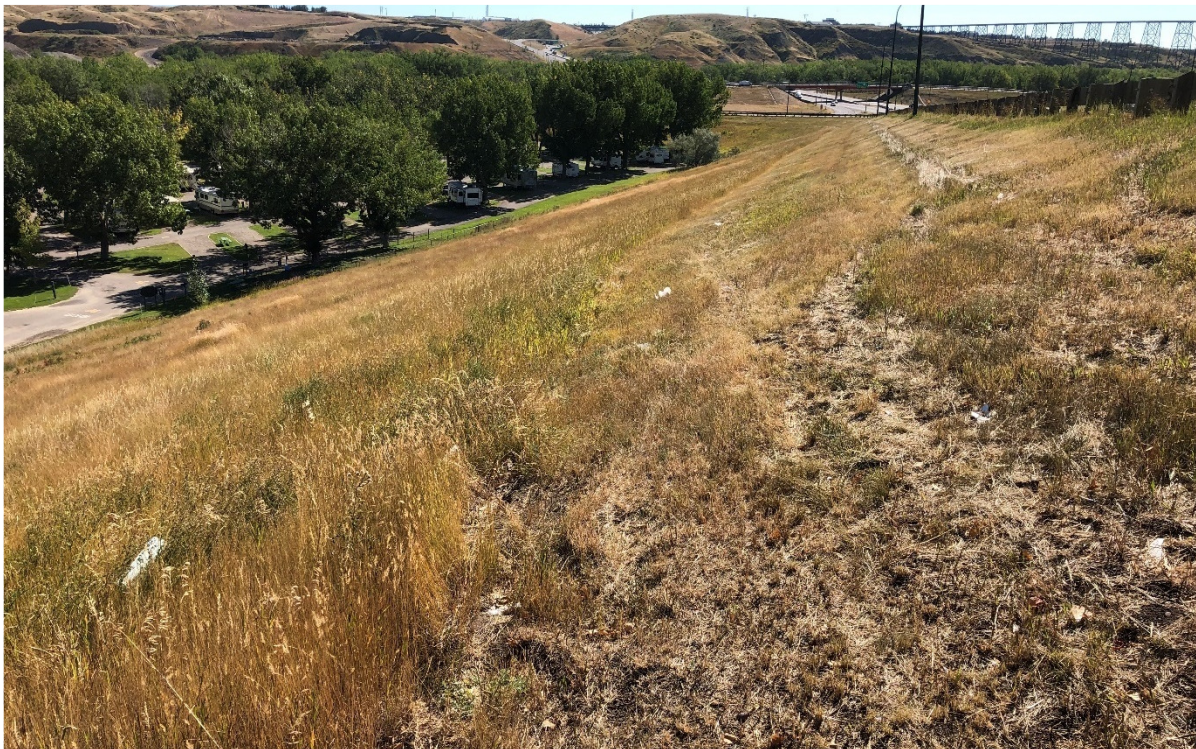
Photo 4 Crest of highway embankment looking southeast. RV Park is located at the toe of the embankment, adjacent to the river. Photo taken on September 9, 2020.

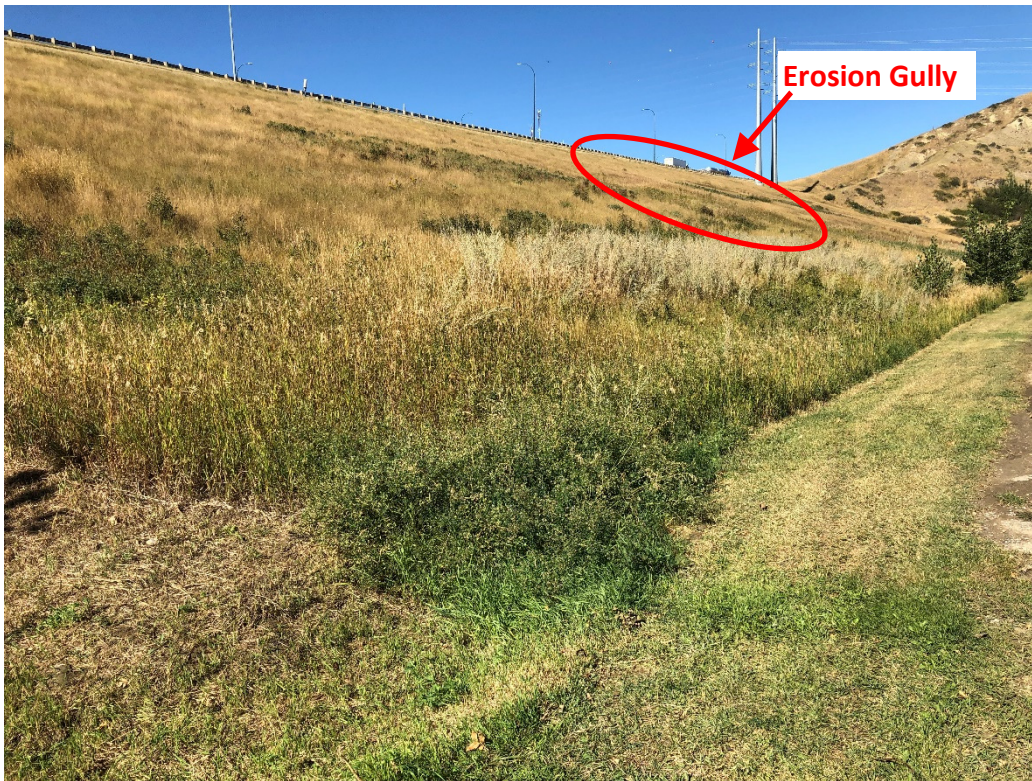
Photo 5 Highway embankment from toe of slope. Photo taken facing southeast from the RV Park on September 9, 2020.

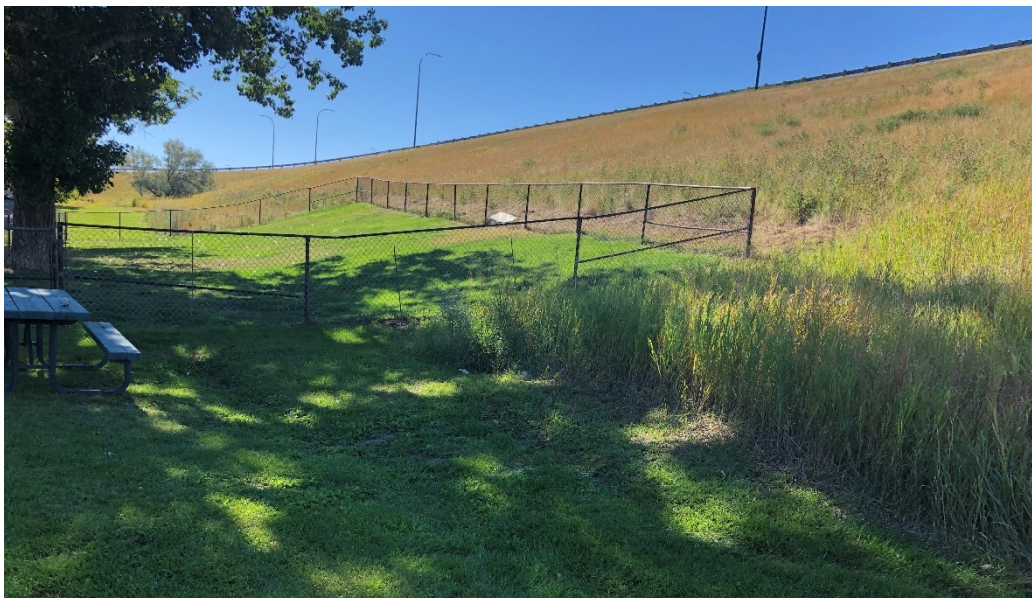
Photo 6 Highway embankment from toe of slope. Photo taken facing southeast from the RV Park on September 9, 2020.

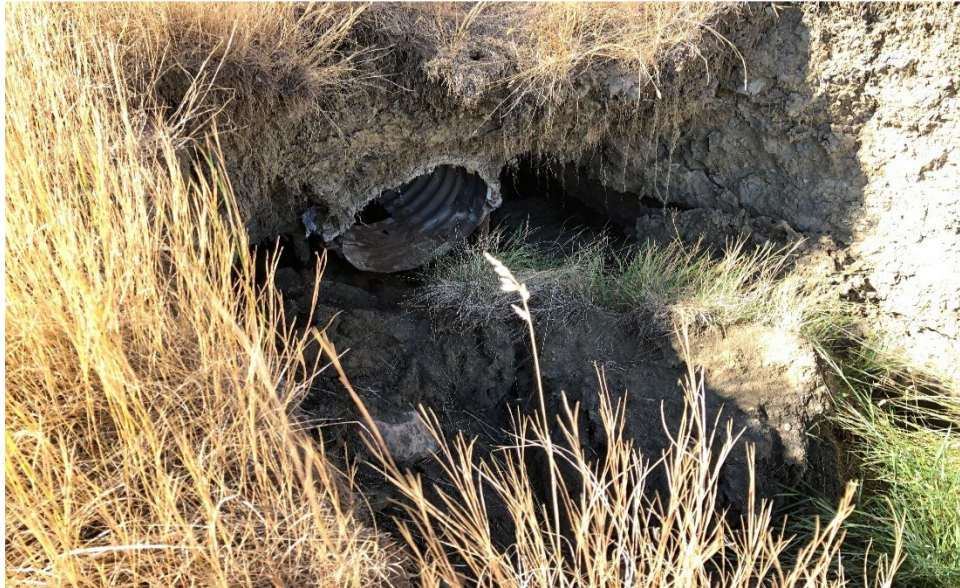
- The erosion gully appears to be due to a CSP slope drain installed in the 1960s corroding at the invert, leading to erosion around the buried pipe and joint separation as ongoing surface water runoff from the highway causes the erosion gully to retrogress up the slope towards the highway. Without remedial actions, surface erosion will continue to retrogress up the slope, ultimately undermining the guard rail and shoulder of the highway.
- A possible sinkhole was observed upslope of the erosion gully, near to a utility box (waypoint 48). The possible sinkhole was estimated as approximately 1.2 m diameter and less than 0.3 m deep.

The erosion gully on the highway embankment is visible in air photo imagery in Google Earth, and is shown in Photos 7 to 10 (Appendix I). Highway runoff from the slope drain discharges into the erosion gully and there is no visible collector drains at the toe of the slope.

Photo 7 Highway drainage includes three buried CSP culverts (reportedly installed in the 1960s and 1 m diameter). The culverts have rusted out leading to erosion gullies forming on the slope. Photo taken on September 9, 2020.

- Repair the erosion gully and reinstate the slope drain using a buried culvert; and
- Construct a collector drain for surface runoff and drainage from the highway embankment at the downstream toe.

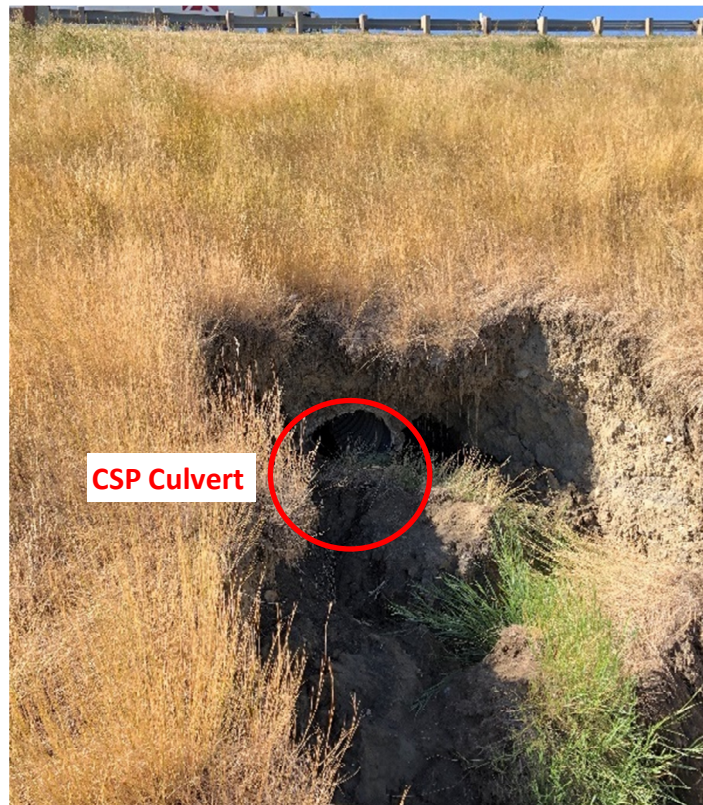
The geohazard concern at the site (primary issue) is considered to be the result of ongoing highway drainage through corroded buried CSP culverts, leading to the surface expression of the erosion gully and ongoing retrogression of the erosion, as the CSP is undermined and separates at culvert joints. The erosion gully has the potential to increase in size during rainfall events and ultimately will begin to undermine the W-beam guardrail and shoulder of the highway. There is a risk of sinkholes or localized erosion features forming in the embankment or the highway due to ongoing internal erosion. The unknown condition of the internal drainage system along the embankment and potential deterioration could cause the phreatic surface in the embankment to increase, leading to potential slope instability.

Photo 8 The CSP culvert has rusted over time and separated at joints, causing the erosion gully to retrogress up the slope. Photo taken facing southwest on September 9, 2020.

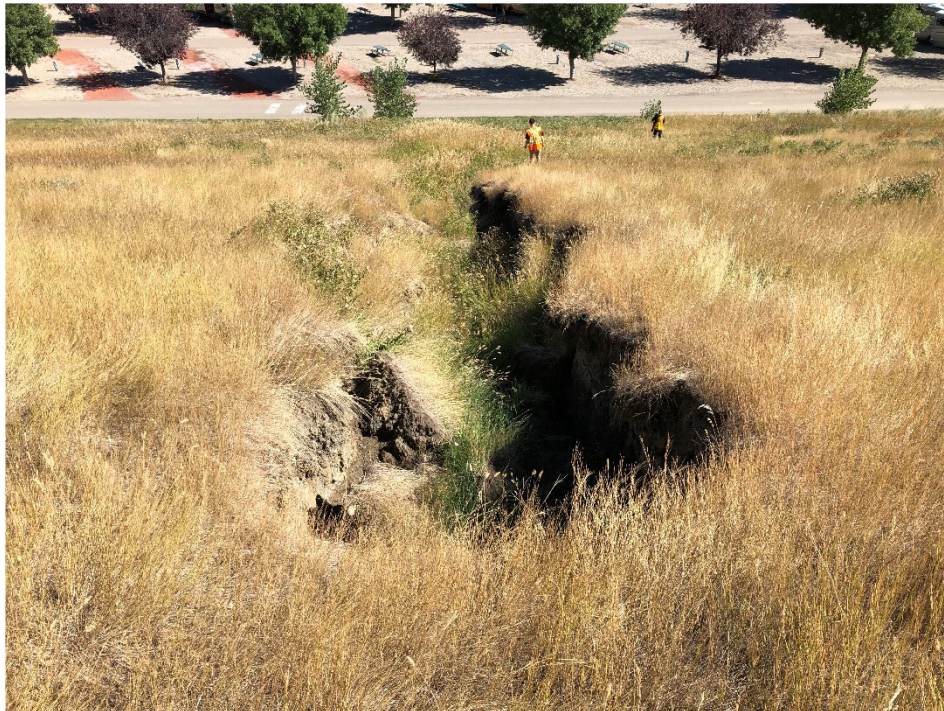
- Probability Factor – A rating of 9 was selected, because the erosion is expected to be active at moderate rainfall events due to the culvert discharging surface water onto the erosion gully. The gully was approximately 2 m deep and 3 m to 5 m wide.

Photo 9 Surface runoff erosion gully (approximately 2 m deep and 3 to 5 m wide) viewed from crest of embankment. Photo was taken facing northeast on September 9, 2020.

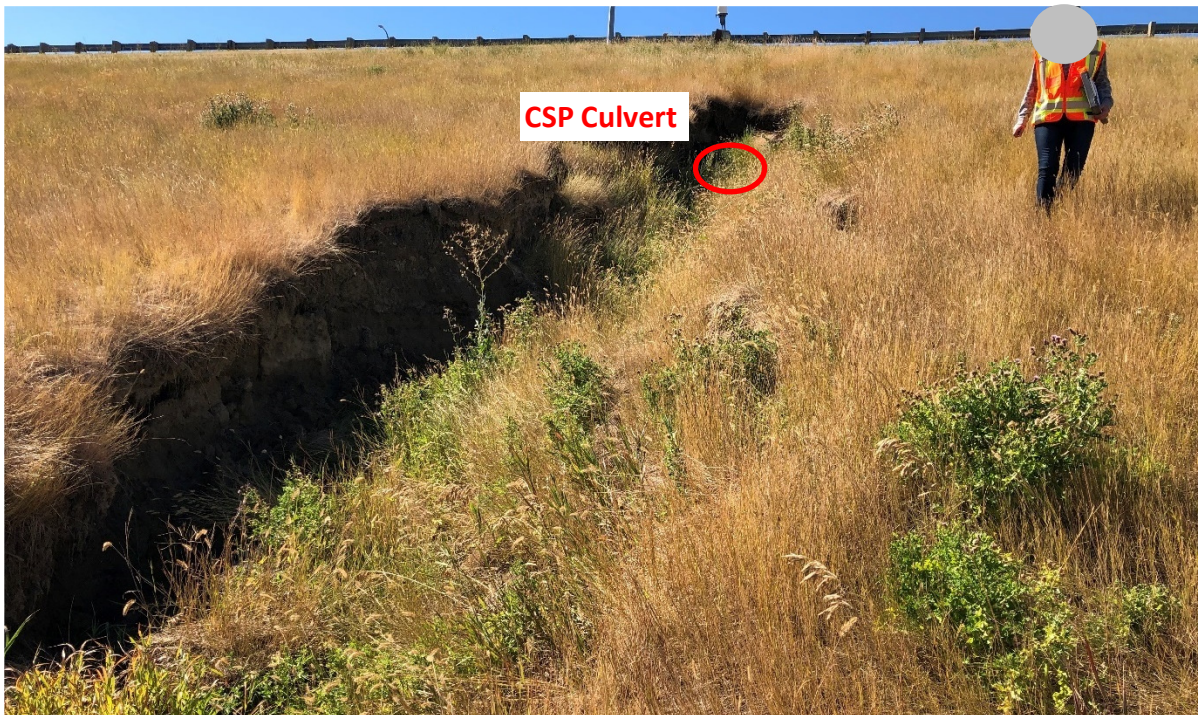
Photo 10 Surface runoff erosion gully viewed from midway down the embankment. Photo was taken facing west on September 9, 2020.

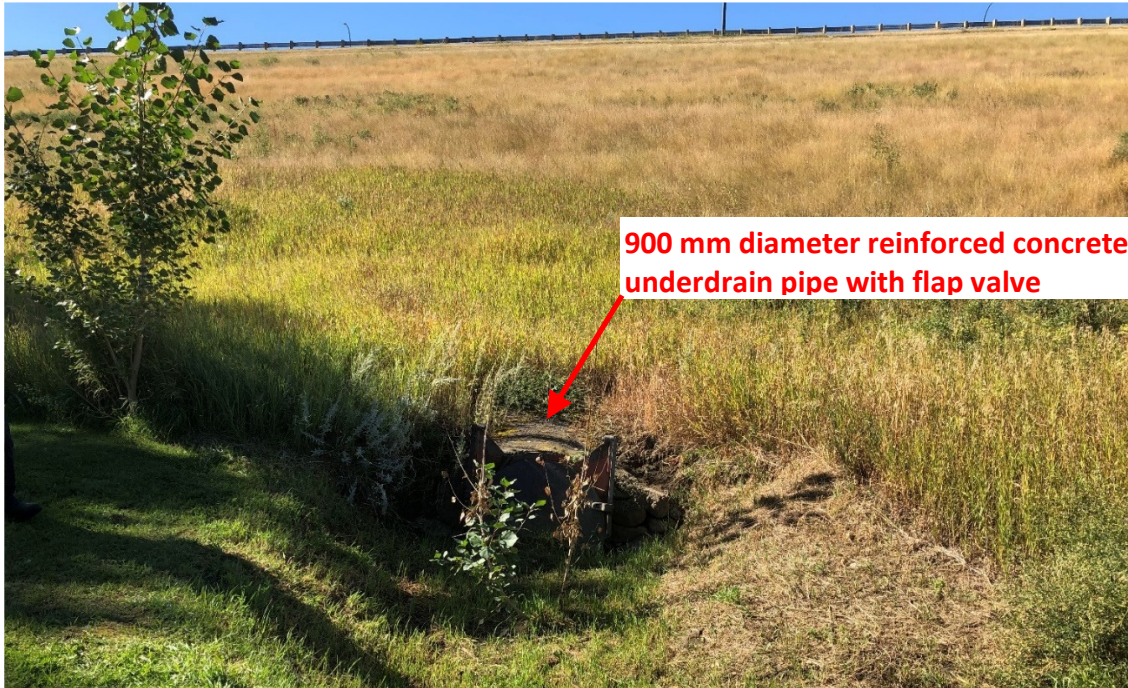
- Surface runoff from the highway embankment, including discharge from a buried slope drain that has corroded and degraded leading to the erosion gully.
- Discharge from the sediment clogged highway underdrain (900-mm-diameter reinforced concrete culvert) that is located at the downstream embankment toe (waypoint 44). The underdrain is reported to convey surface water flow from the west side of the highway to the single shallow drainage channel through the RV Park to the Oldman River. The downstream end of the culvert is covered with a flap valve that has been bolted open (approximately 100 mm gap at the base), and the flap valve is approximately 2/3 clogged with sediment due to runoff erosion on the west side of the highway (discussed in Section 2).

Photo 11 Underdrainage from the west side of the highway to the east side of the highway (and the river) is provided by a 900 mm (32") diameter reinforced concrete pipe with a flap valve. The underdrainage is not connected to the highway road surface drainage. Photo was taken facing southwest on September 9, 2020.

In addition to short-term maintenance activities, it is recommended that a clean-out and a CCTV camera survey is carried out to reduce potential sediment accumulations and establish the condition of the underdrain.

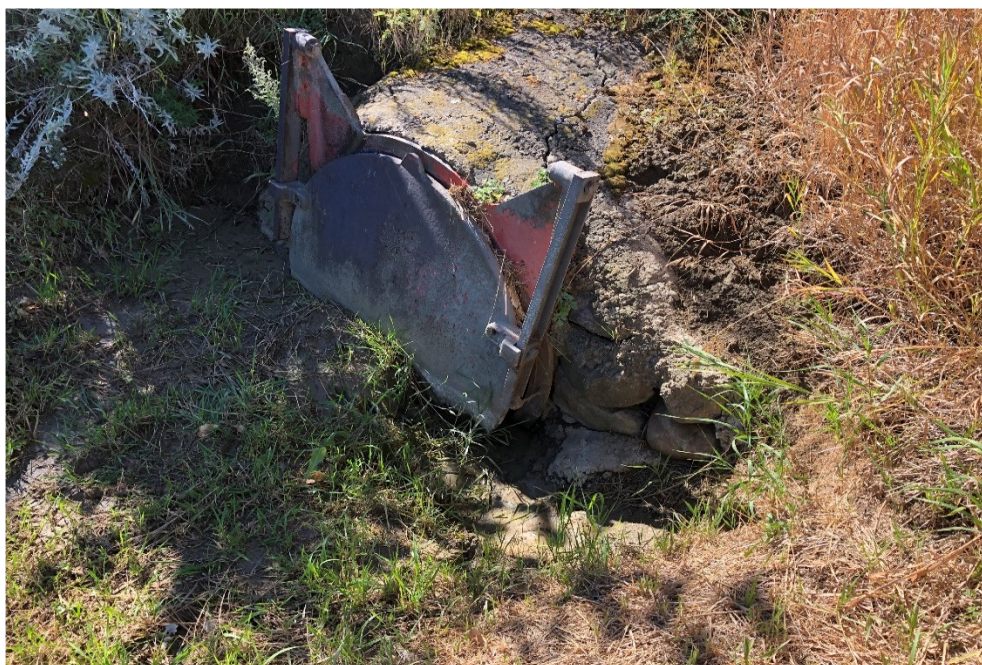
Photo 12 The flap valve is bolted open, but the outflow channel has silted up due to sediment from the west side of the highway washing through the underdrain culvert.

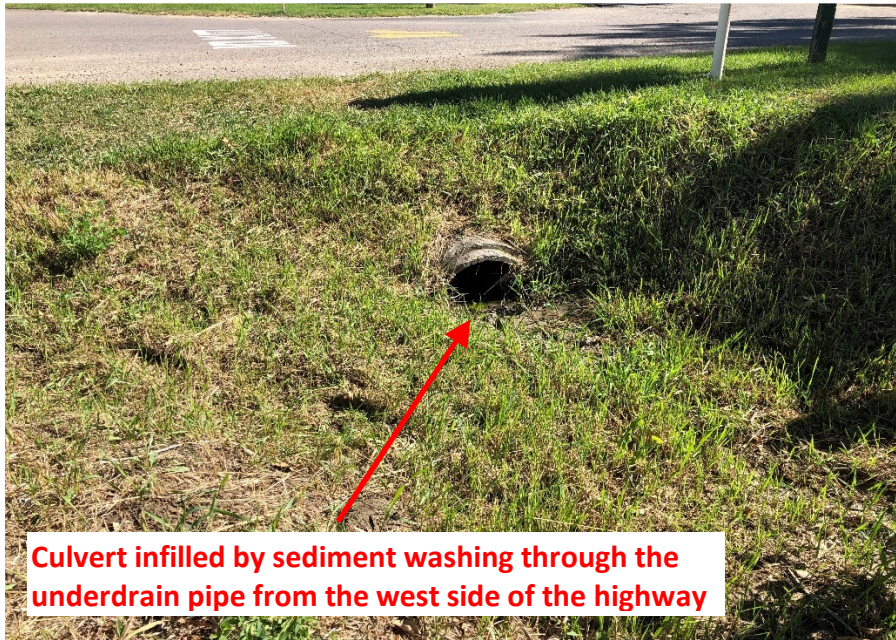
At the time of the site visit, the culverts and the drainage channel were partly silted up and did not appear to be maintained (grass was well established at the partially plugged culverts). The original channel appeared to have been shallow and relatively narrow, and the capacity is further reduced due to sediment deposition over time.

Photo 13 Shallow drainage channel and partially infilled concrete culvert immediately downstream of the flap valve. Photo taken facing northeast on September 9, 2020.

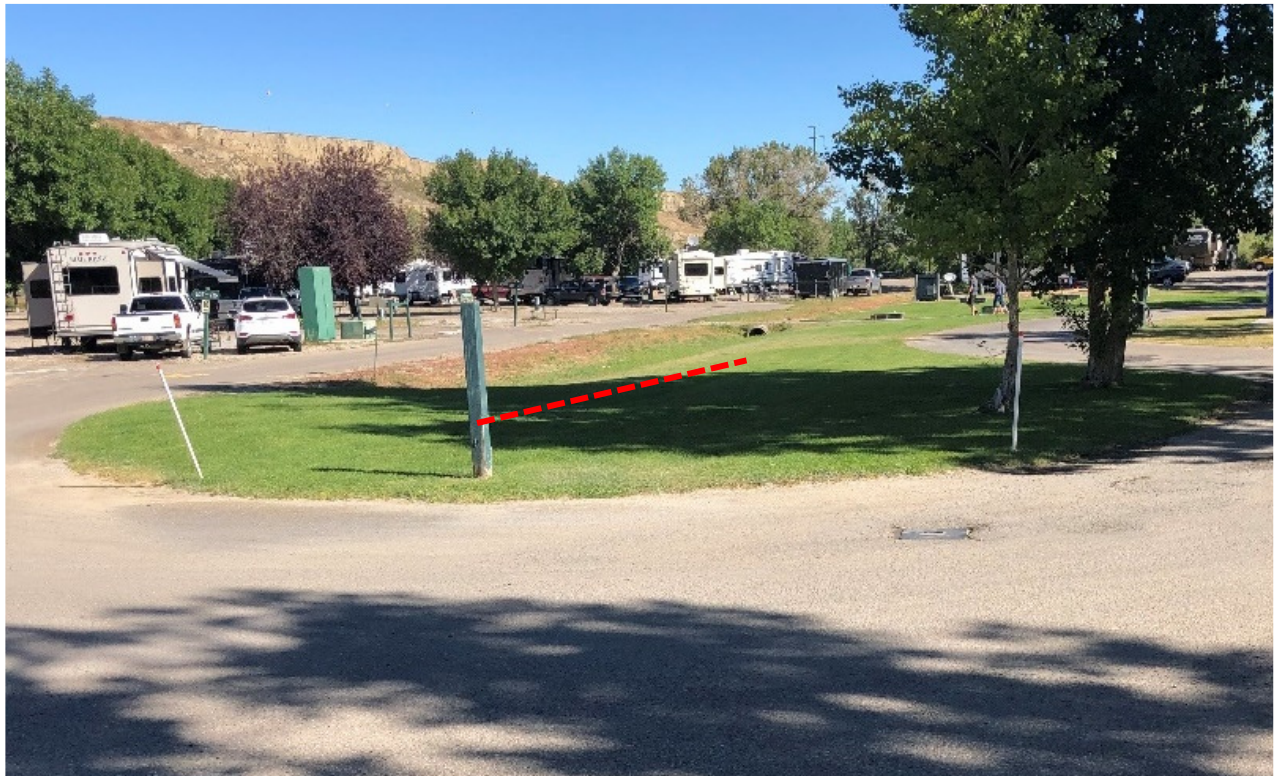
Surface runoff reports to a shallow (less than 0.5 m deep) partly sediment infilled drainage channel that runs perpendicular to the highway right of way through the RV Park. The channel deepens slightly in the downstream direction. Along the channel route, there are three concrete culverts (estimated diameter 450 mm) where roads and pathways in the RV Park cross the channel.

Photo 14 Shallow open drainage channel from the underdrain pipe to the river (red dashed line). Photo taken facing north on September 9, 2020.

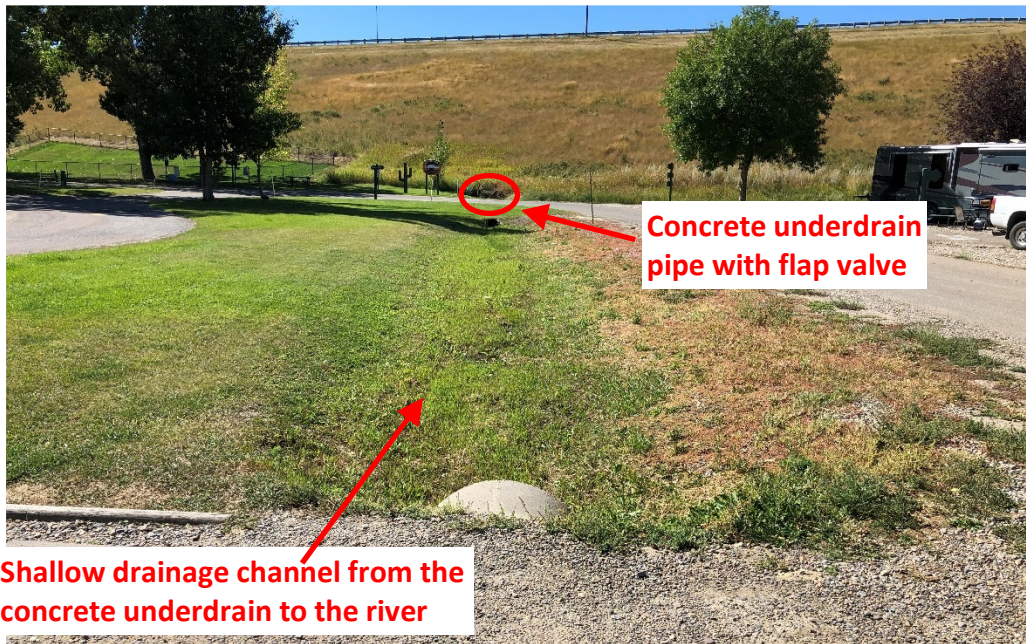
Photo 15 Shallow drainage channel from the concrete underdrain to the river. View from RV Park towards highway. Photo taken facing southwest on September 9, 2020.

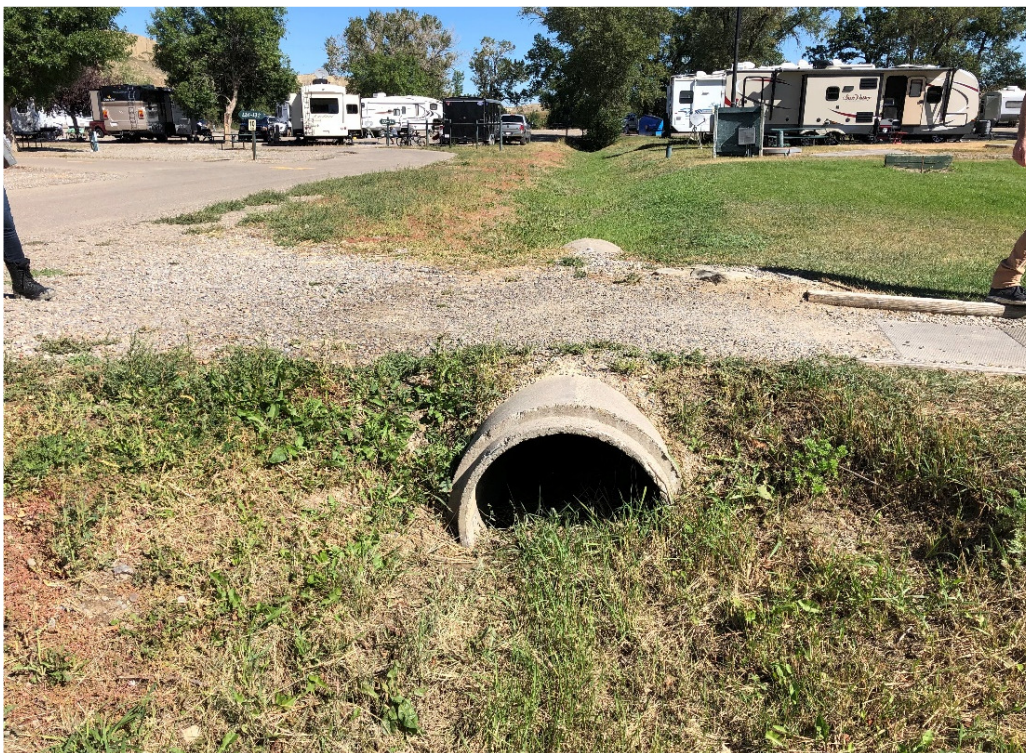
Photo 16 Shallow drainage channel from the concrete underdrain to the river. Several silted up culverts are located along the drainage channel which contributes to overland flooding in the RV Park. Photo taken facing northeast on September 9, 2020.

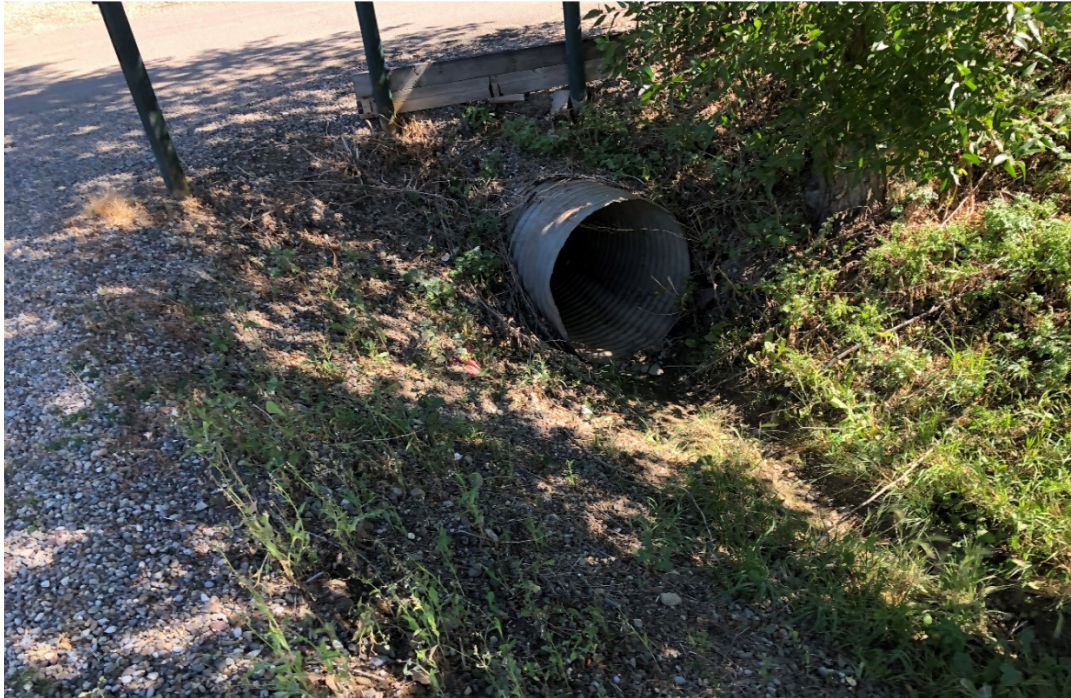
At the northeast end of the drainage channel, a bridge-sized CSP culvert (estimated diameter of 1500 mm) is present. Downstream of the CSP culvert is an overgrown and partly obstructed drainage channel that reports to the Oldman River.

Photo 17 **Unobstructed CSP culvert at northeast end of irrigation return channel. The culvert discharges into an overgrown channel that reports to the river. Photo taken facing north on September 9, 2020.**

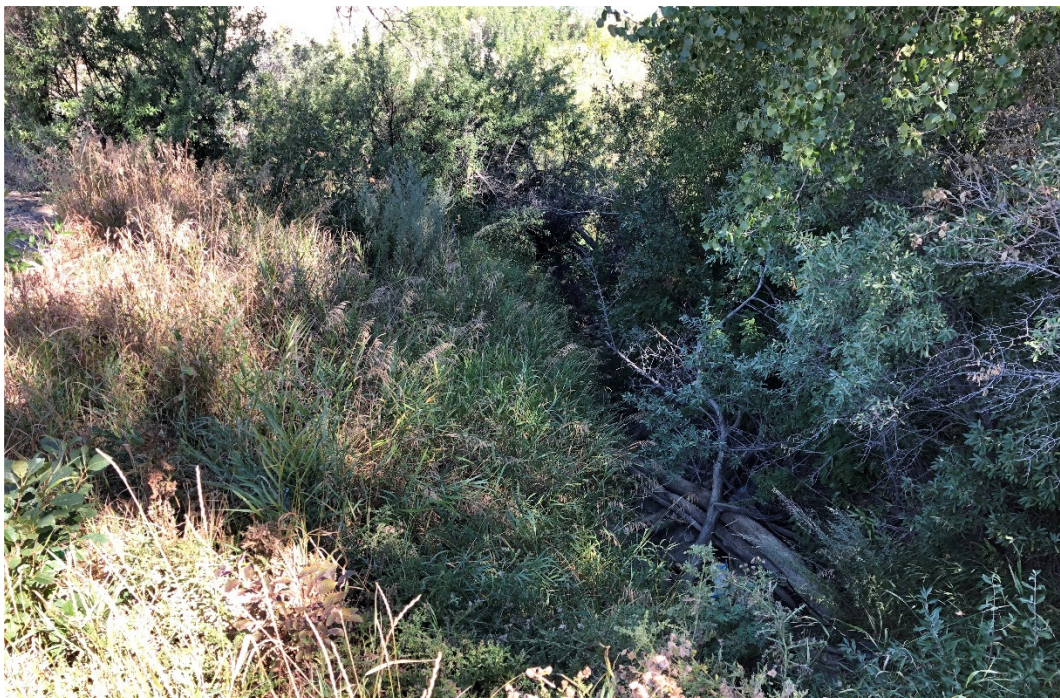
Photo 18 **Overgrown drainage channel between the CSP culvert and the river. Photo taken on September 9, 2020.**
