SITE NUMBER AND NAME: <b>S063 Lethbridge RV Park</b>		HIGHWAY & KM: 3:09 km 1.370	PREVIOUS INSPECTION DATE: September 9, 2020	INSPECTION DATE: <b>July 8, 2021</b>
LEGAL DESCRIPTION: 16-02-09-22 W4	NAD 83 COORDINATES: UTM: Northing: Easting: 12 5508224 364831		RISK ASSESSMENT: PF: 8 CF: 6 TOTAL: 48	
AVERAGE ANNUAL DAILY TRAFFIC: 30420 (east) & 22320 (west) (Ref. No. 50000001)			CONTRACTOR MAINTENANCE AREA (CMA): 25

PROJECT  
 SOUTHERN REGION GEOHAZARD RISK MANAGEMENT PROGRAM

TITLE  
 Site Plan  
 S063 - Hwy 3: Lethbridge RV Park  
 Hwy 3:09, km 1.37

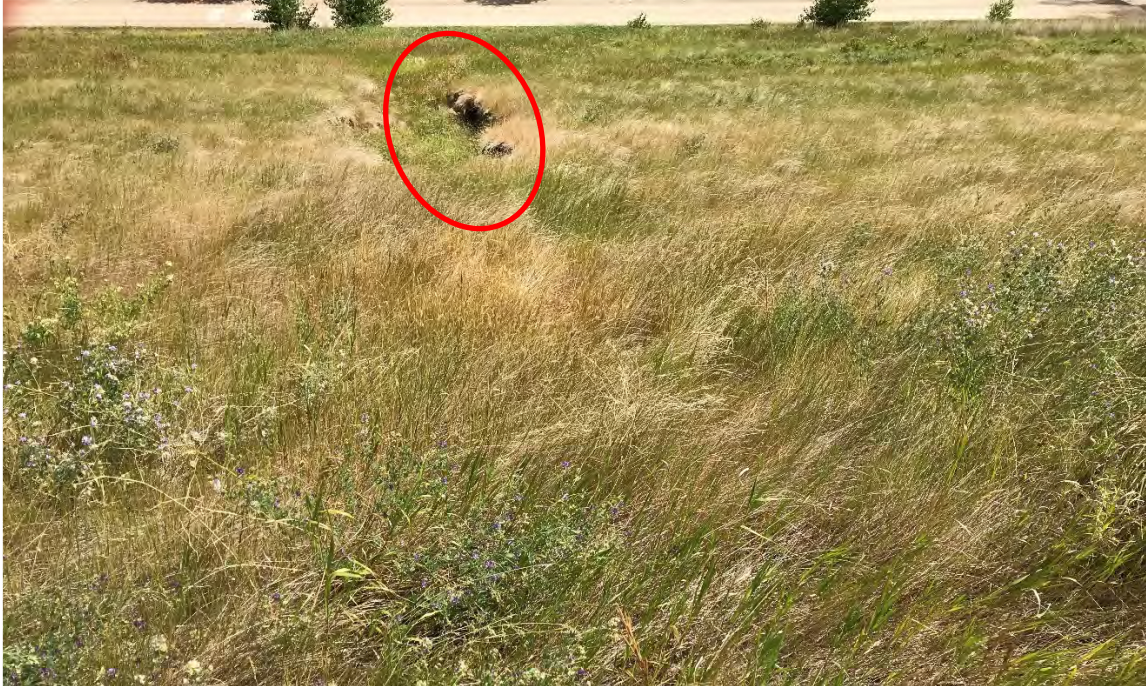
Culvert leakage has contributed to the formation of one large erosion gully and two smaller erosion features at the buried slope drains. The largest erosion gully is located near waypoint 144 and is approximately 7 m downslope of the guardrail. In 2021, the gully was measured as up to 2 m deep and between 3.0 m and 3.5 m wide.

**Photo 1** Surface runoff erosion gully (approximately 2 m deep and 3.5 m wide) viewed from crest of embankment. Photo was taken facing northeast on July 8, 2021.

- Upgrade the surface water drainage channel through the RV Park.
- Evaluate and upgrade the buried slope drains on the east side of the highway to reduce embankment erosion. Construct a collector drain at the downstream toe.

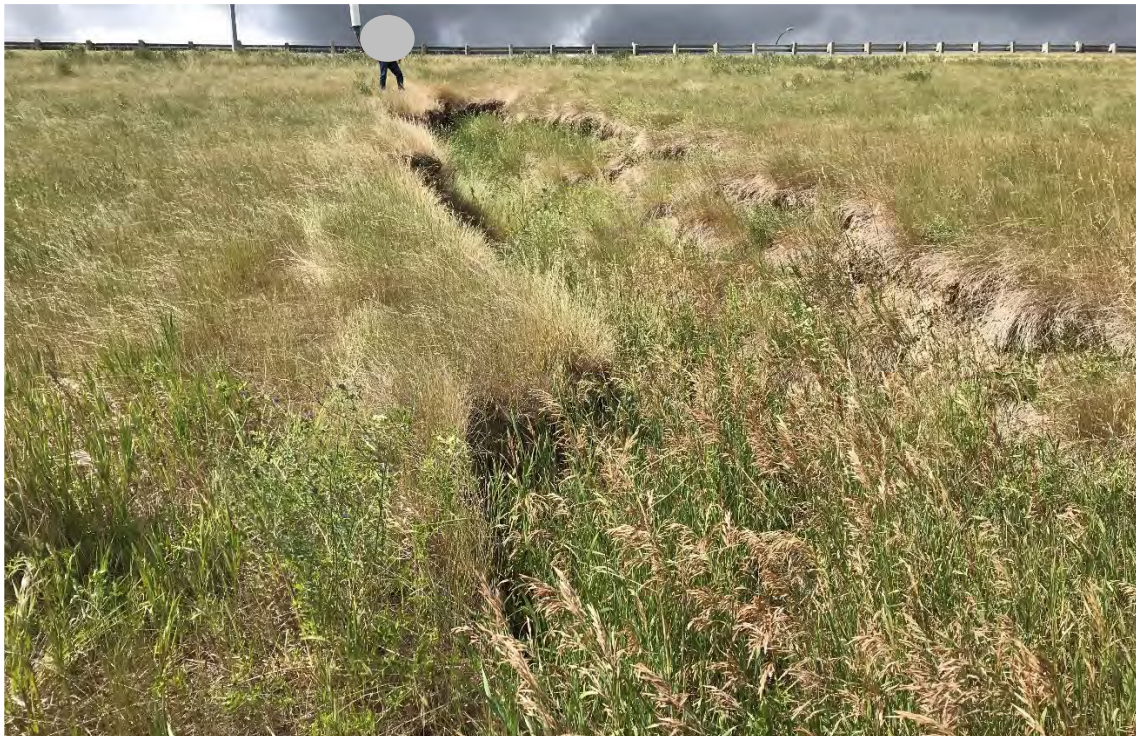
**Photo 2** Surface runoff erosion gully viewed from lower part of the embankment. Photo was taken facing west on July 8, 2021.

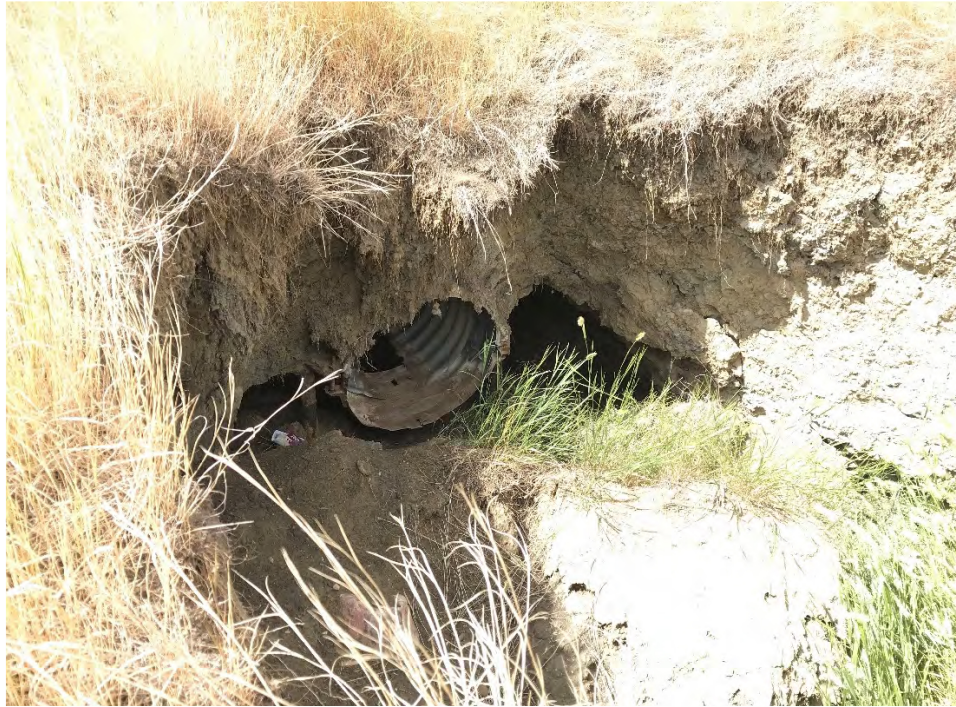
Buried CSP slope drains are corroding at the invert, leading to leakage and washout of embankment material around buried culverts and formation of an erosion gully. Culvert joints are separating as erosion retrogresses towards the highway.

**Photo 3** Highway drainage includes buried 1 m diameter CSP culvert slope drains (reportedly installed in the 1960s). The culverts have corroded leading to erosion gullies forming on the slope. Photo taken on July 8, 2021.

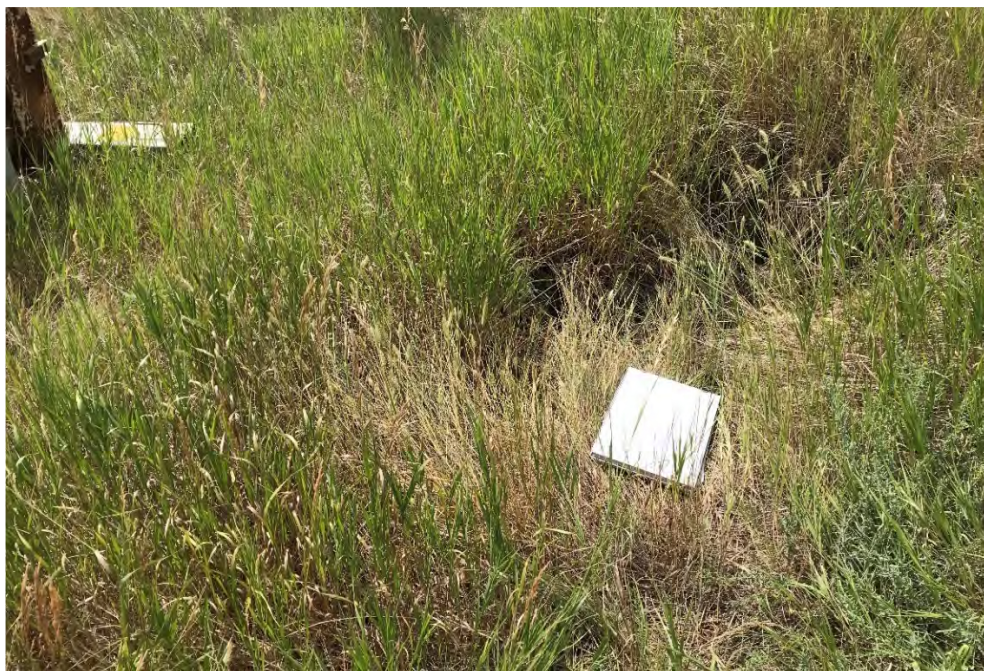
A possible sinkhole was observed near the crest of the embankment during the 2020 and 2021 site inspections, between the highway and the erosion gully (waypoint 144).

**Photo 4** Possible sinkhole forming near crest of slope, near to a utility box. Photo taken facing south on July 8, 2021.
