SITE NUMBER AND NAME: S043 Pine Ridge		HIGHWAY & KM: 6:04, 10.000	PREVIOUS INSPECTION DATE: May 2, 2018	INSPECTION DATE: May 10, 2019
LEGAL DESCRIPTION: 02-09-003-29 W4M	NAD 83 COORDINATES: UTM Northing Easting 12 5452673 292619		RISK ASSESMENT: PF: 9 CF: 4 TOTAL: 36	
AVERAGE ANNUAL DAILY TRAFFIC (AADT): 353 (north), 328 (south), (Ref No. 60060410)			CONTRACTOR MAINTENANCE AREA (CMA): 26

SUMMARY OF SITE INSTRUMENTATION: None	INSPECTED BY: Chris Gräpel (KCB) Chris Morgan (KCB) Alex Frotten (AT) Roger Skirrow (AT) Nicolas Ropchan (AT)
LAST READING DATE: N/A	
PRIMARY SITE ISSUE: Embankment sliding and/or settlement causing cracks in pavement extending across the southbound lane.	
APPROXIMATE DIMENSIONS: Approximately 30 m to 35 m wide, extending 3 m into the southbound lane. Embankment fill and natural slope at approximately 1.5H:1V. Fill is approximately 8 m high with natural slope approximately 20 m high below the fill.	
DATE OF ANY REMEDIAL ACTION: No recent remedial measures have been undertaken. An overlay appears to have been placed approximately 20 years ago, according to AT.

PROJECT SOUTHERN REGION GEOHAZARD RISK MANAGEMENT PROGRAM		
TITLE Site Plan S043 - Pine Ridge Hwy 6:0

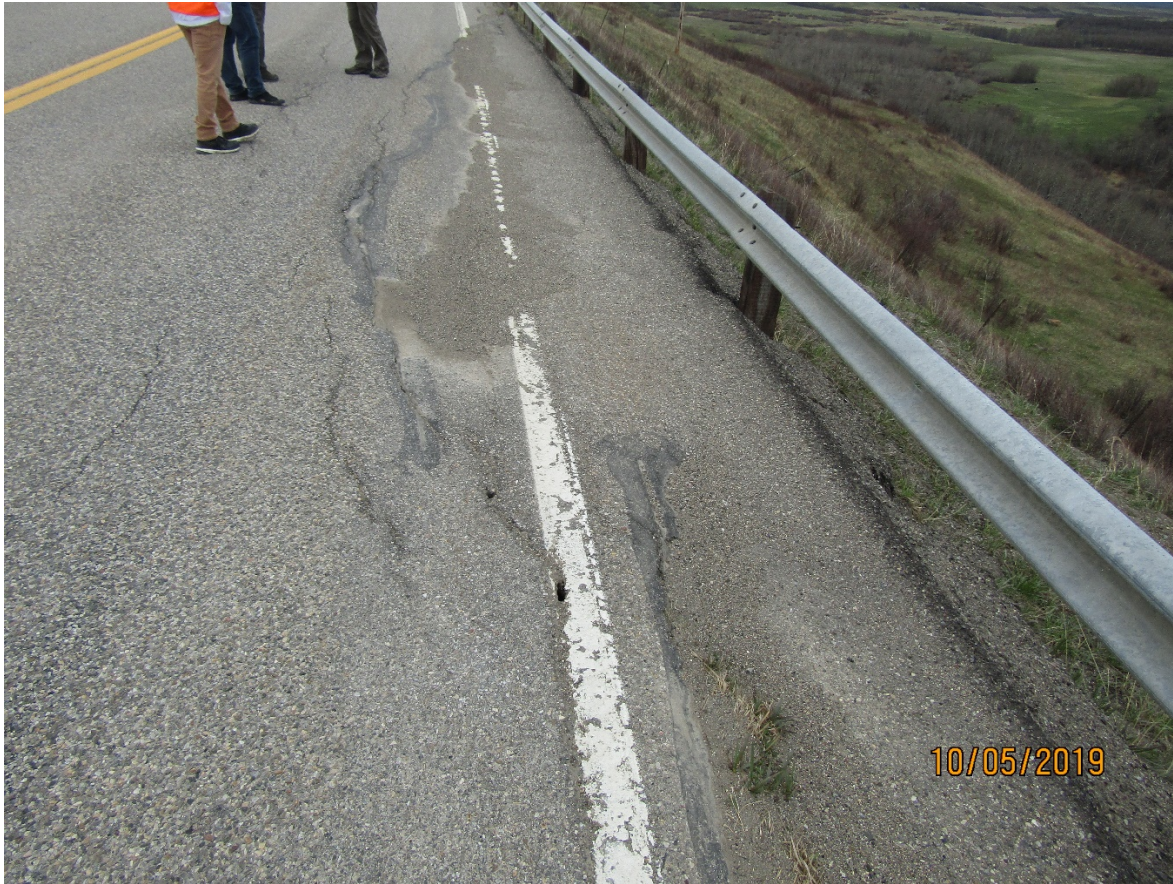
ITEM	CONDITION EXISTS		DESCRIPTION AND LOCATION	NOTICABLE CHANGE FROM LAST INSPECTION	
	YES	NO		YES	NO
Pavement Distress	X		Cracking of the pavement extends to the middle of the southbound lane and near centreline.	X	
Slope Movement	X		Slope below the highway is exhibiting signs of movement.		X
Erosion		X			X
Seepage		X			X
Culvert Distress		X			X

COMMENTS
Ongoing slope movement. Pavement cracking has enlarged slightly in width and extent. Areas of sealed cracks appear to be opening slightly. There is cracking at the west edge of the pavement on the south side of the slope, and cracks seem to be opening and joining together.
Cracks up to 50 to 75 mm wide at southern extent of the failure area, with up to 50 mm of settlement. The cracking extends to the middle of the southbound lane but has not changed significantly since 2018.
There appears to be persistent ponding of water in the upslope ditch opposite the slide zone, with probable infiltration into the slide mass. The ditch was dry at the time of the inspection.
There is an existing draw feature to the northeast and southwest of the site, that was likely filled in as part of the highway construction works.

Photo 1 Cracks at south end of failed area extending to middle of southbound lane. Photo was taken facing southeast on May 10, 2019.

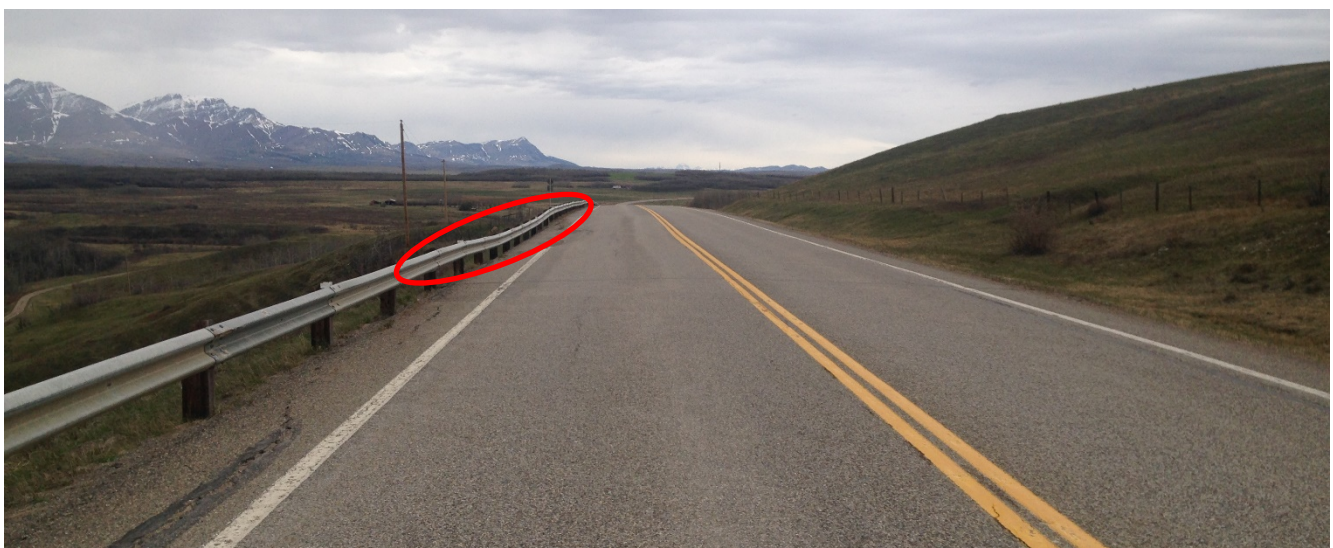
<p>The guard rail above the failure zone on the highway has dropped and a dip is apparent.</p>
<p>Up to 1 to 1.2 m thickness of asphalt was observed at various points along the highway shoulder on the crest of the downslope embankment. However, this could be overspill from the last overlay.</p>
<p>Vegetation was observed at the fill-natural soil contact at the toe of the embankment downslope of the highway. The density of vegetation could indicate seepage at the fill-foundation contact.</p>
<p>A noticeable deflection (approximately 1-2 m) of the barbed wire fence running parallel to the highway was noted in 2018. The fence is located approximately 5 m below the highway.</p>
<p>The embankment failure appears to be due to groundwater seepage and seepage from the adjacent drainage ditch leading to instability downslope. Ponded water in the drainage ditch is infiltrating into the adjacent highway embankment. It may also be possible that organic material present beneath the embankment was left in-situ during the embankment construction, or that sub-drainage was not included to drain springs, as was a common highway construction practice in the past.</p>

Photo 2 Dip in guard rail (red circle) due to slope movement. Photo was taken facing northwest on May 10, 2019.

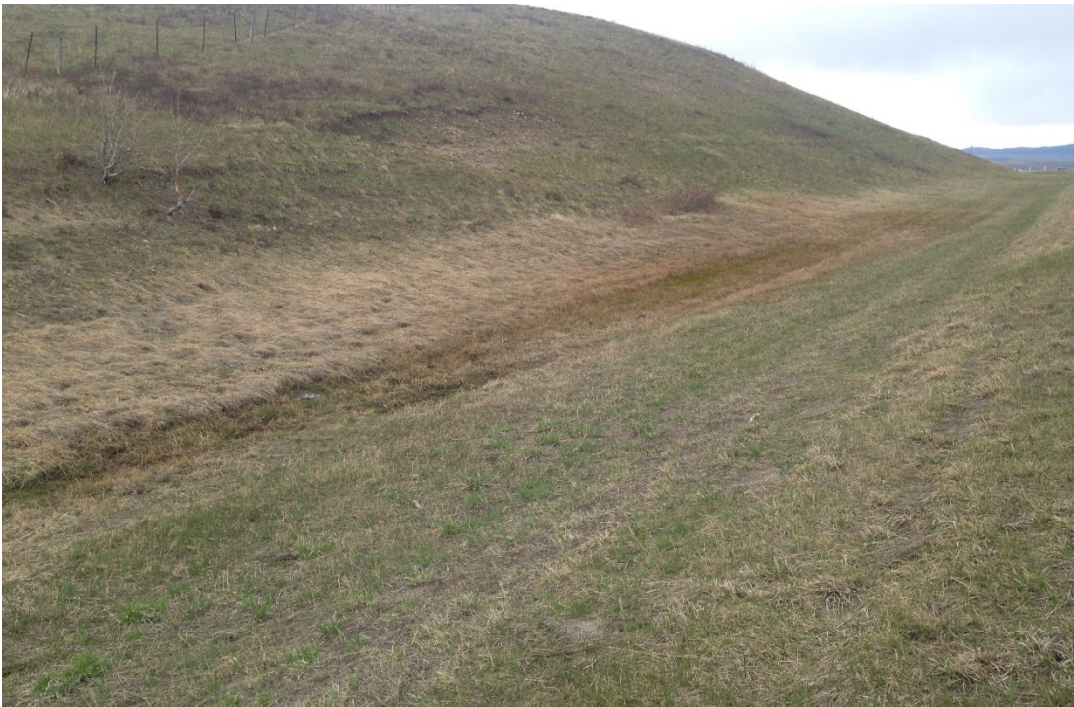
Photo 3 **Drainage ditch on upslope side of site. Damp areas observed in the poorly graded ditch. Photo was taken facing east on May 10, 2019.**

<p>Short-Term:</p> <ul style="list-style-type: none"> - The drainage ditch should be regraded to allow water to pass through this area without ponding, to see whether slope movements cease. If not, the ditch should be lined with a geomembrane to limit infiltration into the embankment fill. Additional stabilization measures such as a pile wall may be required if current rates of movement accelerate significantly. - If drainage improvements don't reduce slide activity, the highway should be relocated 1.5 lanes northeast with buried highway drainage.

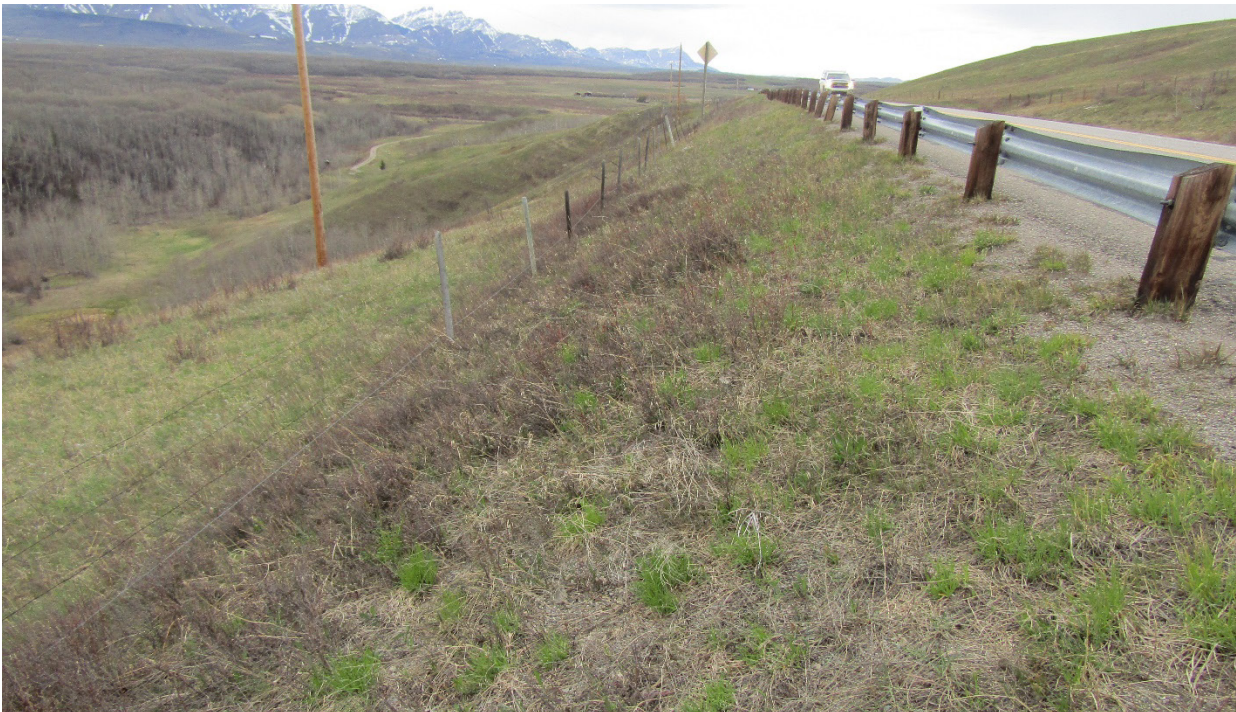
Photo 4 **Embankment slope south of highway. Photo was taken facing northwest on May 10, 2019.**
