| SITE NUMBER AND NAME: S043 Pine Ridge | | HIGHWAY & KM: 6:04, 10.000 | PREVIOUS INSPECTION DATE: May 10, 2019 | INSPECTION DATE: May 10, 2023 |

PRIMARY SITE ISSUE: Embankment sliding and/or settlement causing cracks in pavement extending across the southbound lane.

| PROJECT SOUTHERN REGION GEOHAZARD RISK MANAGEMENT PROGRAM | | |

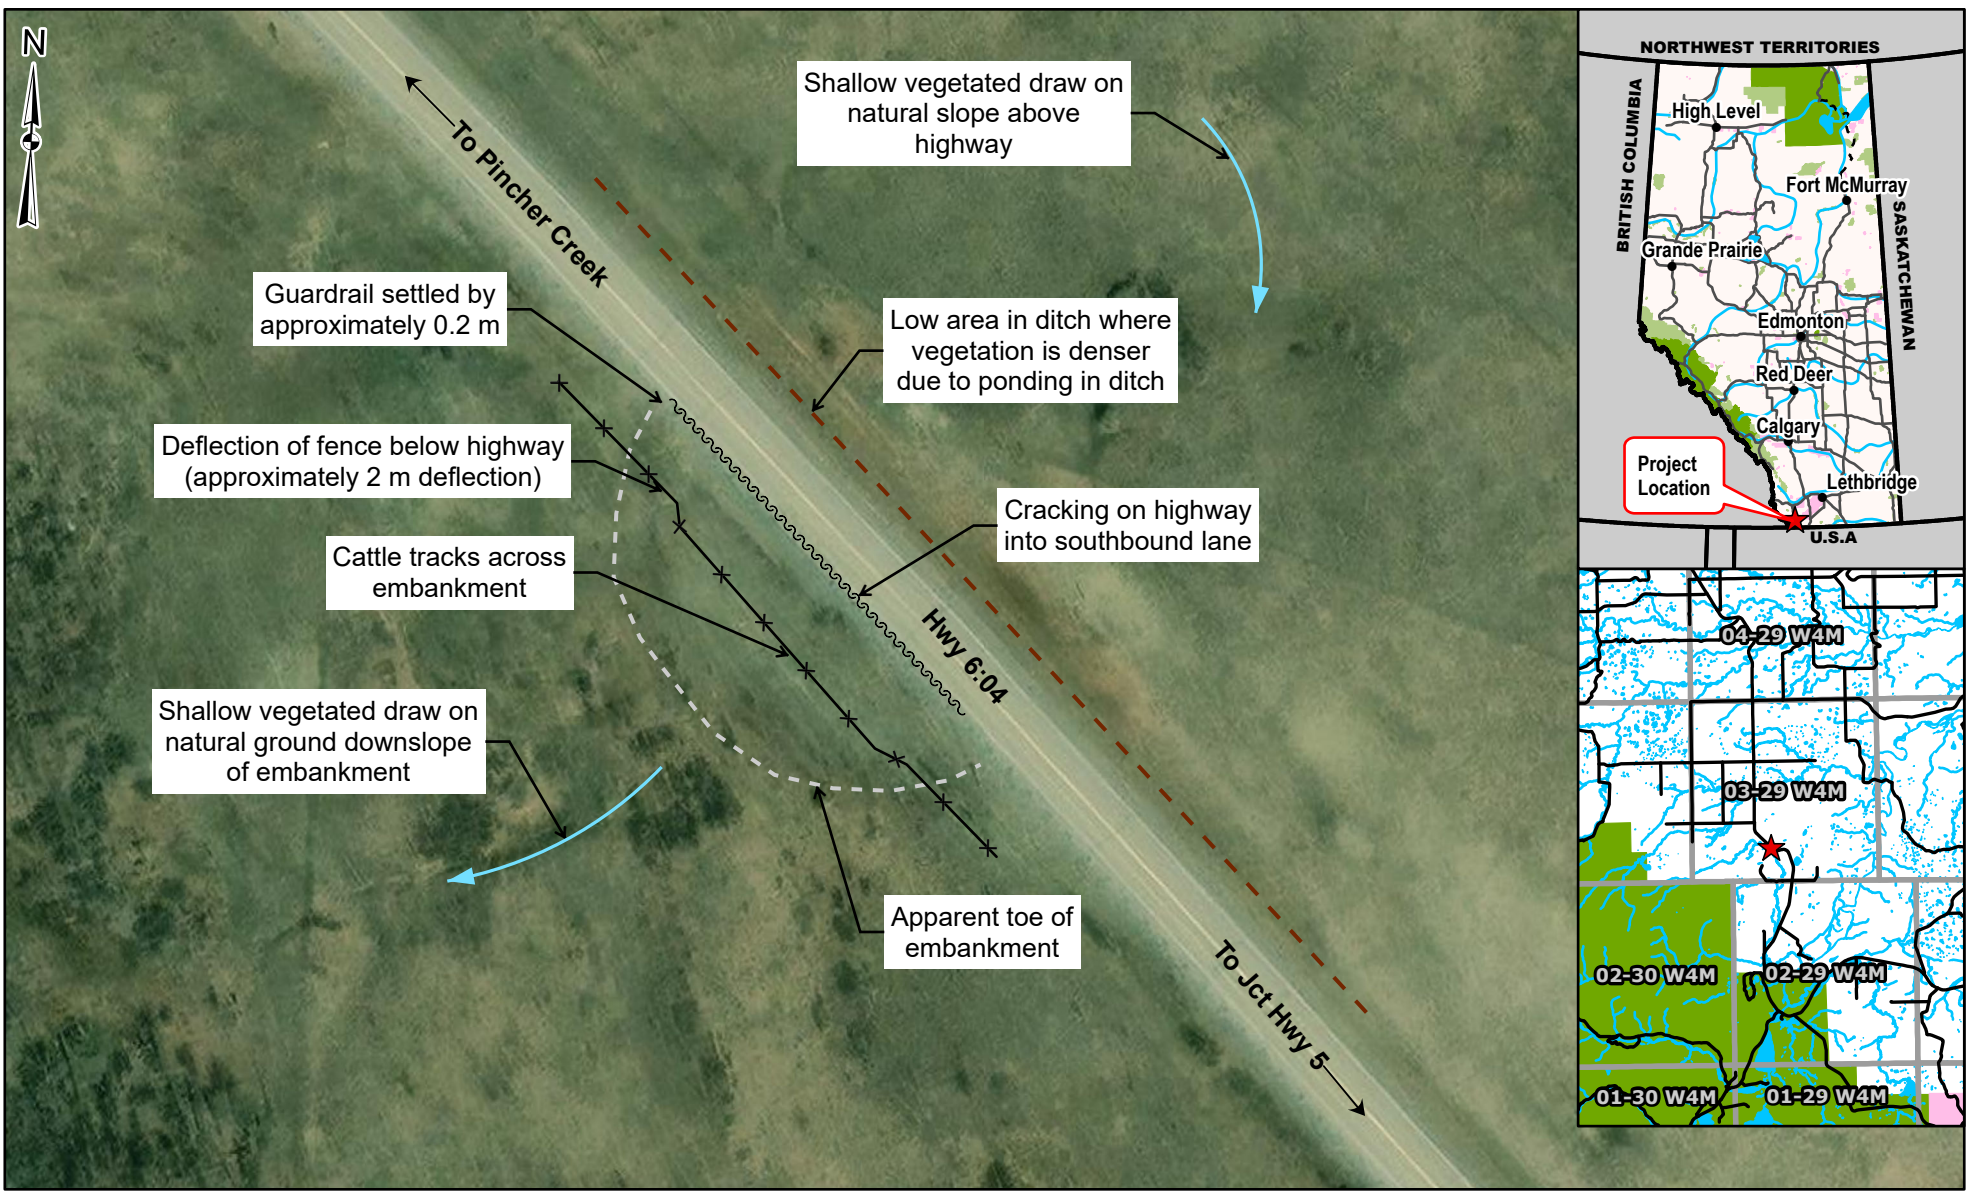
| SCALE 1:1,000 | PROJECT No. A05116A03 | FIG No. 1 |

| TITLE Site Plan S043 - Pine Ridge Hwy 6:04, km 10.00 | | |

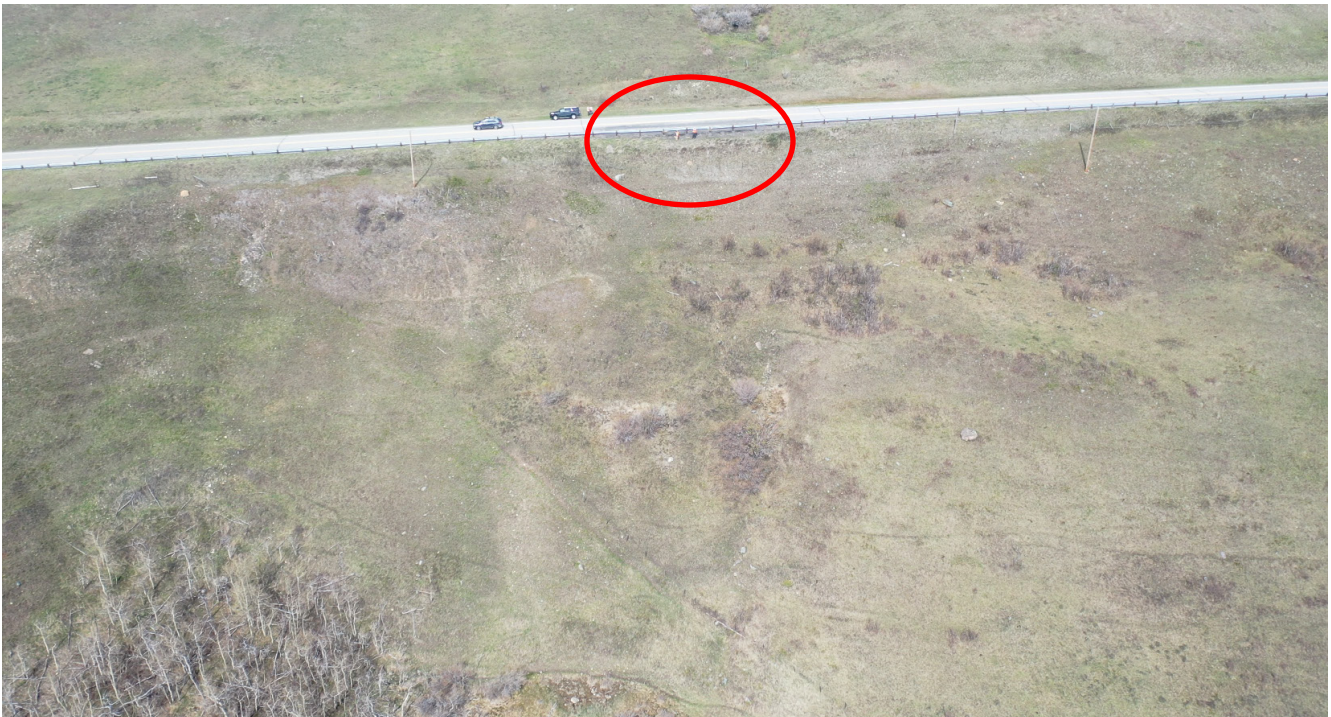
| ITEM | CONDITION EXISTS | | DESCRIPTION AND LOCATION | NOTICABLE CHANGE FROM LAST INSPECTION | |
|---|---|---|--|---|---|
| Slope Movement | X | | Slope below the highway is exhibiting signs of movement. | | X |

The embankment failure appears to be due to groundwater seepage and seepage from the adjacent drainage ditch leading to instability downslope. Pondered water in the drainage ditch is infiltrating into the adjacent highway embankment. It may also be possible that organic material present beneath the embankment was left in-situ during the embankment construction, or that sub-drainage was not included to drain springs, as was a common highway construction practice in the past.

Photo 1 **Embankment slope. Red circle below shows movement area on the highway. Photo taken facing northeast on May 10, 2023.**

- The drainage ditch should be regraded to allow water to pass through this area without ponding, to see whether slope movements cease. If not, the ditch should be lined with a geomembrane to limit infiltration into the embankment fill. Additional stabilization measures such as a pile wall may be required if current rates of movement accelerate significantly.
- If drainage improvements don't reduce slide activity, the highway should be relocated 1.5 lanes northeast with buried highway drainage.

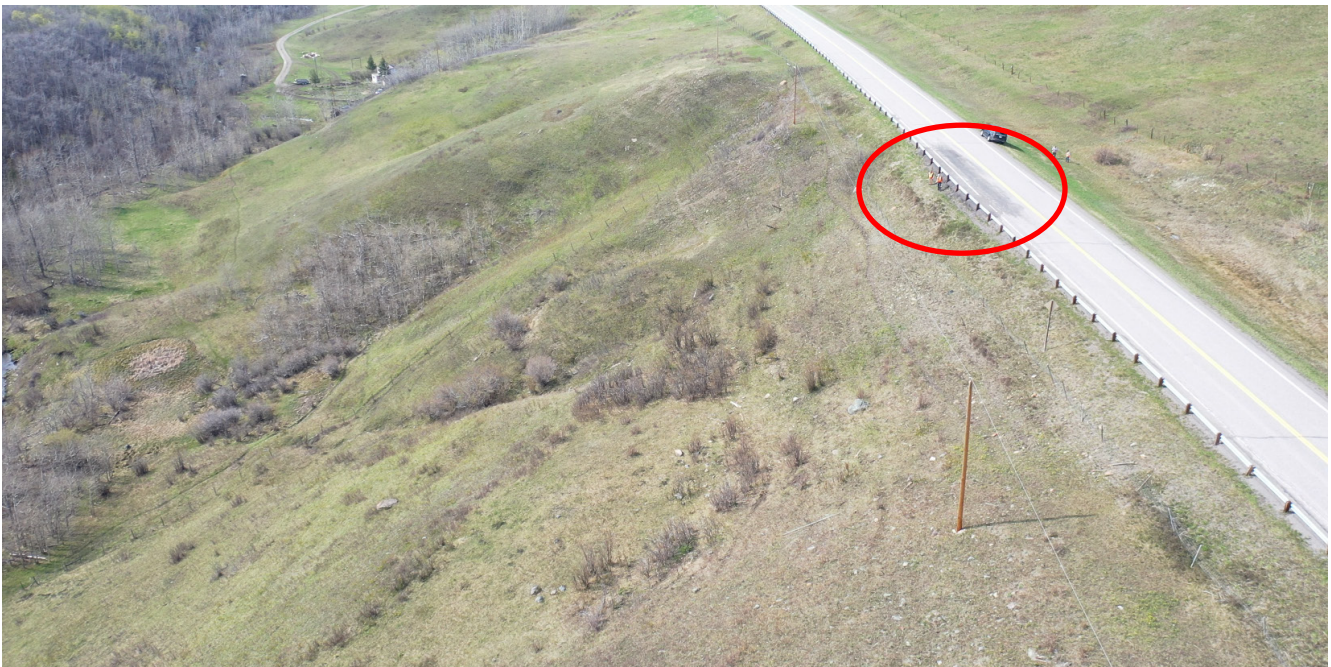
Photo 2 **Embankment slope. Patch shown at red circle below. Photo taken facing north on May 10, 2023.**

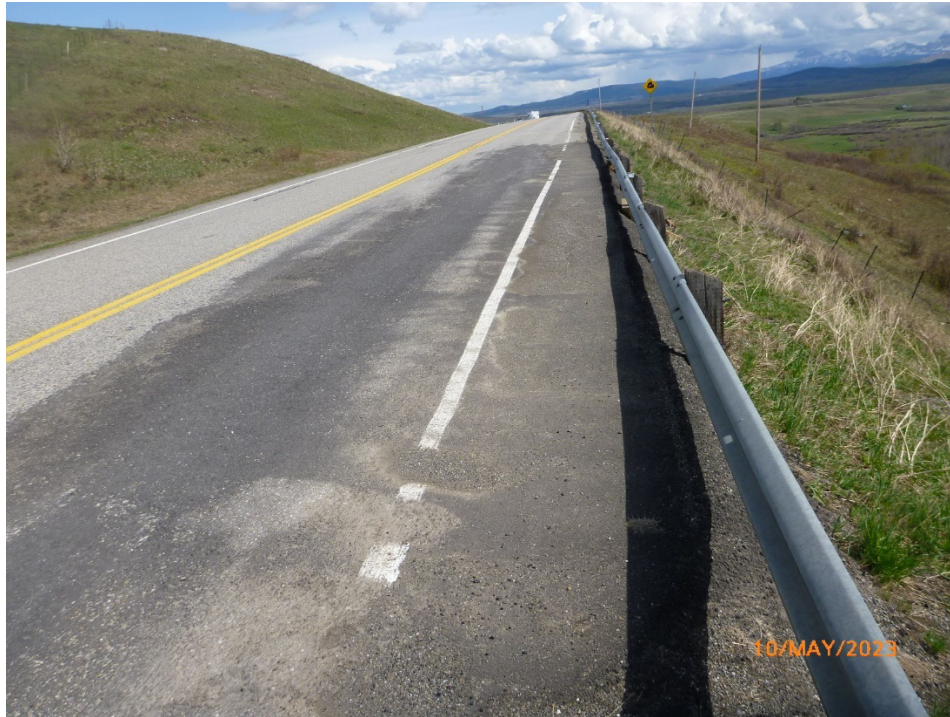
Ongoing slope movement. Patching has been completed since the previous inspection, minor cracking showing through the patching.

Photo 3 Patching completed since last inspection. Minor cracking showing through. Photo taken facing southeast on May 10, 2023.

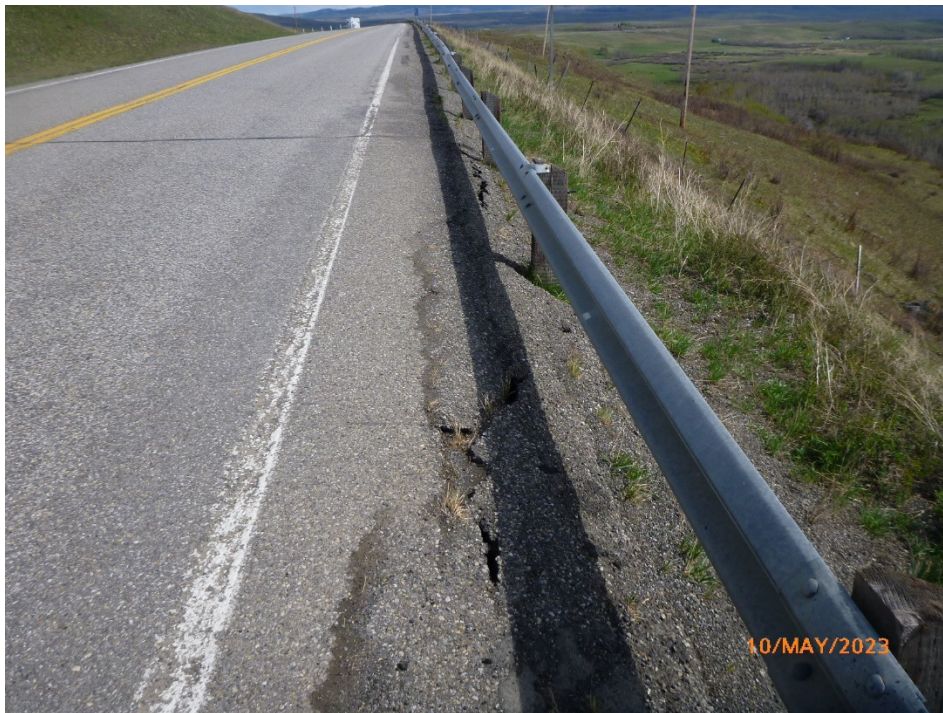
Cracking on the shoulder south of the patching up to 30 mm wide, near the guard rail. Appears to be little change since the previous inspection in 2019.

Photo 4 Cracking on the west shoulder of the highway outside of patched area. Photo taken facing southeast on May 10, 2023.

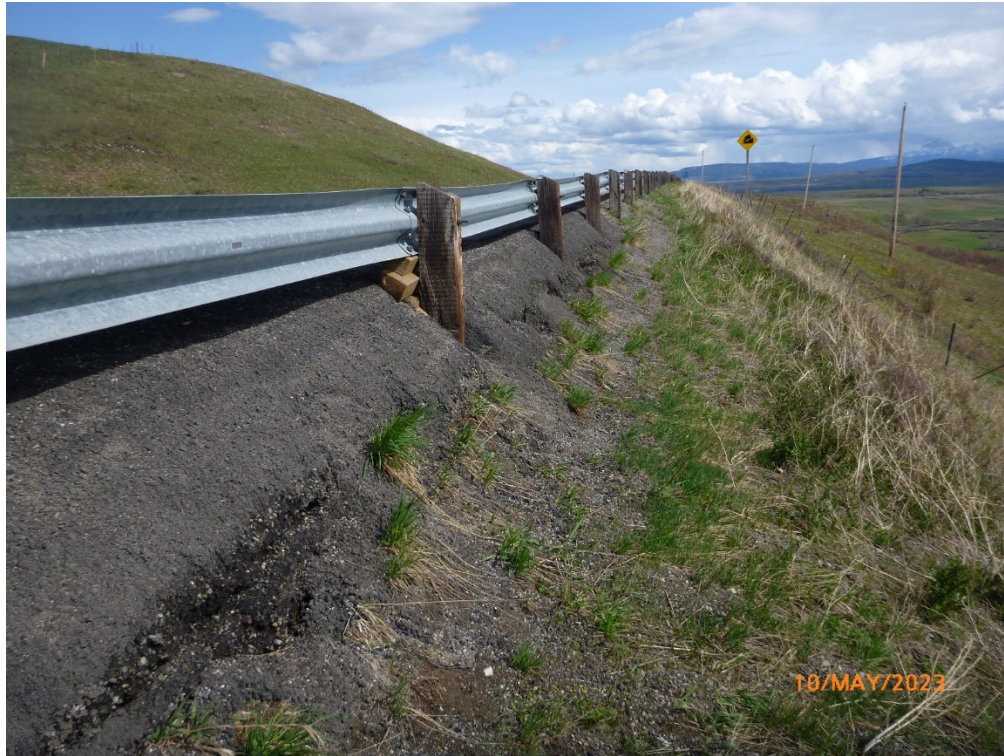
Up 1.2 m thickness of asphalt was observed at various points along the highway shoulder on the crest of the downslope embankment. However, this could be overspill from the last overlay.

Photo 5 Up to 1.2 m of asphalt on west shoulder. Photo taken facing southeast on May 10, 2023.
