SITE NUMBER AND NAME: S059 Siddons Slide		HIGHWAY & KM: 22:10, 27.5	PREVIOUS INSPECTION DATE: May 6, 2019	INSPECTION DATE: June 8, 2020
LEGAL DESCRIPTION: 01-20-017-02 W5M	NAD 83 COORDINATES: UTM Northing Easting 11 5591352 696456		RISK ASSESSMENT: PF: 9 CF: 4 TOTAL: 36	
AVERAGE ANNUAL DAILY TRAFFIC: 1470 (north), 1850 (south), (Ref. No. 71130)			CONTRACTOR MAINTENANCE AREA (CMA): 27

SUMMARY OF SITE INSTRUMENTATION: None	INSPECTED BY: Chris Morgan (KCB) Margot Lederman Roger Skirrow (AT) Alex Frotten (AT)
LAST READING DATE: N/A	
PRIMARY SITE ISSUE: Back slope failure of earth slope, with toe zone blocking the highway drainage ditch. Pavement cracking was noted on the east side of the highway. The failure has undermined a length of fence line approximately 36 m long (along the highway) and is retrogressing onto adjacent private property.	
APPROXIMATE DIMENSIONS: Slope failure zone approximately 170 m long. Embankment slope approximately 12 to 14 m high.	
DATE OF ANY REMEDIAL ACTION: N/A

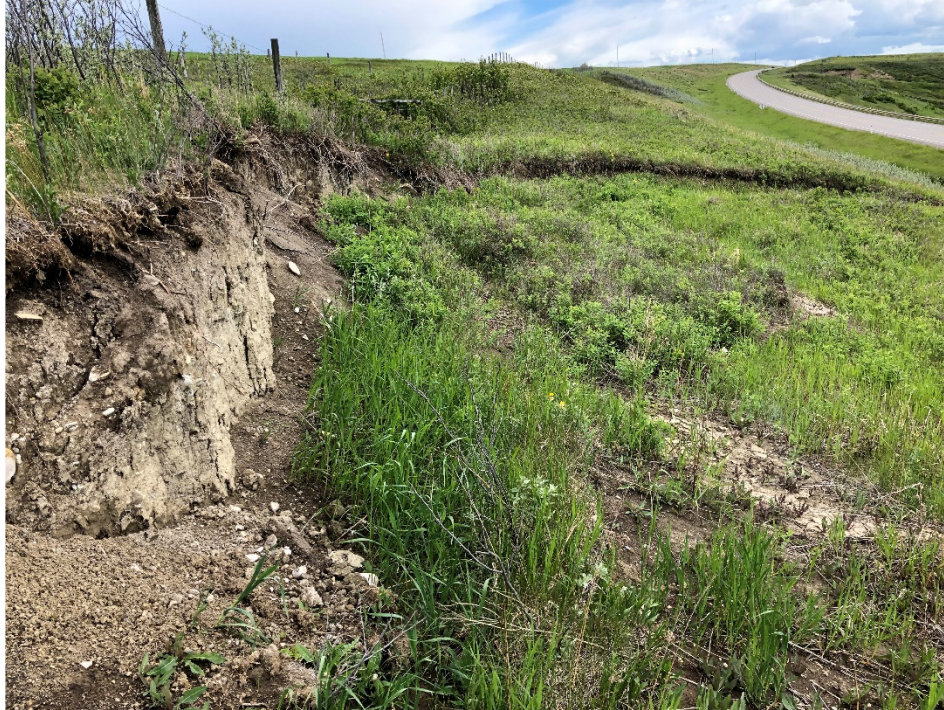
Photo 1 Slide zone and back scarp looking towards left flank. Photo taken facing south on June 8, 2020.

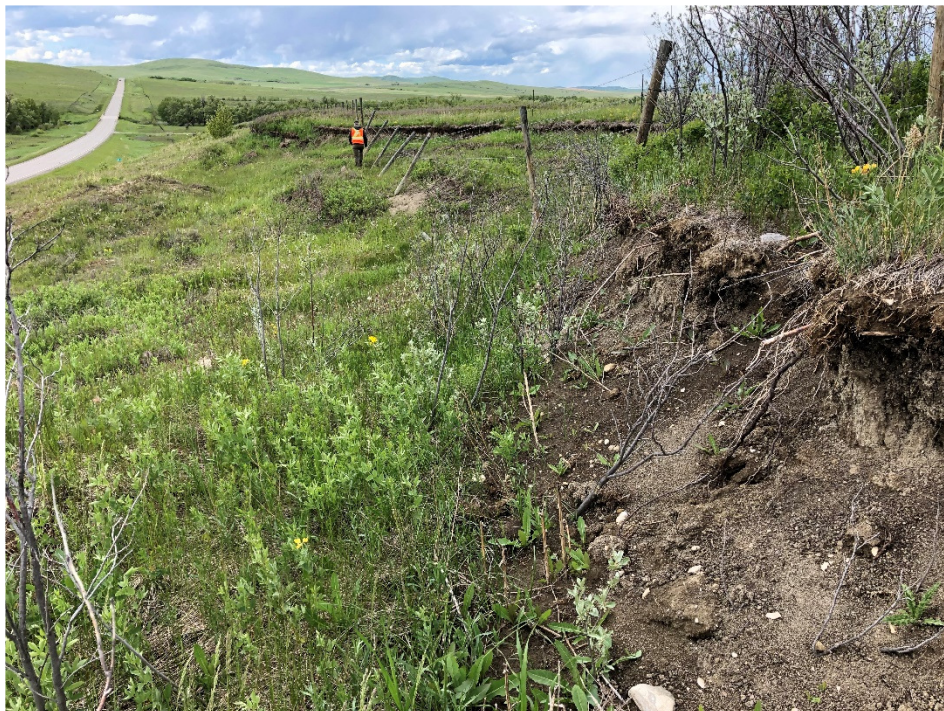
COMMENTS
No obvious or significant changes to the back slope failure when compared to 2019 observations.
The failure has undermined the fence near the back scarp over a length of approximately 36 m. Back scarp is up to 1.3 m high. The failure extends approximately 6.7 m onto private land and the landowner has installed new fence around the failure zone since 2019.
Ground was saturated due to recent rainfall. Two areas of ponded water were visible midslope, consistent with 2019 locations.
Toe rolls appear to be more extensive than 2019. Three areas of toe rolls were noted, one of 21 m long and one of 19 m long (two adjacent toe rolls have coalesced together) with a gap of 19 m measured between them. The ditch was flowing at the time of the site visit and runoff was flowing around the toe rolls uninhibited.

Photo 2 Approximately 36 m length of undermined fence line at crest of slope. Photo taken facing northeast on June 8, 2020.

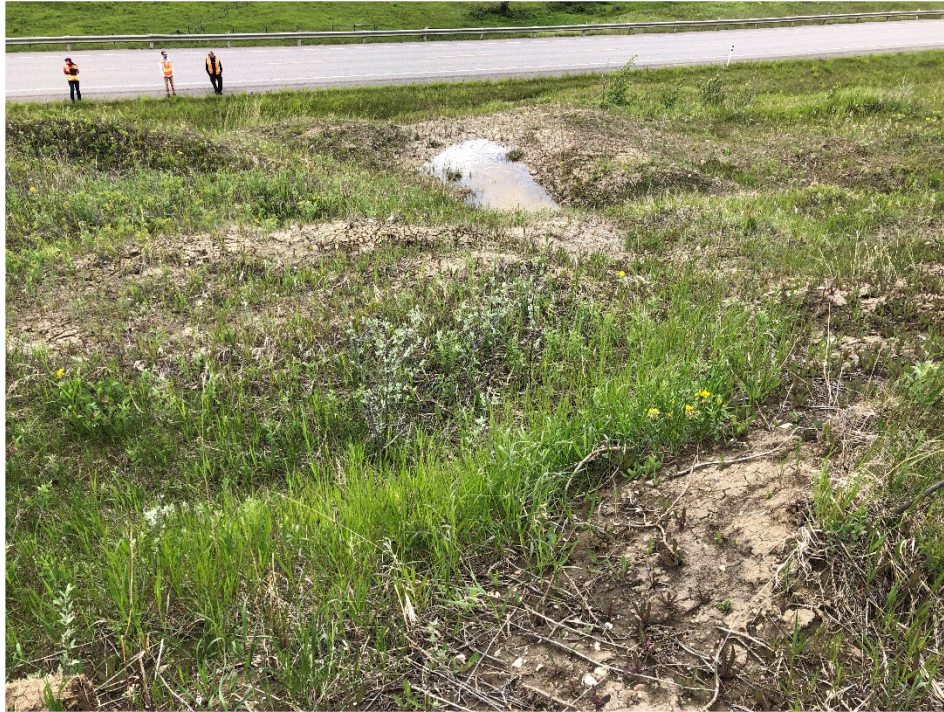
Photo 3 Ponded water midway up the slide zone. Photo taken facing west on June 8, 2020.

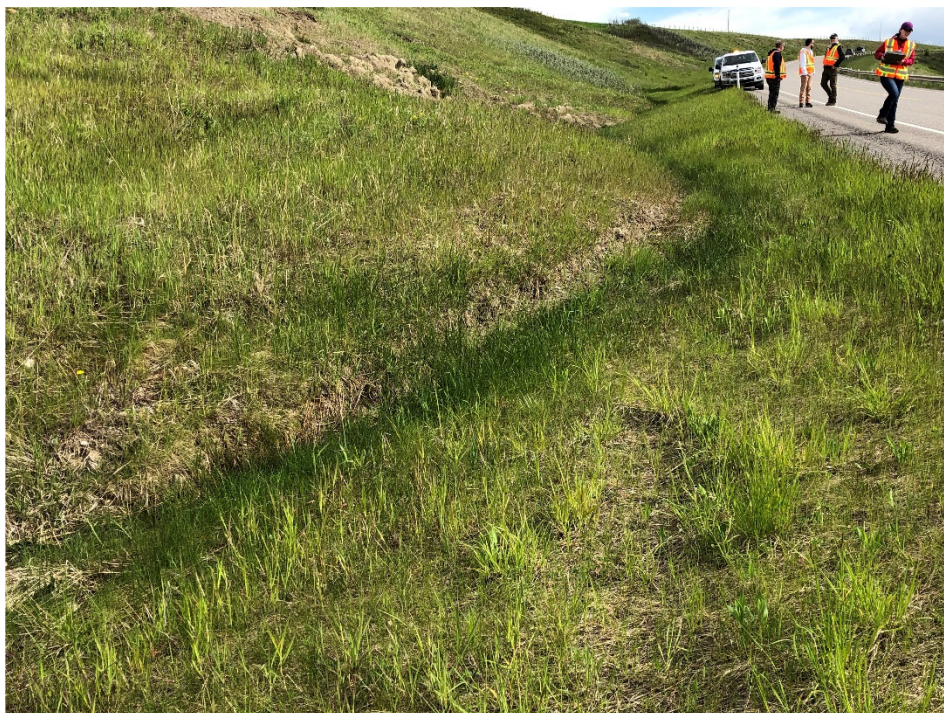
Photo 4 Toe rolls partially blocking the ditch. Photo taken from east side of highway facing southeast on June 8, 2020.

- Backslope reprofiling to flatten the overall slope to approximately 10H:1V;
- Slope reconstruction in panels, replacing failed material with geogrid reinforced free draining gravel and with perforated pipe drains; and
- Installation of a culvert along the toe of the slope (beneath the toe roll) to reinstate highway drainage.
