SITE NUMBER AND NAME: S059 Siddons Slide		HIGHWAY & KM: 22:10, 27.530	PREVIOUS INSPECTION DATE: June 8, 2020	INSPECTION DATE: July 5, 2021
LEGAL DESCRIPTION: 01-20-017-02 W5M	NAD 83 COORDINATES: UTM Northing Easting 11 5591352 696456		RISK ASSESMENT: PF: 9 CF: 3 TOTAL: 27	
AVERAGE ANNUAL DAILY TRAFFIC: 1470 (north), 1850 (south), (Ref. No. 71130)			CONTRACTOR MAINTENANCE AREA (CMA): 27

NOTES: 1. HORIZONTAL DATUM: NAD83 2. GRID ZONE: UTM Zone 11N 3. IMAGE SOURCE: 2020 Google Earth, 2020 CNES/Airbus. Source date September 6, 2019.	CLIENT 	PROJECT SOUTHERN REGION GEOHAZARD RISK MANAGEMENT PROGRAM
		TITLE Site Plan S059 Siddons Slide Hwy 22:10, km 27.5
SCALE 1:2,000	PROJECT No. A05116A03	FIG No. 1

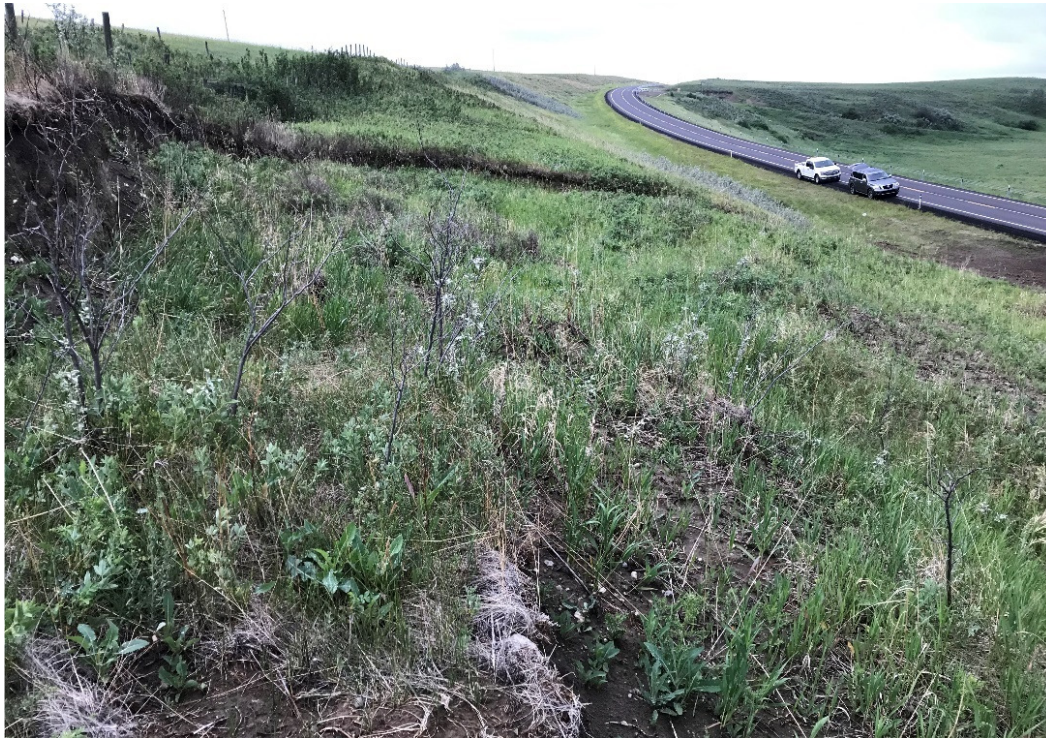
Photo 1 Slide zone and back scarp looking towards left flank. Photo taken facing south on July 5, 2021.

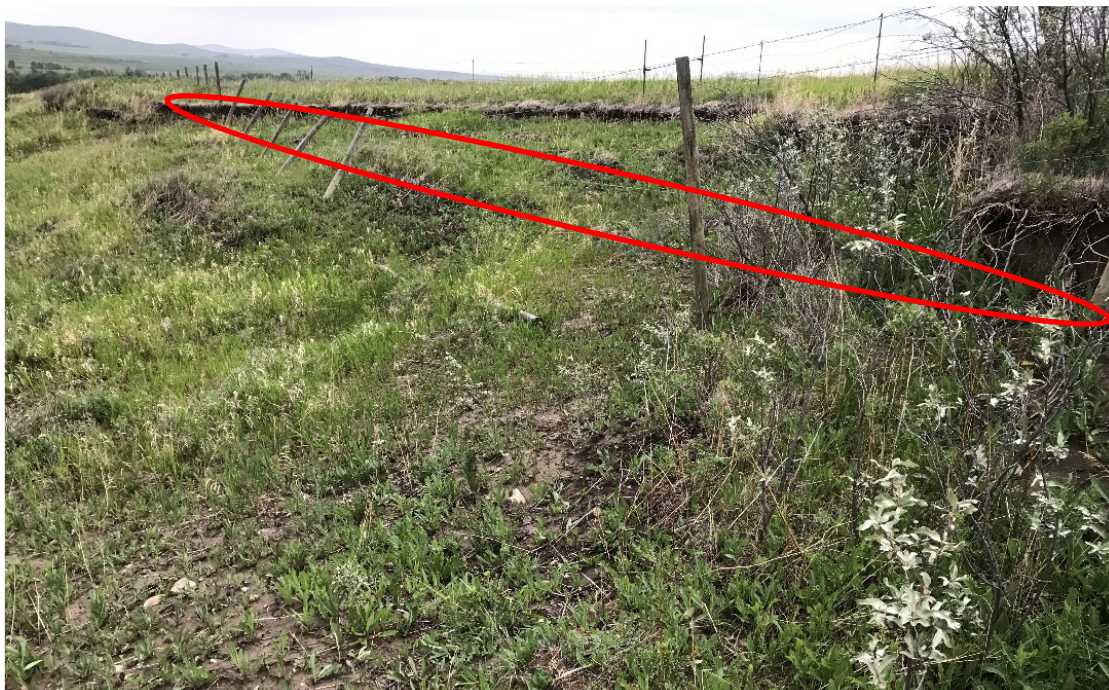
PRIMARY SITE ISSUE: Back slope failure of earth slope, with toe zone blocking the highway drainage ditch. Pavement cracking was noted on the east side of the highway. The failure has undermined a length of fence line approximately 36 m long (along the highway) and is retrogressing onto adjacent private property.

Photo 2 Approximately 36 m length of undermined fence line at crest of slope. Photo taken facing northeast on July 5, 2021.

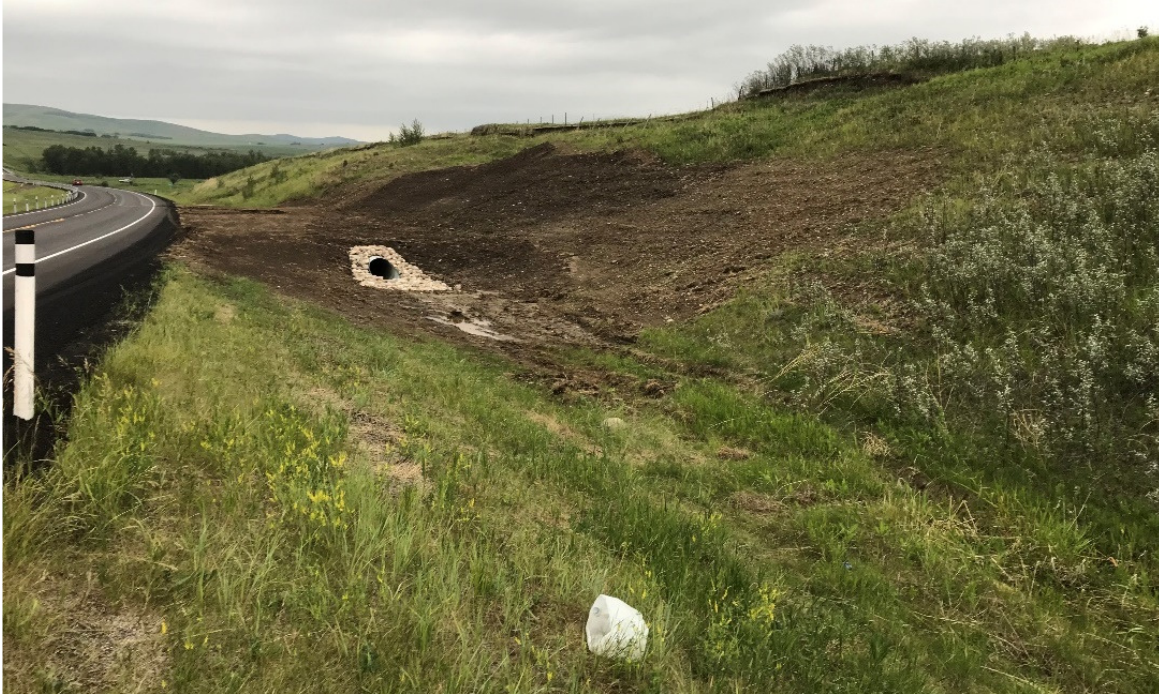
Photo 3 Ditch regrading and culvert installation carried out in June 2021 to remove the toe roll blocking the ditch. Culvert installation included localized regrading at the toe of the slide zone. Photo taken facing west on July 5, 2021.

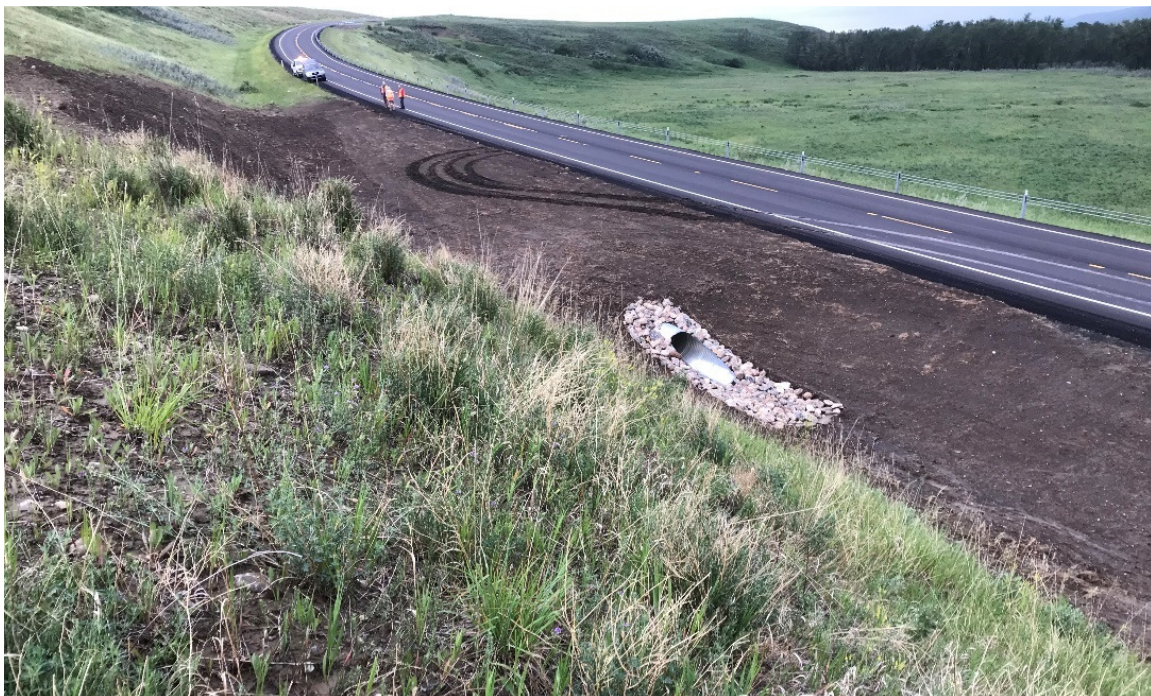
Photo 4 Culvert installation and ditch regrading on east side of the highway completed during 2021 paving activities. Photo taken facing south on July 5, 2021.
