SITE NUMBER AND NAME: <b>S059 Siddons Slide</b>		HIGHWAY & KM: 22:10, 27.530	PREVIOUS INSPECTION DATE: July 5, 2021	INSPECTION DATE: <b>May 9, 2023</b>
LEGAL DESCRIPTION: 01-20-017-02 W5M	NAD 83 COORDINATES: UTM Northing Easting 11 5591352 696456		RISK ASSESMENT: PF: 7 CF: 2 TOTAL: 14	
AVERAGE ANNUAL DAILY TRAFFIC: 1400 (north), 1720 (south), (Ref. No. 71130)			CONTRACTOR MAINTENANCE AREA (CMA): 27

PRIMARY SITE ISSUE: Back slope failure of earth slope, with toe zone blocking the highway drainage ditch. Pavement cracking was noted on the east side of the highway. The failure has undermined a length of fence line approximately 36 m long (along the highway) and is retrogressing onto adjacent private property.

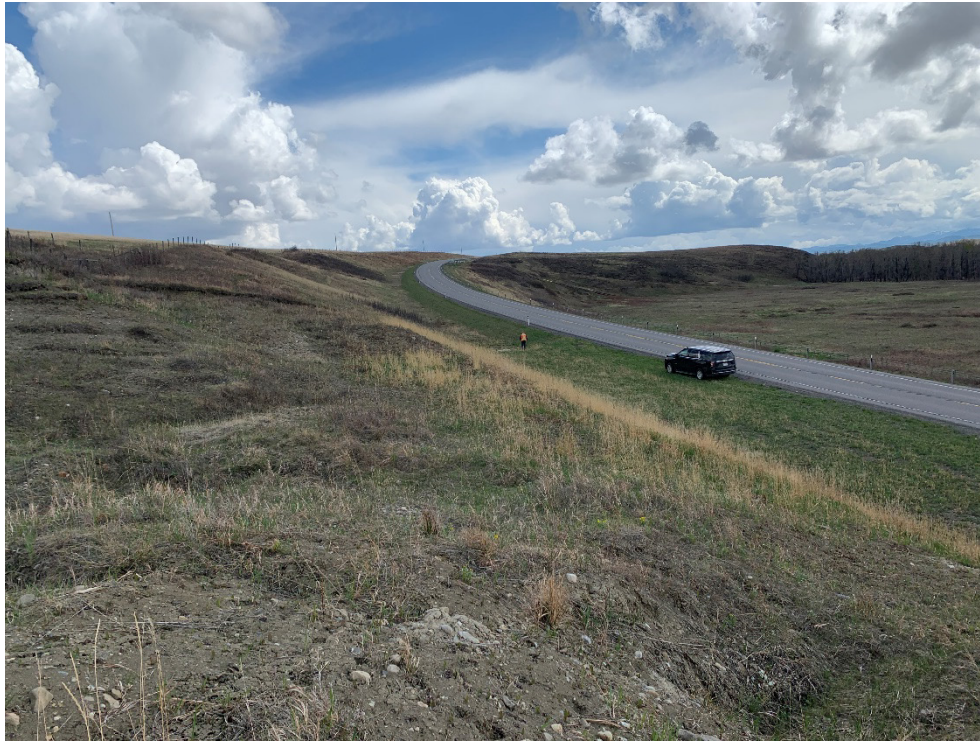
**Photo 1** Slide zone and back scarp looking towards left flank. Photo taken facing south on May 9, 2023.

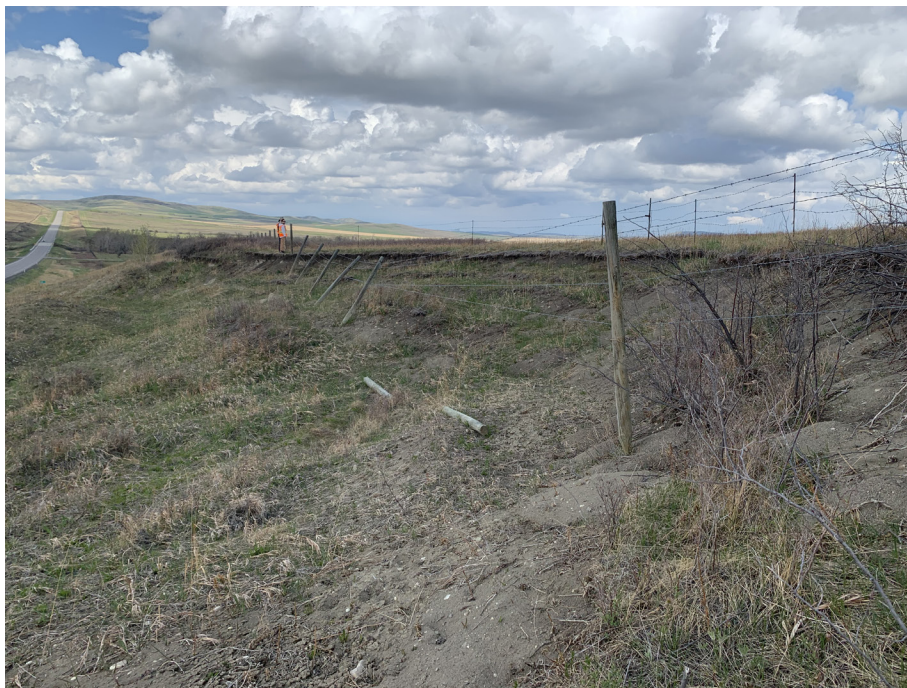
<b>COMMENTS</b>
No obvious or significant changes to the back slope failure when compared to 2021 observations. The ditch topography and lower slope geometry has changed when compared to 2020 observations due to culvert installation and localized backslope regrading to approximately 3H:1V.
The failure has undermined the fence near the back scarp over a length of approximately 36 m. Back scarp is up to 1.3 m high. The failure extends approximately 7.5 m onto private land from the undermined fence line. The landowner installed a new fence around the failure zone, sometime after 2019.
The toe rolls observed in the ditch in 2020 were removed during culvert installation in June 2021. Prior to culvert installation, two areas of toe roll were noted, one 21 m long and one 19 m long (two adjacent toe rolls had coalesced together) with a gap of 19 m measured between them.

**Photo 2** Approximately 36 m length of undermined fence line at crest of slope. Photo taken facing north on May 9, 2023.

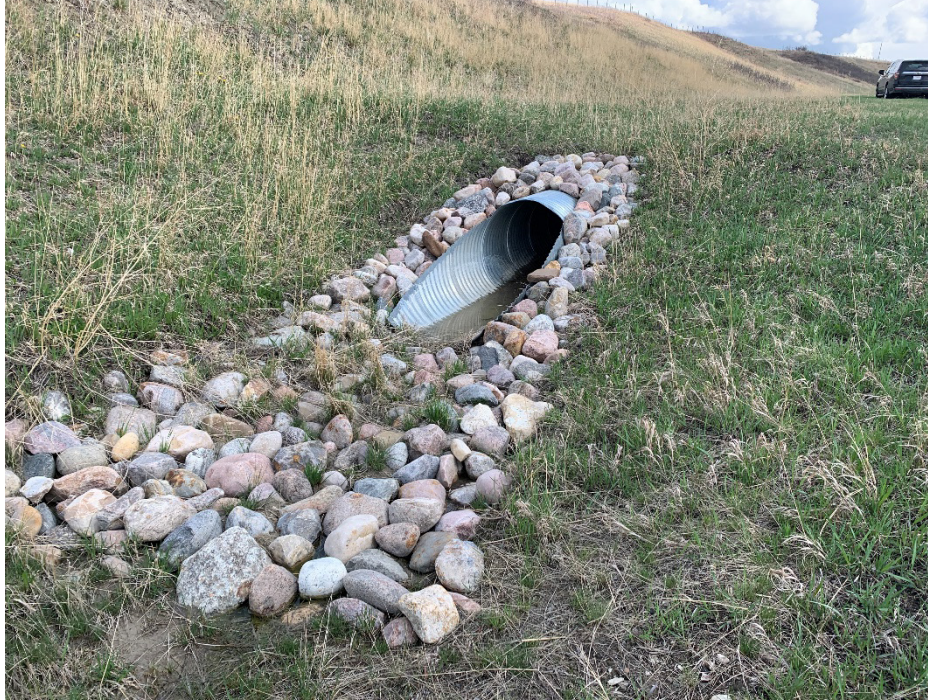
DATE OF ANY REMEDIAL ACTION: Highway was repaved in June 2021 and the work included installation of a CSP culvert in the east ditch at the south end of the slide area where the toe roll had previously blocked ditch flow.

**Photo 3** Ditch regrading and culvert installation carried out in June 2021 to remove the toe roll blocking the ditch. Culvert installation included localized regrading at the toe of the slide zone. Photo taken facing southeast on May 9, 2023.

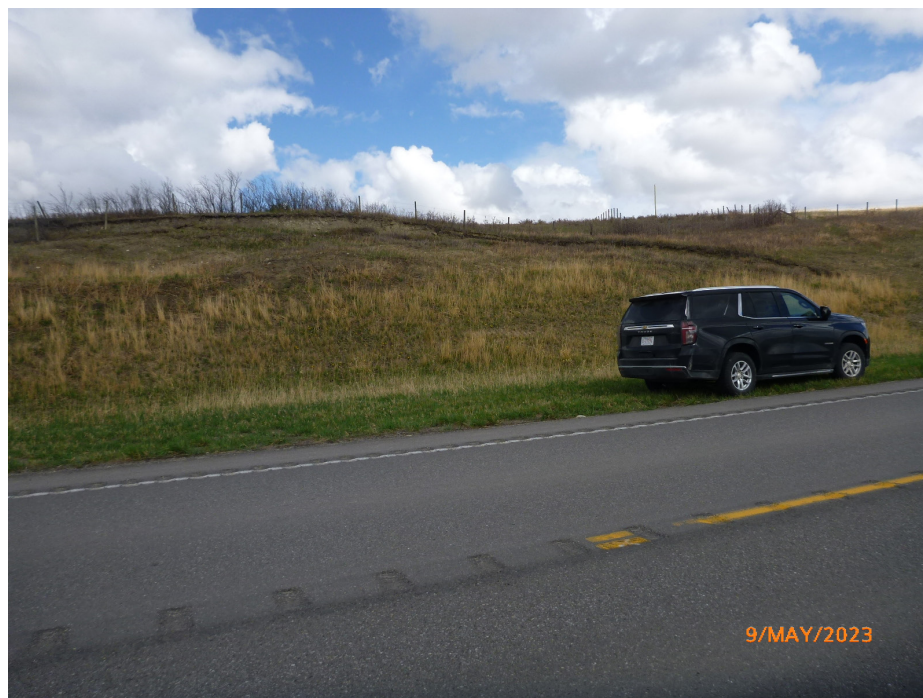
**Photo 4** Slide zone and back scarp at south end of failure. Photo taken facing east on May 9, 2023.
