SITE NUMBER AND NAME: <b>S002 Priddis</b>		HIGHWAY & KM: 22:14, 12.595	PREVIOUS INSPECTION DATE: April 30, 2018	INSPECTION DATE: <b>May 6, 2019</b>
LEGAL DESCRIPTION: 01-34-022-04 W5M	NAD 83 COORDINATES: UTM Northing Easting 11 5642606 678005		RISK ASSESMENT: PF: 7 CF: 4 TOTAL: 28	
AVERAGE ANNUAL DAILY TRAFFIC: 4,200 (east) & 4,180 (west) (Ref No. 62187)			CONTRACTOR MAINTENANCE AREA (CMA): 27

SUMMARY OF SITE INSTRUMENTATION:  2 functioning slope inclinometers (SI) SI #9 and SI #11 and 3 active vibrating wire piezometers (VWPs).  LAST READING DATE: May 2019		INSPECTED BY: Chris Gräpel (KCB) Chris Morgan (KCB) Roger Skirrow (AT) Alex Frotten (AT) Nicolas Ropchan (AT)
PRIMARY SITE ISSUE: Pavement cracking at the northwest edge of the highway caused by continued slope movement downslope of a concrete pile wall (unknown date of construction and unknown design details).		
APPROXIMATE DIMENSIONS: Landslide zone affecting highway is approximately 90 m long. Slope varies from 3H:1V on the upper half of the slope and 5H:1V on the lower half of the slope. Embankment slope approximately 15 m high.		
DATE OF ANY REMEDIAL ACTION: A concrete pile wall was installed along the northwest shoulder

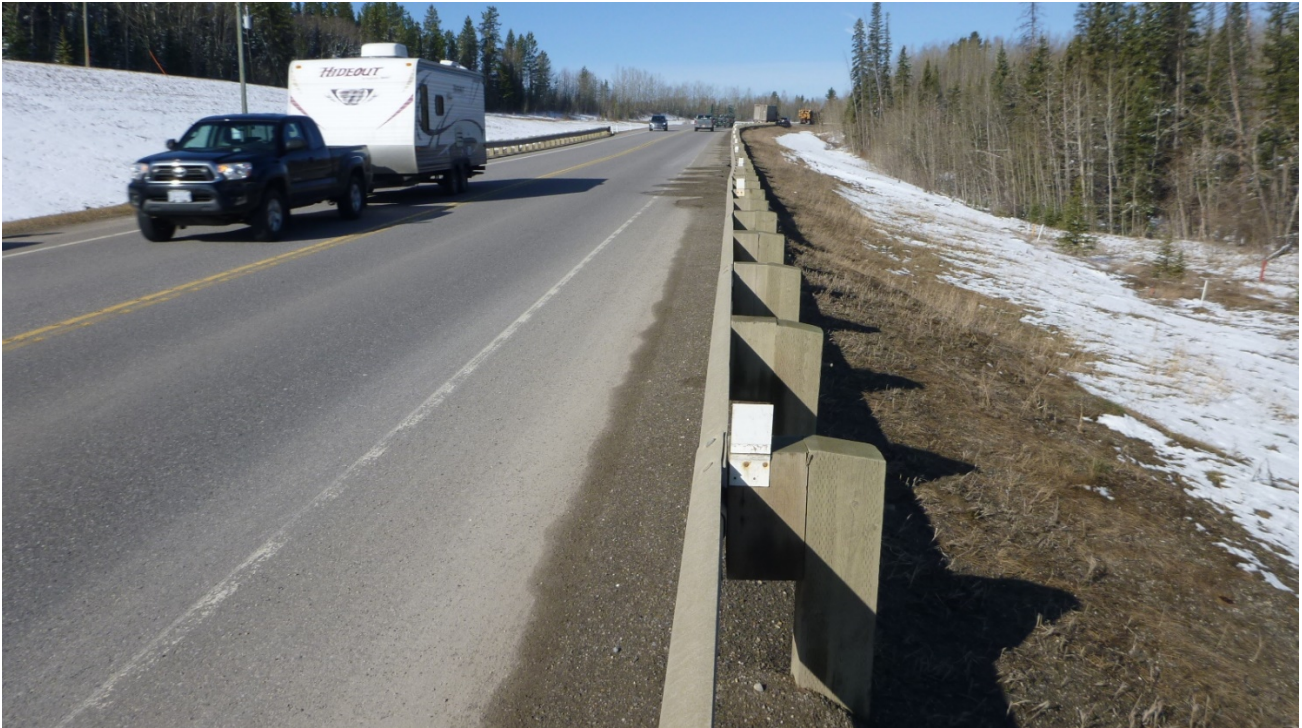
**Photo 1** Pavement distress at the location of the pile wall. Photo taken facing west on May 6, 2019.

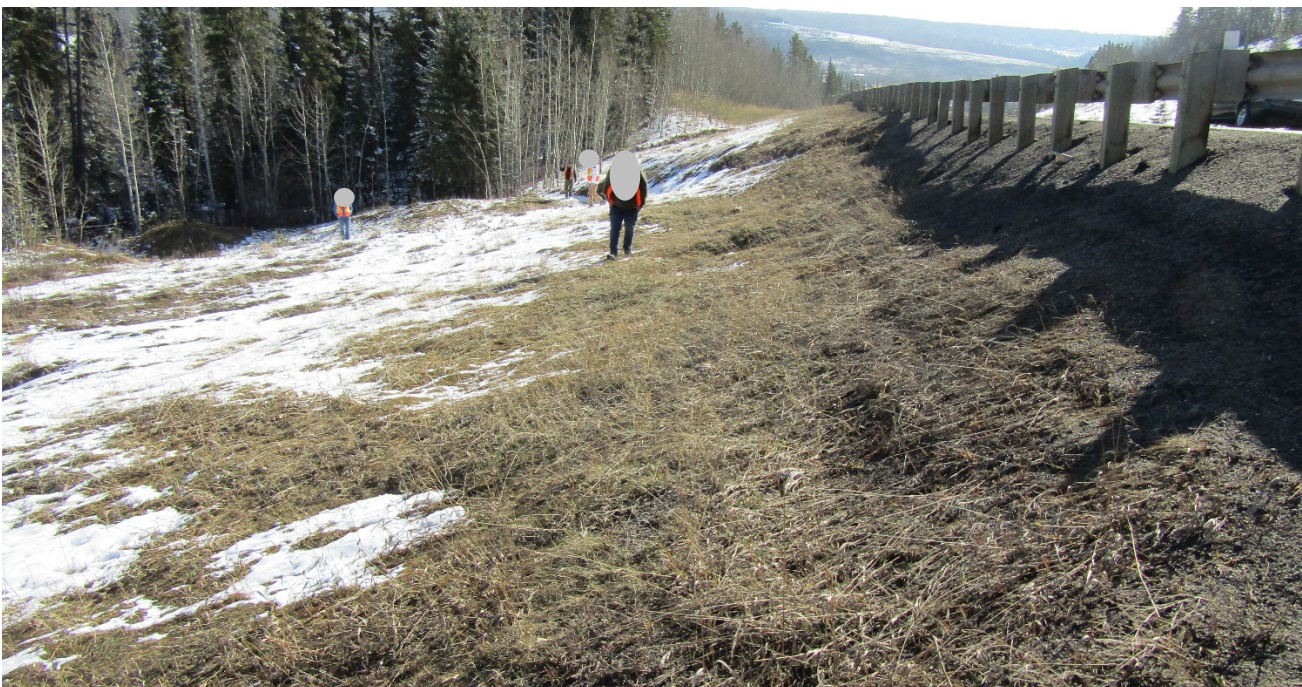
**Photo 2** Embankment slope facing toward right flank of slide. Photo taken facing east on May 6, 2019.

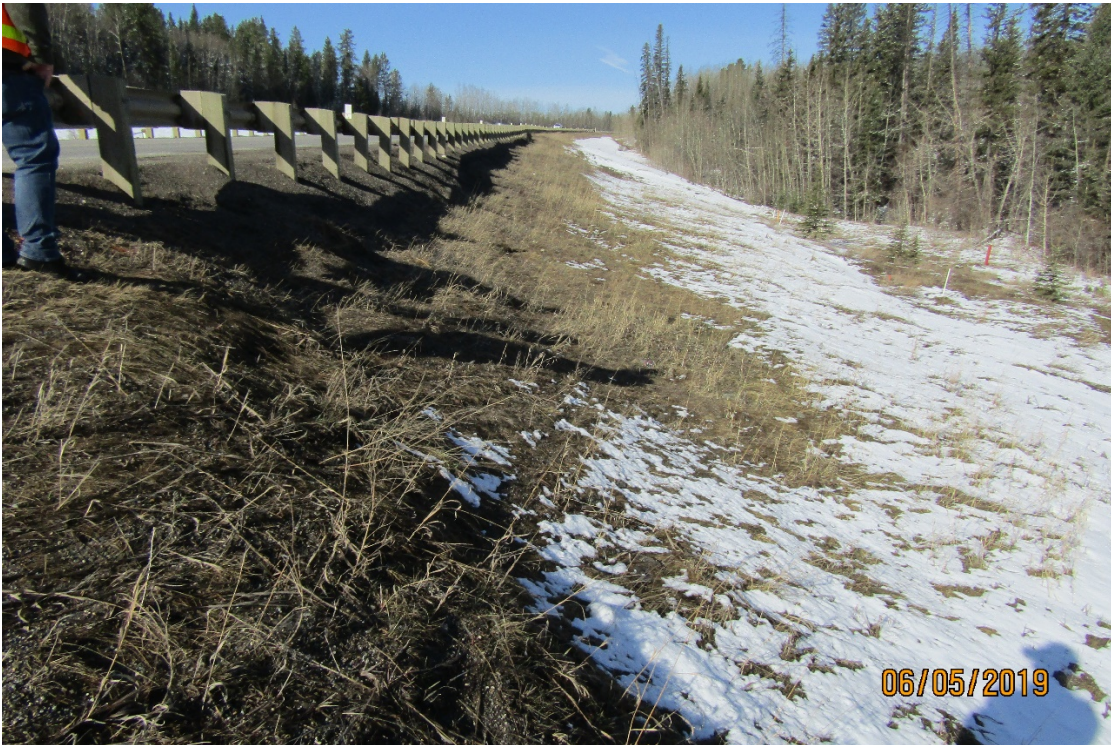
**Photo 3** Embankment slope in slide area. Photo taken facing west on May 6, 2019.

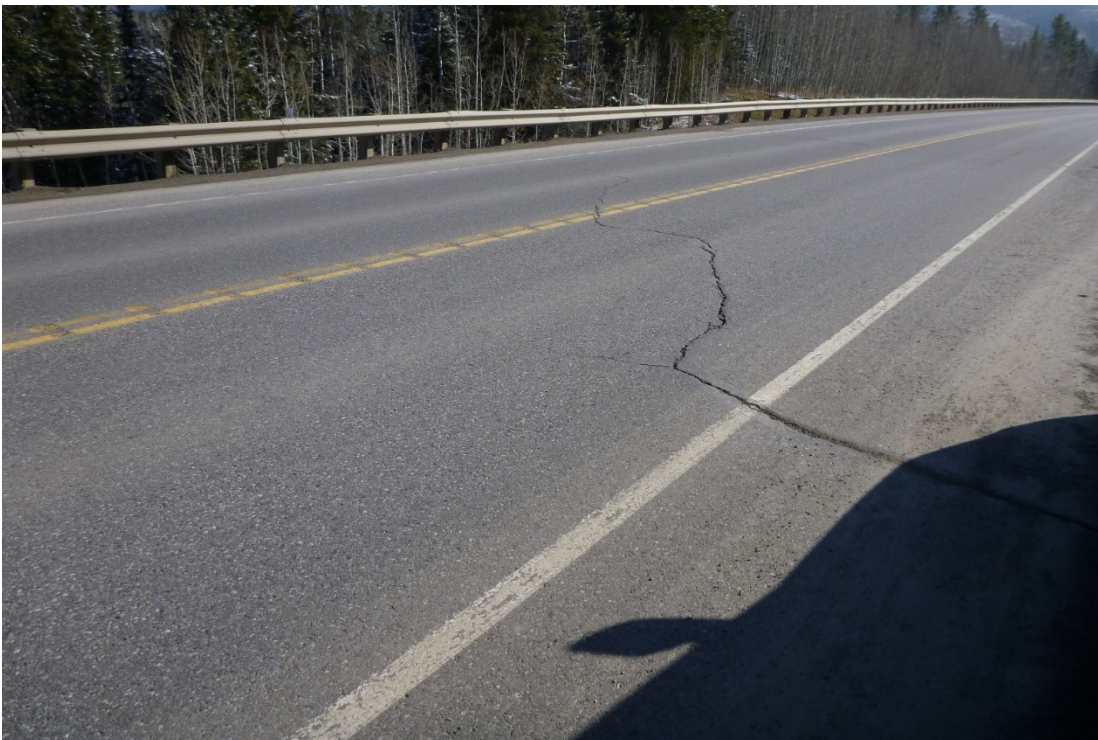
**Photo 4** Pavement cracking. Photo taken from south side of highway facing northeast on May 6, 2019.
