SITE NUMBER AND NAME: S002 Priddis		HIGHWAY & KM: 22:14, 12.595	PREVIOUS INSPECTION DATE: May 6, 2019	INSPECTION DATE: June 8, 2020
LEGAL DESCRIPTION: 01-34-022-04 W5M	NAD 83 COORDINATES: UTM Northing Easting 11 5642606 678005		RISK ASSESMENT: PF: 7 CF: 4 TOTAL: 28	
AVERAGE ANNUAL DAILY TRAFFIC: 4260 (east) & 4260 (west) (Ref. No. 62187)			CONTRACTOR MAINTENANCE AREA (CMA): 27

NOTES: 1. HORIZONTAL DATUM: NAD83 2. GRID ZONE: UTM Zone 11N 3. IMAGE SOURCE: World Imagery from ESRI ArcGIS Online. Source date January 15, 2015	CLIENT 	PROJECT SOUTHERN REGION GEOHAZARD RISK MANAGEMENT PROGRAM
		TITLE Site Plan S002 - Priddis Hwy 22:14, km 12.595
SCALE 1:1,000	PROJECT No. A05115A03	FIG No. 1

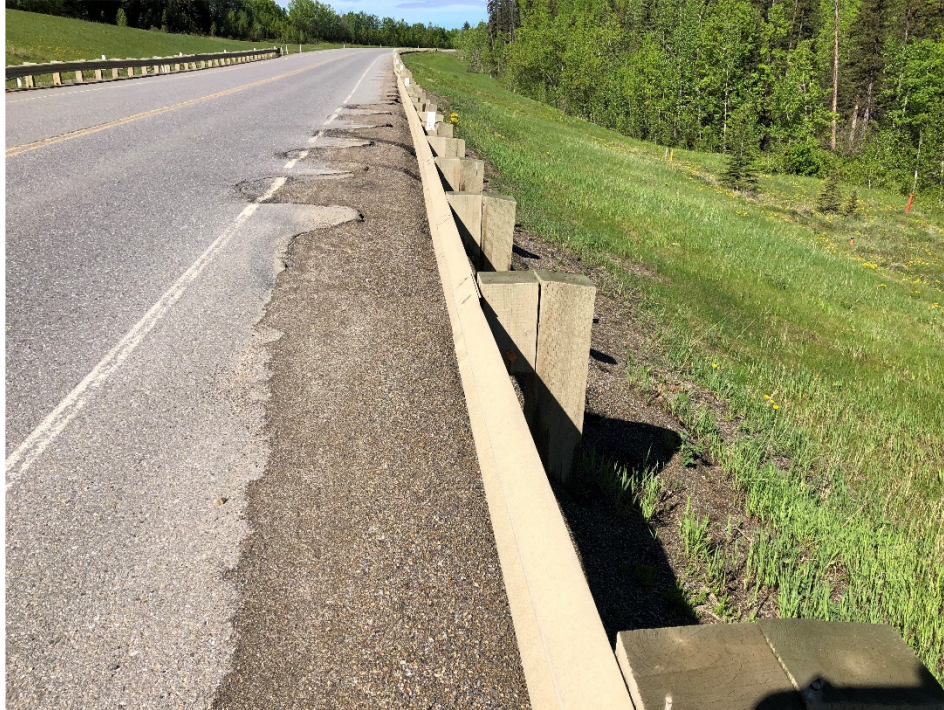
Photo 1 Pavement distress at the location of the pile wall. Photo taken facing west on June 8, 2020.

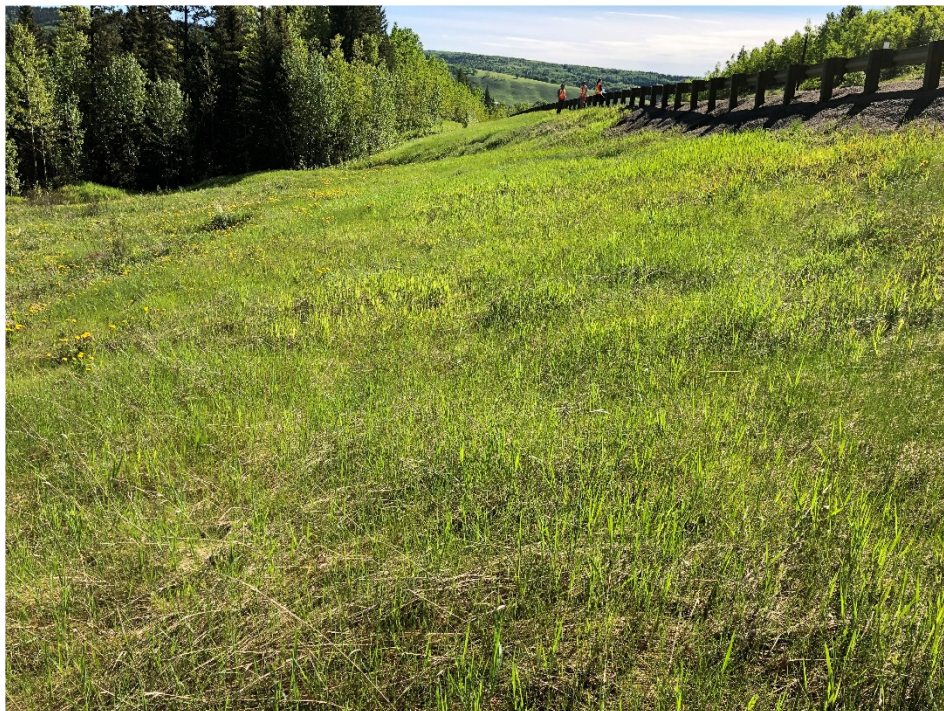
Photo 2 Embankment slope facing toward right flank of slide. Photo taken facing east on June 8, 2020.

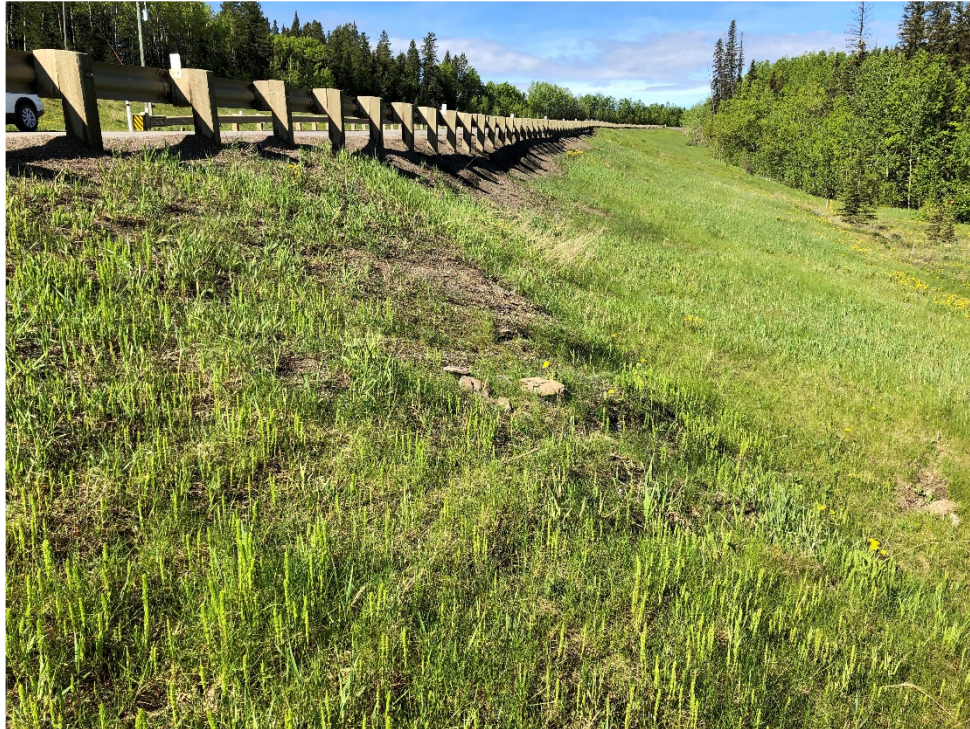
Photo 3 Embankment slope in slide area. Photo taken facing west on June 8, 2020.

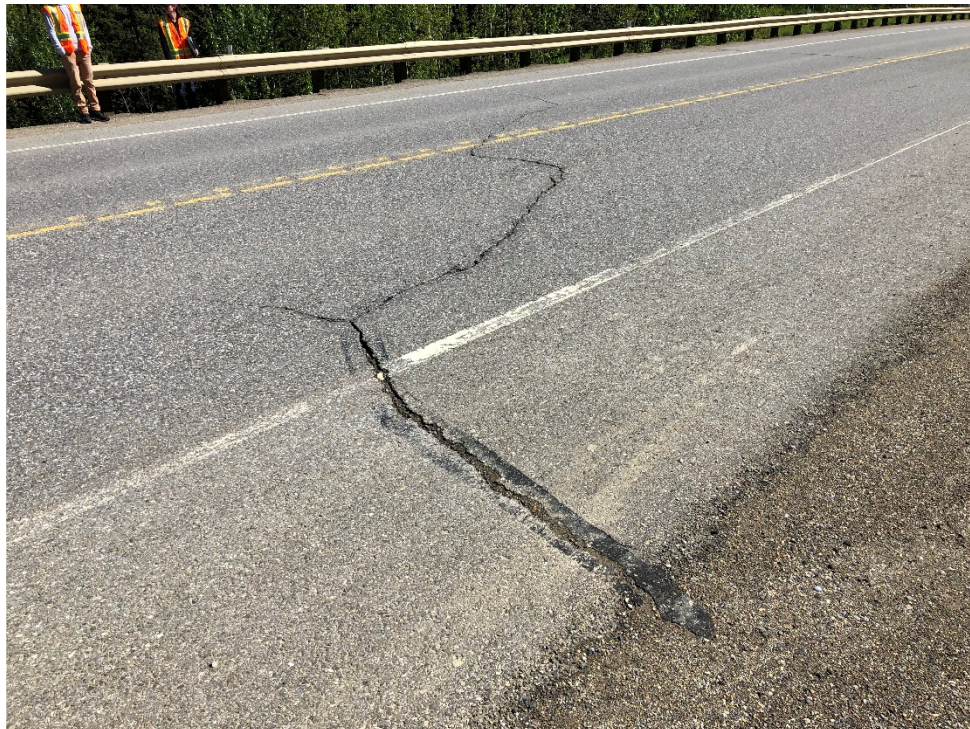
COMMENTS
<p>Pavement cracks seem to have widened slightly when compared to 2019 observations. In 2019 the cracking extended to approximately 1.12 m inside of the north shoulder white line, whereas in 2020 the cracking had extended north and was between the white line and north side guard rail. Cracking should be repaired by the maintenance contractor through patching.</p>
<p>At the time of the site visit, the pumps in the gravel columns were operational with active discharge. The pumps are permanently installed in the wells and get turned on and off for winter. Ponded water was observed in the upslope ditch, adjacent to the discharge lines from the groundwater pumps.</p>
<p>No obvious increase in slope cracking was noted. Guard rail deflection appears unchanged from the 2019 site visit.</p>
<p>Seepage was noted at the tree line approximately in the centre of the slide upslope of a buried culvert. Seepage reports to a drainage channel, which contains standing water.</p>

Photo 4 Pavement cracking has extended northwards when compared to 2019 observations. Photo taken from south side of highway facing northeast on June 8, 2020.

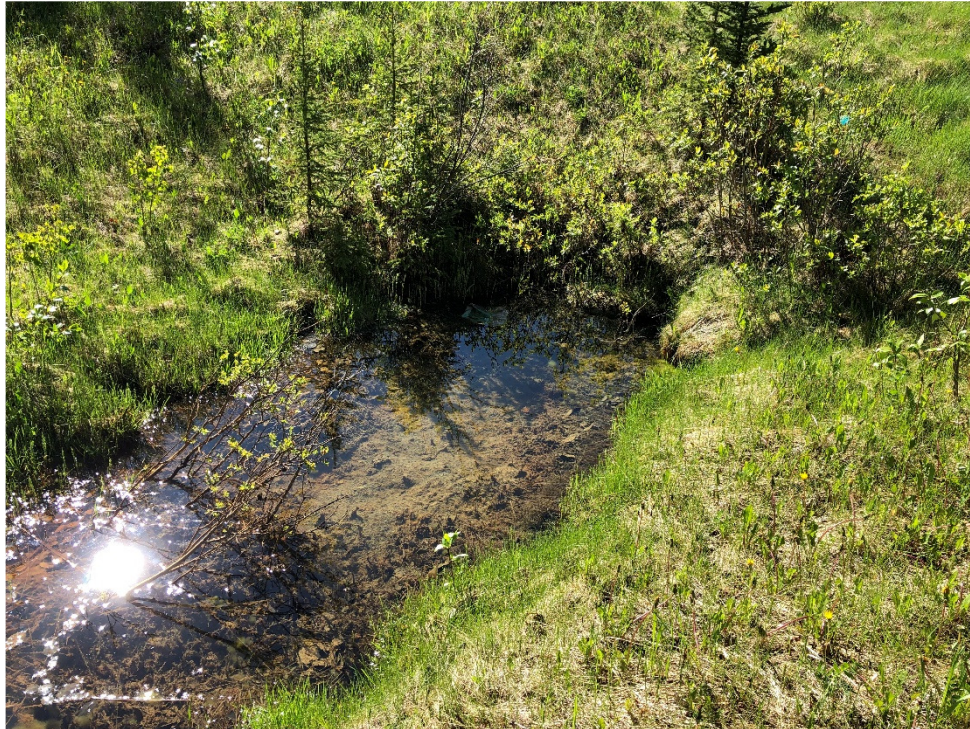
Photo 5 **Ponded water at the toe of the slope facing southeast. June 8, 2020.**
