September 21, 2022

**CON0022161 Southern Region GRMP Instrumentation Monitoring
Site S002; H22:14, km 12.95 Priddis
Section C – 2022 Spring Readings**

PROJECT SOUTHERN REGION GEOHAZARD RISK MANAGEMENT PROGRAM		
TITLE Site Plan S002 - Priddis Hwy 22:14, km 12.95		
SCALE 1:800	PROJECT No. A05116A03	FIG No. 1

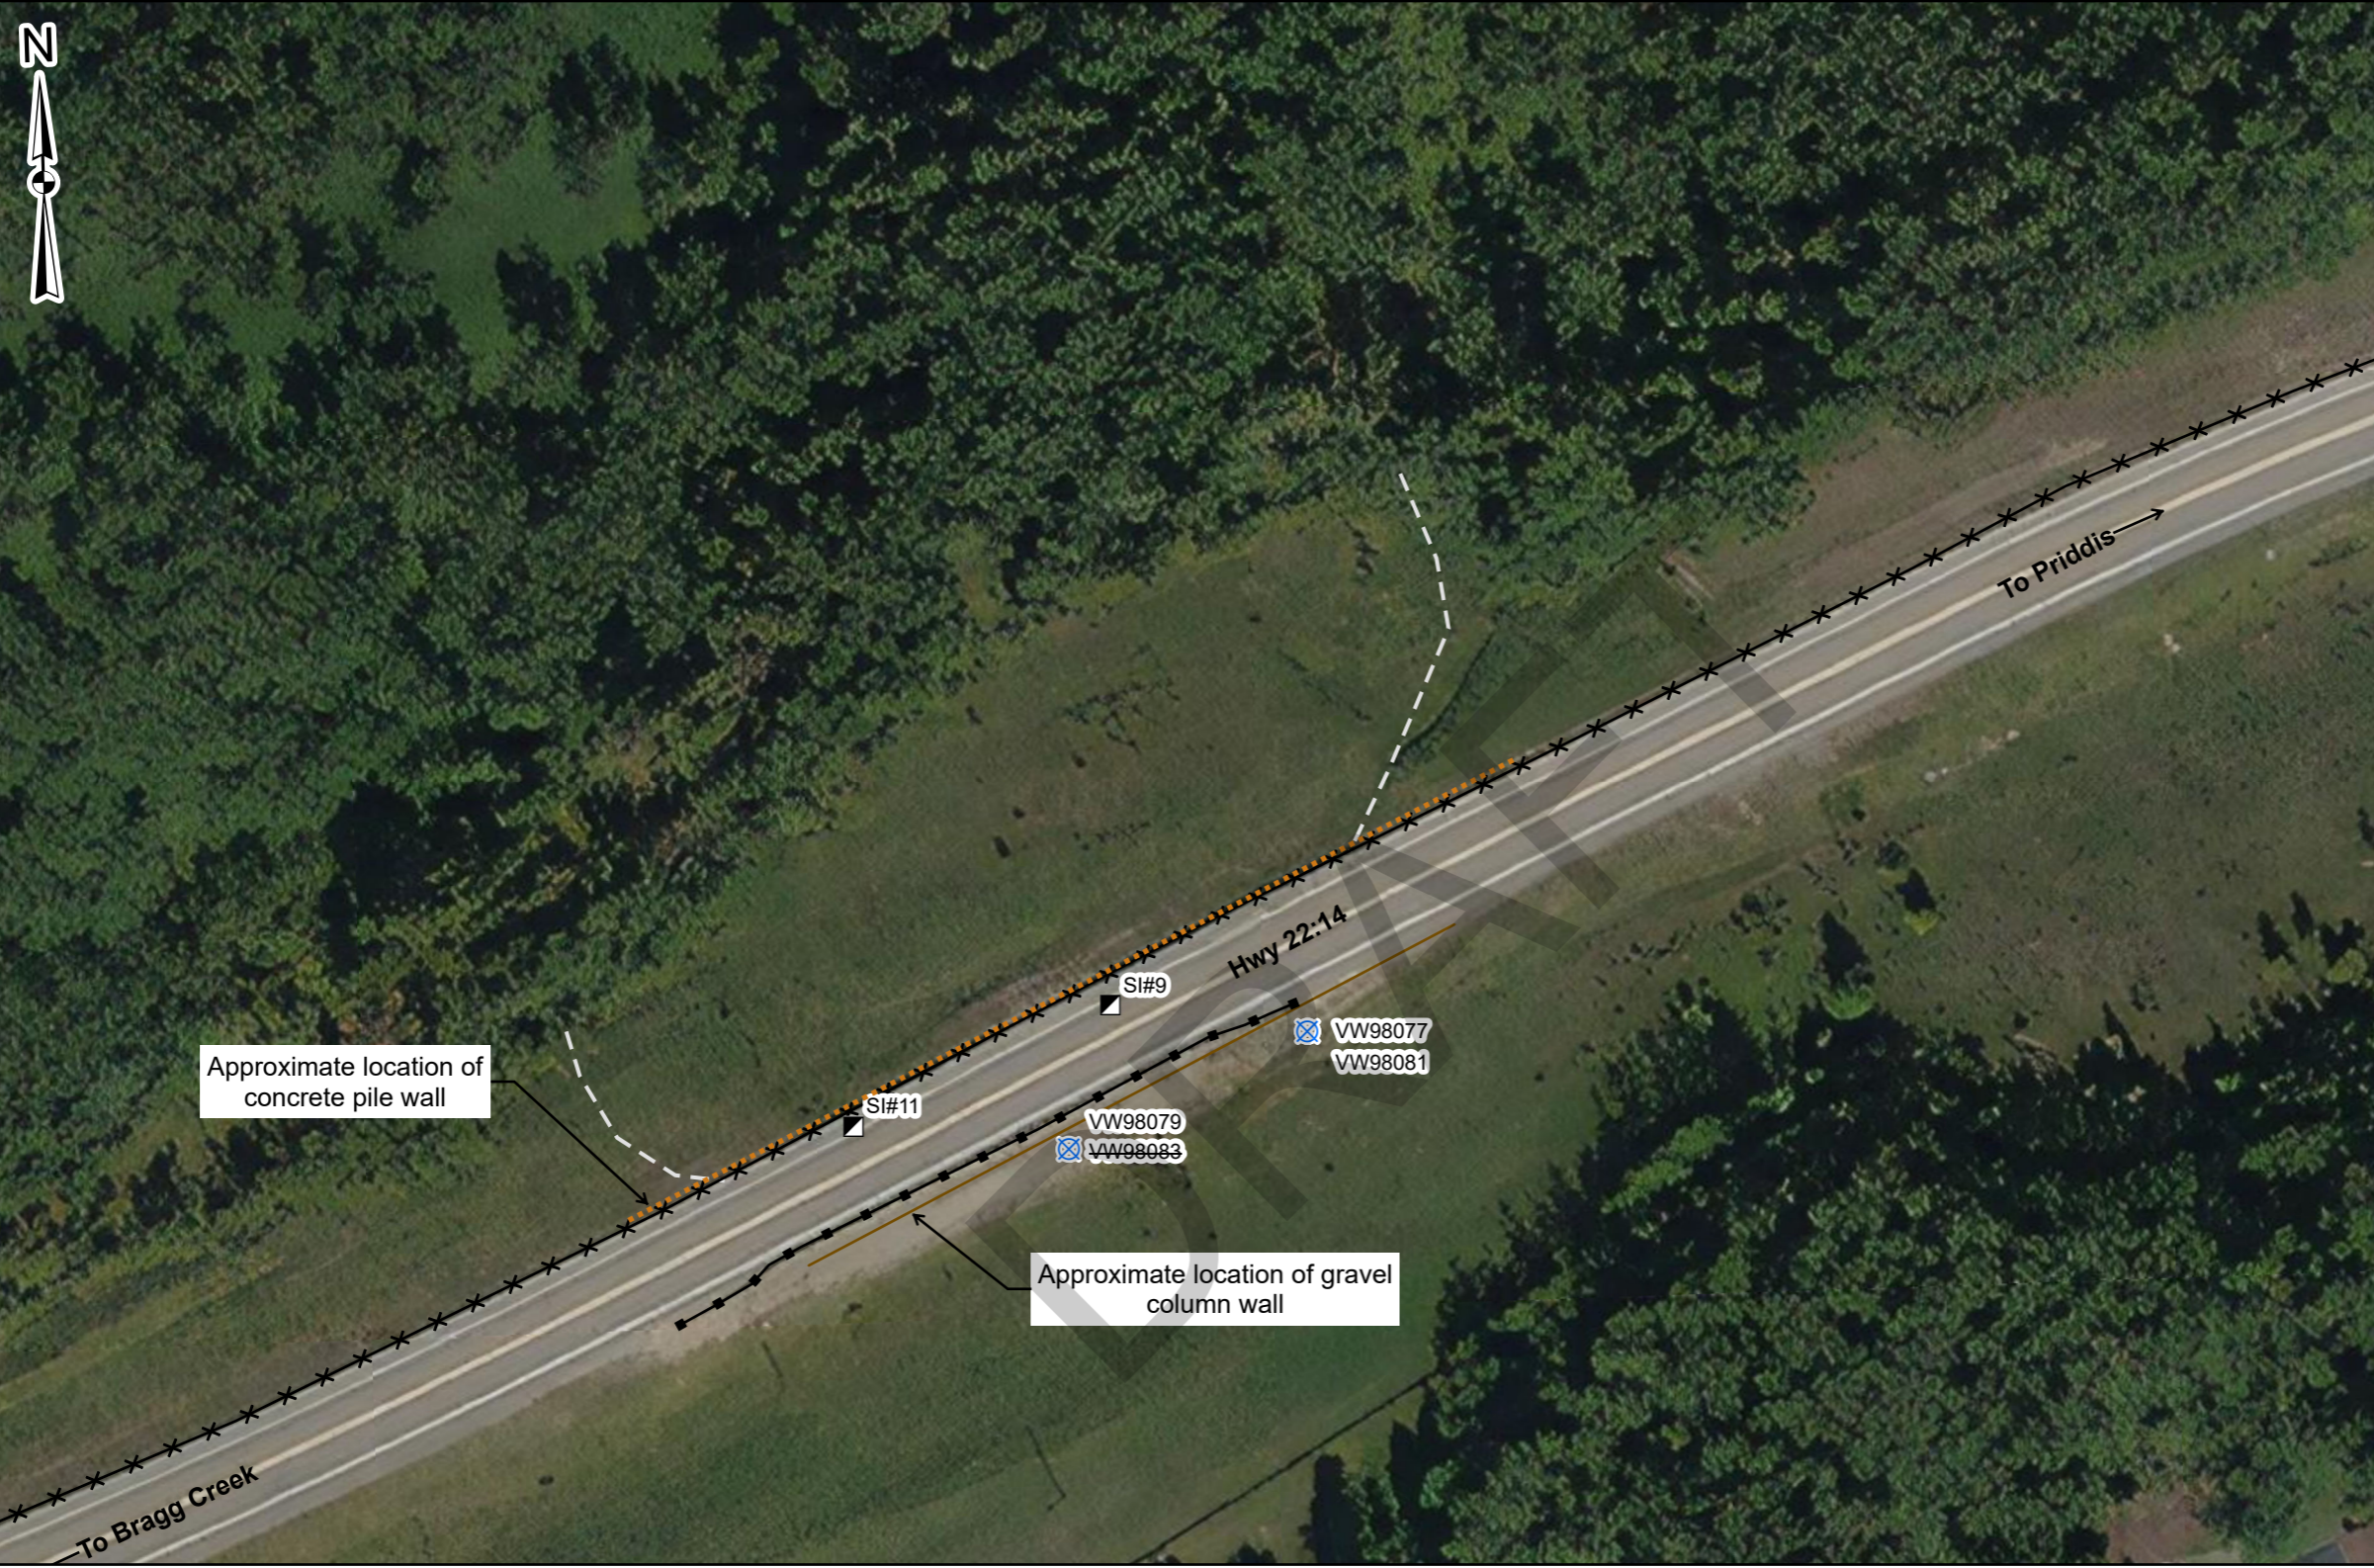
The geohazard at the S002 site consists of a slope failure on the north side of the highway which is impacting the westbound lane and north shoulder. Previous remedial actions at this site include installing a concrete pile wall in 1992, along the north shoulder (westbound lane) of Hwy 22:14 in an effort to stabilize the highway. Additionally, a row of gravel columns was installed on the upslope (south) side of the highway. Pumps were installed in two of the columns with water level activated switches (operable, but turned off during the winter months). Regular pavement patching has also been completed at the site.

No discernible movement has been recorded in SI#9 and SI#11 since KCB began reading the instruments in 2016. Both SIs are located above (upslope of) the concrete pile wall.

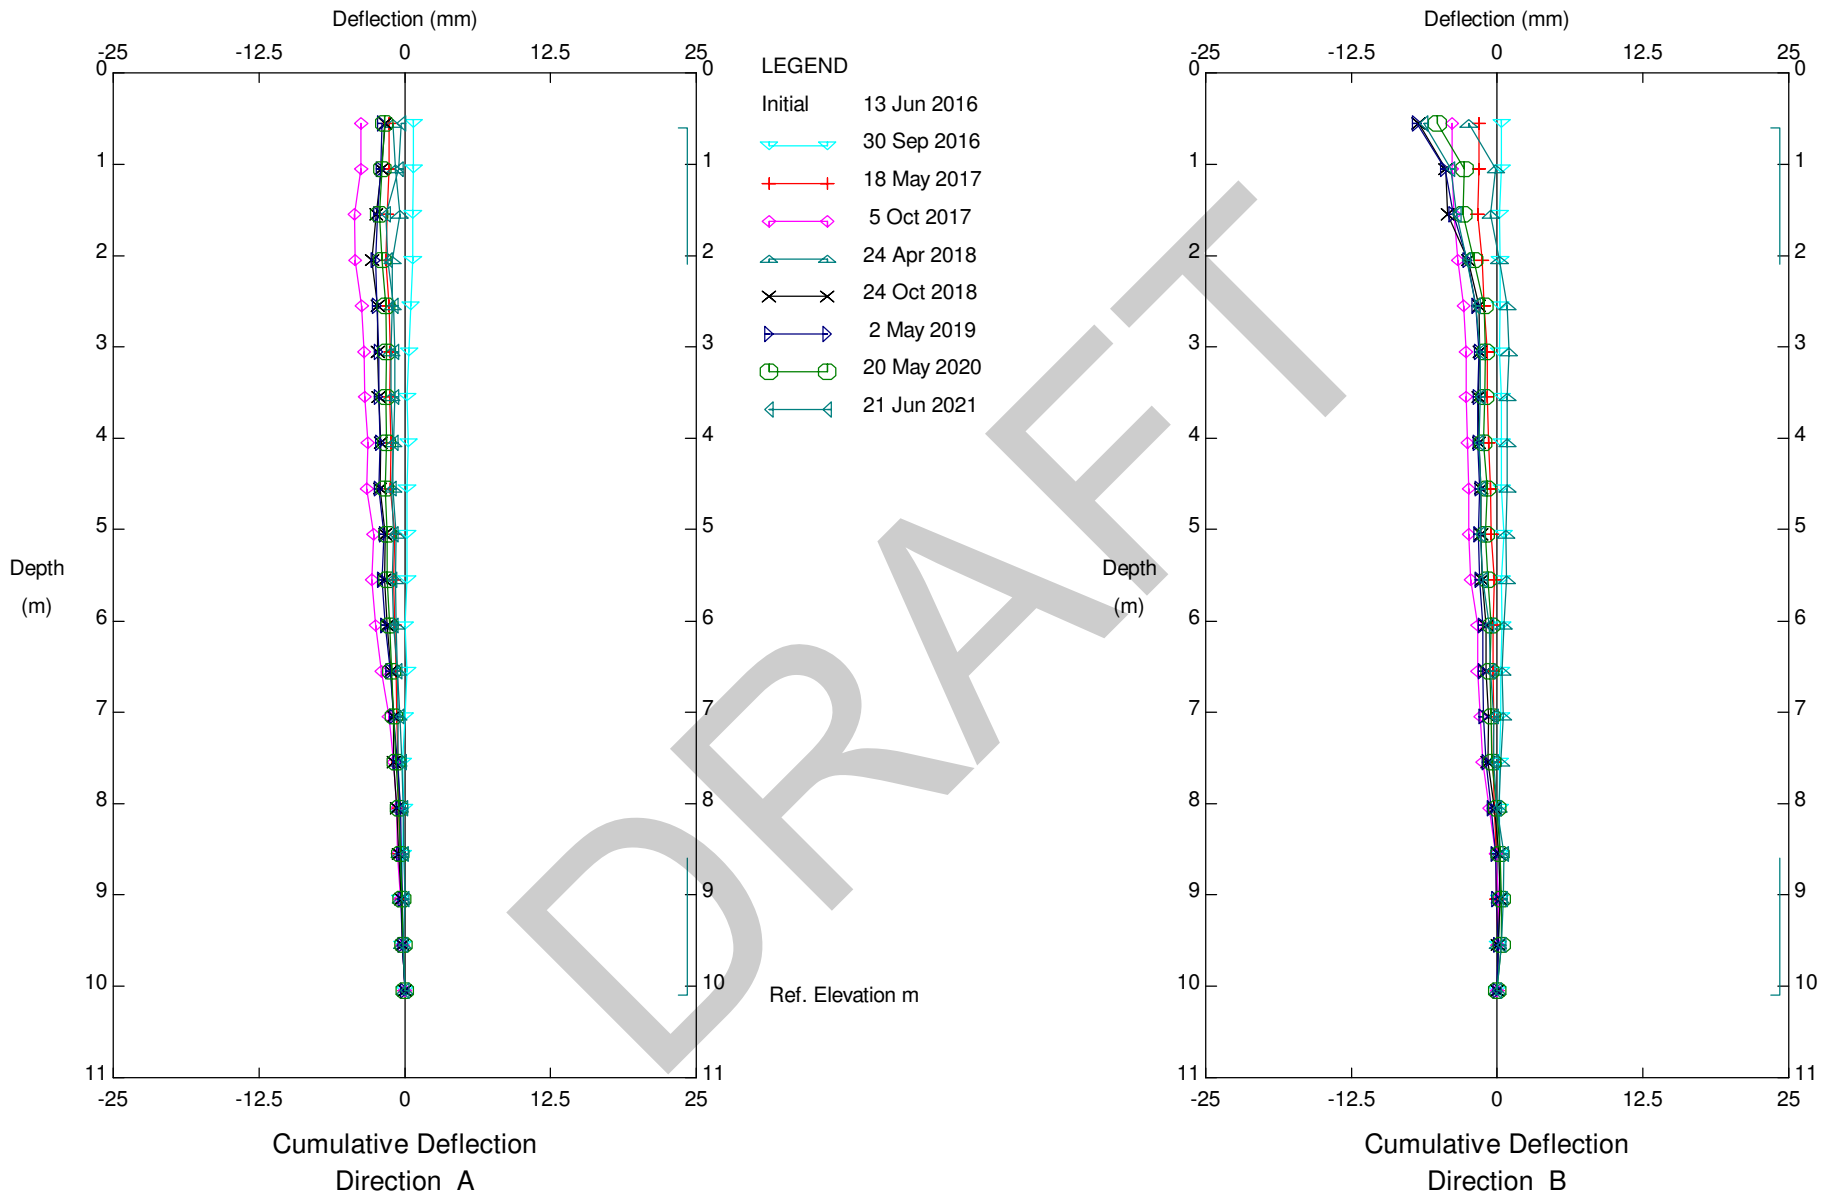
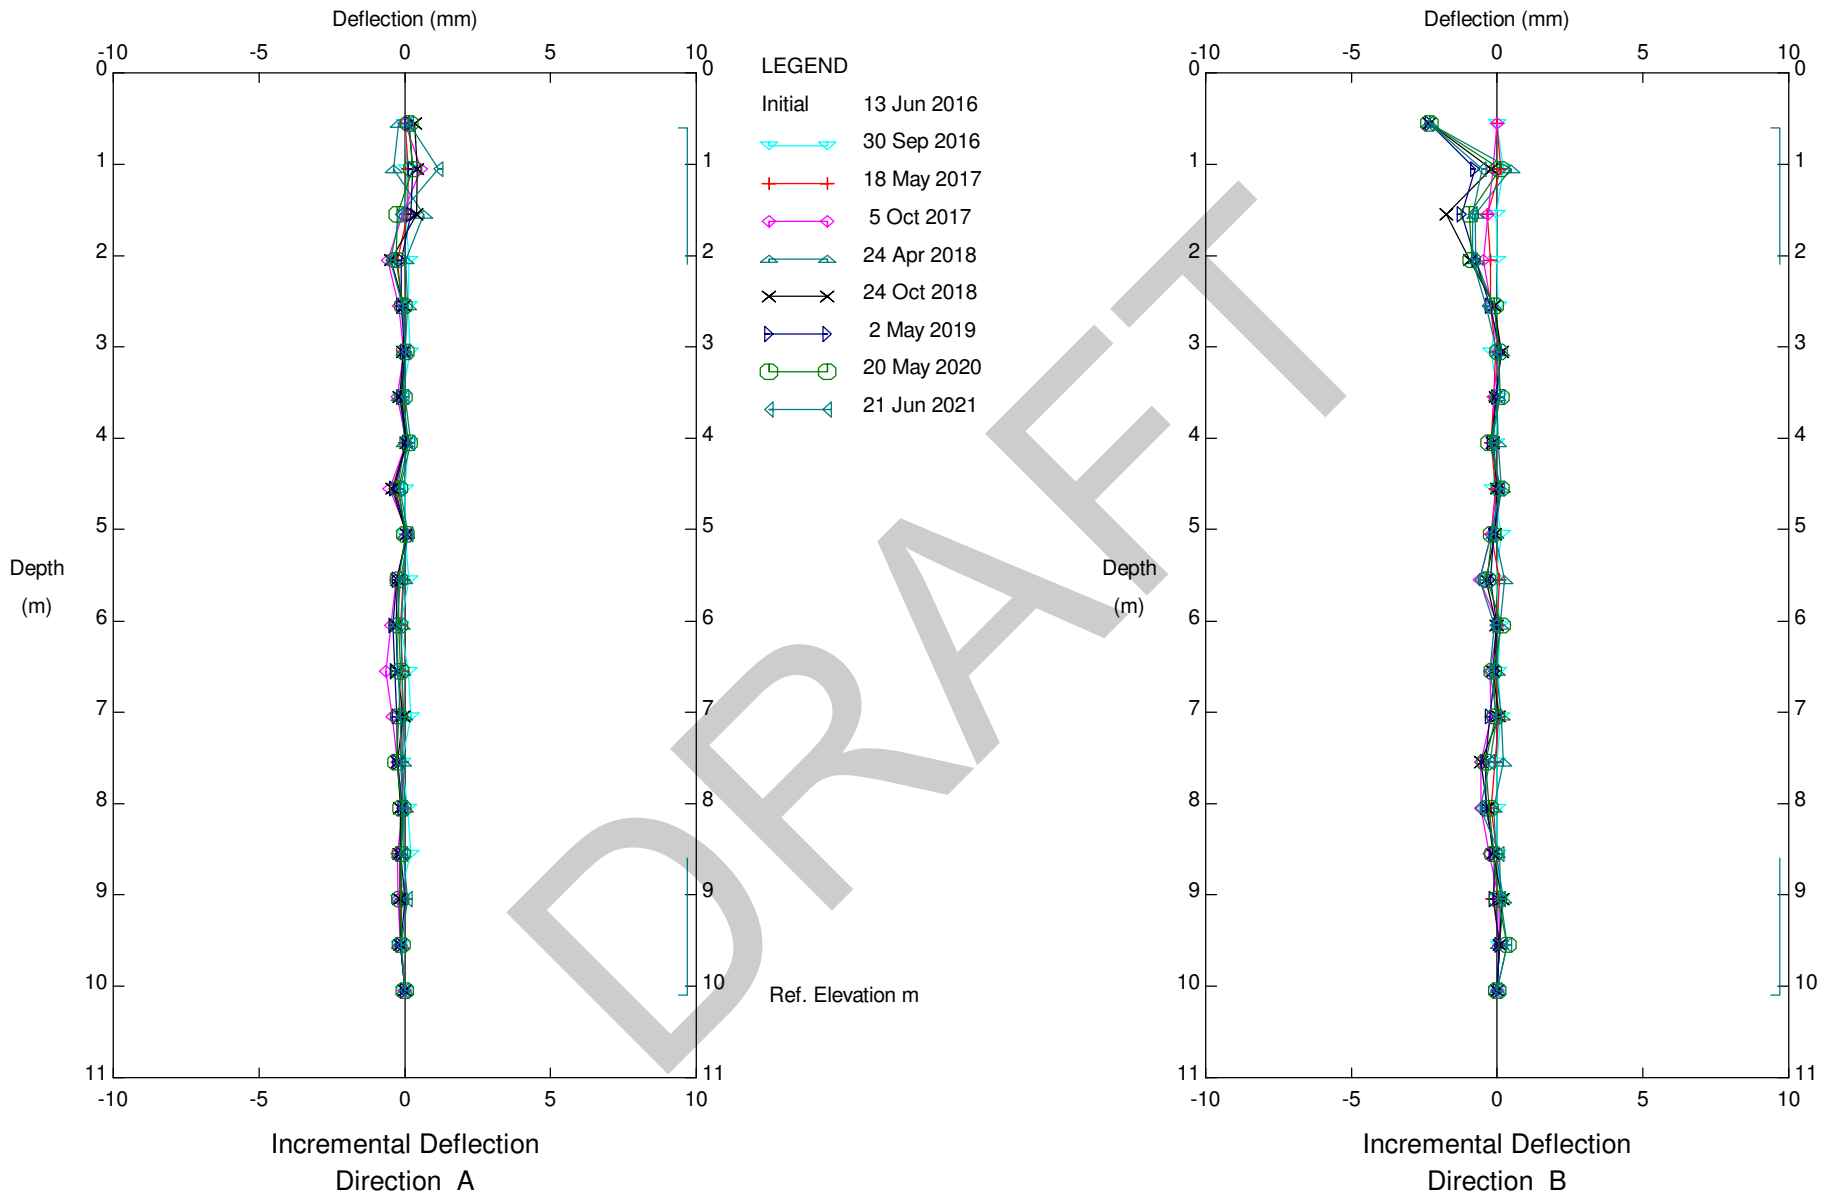
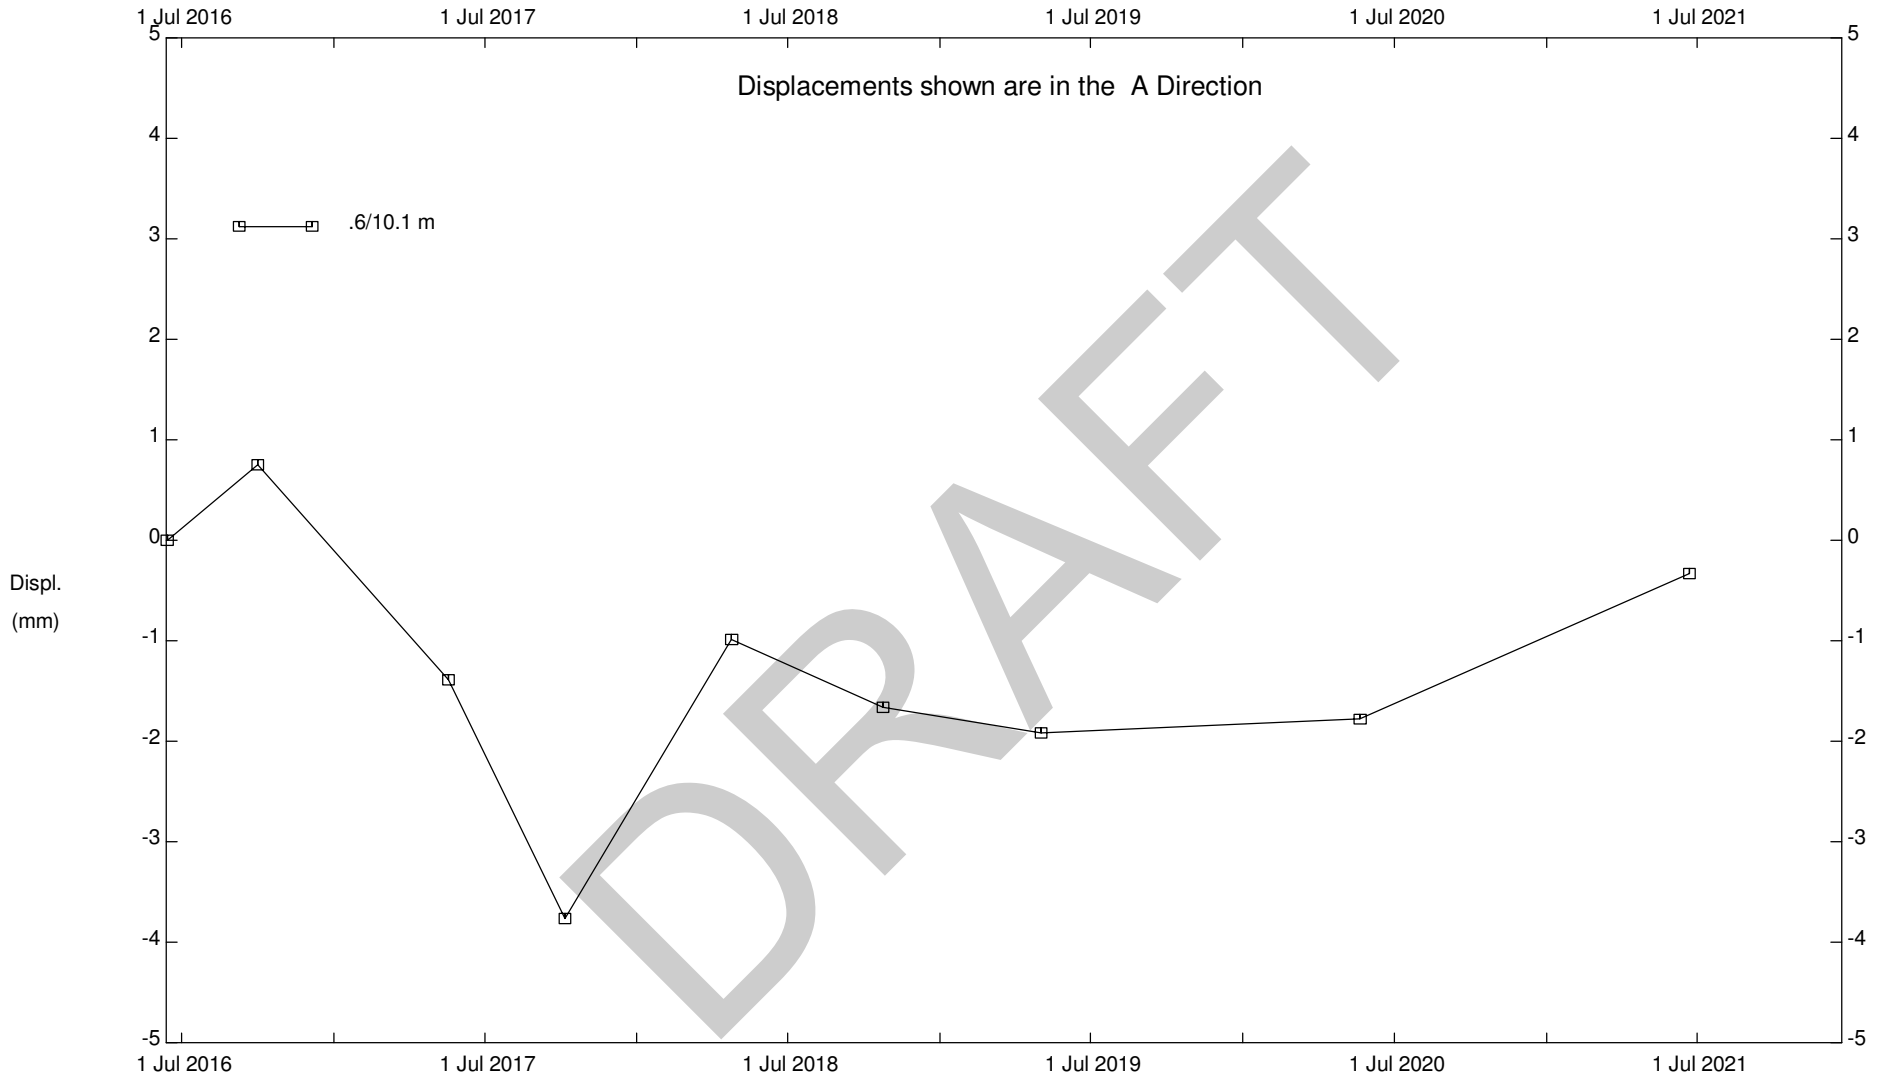
S002; H22:14, Priddis, Inclinator SI#9
Alberta Transportation

Distributed movement was reported by the previous consultant near surface in SI#9 from approximately 0 m to 2 m below ground surface (approximately El. 1300 m to El. 1298 m) and in SI#11 from approximately 0 m to 3 m below ground surface (approximately El. 1300 m to El. 1297 m).

With the majority of the movement in the SIs being recorded before 2014 (as reported by previous consultants) it appears as though the concrete pile wall has picked up load stabilizing the sliding mass and reducing the rate of movement.

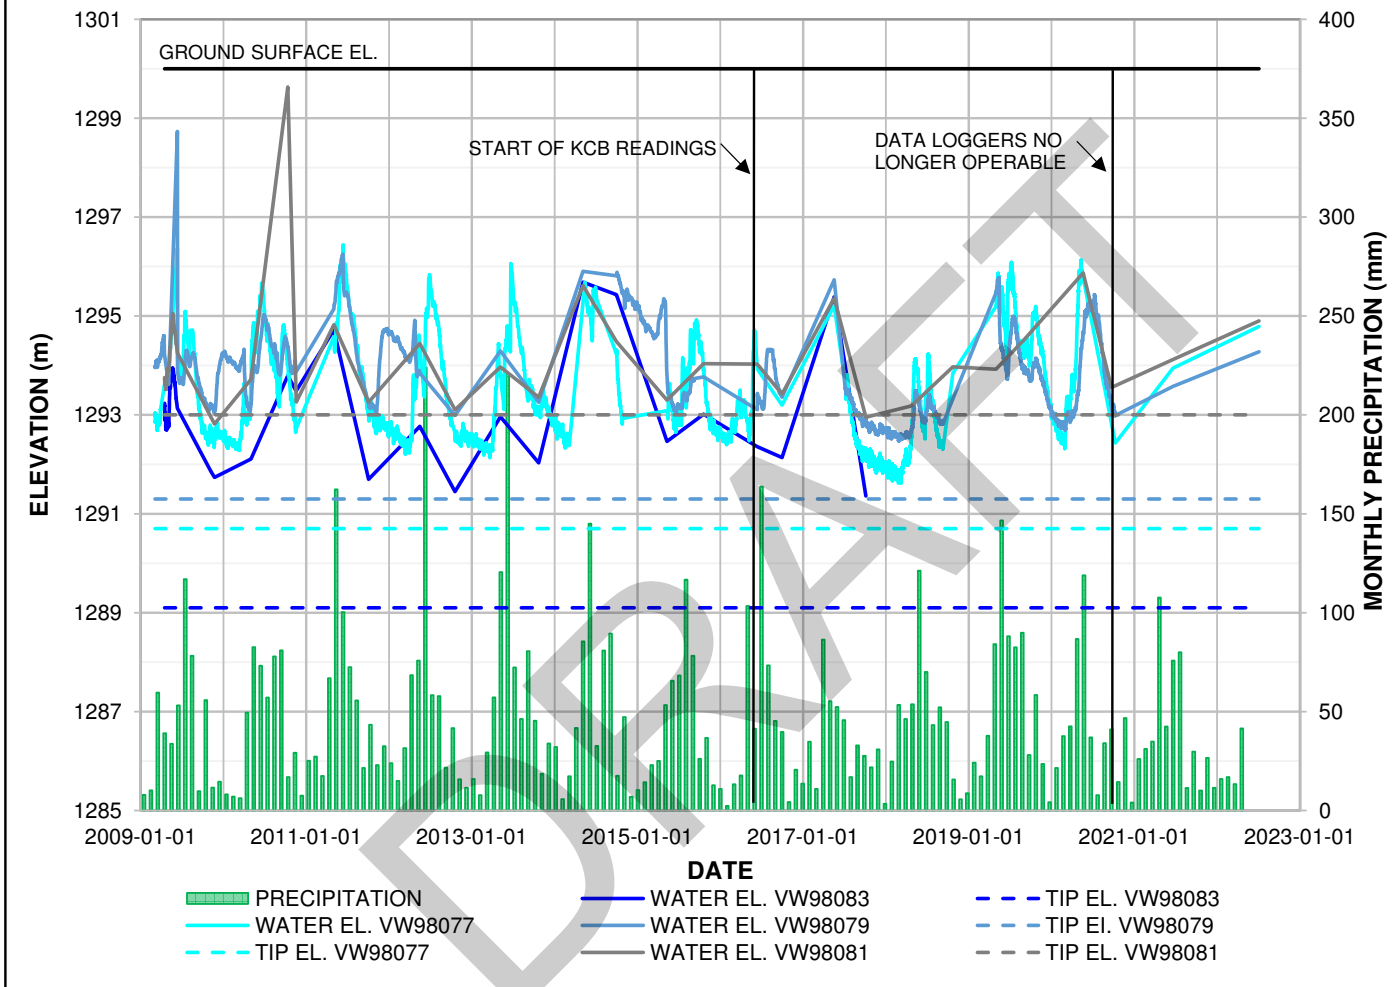
Piezometer Data
S002 - Priddis
Hwy 22:14, km 12.95

Since June 2021, a 0.6 m to 1.5 m increase in water level has been recorded in the three operable VWPs (VW98077, VW98079, and VW98081). Water levels recorded in the VWPs appear to fluctuate seasonally, with the spring readings typically being higher than fall readings.

1. MONTHLY PRECIPITATION DATA OBTAINED FROM THE ALBERTA CLIMATE INFORMATION SERVICE (ACIS) DATABASE, REFERENCING LEGAL SUBDIVISION T022R04W5.
2. VW98083 BECAME INOPERALBE BETWEEN THE FALL 2017 AND SPRING 2018 READINGS.

The operable instruments should continue to be read once per year (spring).
