SITE NUMBER AND NAME: S002 Priddis		HIGHWAY & KM: 22:14, 12.595	PREVIOUS INSPECTION DATE: June 9, 2020	INSPECTION DATE: May 9, 2023
LEGAL DESCRIPTION: 01-34-022-04 W5M	NAD 83 COORDINATES: UTM Northing Easting 11 5642606 678005		RISK ASSESSMENT: PF: 7 CF: 4 TOTAL: 28	
AVERAGE ANNUAL DAILY TRAFFIC: 2520 (east) & 2520 (west) (Ref. No. 62187)			CONTRACTOR MAINTENANCE AREA (CMA): 27

PRIMARY SITE ISSUE: Pavement cracking at the northwest edge of the highway caused by continued slope movement downslope of a concrete pile wall (unknown date of construction and unknown design details).

PROJECT SOUTHERN REGION GEOHAZARD RISK MANAGEMENT PROGRAM		
TITLE Site Plan S002 - Priddis Hwy 22:14, km 12.95		
SCALE 1:1,000	PROJECT No. A05116A03	FIG No. 1

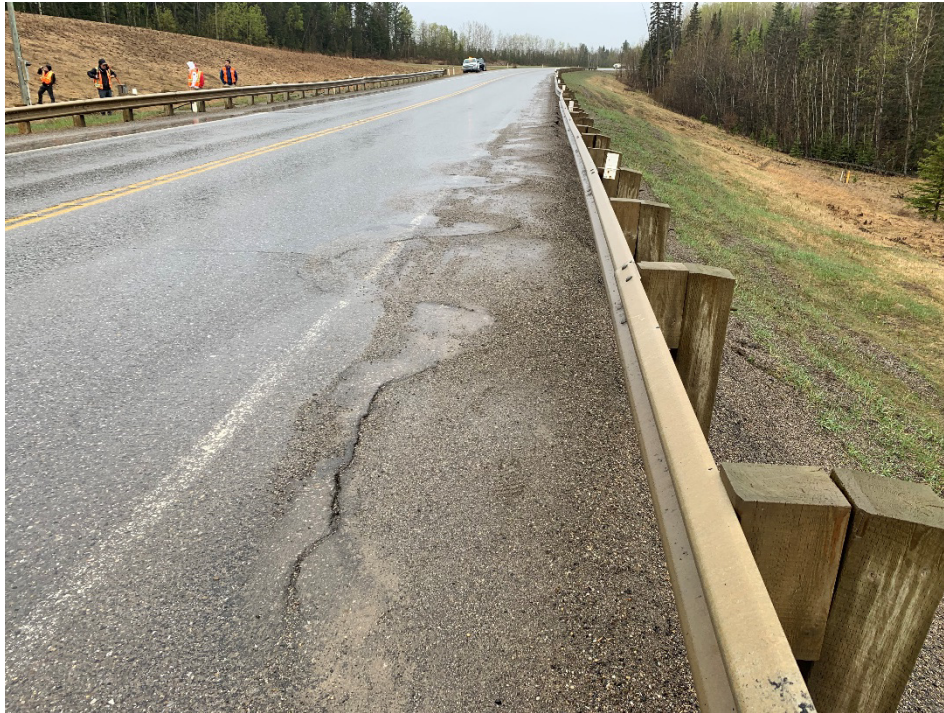
ITEM	CONDITION EXISTS		DESCRIPTION AND LOCATION	NOTICABLE CHANGE FROM LAST INSPECTION	
	YES	NO		YES	NO
Pavement Distress	X		Cracking and settlement of the north shoulder of the road surface was observed, between the guard rail and existing pile wall location. Depth of settlement around piles appears to be about the same in 2020. The pavement cracking at the east end of the slide extends the full width of the highway.		X
Slope Movement	X		There is an active slope failure to the north of the highway in front of the pile wall. Dip in guard rail.	X	
Erosion	X		None noted. Vegetation cover was continuous over the slide area.		X
Seepage	X		Seepage at the toe of the slope, from buried culvert.		X
Culvert Distress	X		Buried culvert appears to be discharging water into small pond at the toe of the slope.		X

Photo 1 Pavement distress at the location of the pile wall. Photo taken facing west on May 9, 2023.

COMMENTS
<p>Pavement cracks were patched a few years ago after the previous inspection in 2020, cracking has come though the patches. Cracking should be repaired by the maintenance contractor through patching. Cracking at the east extent of the slide across the highway surface appears unchanged since the previous inspection in 2020.</p>
<p>At the time of the site visit, the pumps in the gravel columns were operational with active discharge. The pumps are permanently installed in the wells and get turned on and off for winter. Pondered water was observed in the upslope ditch, adjacent to the discharge lines from the groundwater pumps.</p>
<p>No obvious increase in slope cracking was noted. Guard rail deflection appears unchanged from the 2020 site visit.</p>
<p>Seepage was noted at the tree line approximately in the centre of the slide upslope of a buried culvert. Seepage reports to a drainage channel, which contains standing water.</p>

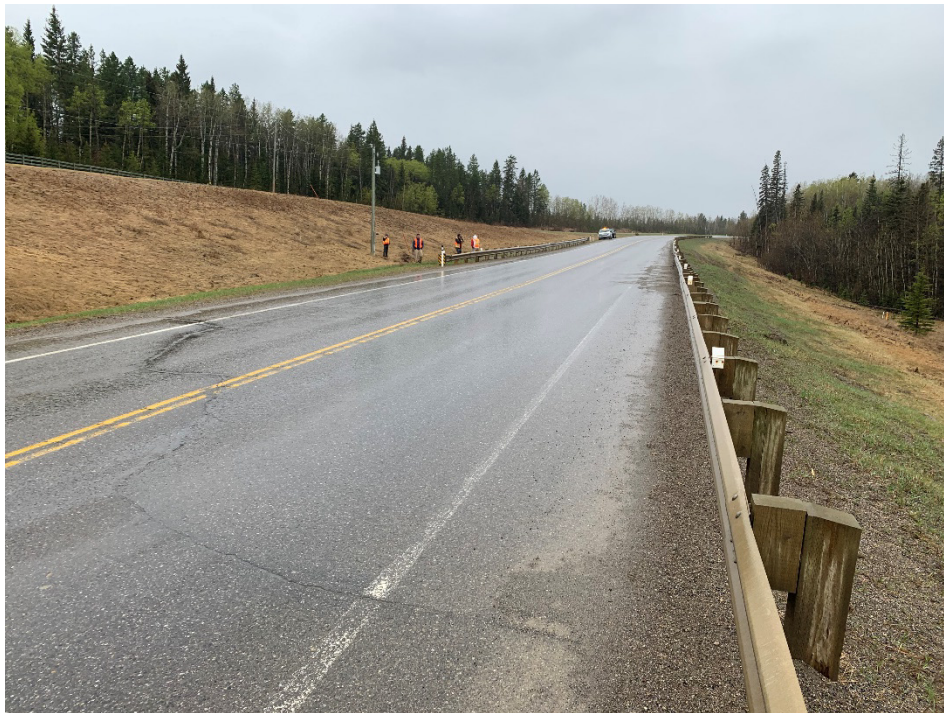
Photo 2 Cracking at the east extent of the slide on the highway. Photo taken facing west on May 9, 2023.

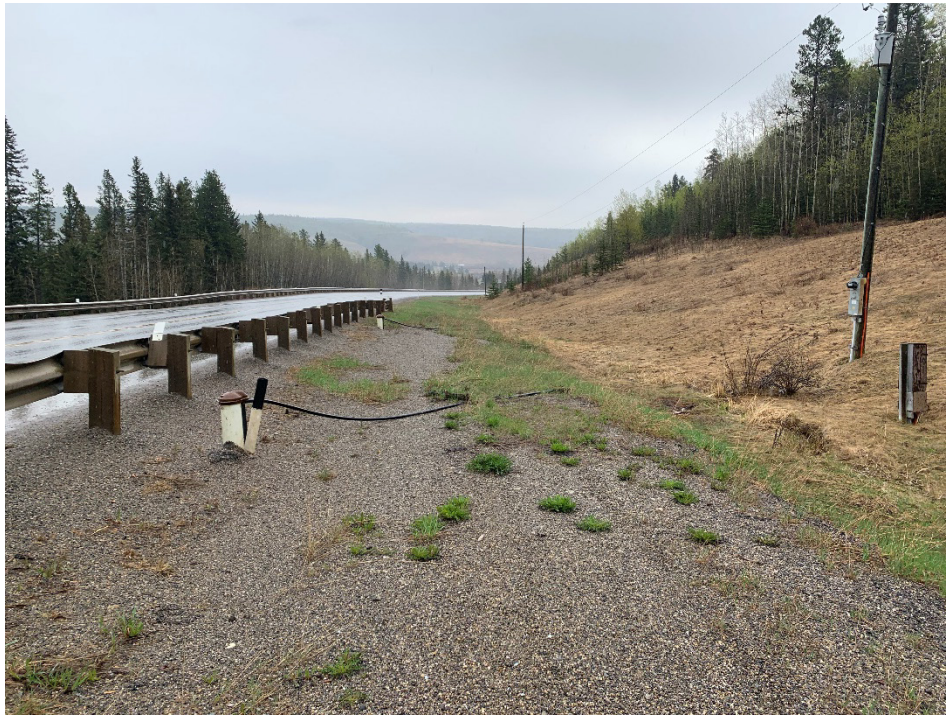
Photo 3 South ditch with pumps shown. Photo taken facing east on May 9, 2023.

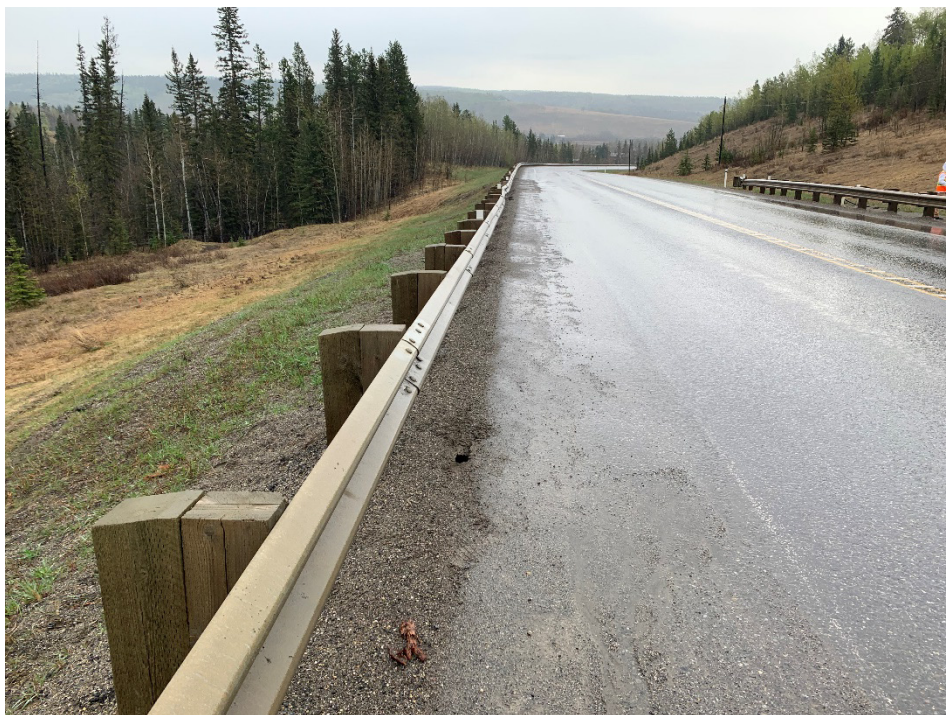
Photo 4 Cracking and hole in pavement at pile wall location. Photo taken facing east May 9, 2023.

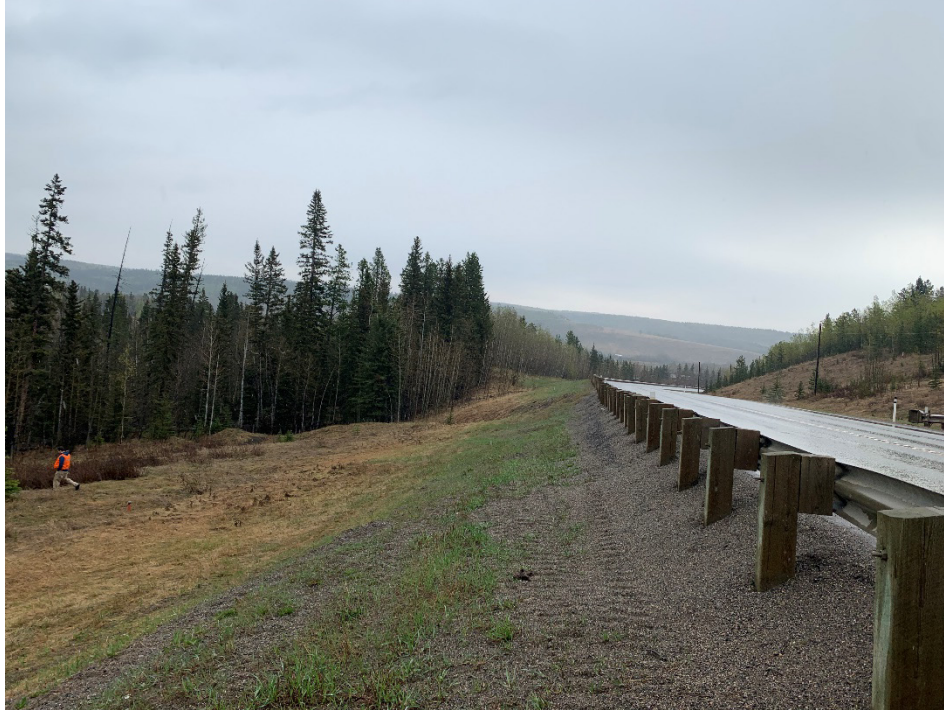
Photo 5 Embankment slope north of the highway. Photo taken facing east on May 9, 2023.

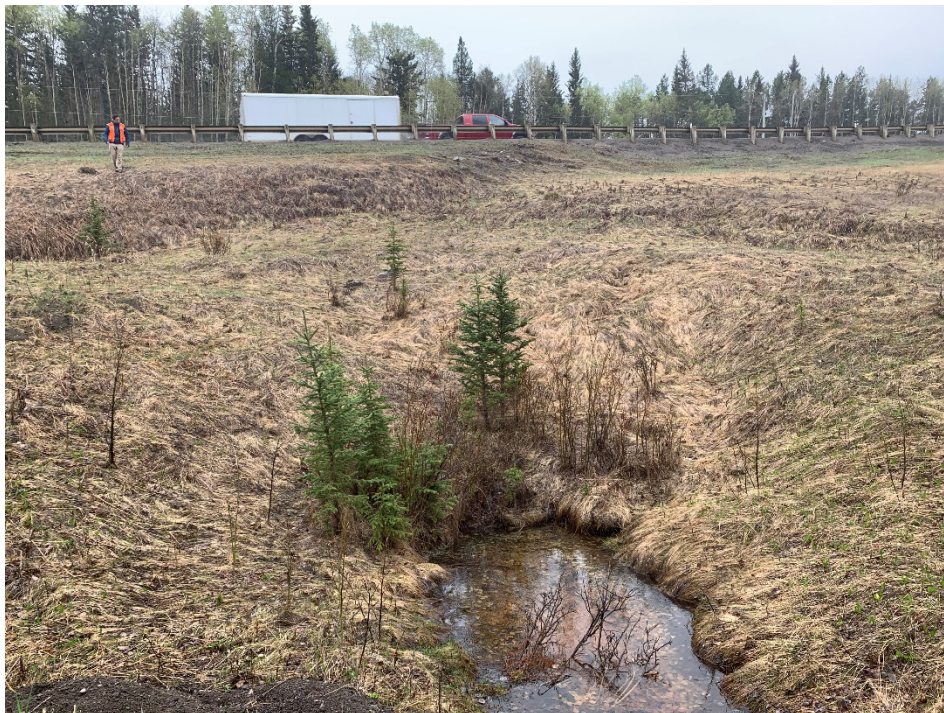
Photo 6 Ponded water at the toe of the slope. Photo taken facing south on May 9, 2023.
