SITE NUMBER AND NAME: S003 Cochrane		HIGHWAY & KM: 22:16, 9.875	PREVIOUS INSPECTION DATE: April 30, 2018	INSPECTION DATE: May 7, 2019
LEGAL DESCRIPTION: 06-34-025-04 W5M	NAD 83 COORDINATES: UTM Northing Easting 11 5672104 676003		RISK ASSESMENT: PF: 13 CF: 4 TOTAL: 52	
AVERAGE ANNUAL DAILY TRAFFIC (AADT): 19530 (north), 14900 (south) (Ref No. 70000075)			CONTRACTOR MAINTENANCE AREA (CMA): 28

PROJECT SOUTHERN REGION GEOHAZARD RISK MANAGEMENT PROGRAM		
TITLE Site Plan S003 - Cochrane Hwy 22:16, km 9.875		
SCALE 1:1,000	PROJECT No. A05115A03	FIG No. 1

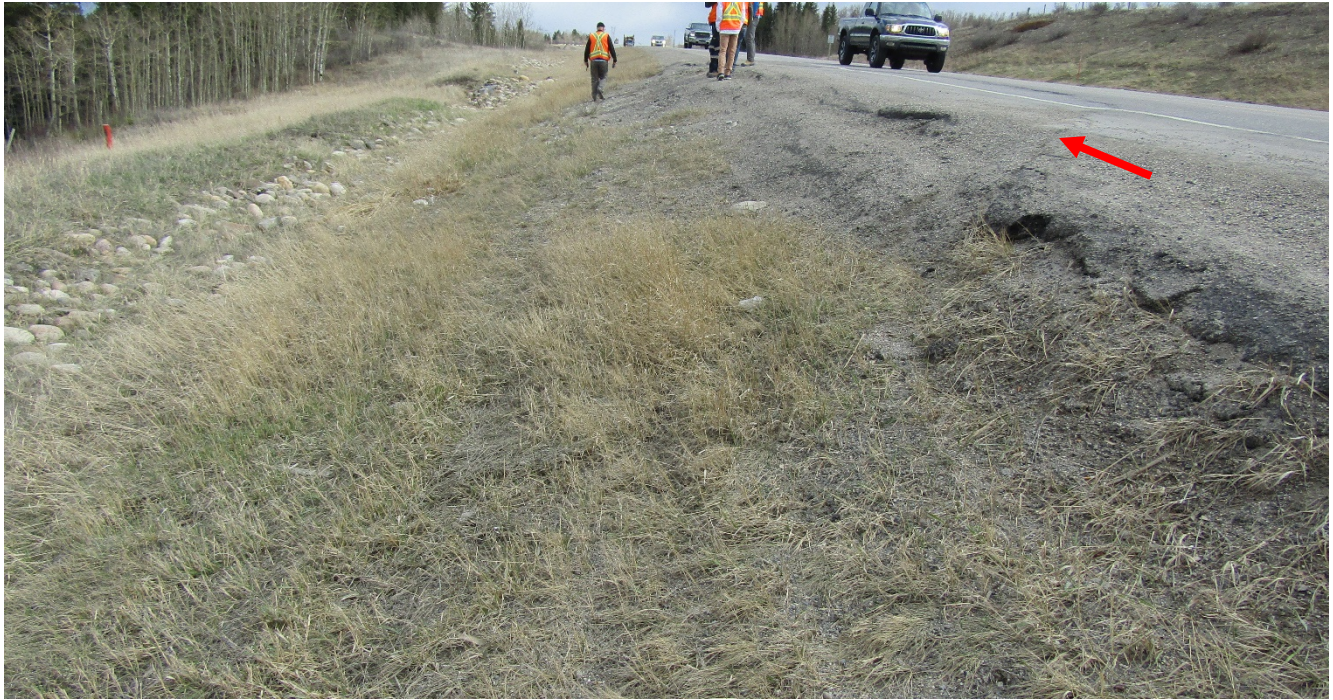
Photo 1 **Landslide affecting northbound lane approximately 3 m into the lane (red arrow).
Photo was taken facing southeast on May 7, 2019.**

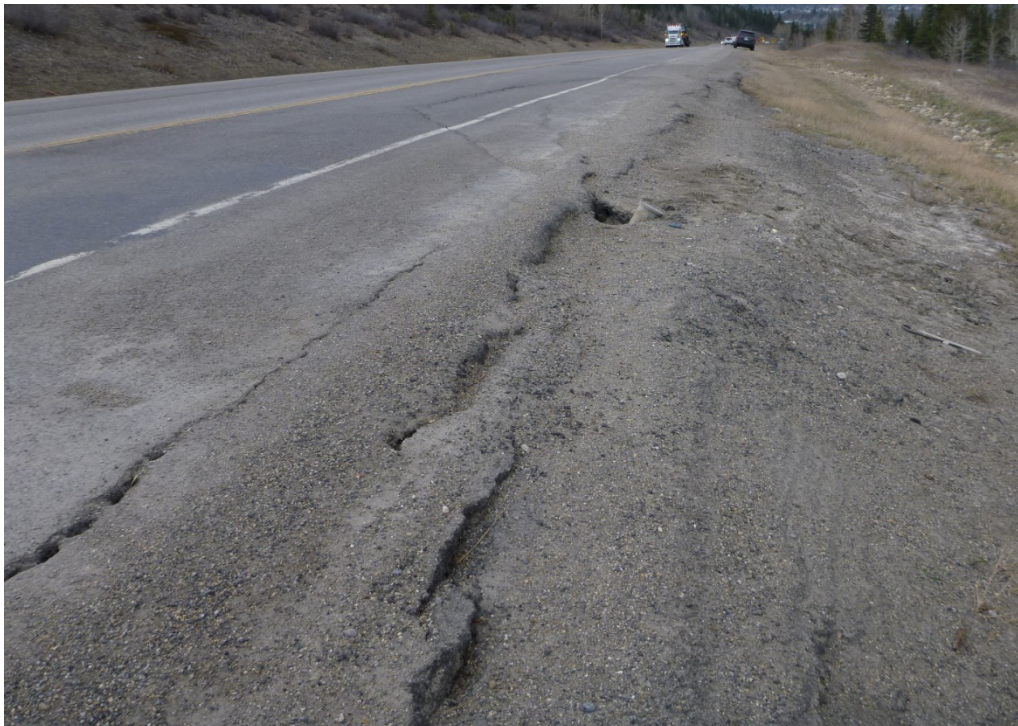
Photo 2 **Cracking and settlement on the highway shoulder. Photo taken facing northwest on
May 7, 2019.**

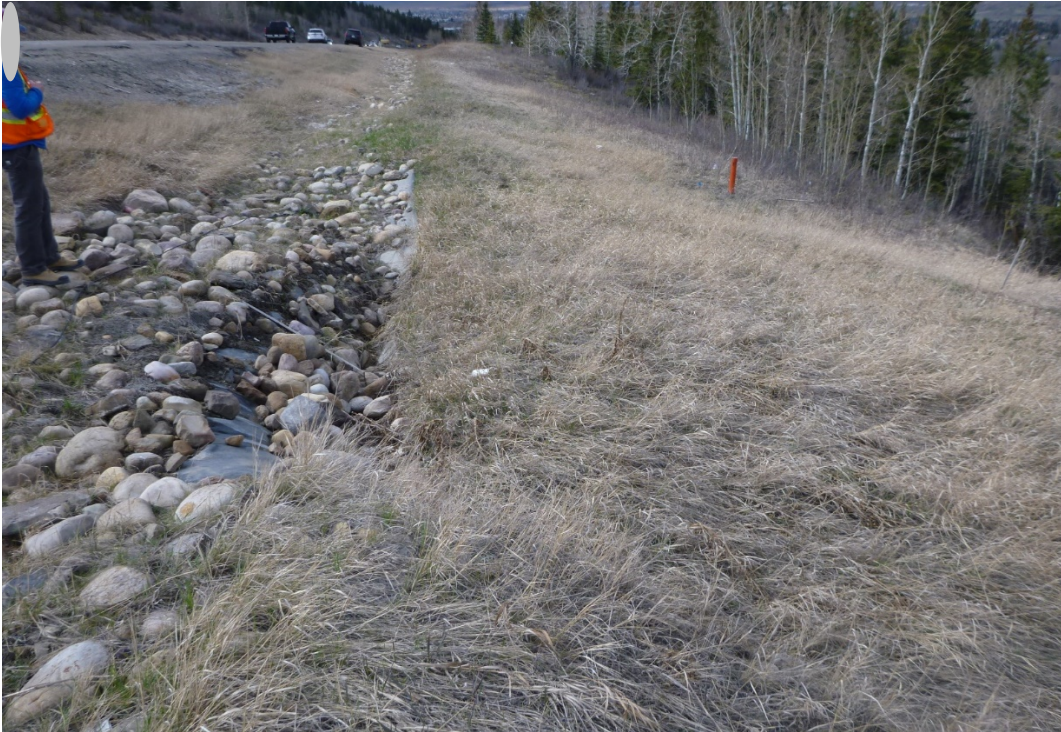
The highway ditch across slide area is lined with geomembrane and riprap, and has completely settled. Ditch now discharges directly into the slide zone and the geotextile is exposed. Pavement patching and crack sealing should continue, however surface runoff will continue to saturate the slide mass and exacerbate instability. Only one functional slope inclinometer remains at the site.

Photo 3 Complete settlement of the drainage ditch with exposed liner, surface water runoff now discharging directly onto the slide zone. Photo taken facing northwest on May 7, 2019.

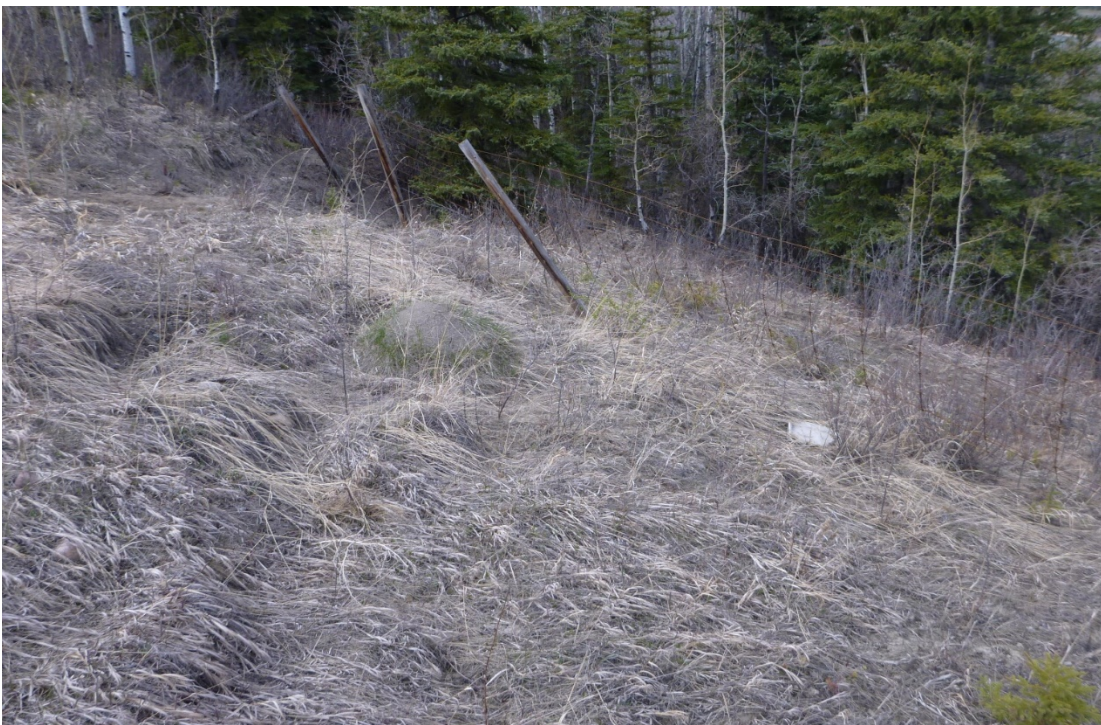
Fence across slide zone is deflected, undermined, and tipped over by slope movement.

Photo 4 Fence deflection due to slope movement. Photo taken facing north on May 7, 2019.

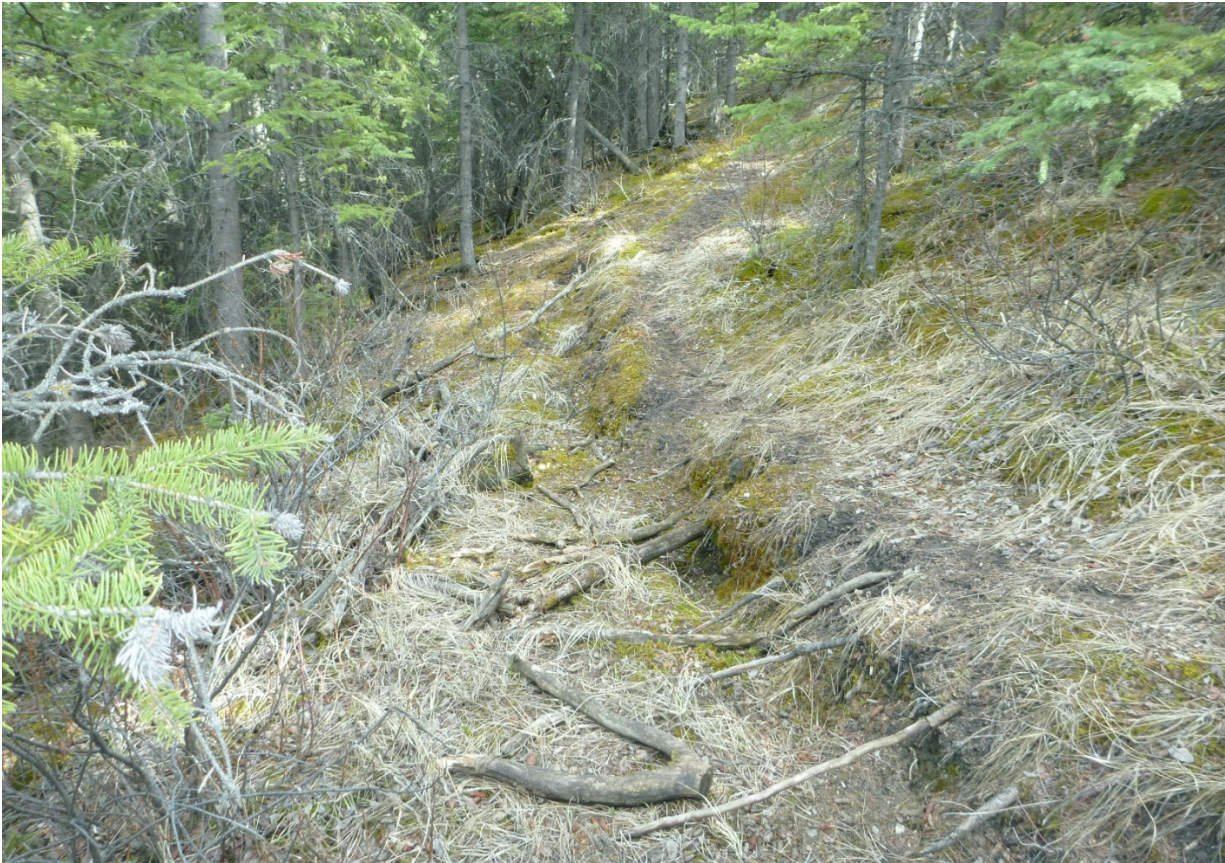
Shallow failures downstream correspond with runoff areas. Slope movement on the steeper section of the slope (outside of highway boundary) are visible, including tension cracking, erosion scars, and dislocated trees.

Photo 5 Slope movement in forested area to the east of the highway. Photo taken facing south on May 7, 2019.
