SITE NUMBER AND NAME: <b>S003 Cochrane</b>		HIGHWAY & KM: 22:16, 9.875	PREVIOUS INSPECTION DATE: May 7, 2019	INSPECTION DATE: <b>June 8, 2020</b>
LEGAL DESCRIPTION: 06-34-025-04 W5M	NAD 83 COORDINATES: UTM Northing Easting 11 5672104 676003		RISK ASSESMENT: PF: 13 CF: 4 TOTAL: 52	
AVERAGE ANNUAL DAILY TRAFFIC (AADT): 20860 (north), 16690 (south) (Ref. No. 70000075)			CONTRACTOR MAINTENANCE AREA (CMA): 28

NOTES: 1. HORIZONTAL DATUM: NAD83 2. GRID ZONE: UTM Zone 11N 3. IMAGE SOURCE: World Imagery from ArcGIS Online. Source date January 1, 2017	CLIENT	PROJECT
		SOUTHERN REGION GEOHAZARD RISK MANAGEMENT PROGRAM
	TITLE Site Plan S003 - Cochrane Hwy 22:16, km 9.875	
SCALE 1:1,000	PROJECT No. A05115A03	FIG No. 1

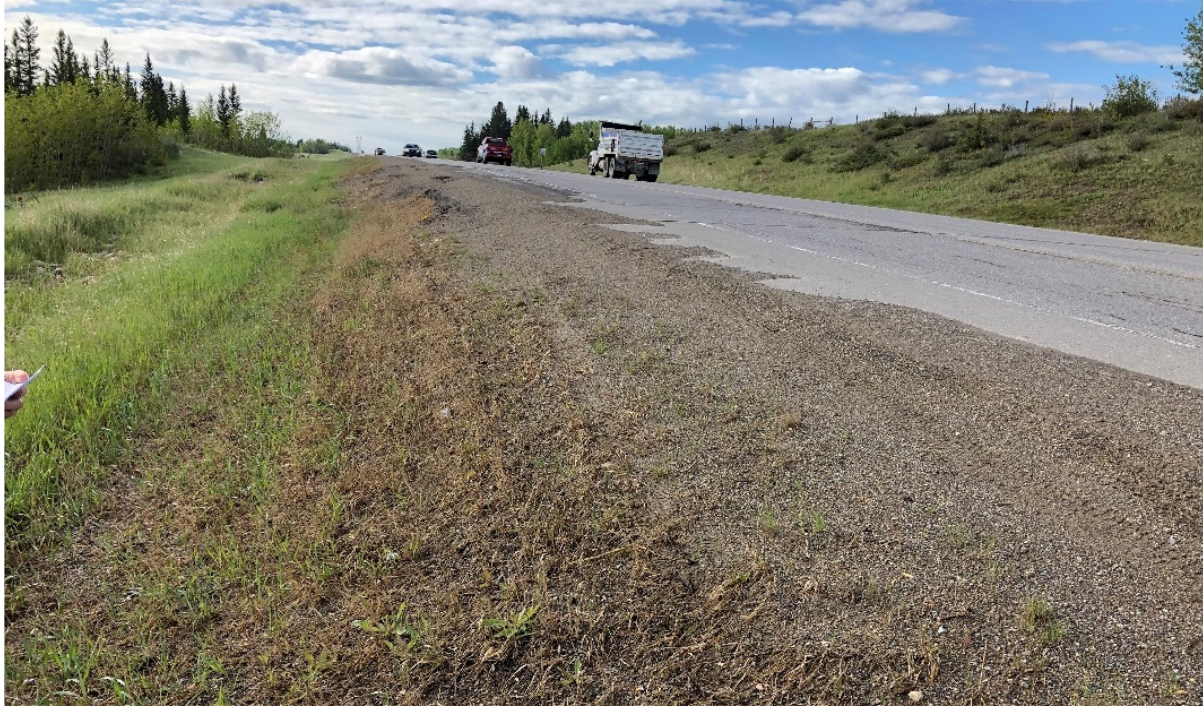
SUMMARY OF SITE INSTRUMENTATION:  4 functional piezometers and 1 functional slope inclinometer  LAST READING DATE: May 2020		INSPECTED BY: Chris Morgan (KCB) Margot Lederman (KCB) Roger Skirrow (AT) Alex Frotten (AT)
PRIMARY SITE ISSUE: Slope instability affecting northbound lane, approximately 3 m into northbound lane. Landslide appears to be related to seepage and deeper instability located downslope.		
APPROXIMATE DIMENSIONS: Embankment slope (within highway boundary) is approximately 10 m high and sloped at 3H:1V. Natural slope below embankment is quite high (over 30 m) and there is a zone of landsliding at the outside bend of the Bow River. Embankment slide area is approximately 50 m by 50 m in area of highway with 4 m to 9 m slide depth.  Sliding below the highway embankment appears to be shallow but has the potential to undermine and exacerbate the sliding at the highway embankment. The valley slope below the main slide area has a slope angle of 70%.

**Photo 1**      **Landslide affecting northbound lane. Photo was taken facing southeast on June 8, 2020.**

Long-term plans at this site include twinning on the uphill side. A design has been submitted by KCB which includes a pile wall to stabilize the existing highway lanes, drainage, and an improved ditch. The ditch should be lined and be upslope of the pile wall to maintain ditch integrity. The pile wall is planned to be installed off the northbound lane shoulder, and design allowed for an additional lane width of fill on the east side of the highway (to account for loading when the highway is twinned). Pile wall construction is scheduled for 2021.

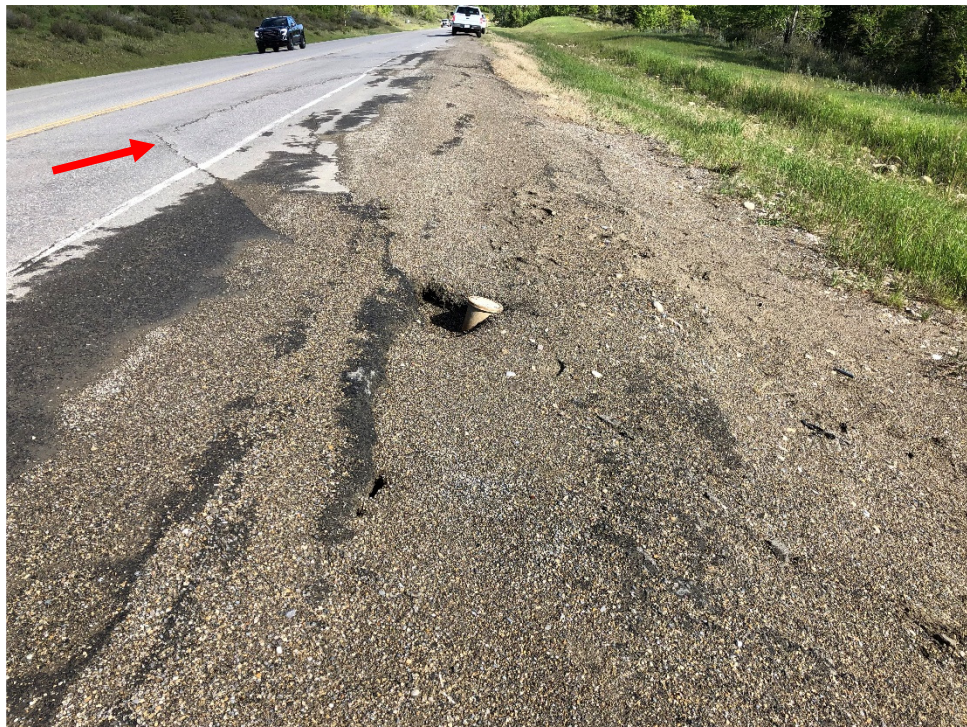
**Photo 2**      **Cracking and settlement on the highway shoulder approximately 3 m into the lane (red arrow). Photo taken facing northwest on June 8, 2020.**

Standing water was present in the ditch. Water discharges directly onto the slide zone and the geotextile is exposed. Pavement patching and crack sealing should continue; however, surface runoff will continue to saturate the slide mass and exacerbate instability. Only one functional slope inclinometer remains at the site.

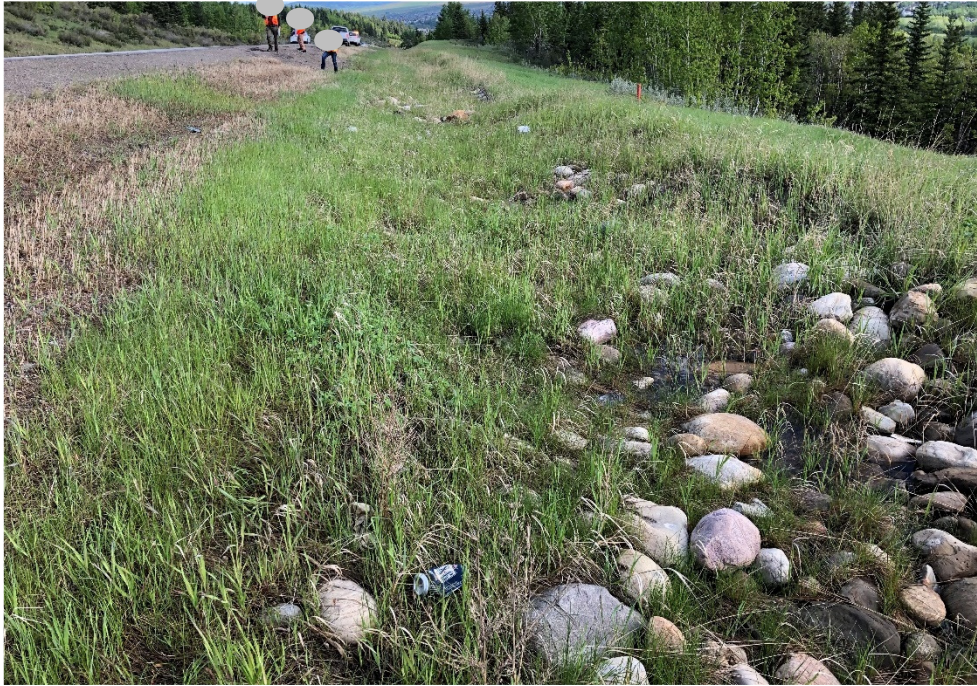
ITEM	CONDITION EXISTS		DESCRIPTION AND LOCATION	NOTICABLE CHANGE FROM LAST INSPECTION	
	YES	NO		YES	NO
Pavement Distress	X		Increased settlement and cracking on northbound lane and shoulder.	X	
Slope Movement	X		Cracking and settlement on shoulder of highway. Slides observed downslope in wooded area. Toe roll and slope cracking appear more pronounced than in 2019.	X	
Erosion	X		Downslope of highway boundary.	X	
Seepage	X		Downslope of toe roll.	X	
Culvert Distress		X	None present.		X
<b>COMMENTS</b>					
Site has deteriorated since 2019 site visit and the pavement appears to have settled. Cracking at edge of pavement appears to have enlarged since 2019 and is up to 40 mm wide and 400 mm depth (possibly full depth of pavement). Additional feather cracking observed 35 m southeast from VWP18-02.					
Fence across slide zone is deflected, undermined, and tipped over by slope movement.					
The highway ditch across the slide area is lined with geomembrane and riprap, and has completely settled.

**Photo 3** Complete settlement of the drainage ditch with exposed liner, surface water runoff now discharging directly onto the slide zone. Photo taken facing northwest on June 8, 2020.

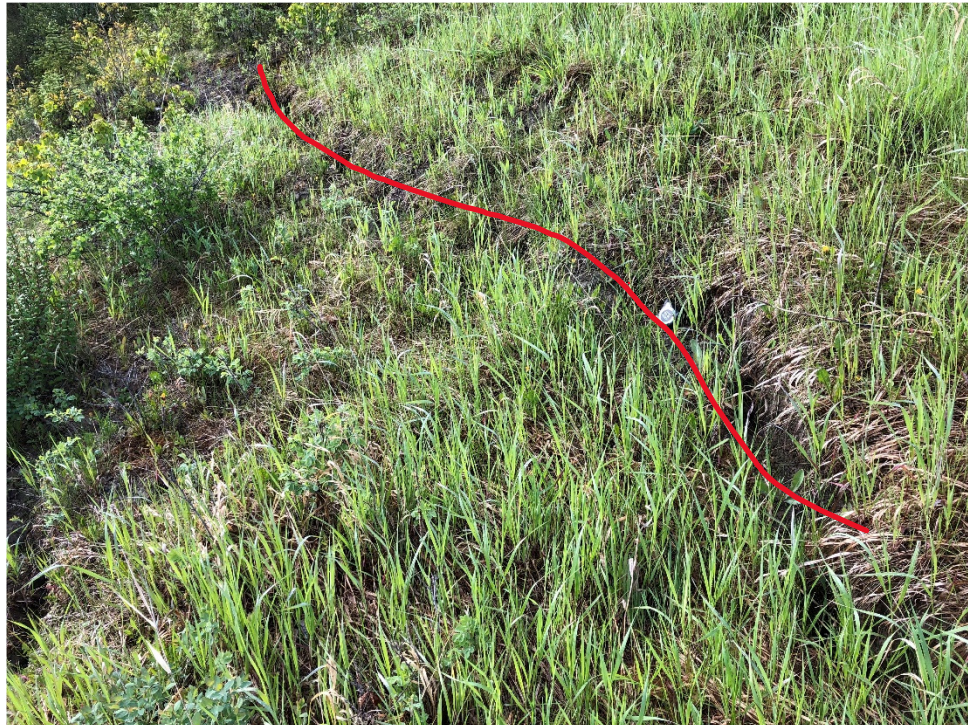
Shallow failures downstream correspond with runoff areas. Slope movement on the steeper section of the slope (outside of highway boundary) are visible, including tension cracking, erosion scars, and leaning trees. Some sections of the slide are moving faster than others.

**Photo 4** Tension cracking near fence line due to midslope movement (minor scarp). Photo taken facing north on June 8, 2020.
